**COASTAL ROCK POOL SURVEY**

**OPTIONS AND RECOMMENDATIONS**

**JANUARY 2010**

Report Yamba Rock Pool January 2010 compiled by Greig McDowall Coordinator Open spaces East

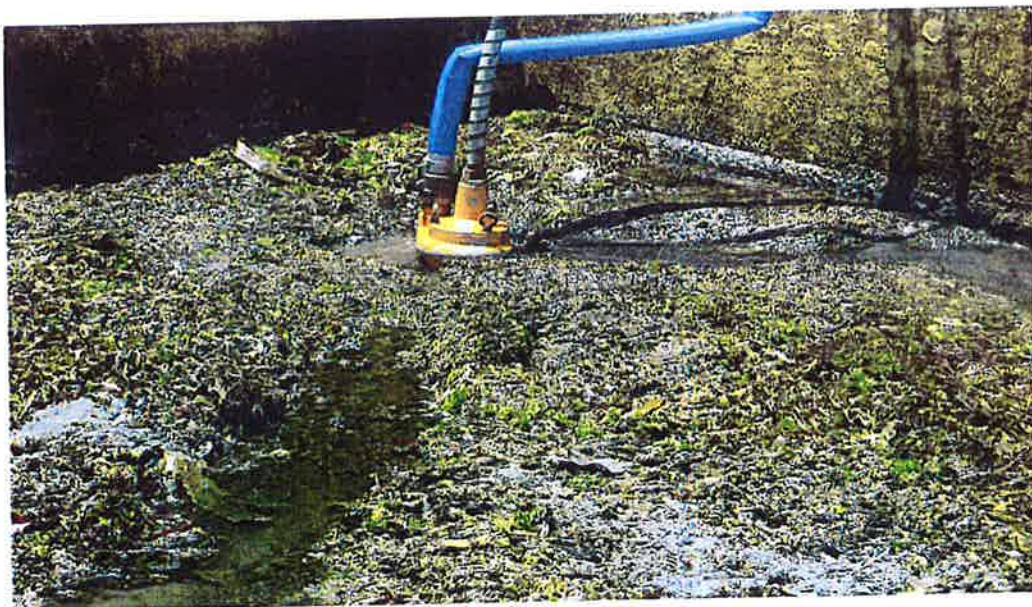
**“The seaweed that is trapped in the pool eventually starts to rot and break down”**

Since the report in May 2009 the cracks have become wider making the pool less capable of holding water especially in times of low swell and small tides. Several attempts have been made since then to repair these holes/cracks, which have been mainly unsuccessful, the reason being “we are trying to repair on repairs”. In some cases the crack has widened so much that the water pressure blows the patching material from the hole.

- Replacing worn damaged sections of the pool that are affected by Concrete Cancer is recommended. Although it may seem an expensive option to replace these affected sections, experience has shown that if at first you attempt to repair you will only end up replacing, adding extra costs to the project. It is more prudent to plan their staged replacement.

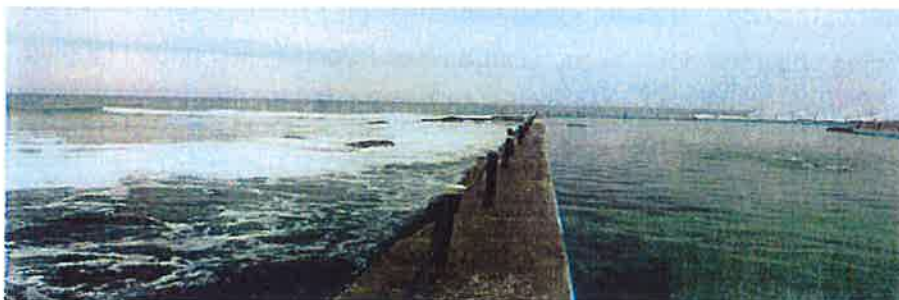
**“Curl Curl planned replacement North wall 2010”**

- Replace damaged sections of rock pools. All pools surveyed facing similar problems of structural integrity, as part of their management strategy have planned removal and replacement of damaged sections (Dee Why 2009 replaced North wall, Curl Curl planned replacement North wall 2010).

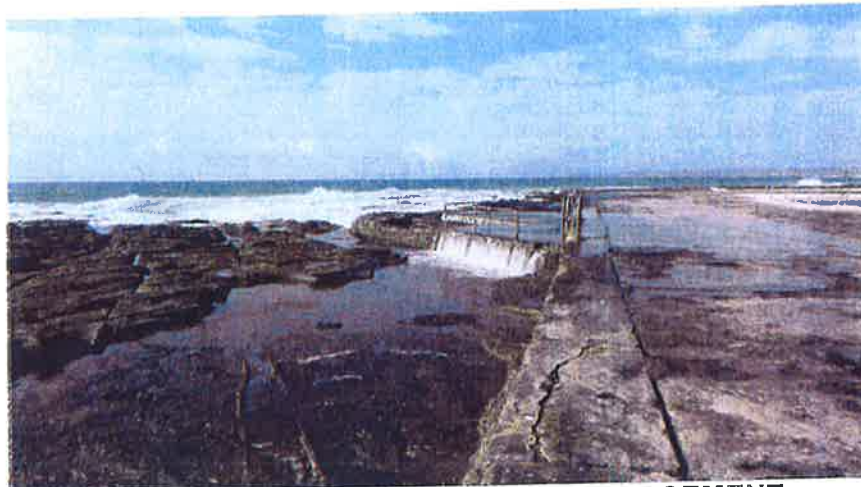
**PROMENADE SCHEDULED FOR REPLACEMENT**

- An active maintenance program is in place with major replacement of the promenades planned.

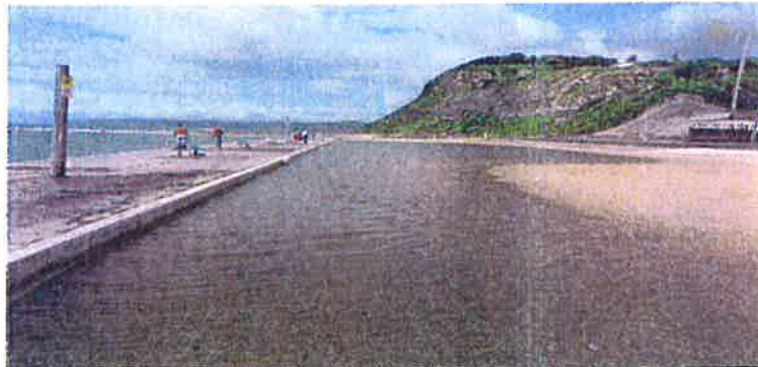
**THE TODDLER POOL**

The toddler's pool at Merewether also has a concrete floor. Because of ongoing maintenance issues associated with ongoing lifting and cracking in the floor the floor has been covered with over 30 centimetres of sand. This strategy has been very successful in resolving the issue as well as providing a very much appreciated soft environment for toddlers using the area.

- Replace Promenade continuing to be completed over several years
- Floor in toddlers pool had continues leaks this was overcome by covering with sand to a minimum depth of 300 mm

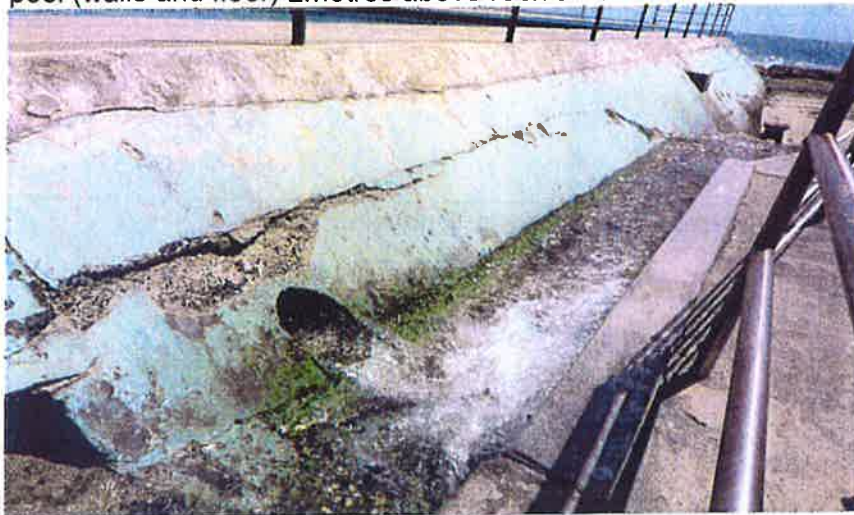
**2 METRE POOL WALL**  
**NOTE THE CRACK ABOVE DRAIN THIS IS WAS THE OLD POOL HEIGHT**  
**BEFOR UPGRADE**

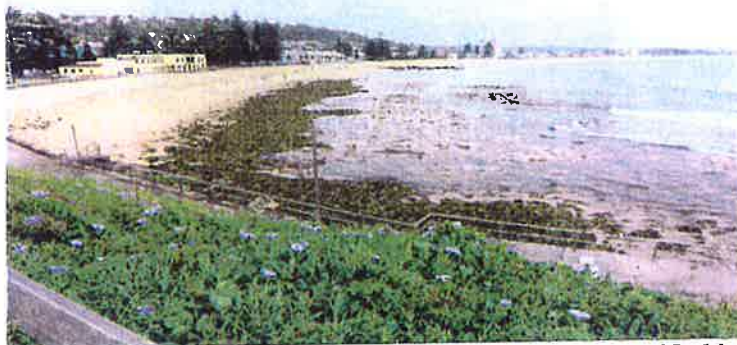
**SEAWEED BUILDS UP IN THE CORNER OF THE BEACH AND ALSO IMPACTS ON THE POOL**

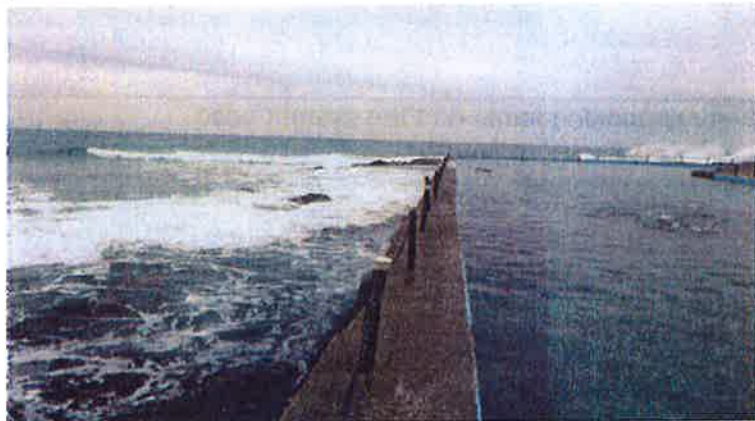
Note; Advice from Warringah council was it more cost effective to replace the walls rather than repair them. And recommend replace rather than repair in similar circumstances.

**NORTH WALL TO BE REPLACED 2010**

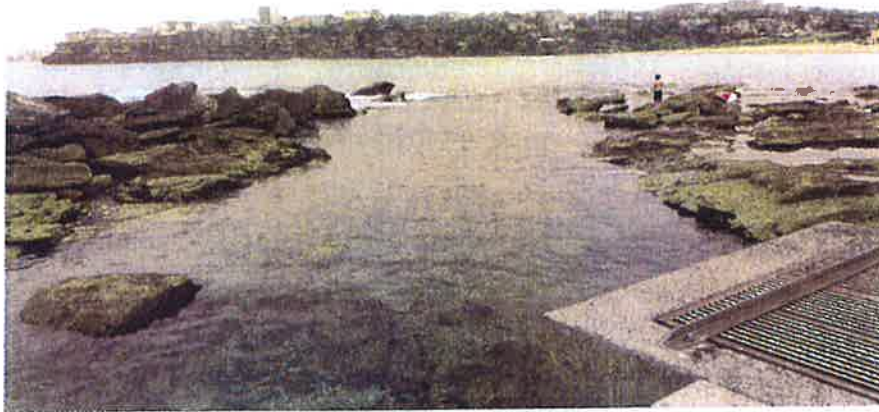
**PUMP INLET TRENCH  
(Planned To Deepen)**

- Repairs are on going as needed
- it is planned to deepen the trench for the pumps inlet pipe

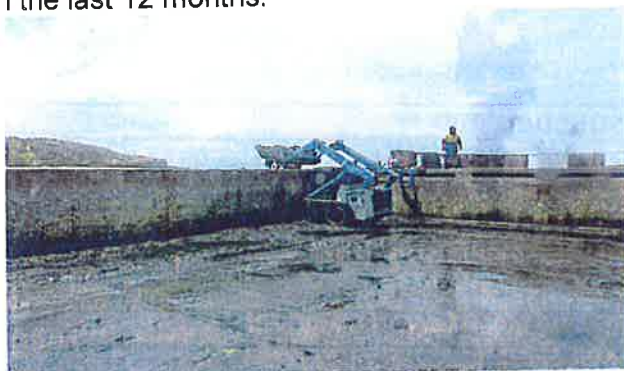
**POOL FLOOR SLUMPED 80 MM ALONG CRACK**

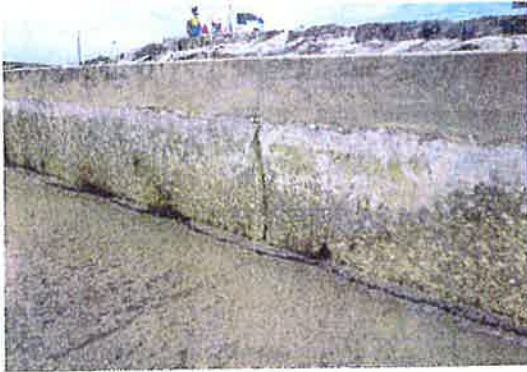
**CRACKS IN THE POOL**

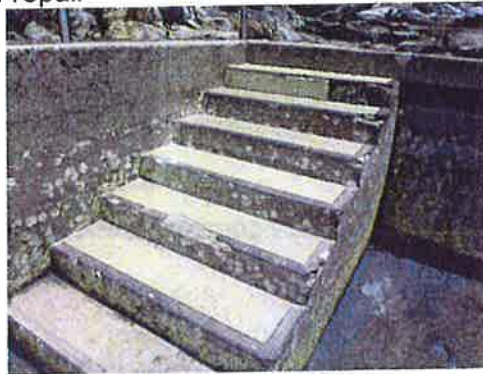
**BROKEN STEPS**

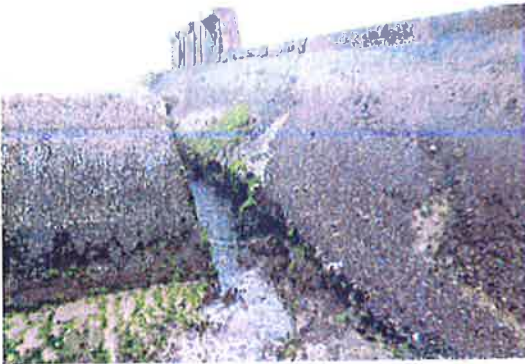
**UNDERMINED POOL WALL**

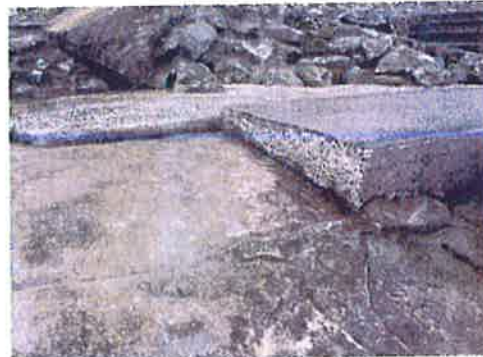
**BROKEN ACCESS PATH**

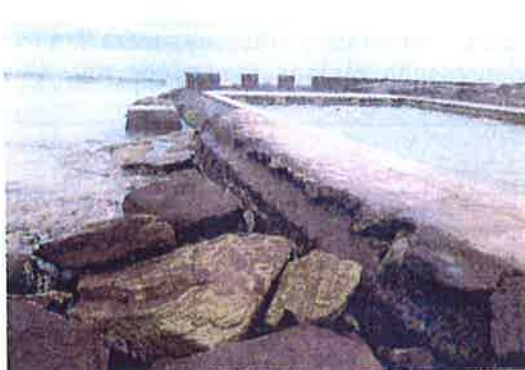
**DAMAGED NORTH WALL**

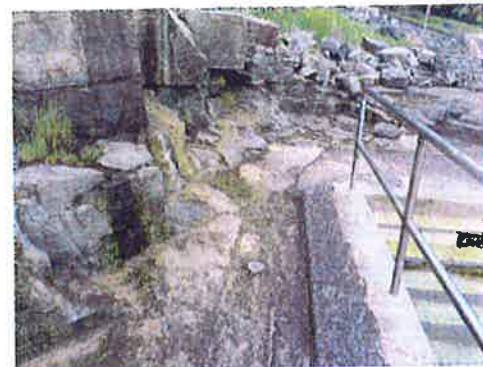
**POOL DECK SLIP TRIP HAZARDS**

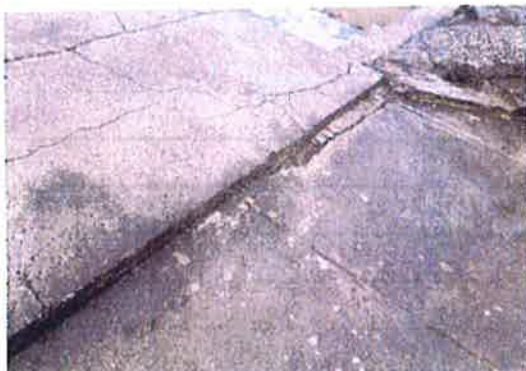
**CRACKING/TRIP HAZARDS**

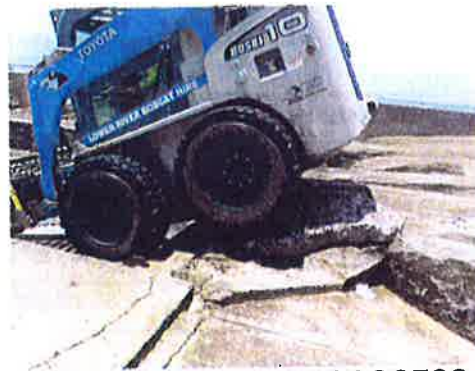
**LIMITED POOL MAINT ACCESS**
