8.3 Ballina Uniting Church - Structural Inadequacy.DOC

Re: Monitoring Report of Structure, Uniting Church Cherry Street Ballina.

Structural Condition Report
Uniting Church, Cherry Street, Ballina

Uniting Church 54 Cherry Street, Ballina

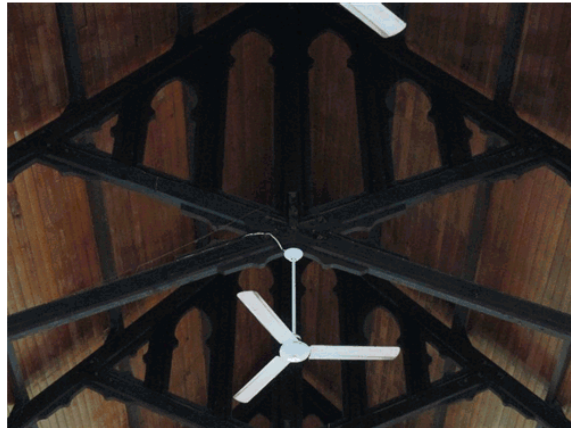
Photo 5 -

The structural system used to support the roof consists of timber "trusses" at approximately 3 metre centres spanning 10 metres with timber purlins at nominal 1.2 metre centres. The purlins support a timber ceiling and corrugated steel roof. The timber trusses appear to be in good structural condition. No apparent damage to the timber or the central connection point was observed. (Refer to Photo 5).

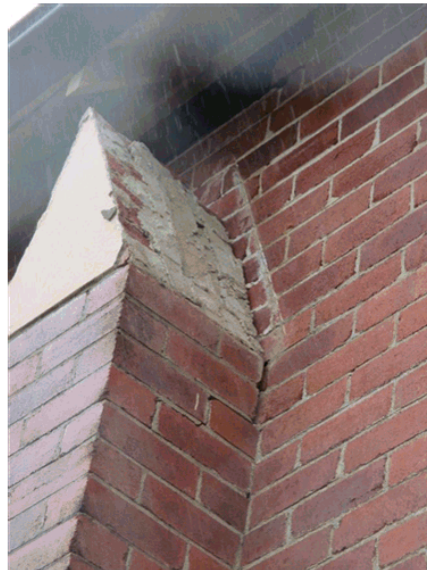
Photo 7 -

The majority of the buttresses to the outside of the brick walls show shear cracks on the 2nd to 3rd brick course from the top of the buttress, which in their form strongly suggest an outward movement. (Refer to Photo 7). These shear cracks seem to coincide in height with the crack lines on the internal wall surfaces.

Based on preliminary desktop assessment the buttresses themselves are undersized to withstand permanent loads from the spreading action. They do however appear adequate for the temporary wind loads for which they would have originally been designed. Note, the majority of them show clear shear cracks in the 2nd and 3rd course from the top indicating outward movement, an evidence of their failure under permanent loading.

The cracking can safely assumed to be the result of spreading of the hybrid "trusses". Greg Alderson has previously provided a tie rod detail to control further spreading of the roof. Such a solution is conventional and recommended in this instance. We would propose some amendments to the detail shown by Greg Alderson regarding connection details. However, the method of solution is essentially the same.

However, further work is required for the cracked and damaged brickwork. Strengthening of this cracked brickwork will be required to ensure structural integrity against wind loads and possible isolated dislodgment of existing loosened bricks. The extent of and type of repair work required will be determined by further evaluation. However, the anticipated method of repair would involve staggered strengthening or replacement of the external brickwork skin at the buttresses and then in between the buttresses.

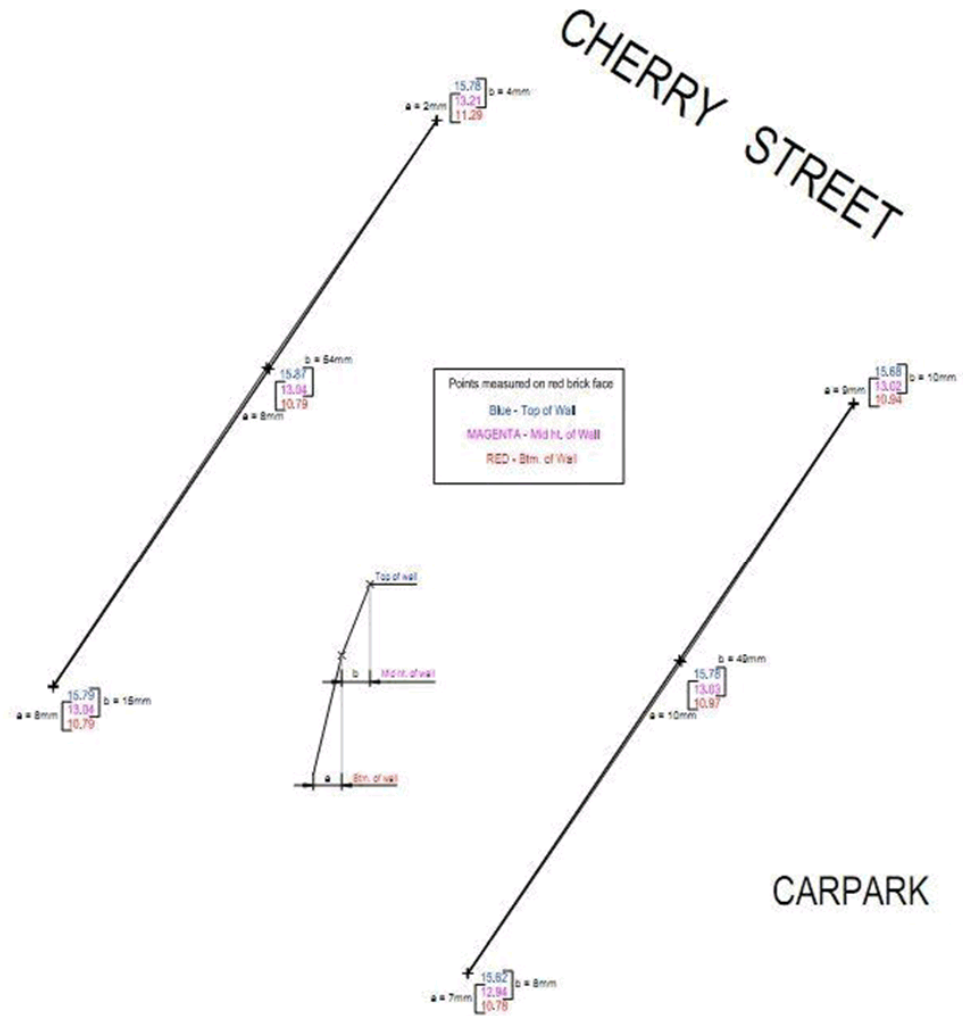
Attachment 2 Survey Results

Rob Jacob of APP undertook a detail survey of the horizontal movement of the external masonry walls on 14th of July 2015. This survey has been undertaken to better understand the extent and possible cause of the damage. Surveys have been taken at bottom, mid-height and top level of the walls. At six points along the church building, explicitly at both ends and mid-way to the north and the south wall these measurements have been taken. (Refer to survey results, **Attachment 2**).

This arrangement of survey points have been chosen to investigate whether the damage to the external walls has been caused by the roof or whether some possible rotation of the footing caused the leaning of the wall.

From the survey results as described in Section 4.2, a rotation of the foundation and subsequent tilting of the walls could be ruled out at this stage.

As described the lower wall part show just minimal offsets whereas the majority of the damage concentrates on the top of the walls. A tilting due to footing rotation would presumably result in a rather even tilting angle over the whole of the wall, which is not the case here.
