Fig Tree Castle Drive, Lennox Head

Prepared by Integral Tree Care for Ballina Shire Council

Arborist report on *Ficus macrophylla* for Ballina Shire Council7th of December 2015**Introduction:**

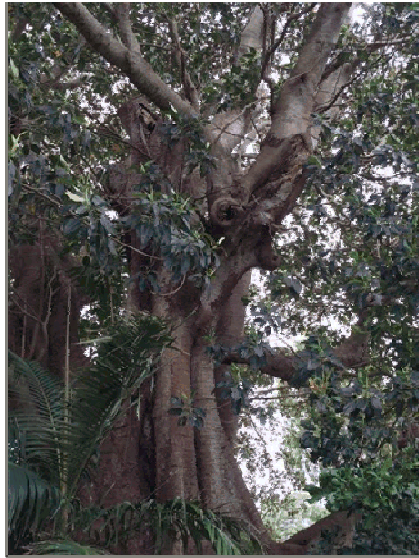
Photo 1

Trunk/s – Sound. Central main trunk has been lopped previously, decay present. Large wound on other main trunk, sound reaction wood adjacent (See Photo 1).

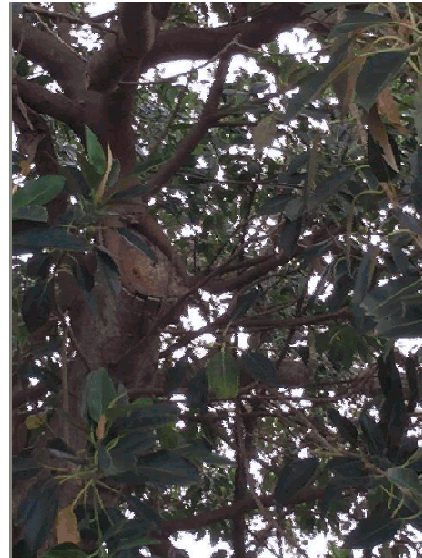
Photo 2

Crown/Branches – Sound. Wounds from previous pruning, sound development of wound wood (See Photo 2). Minor deadwood 50>mm present.

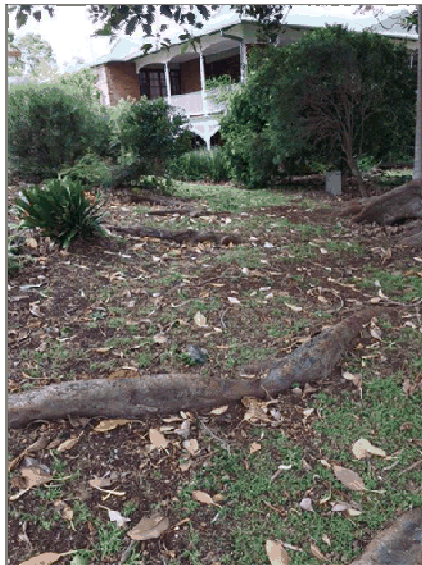
Photo 3

Roots – Sound. There was minor mower damage to surface roots (no decay visible). Major surface roots visible up to 7m from trunk (See Photo 3). Roots interfering with storm water pipe.

Ficus species are known for their vigorous root growth so measures to prevent further interferences with infrastructure should be made. Due to the proximity of the tree to the adjacent properties, root pruning for installation of a root barrier would be within the Tree protection zone (TPZ). *Ficus* species are known to tolerate considerable encroachments into the TPZ, although the incursion into the TPZ in this instance will be major and will require considerable compensatory measures to be diligently executed to maintain a healthy tree.

Option a: Install Root barrier *

- To be installed to a depth of 1.8 m and with 50 mm exposure above ground level.
- All cut roots (and, indeed the cut face of all excavations) are to be treated with a Trichoderma solution (antagonistic fungi) immediately after cutting.
- Root barrier backfilled with a Structured soil
- Services should be diverted around Root barrier where possible as incursions into the root barrier may be an entry point for roots.
- Supplementary watering
 - * Further consultation will be required prior to implementation of Root barrier installation to assess location of underground services, placement of Root barrier and quantify supplementary watering and compensatory measures for the TPZ encroachment.

Option b: Remove tree and replace with native species with less invasive roots.
