Bottle Tree, Main Street, Alstonville

Prepared by Integral Tree Care for Ballina Shire Council

### Arborist report on Brachychiton rupestris for Ballina Shire Council 16th of December 2017

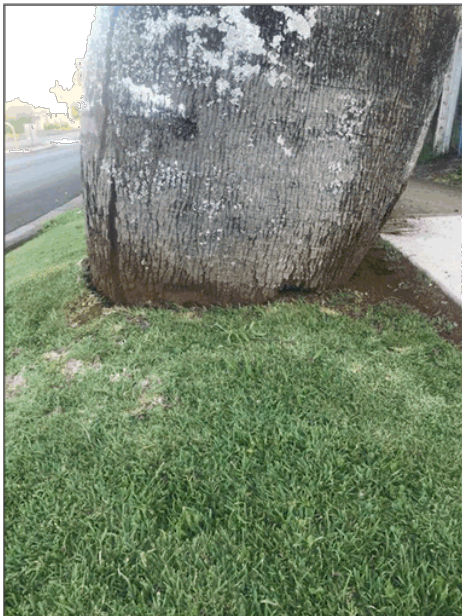
Photo 1

Roots – Recent work to footpath has cut roots and undermined tree on southern side of tree. The northern side of the roots are heaving the ground. Normal ground level mark on trunk now about 50 mm above ground level. (See Photo 1)

The QTRA Risk of harm is 0.04 (High) due to a combination of the partial failure in the root crown, its lean over the foot path and the usage of the foot path. The footpath is a regular route used daily by children to and from school.

The damage to the trees' root crown was affecting its' structural stability so severely that it led to the primary failure of the tree. Once tree failure like in this case is initiated complete failure is typically seen in the near future with the risk of contact with a target being intolerable to the tree owner.

Remove tree.

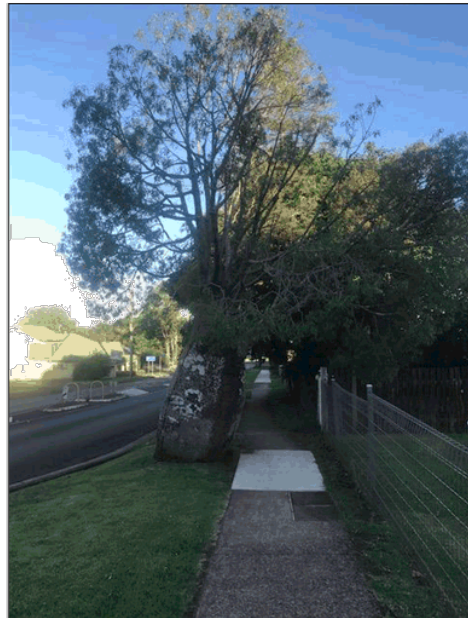
Photo 2

Trunk/s – On 15 % lean. (See Photo 2)

Crown/Branches – Moderate. Dieback through southern part of crown. (See Photo 2)
