Peter Lucena
& Associates
Pty. Ltd.

19th August 2015

**Re: Report on Subsidence/Tree Root Damage at 7 Castle Dr
Lennox Head**

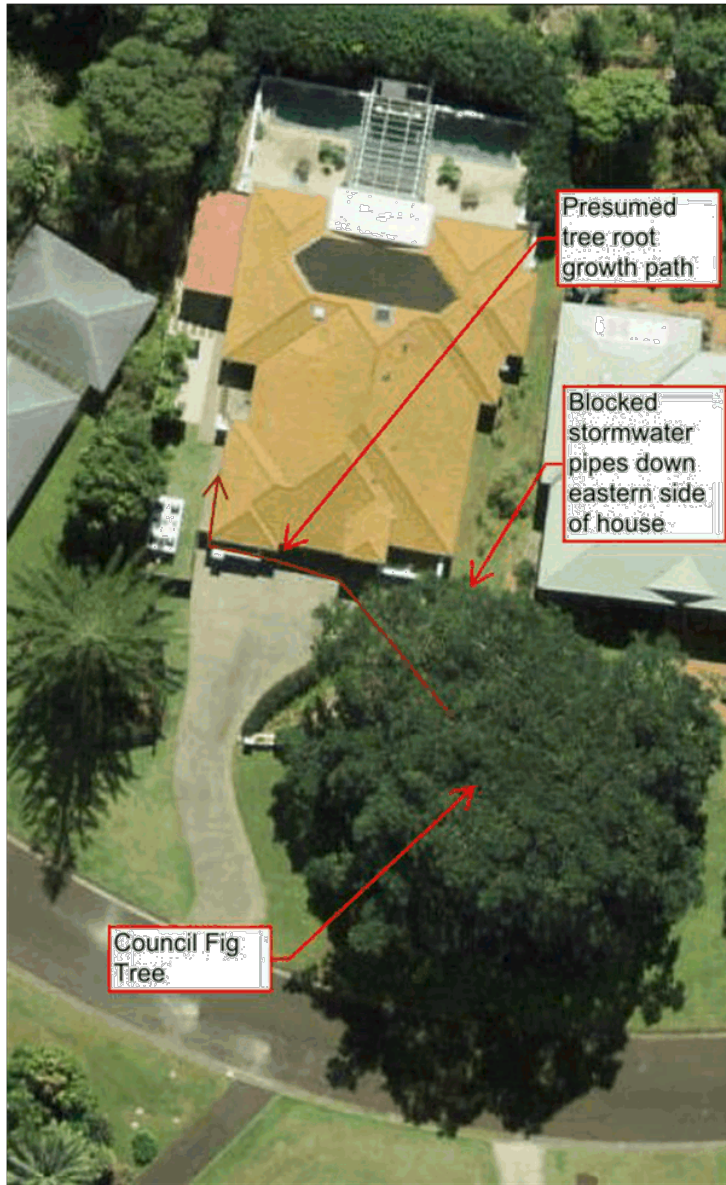
Figure 1: Aerial Image

As discussed, in our opinion some of the damage can be attributed to the fig tree. There appears to be a clear path that a single tree root is following and causing the damage (see Appendix Figure 1 for aerial image). Only a comprehensive destructive investigation would prove this, however from the current evidence, we believe this to be the case. The pre-existing damage to the house (masonry pillar rotation and eastern wall crack) does not appear to be due to the tree roots.

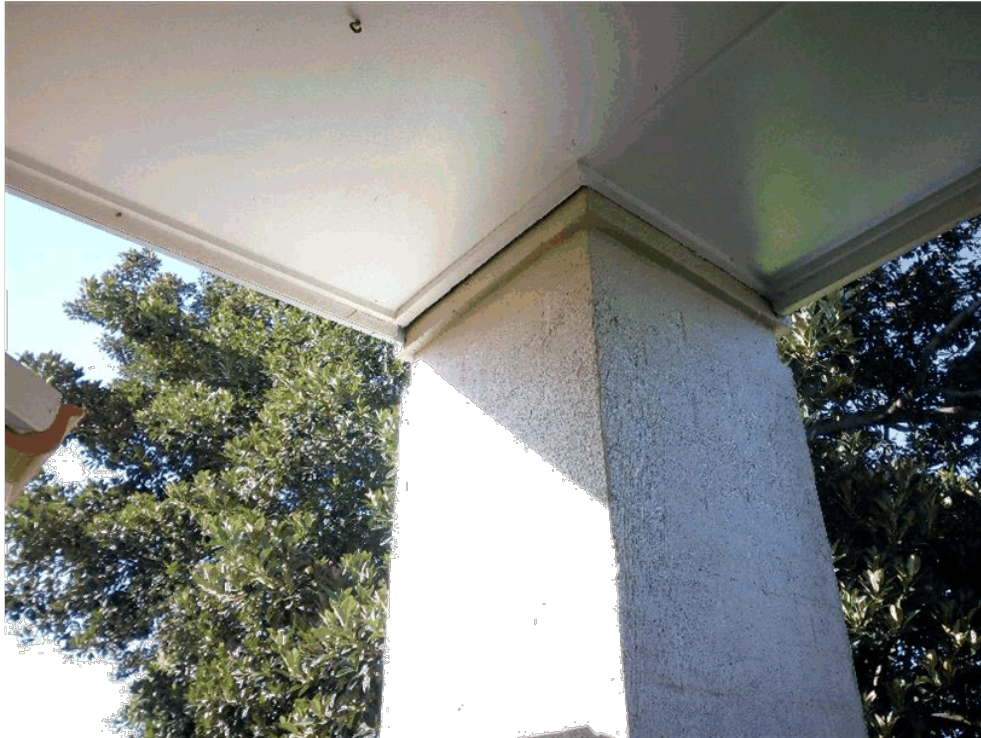
1. Leaning pillar at entry:

There is a masonry pillar to the right of the entry that is subsiding away from the house. There is evidence that the ceiling lining has been repaired in the past, indicating this movement has been occurring for some time.

The front of this house is built on fill, and it is known in this office that AV Jennings (the company who built the house, now defunct) had a reputation for not adequately piercing footings through fill. While not solid evidence, we would imagine this is a likely scenario. In our opinion the pillar movement is more likely to subsidence of the fill rather than root damage, particularly when observing the direction of rotation. The type of movement is certainly what we would describe as typical of foundation subsidence. It may have been worsened by nearby tree root growth, however this is not possible to determine. In either case, the movement has pre-dated the purchase of the property.

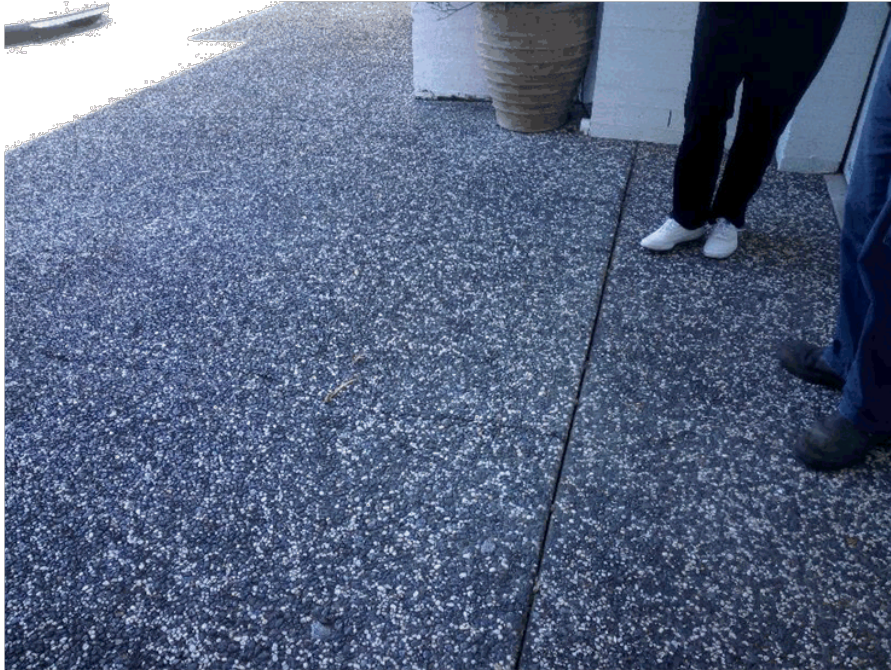
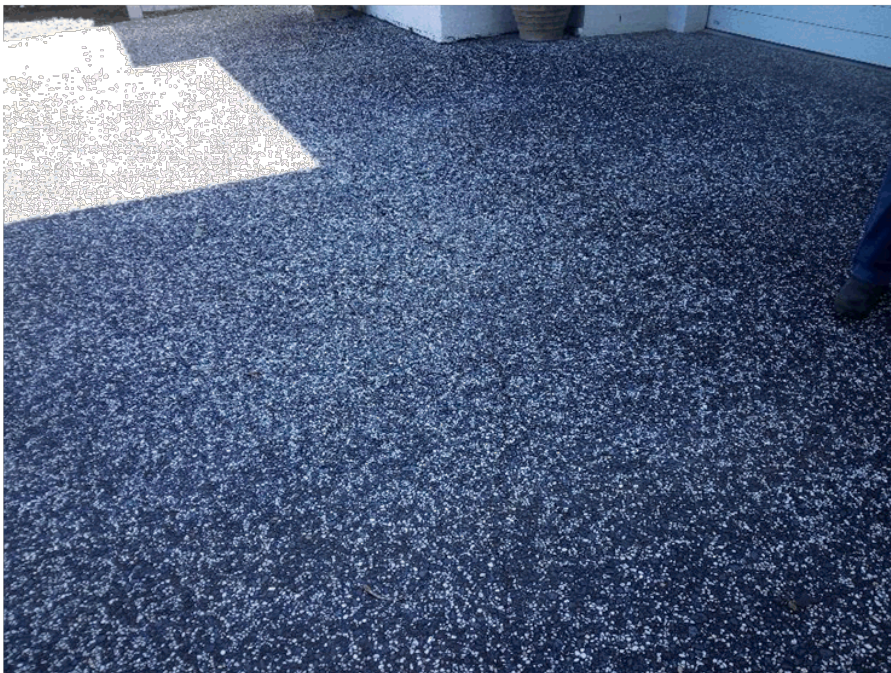
2. Driveway Slab – risen at entry to garage / cracking in driveway surface:

The driveway slab has lifted at a joint line parallel to the garage door. There is cracking in the pebblecrete surface of the driveway slab nearby.

The lifting of the slab almost certainly appears to be due to growth of a tree root underneath. It is very unusual to see this sort of movement from other causes in this local area. The location of the presumed tree root under the slab is in agreement with the findings in items 4 and 5 below. A root appears to extend across the top of the driveway slab, under a masonry privacy wall, and around the corner up the western side of the house.

The driveway cracking is difficult to determine to attribute blame to – it looks very much like normal concrete slab shrinkage cracking. The surface of that slab panel appears generally flat and true with no obvious kinks.

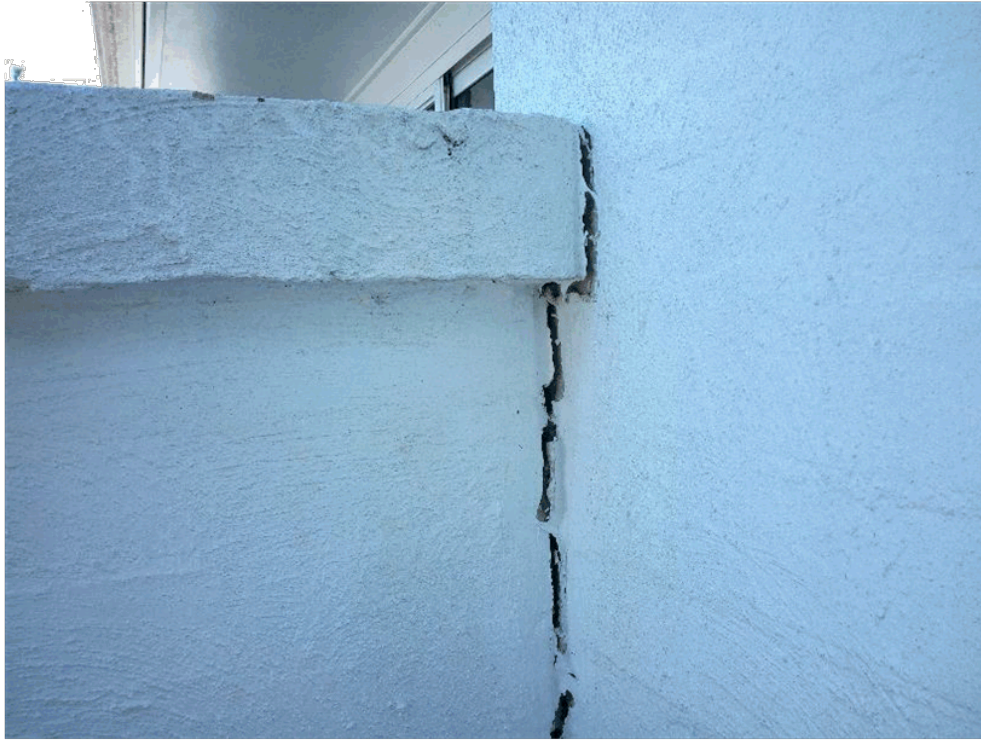
3. Rotating masonry wall adjacent to garage:

This privacy wall has a vertical joint where it joins the exterior wall of the house. The joint has opened up to around 15-20mm. Evidence from the owner indicates that this movement has worsened considerably in recent months. It appears that the wall is lifting at the joint location, at the location where a tree root is presumed to be growing underneath.

While this movement appears quite typical of subsidence due to settlement, given the presumed location of the tree root, the appearance that the wall is lifting at that location, and the worsening recent movement, it is very likely that this movement is caused by the tree root growing underneath the end of the wall against the house.

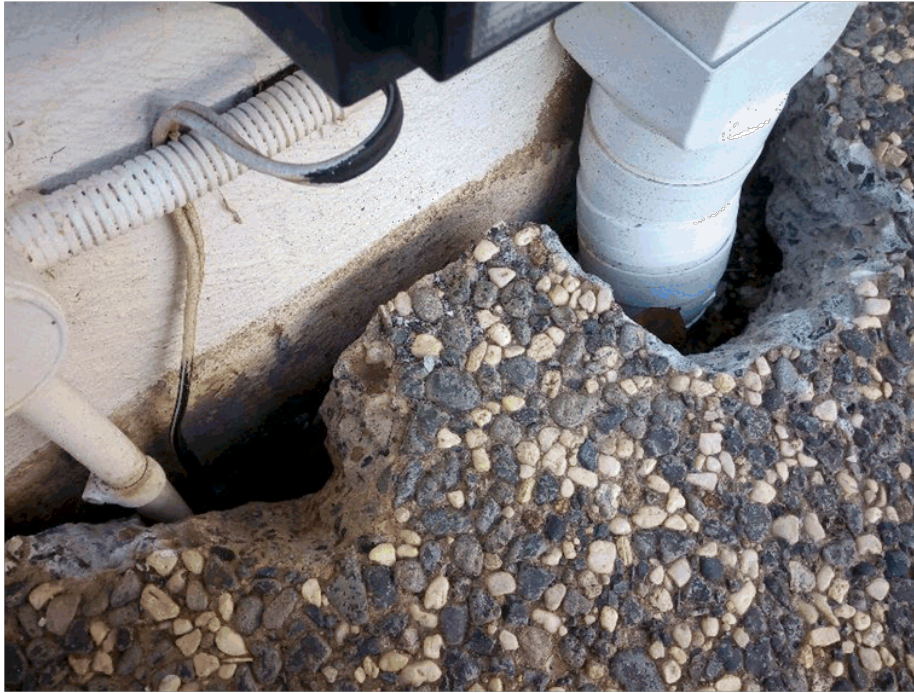
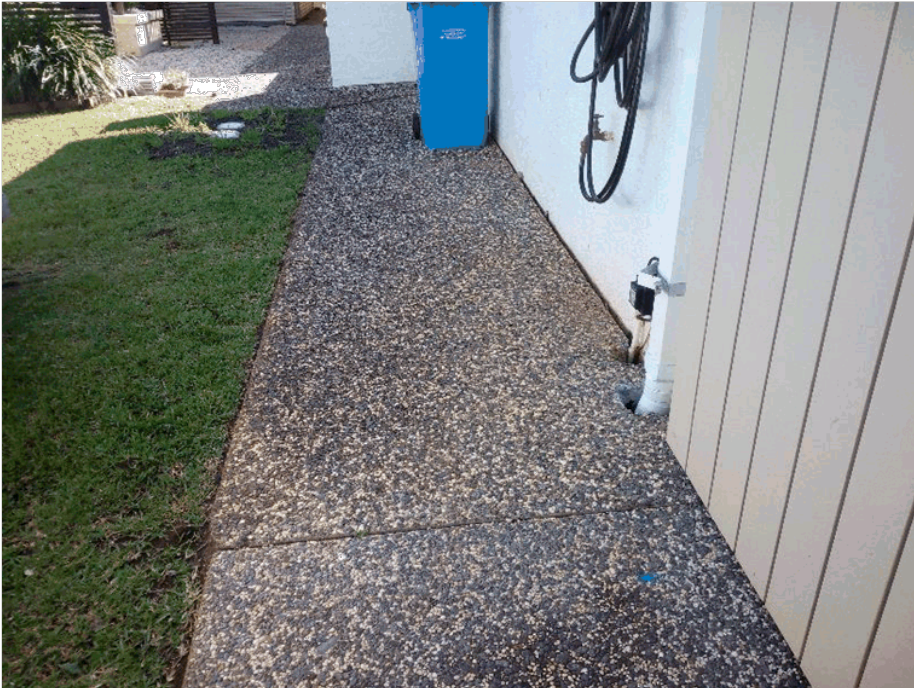
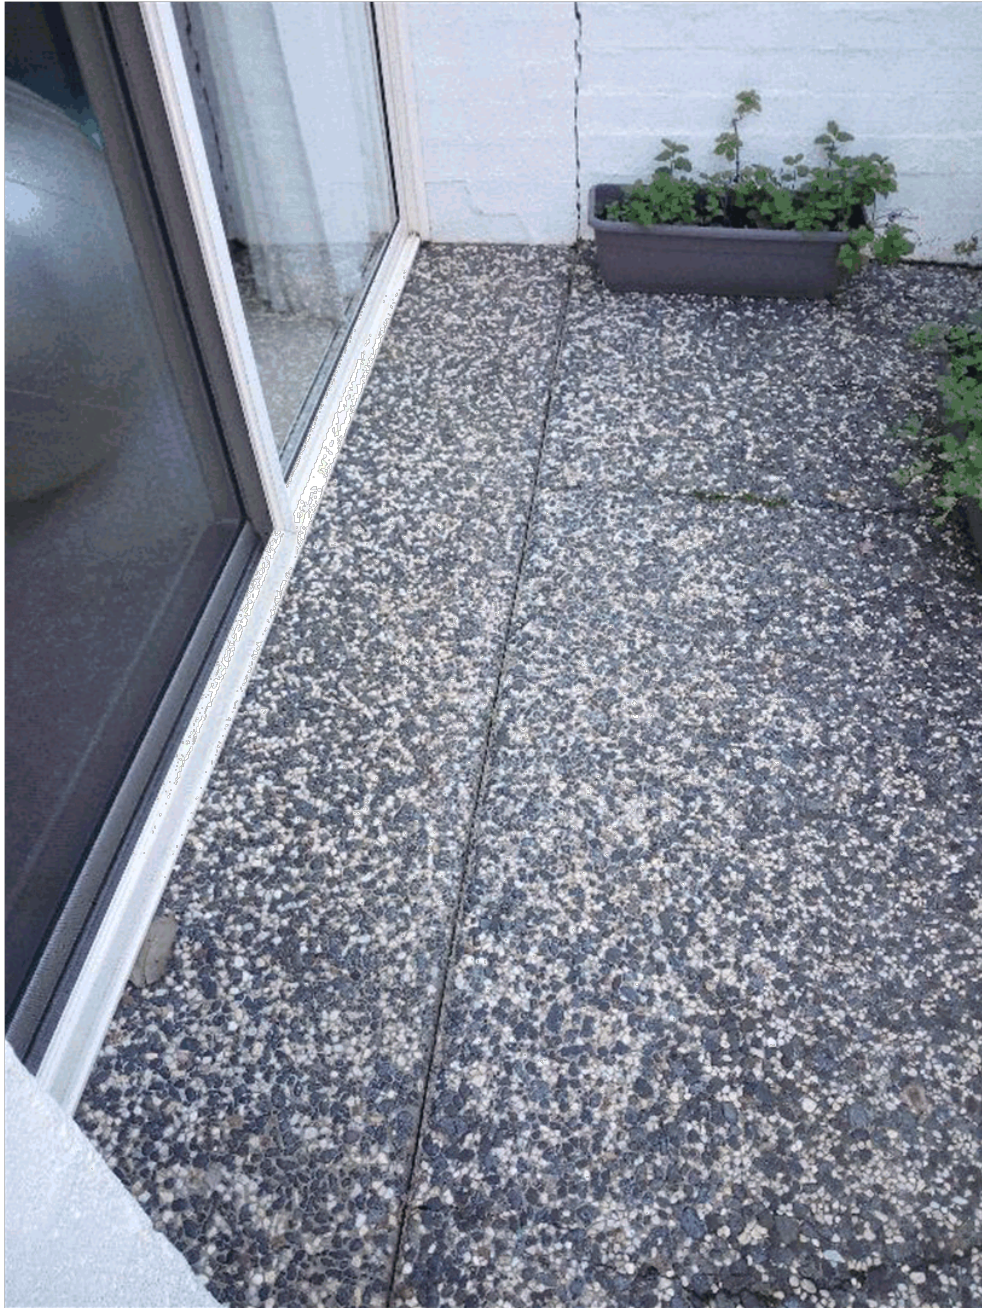
4. Path damage beside house, western side:

On the western side of the house is a concrete path that has separated from the house by around 30-40mm. A tree root can be seen growing in the crack, filling the space. Also a section of path between this location and the driveway has also lifted, similar to the driveway slab.

This all seems to be attributable to the same tree root, as the damage follows a line across the top of the driveway, around the corner and up the side of the house for a few metres where the tree root is visible. Other than the separation from the wall, the western path appears generally level. If the separation was caused by subsidence, we would normally see rotation of external paving slabs.

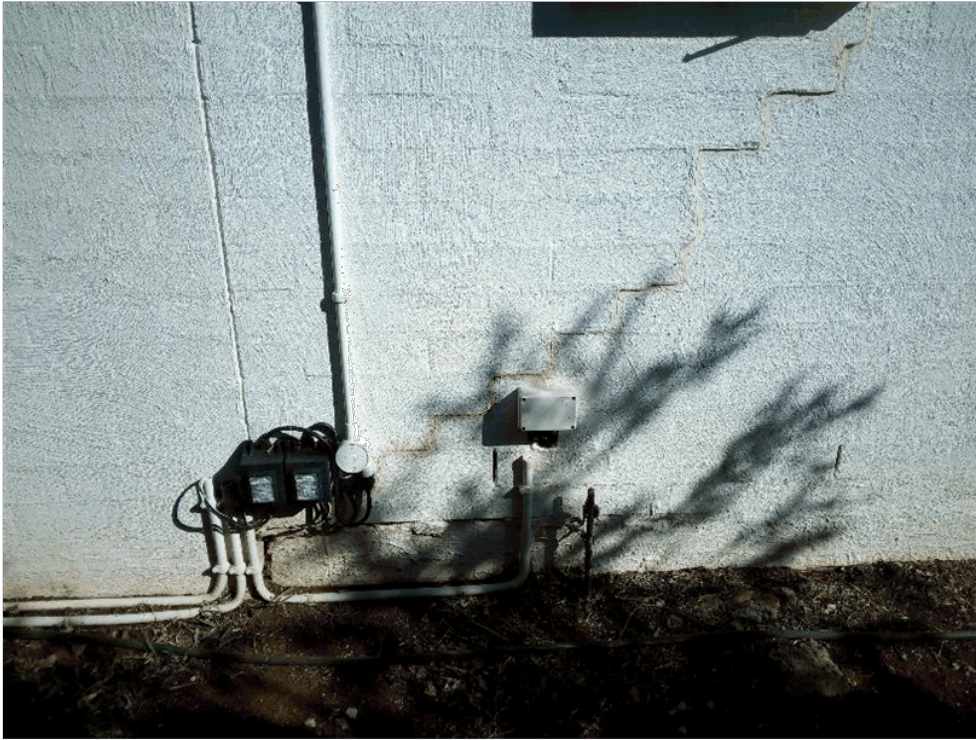
5. Diagonal crack in brick wall (east side):

There is a diagonal crack at the south-east corner of the house, on the eastern wall. The crack follows the bedjoints of the external brick wall and is around 3mm in width. It appears to have been repaired in the past, and has opened up slightly since then.

This crack was present prior to the purchase of the house 3 years ago. In our opinion, it appears to be a crack associated with subsidence of the fill that this corner of the house is sitting on, and is not associated with tree roots.
