Craig Zerk

Consulting Engineer

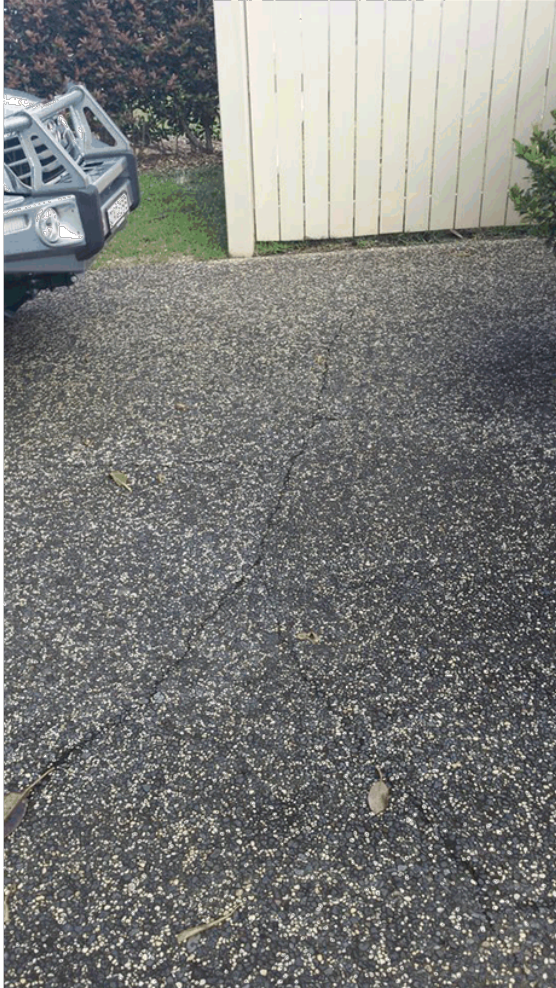
Photo No. 2 – Typical cracking of the concrete driveway slab abutting the garage floor slab.

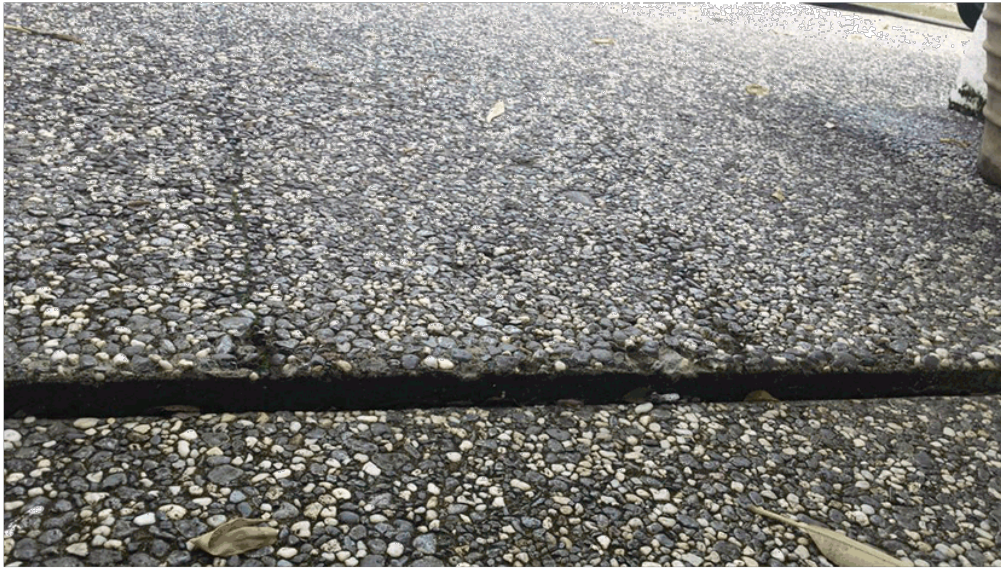
Photo No. 3 – Lifted concrete driveway slab abutting the garage floor slab. Note the presence of cracks.

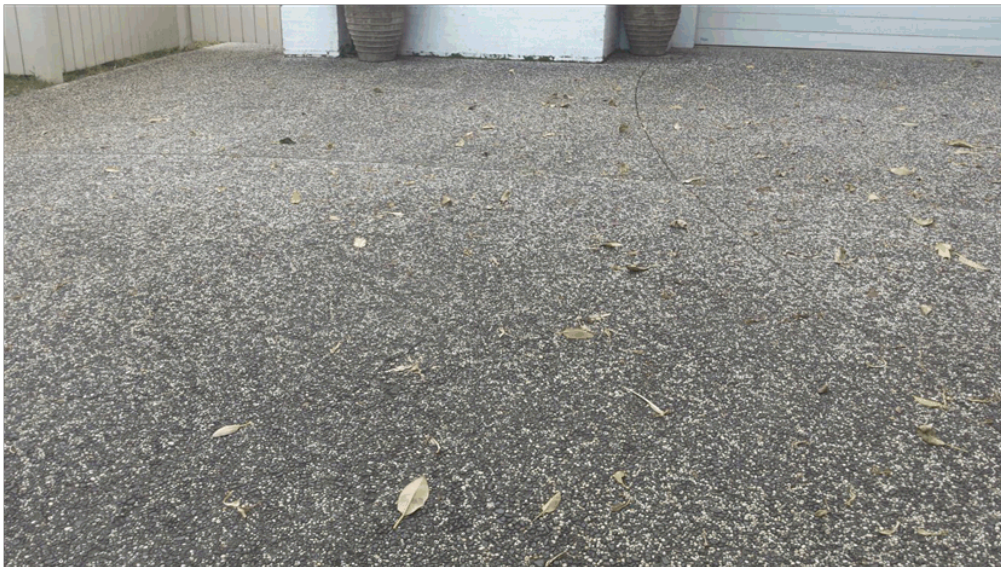
Photo No. 4 – Reflected cracking across a joint in the driveway slab.

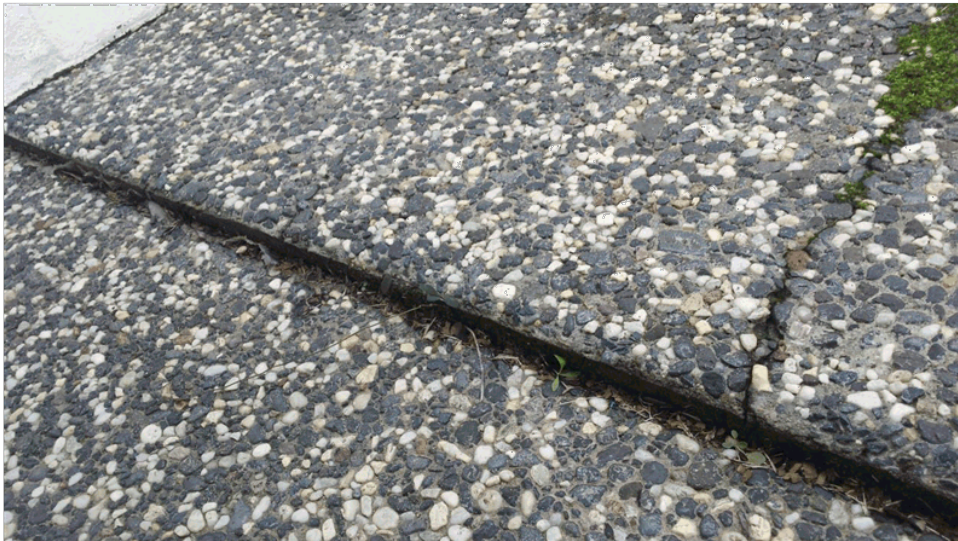
Photo No. 6 – A step and crack in the slab behind the privacy screen on the western side of the garage.

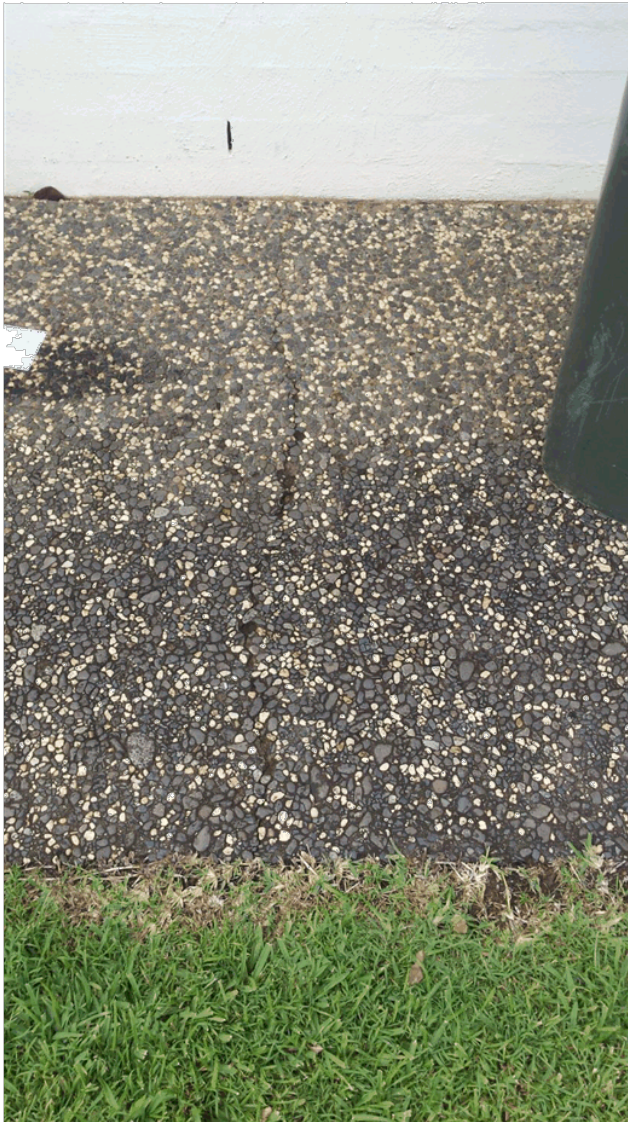
Photo No. 9 –A crack in the 1.3 metre wide concrete path on the western side of the house

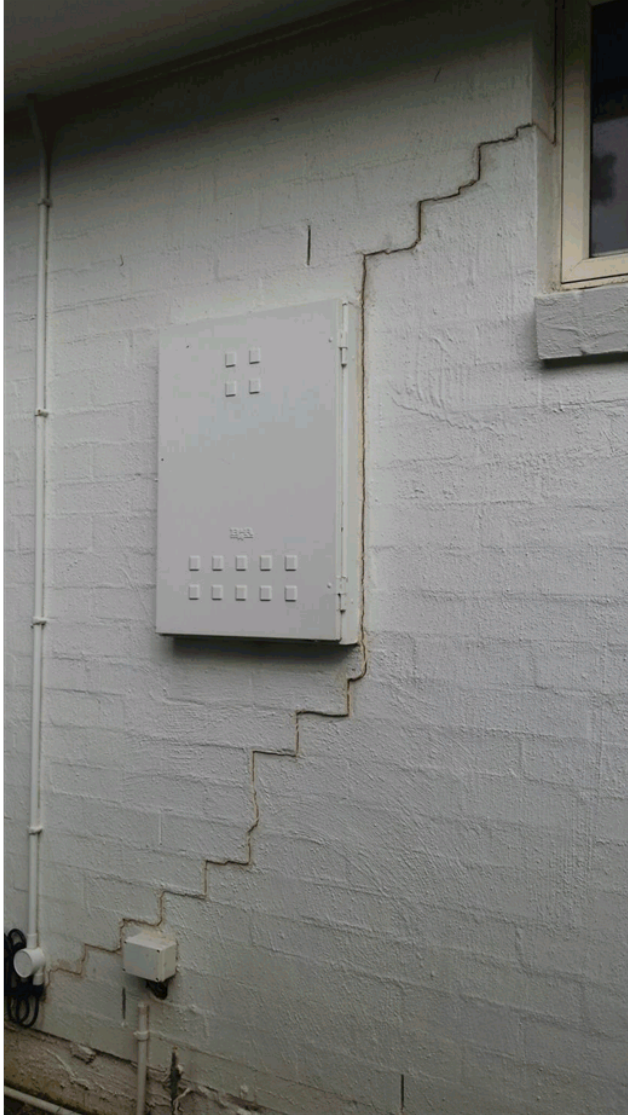
Photo No. 10 – Cracking in the brick wall at the south-eastern corner of the house.
