General Manager Ballina Shire Council PO Box 450 BALLINA NSW 2478 27 April 2018 Ref No. 914108

#### Further Assessment of Damage to Property at 7 Castle Drive, Lennox Head

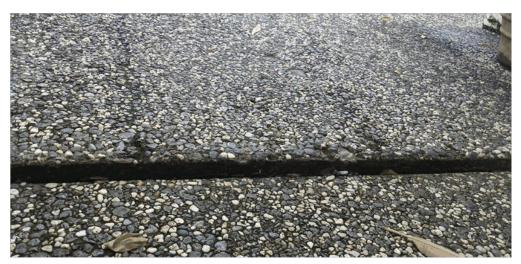
Photo No. 3 – Lifted concrete driveway slab abutting the garage floor slab as photographed on 6 April 2017. At the time the step at the joint was measured at 25mm high.

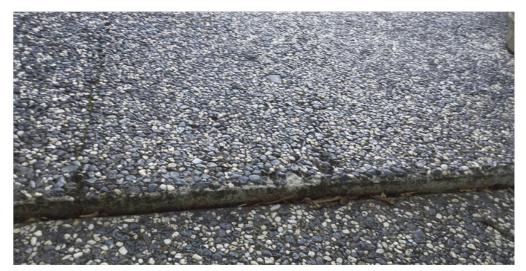
It can be concluded that between 6 April 2017 and 27 April 2018 the extent of damage to the driveway and masonry screen fence at the front of the dwelling at 7 Castle Drive has increased. This has most likely resulted from the continued growth of the root system of the adjoining fig tree. However no other significant increase in movement within the structure of the dwelling was observed.

Photo No. 4 – Lifted concrete driveway slab abutting the garage floor slab as photographed on 27 April 2018 when the step at the joint was measured at 35mm high.

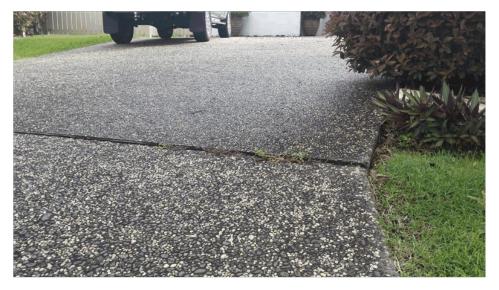
Photo No. 5 – A step in a contraction joint in the driveway slab at the property boundary as photographed on 6 April 2017.

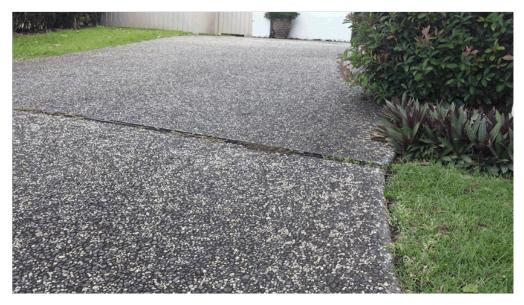
Photo No. 6 – The step in the contraction joint in the driveway slab at the property boundary as photographed on 27 April 2018 did not exhibit any significant change over the past 12 months.

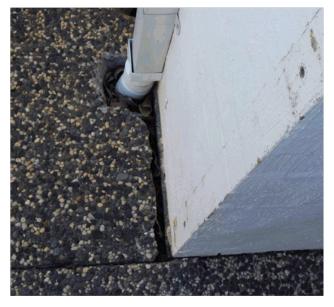
Photo No. 10 – Separation of the 1.3metre wide path from the wall on the western side of the house as photographed on 27 April 2018. The does not appear to have been any significant change since April 2017.

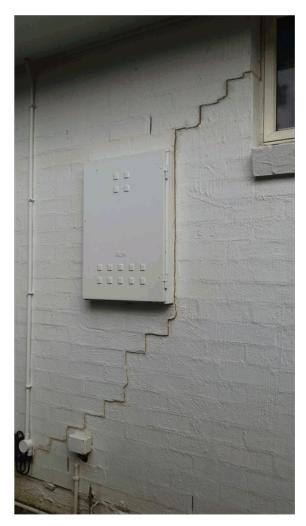
Photo No. 11 – Cracking in the brick wall at the south-eastern corner of the house as photographed on 6 April 2017.

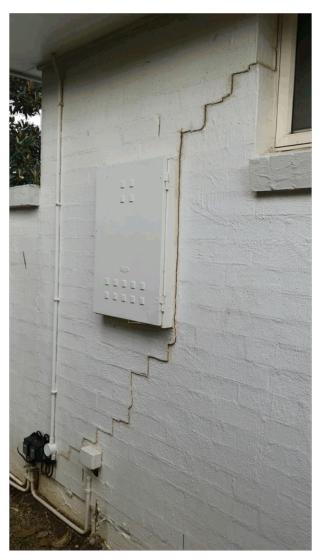
Photo No. 12 – Cracking in the brick wall at the south-eastern corner of the house as photographed on 27 April 2018. This crack does not appear to have deteriorated over the past 12 months.
