ASSESSMENT AND MANAGEMENT OPTIONS

Ficus macrophylla

Castle Drive, Lennox Head

Date: February 2018
Prepared For: Ballina Regional Council

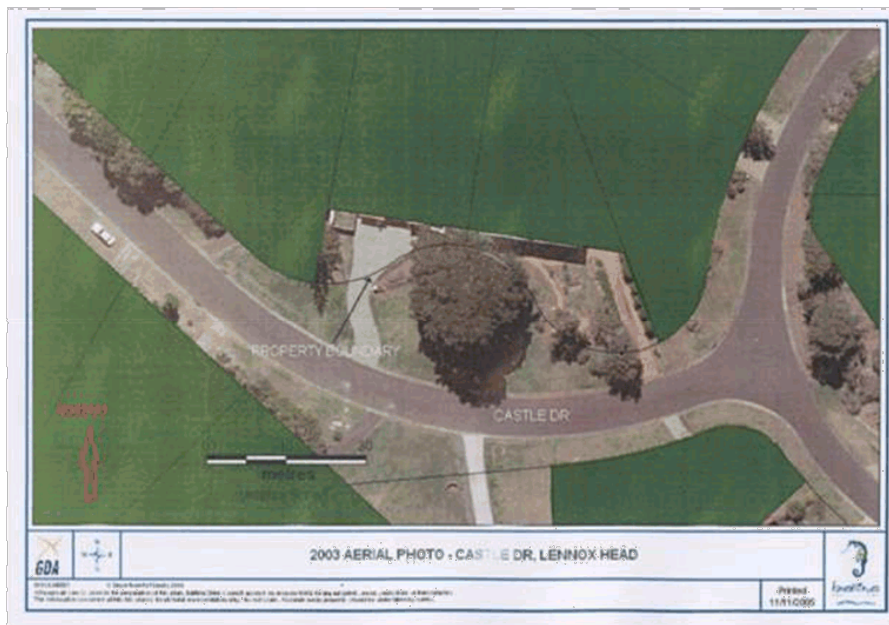
The unfenced and unmarked boundaries of the adjacent lots were set back behind and around the tree (see fig 2). It was n However, portions of the tree canopy appeared to overhang the property boundaries and it was evident that roots from the tree were growing within the adjacent properties for a good distance beyond the canopy. There were landscaped garden and turf areas under the canopy of the tree in both lots. The ground surrounding the tree was mostly well mulched with leaf litter close to the stem and mown grass under the canopy within the verge.

Figure 2: Image provided by Council indicating property boundaries in relation to the tree.

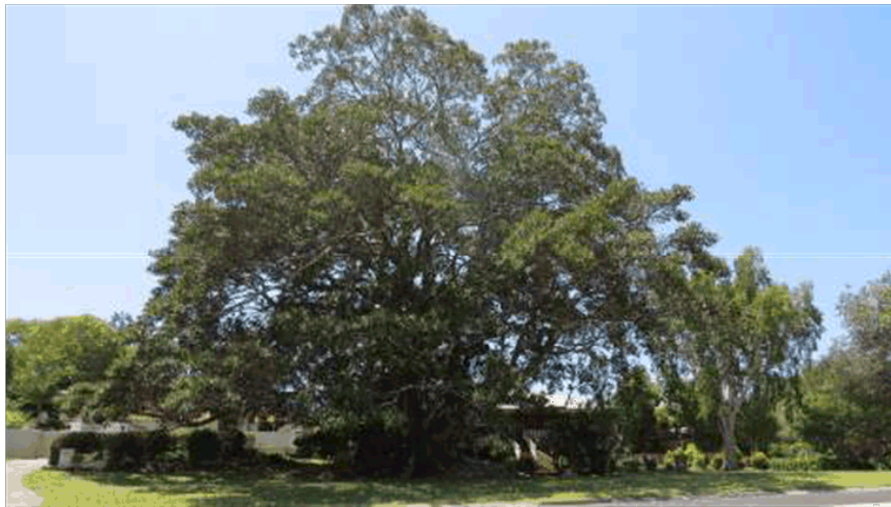
Figure 3: *Ficus macrophylla* (from south)
