## Arborist's Report

**Site:** 7-9 Castle Drive  
Lennox Head NSW 2478

**Client:** Ballina Shire Council

**Date:** 9 March 2018

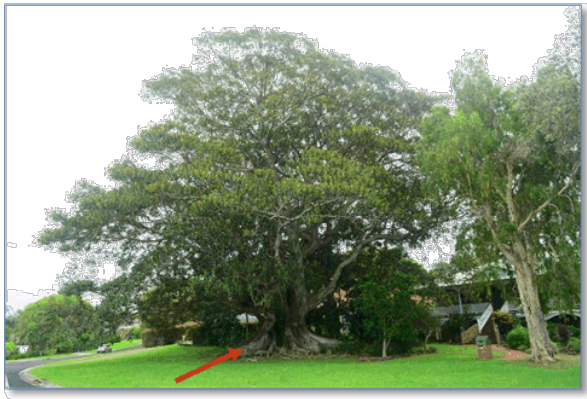
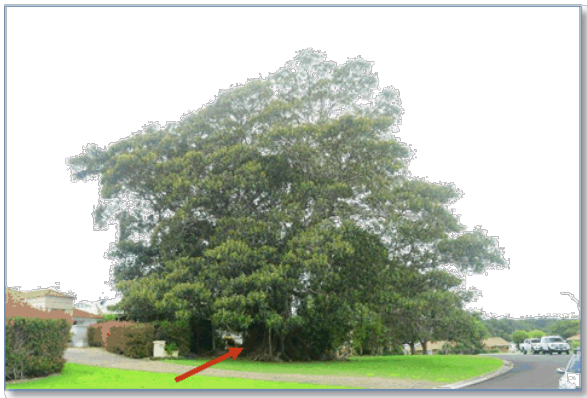
The upper canopy is of typical form and acceptable structure with strong branch taper and branch attachment evident. The upper stem and several first order branches exhibit evidence of past heavy pruning or lopping with several large wounds being evident (see Figures 10 and 11). The pruning may have been a result of storm damage repair and hazard mitigation. Live crown ratio is approximately 90% (see Figures 2 and 3).

The epicormic regrowth resulting from the pruning and damage is generally of acceptable form and structure with strong attachments and production of adaptive growth being evident. Some saprophytic surface decay of larger wounds is evident, as is typical of the species, however, no significant structural weakness was noted. Some small diameter epicormic shoots, i.e. less than 100mm diameter, are evident; this growth will become redundant and will be shed as deadwood (see Figures 2 and 3).

*Figure 2. Subject tree viewed to north-west.*

*Figure 3. Subject tree viewed to east.*

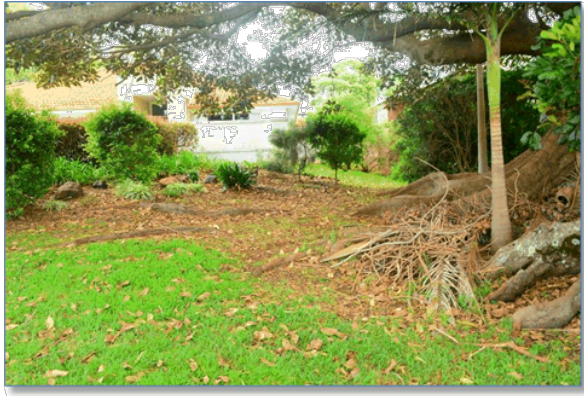
The subject tree is growing in the open grassed area immediately to the north of the street surface. The area under the canopy of the tree is dominated by pronounced buttressing of the lower stem and root crown; a thick layer of organic detritus is also present under the tree (see Figures 4 & 6).

The tree appears to be growing at or near to natural grades with the presence of fill over the root zone being noted to the north-west of the root zone (see Figure 4). The site exhibits a gentle slope to the south of less than 5°.

*Figure 4. Subject tree viewed to south-west.*

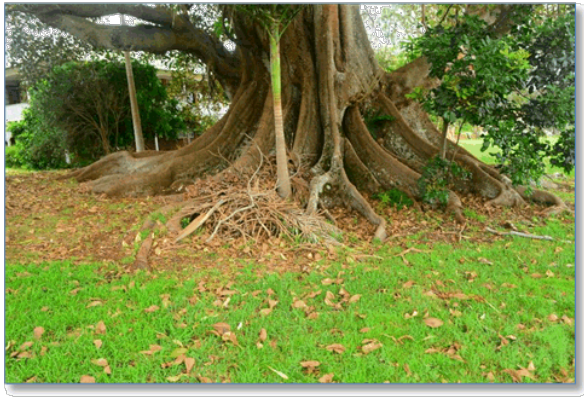
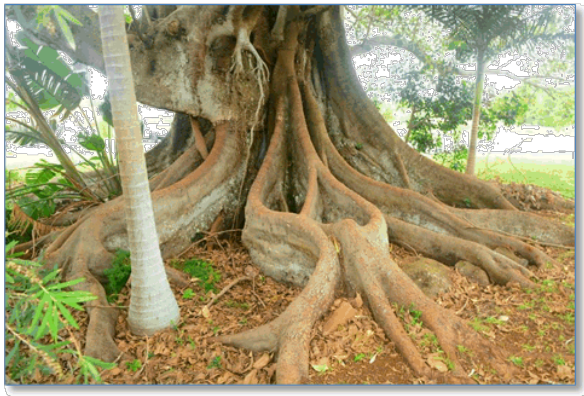
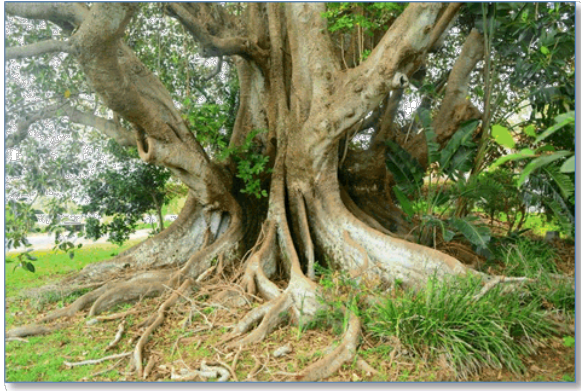
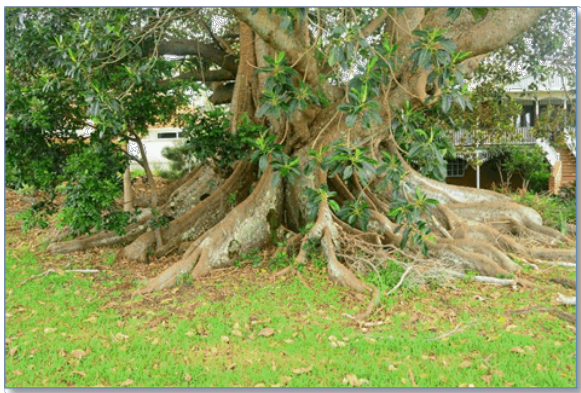
The tree is of a strongly decurrent form, i.e. the canopy is wider than the tree is tall, which is typical of the species. The structure is based on a short, massive trunk of approximately 2 metres in height which broadens to form the first order branches/stems (see Figures 5 to 8).

The root crown is of good form with extensive, pronounced buttressing present and is without evidence of weakness or defect (see Figures 5 to 8).

*Figure 5. Subject tree – root crown detail west face.*

*Figure 6. Subject tree – root crown detail north face.*

**Figure 7.** Subject tree – root crown detail east face.

**Figure 8.** Subject tree – root crown detail south face.

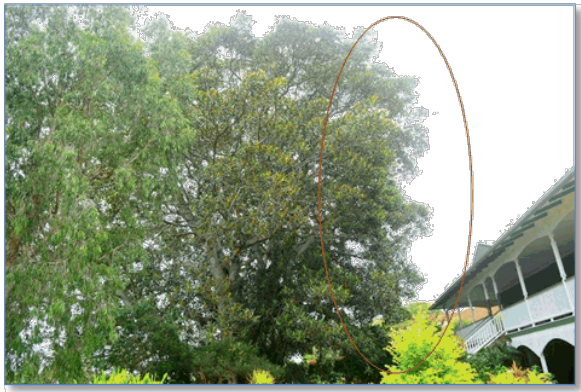
Some pruning to raise the canopy has been performed on the south face. The canopy has been reduced in width on the north face to reduce encroachment and provide building clearance to the dwelling at 9 Castle Drive. The pruning will have no detrimental effect on the tree (see Figure 9).

**Figure 9.** Subject tree – pruning to provide building clearance on the north face of the canopy.

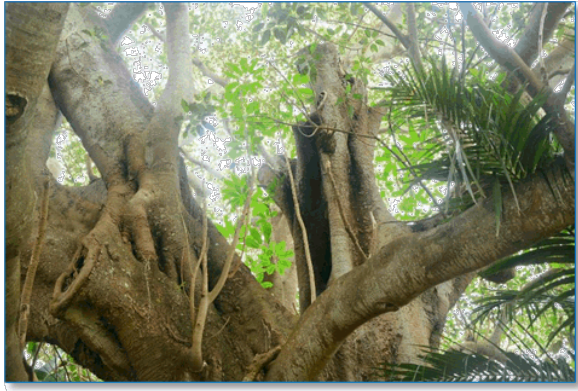
*Figure 10. Wounds created by previous lopping and or storm damage repair viewed from north-west.*

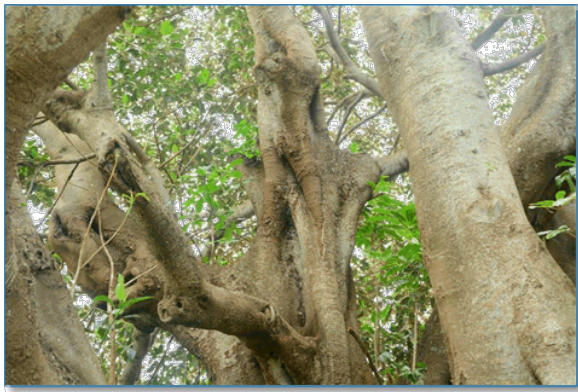
*Figure 11. Wounds created by previous lopping and/or storm damage repair viewed from south-east.*

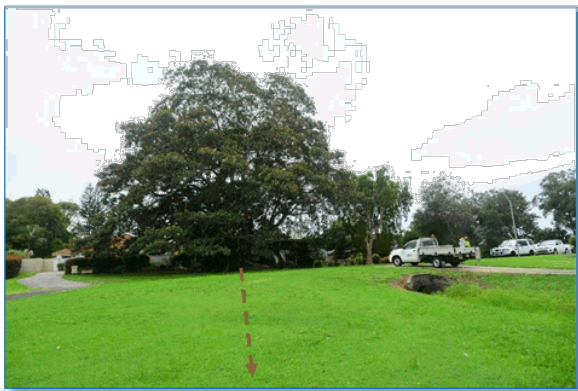
*Figure 12. Subject tree viewed to north from open space area suitable for the planting of the relocated tree.*

A large open area, suitable for the planting of the relocated tree, is present to the south of the tree on the opposite side of the street (see Figures 12 to 14). Other than planting site excavation and the installation of drainage around the root ball, no significant works are required to plant the tree in the open space. An exact planting position for the tree was not discussed or determined, however, the open space area is of sufficient size for the tree to be replanted without hindrance to adjacent properties and for suitable root control systems to be installed.

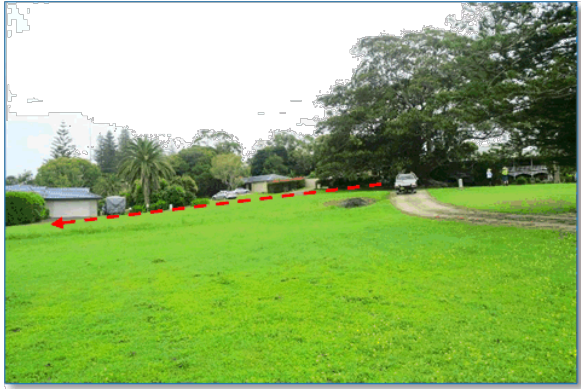
**Figure 13.** Open space area viewed to west. Note the decline in gradient of approximately 2- 3m depending distance moved.

To install the pipe raft under the tree, a drive line is required; an area approximately 18 metres wide and 30 metres long is needed to allow the pipes to be installed by the excavator. In this instance and so as to minimize excavation and allow ease of tree movement, the drive line is best sited to the south of the tree across the road toward the proposed planting area (see Figure 13).

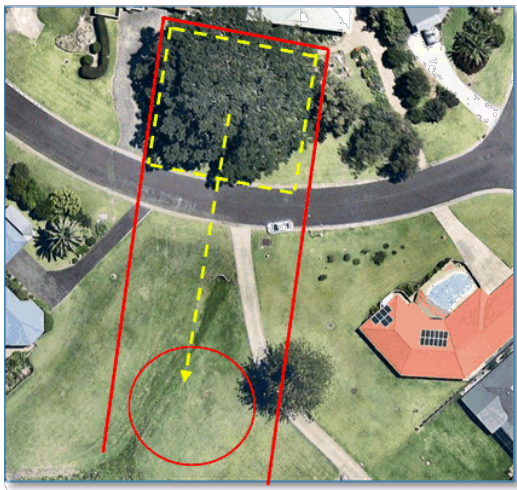
**Figure 14.** Aerial image of site indicating approximate position, orientation and direction of movement of a 14m x14m rootball (dashed) and limits of excavation (red). A suitable planting area is also indicated.

Tree size The tree is very large and may be considered in the upper range of tree size that may be transplanted. Site inspection revealed the exposed root plate, i.e. to the edge of the obvious buttress, to be an average of 13m in diameter. A root ball of approximately 14m in width would be required for relocation. The total weight of approximately 390 - 400 tonnes is significantly heavier than trees which have been transplanted in Australia. Trees of this size have been relocated in the USA.
