4th May 2018

Our ref: 4325

Project:	Engineering Inspection & Report
Property Owner:	Robin Lowry
Property Address:	7 Castle Drive Lennox Head NSW
Ballina S.C. Work Order No:	62353

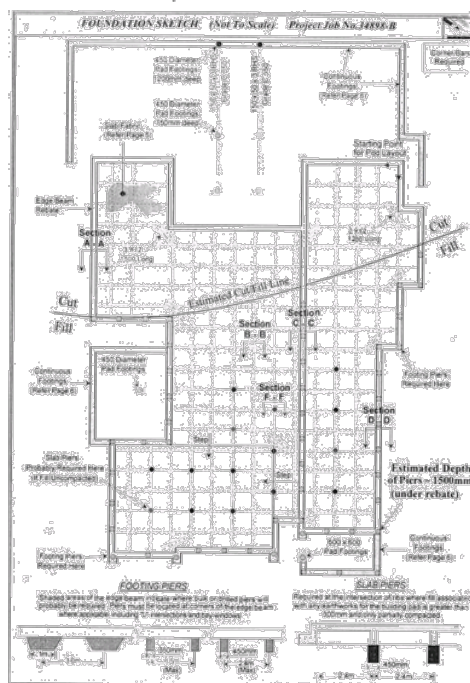
The house slab and footings have been engineered to accommodate for expected shrink swell conditions as well as with the provision of supporting piers taken through landfill into solid natural ground (see foundation sketch).

It should be noted that the office courtyard wall was *not* on the approved plans (see page 2), would be located on uncompacted landfill and apparently is supported only on the driveway slab with no supporting strip or pier footings.

Settlement of loose landfill under the supporting slab therefore is likely to be a contributing factor in the rotation of *this* wall.

To ensure stability, the wall will require to be rebuilt with a supporting footing founded in solid natural ground and in accordance with AS280-2011, *Residential Slabs & Footings*.

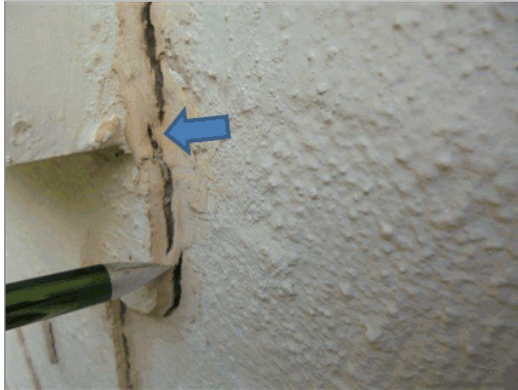
In addition, the cracking damage of the east wall of bedroom 2 shows lateral displacement of the masonry which is indicative of some localised pressures from tree roots.

07: Bedroom 2 east wall crack. Note lateral displacement

The damaged bricks can be removed and replaced then re-rendered in accordance with the relevant requirements of the Building Code of Australia.

Other wall cracks can be repaired by grinding and cleaning and bonding with epoxy or cementitious grout and rendering.

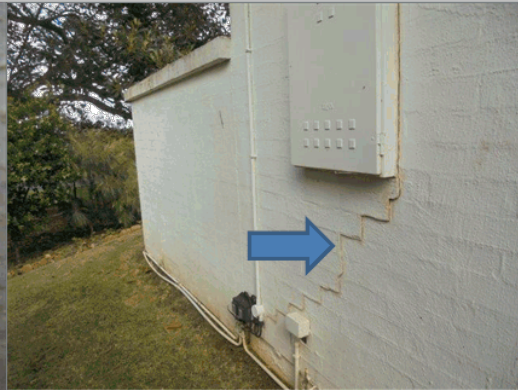
- **Bed 2:** Cracks (partially filled) and lateral (sideways) displacement in south end of east wall, hairline crack in south wall at east end, courtyard east wall has rotated outwards and gap has opened at house abutment

08: Bedroom 2 east wall crack

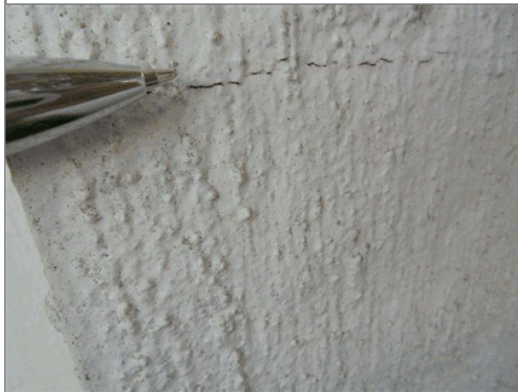
09: Bed 2 crack in south wall

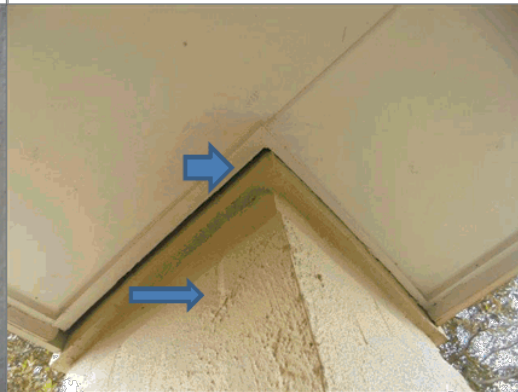
- **Portico:** Top of column at east side has rotated slightly outwards to the south and soffit lining gap has appeared. Column also has hairline horizontal tension cracking

10: Portico column slight rotation and soffit gap

The column doesn't require structural repairs. The gap in the soffit lining can be filled with architrave and then painted.

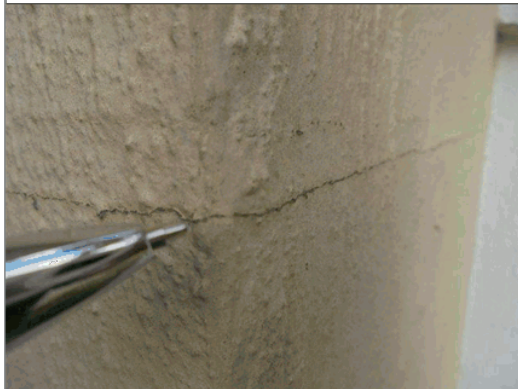
11: Portico column crack

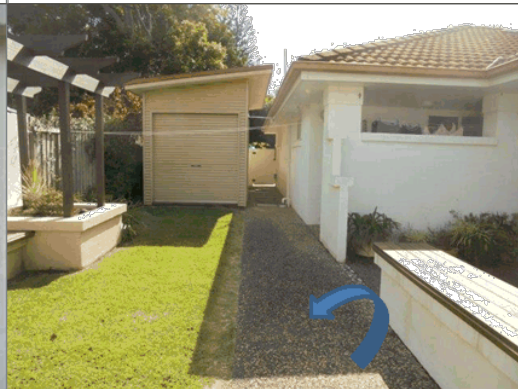
- **Office:** South side courtyard wall rotated outwards and large gap opened at house wall abutment, concrete path slab (apparently supporting the same wall) has lifted at the northern edge wall, crack at south east corner, concrete path at western side has tilted to the west

12: Path at west side rotated outwards

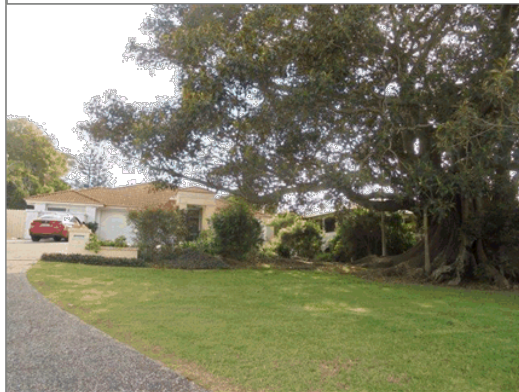
17: The fig tree

It is recommended therefore that, subject to an arborist's recommendations and project management, either the tree is removed or the roots are trimmed and a structural root barrier (not a conventional moisture barrier) is constructed to isolate the tree roots from the house and driveway.

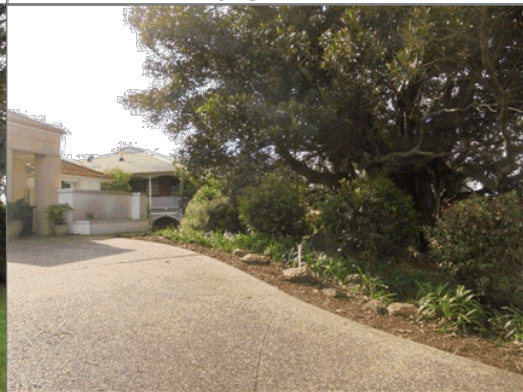
18: The fig tree

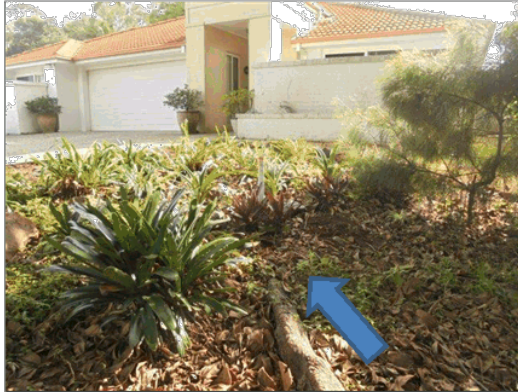
19: Tree roots running towards the house

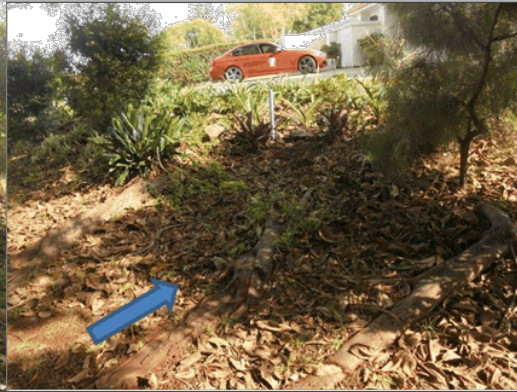
20: Tree roots running towards the driveway

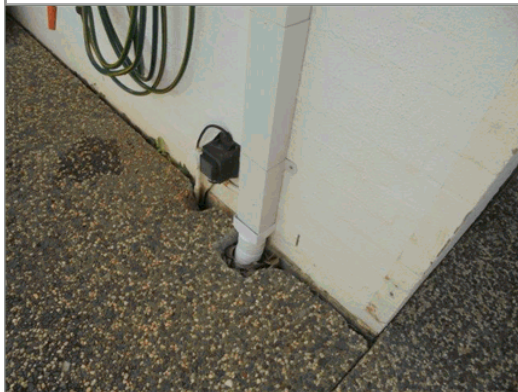
21: The owner found tree roots between the house where the path is lifting at the western side of the office

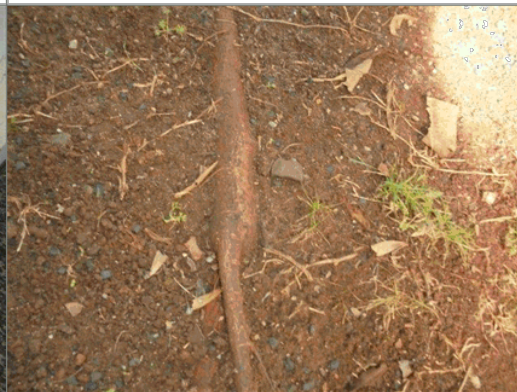
- **Tree roots:** Fig tree surface roots identified in abundance at the south east corner. Surface roots also visible at the east side of the house near Bedroom 3 / bathroom. The insured advised that tree roots had been removed from drains at the east and west sides of the house.

22: Fig tree roots at the east side of the bathroom

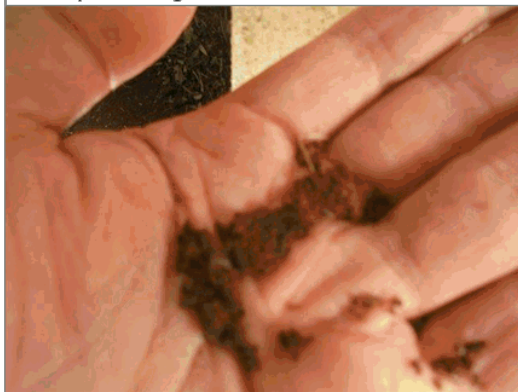
23: Surface soils are low plasticity silty clays (CL) with trace of sand
