REPLACEMENT REVETMENT WALL 135 RIVERSIDE DRIVE BALLINA CLIENT: G.& J.COLEFAX	RICHARD CRANDON CPEng. MIEAust. CONSULTING ENGINEER OFFICE: P.O. Box 1400 Ballina NSW 2478 Phone & Fax 66 86 4549 Mobile: 04114222 22	JOB No.
		2019/62
		DRG. No.
		S1

CERTIFICATE OF SUFFICIENCY OF DESIGN & COMPLIANCE

Ref: Replacement Retaining Wall
Lot 10 DP 263861
135 Riverside Drive
West Ballina

**REPLACEMENT REVETMENT WALL
135 RIVERSIDE DRIVE
WEST BALLINA
STRUCTURAL REPORT**

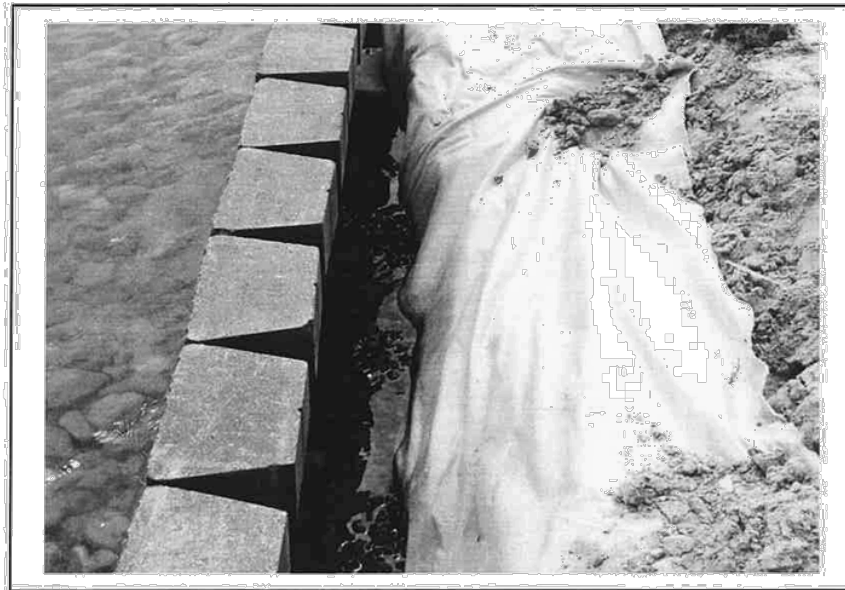
PHOTO 1 REMOVAL OF ORIGINAL WALLING AND THE DIFFICULTY IN RETAINING EXISTING BEACH DURING CONSTRUCTION OF THE REPLACEMENT WALL

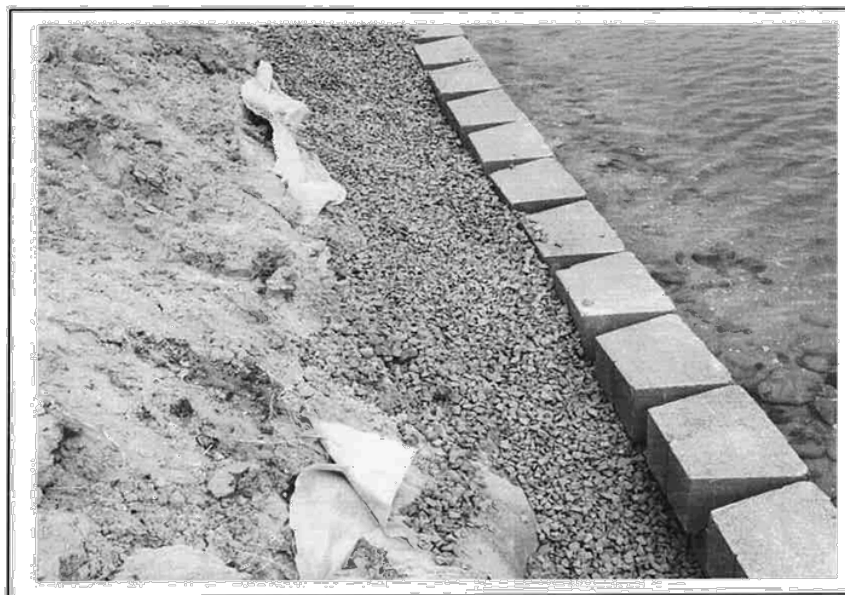
PHOTO 2 REPLACEMENT WALLING BACKFILLED WITH DRAINAGE MEDIUM IN PLACE - NOTE EXCESS EXCAVATED CUT MATERIAL ON BANK

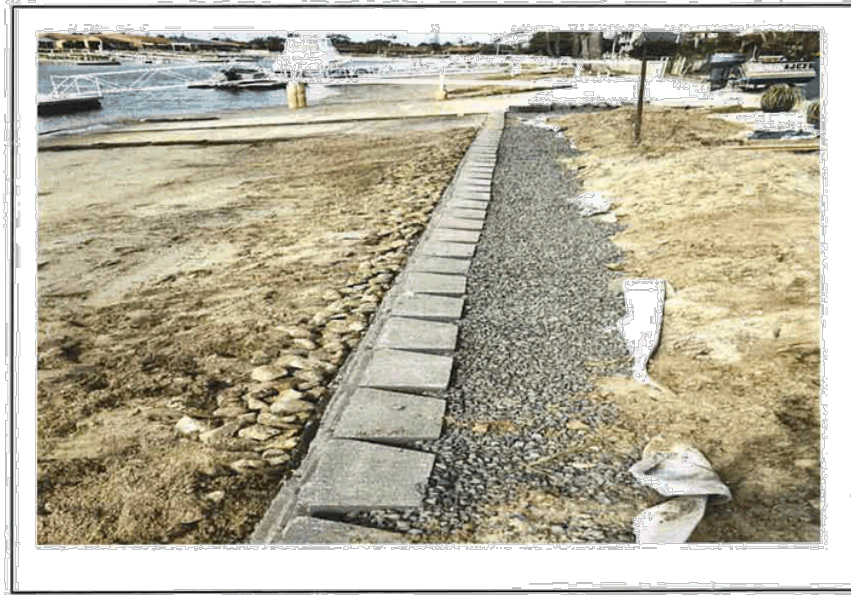
**PHOTO 3 GENERAL VIEW OF REPLACEMENT WALL—
BACKFILLED—NOTE EXCESS CUT BEACH MATERIAL—TO BE
PLACED ONTO AND RESTORE THE BEACH.**

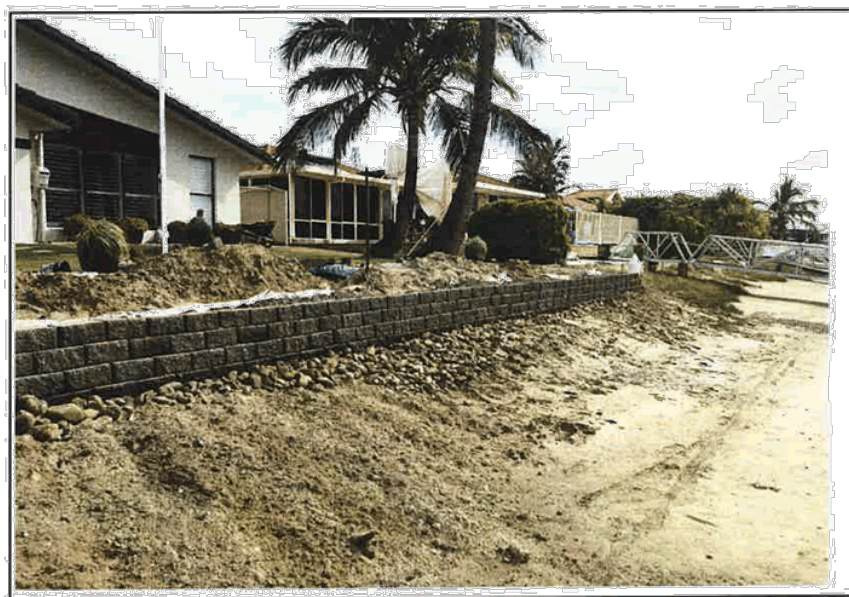
**PHOTO 4 GENERAL VIEW OF REPLACEMENT WALL—
BACKFILLED—NOTE EXCESS CUT MATERIAL—PLACED ONTO
BEACH AREA IN FRONT OF THE WALL**

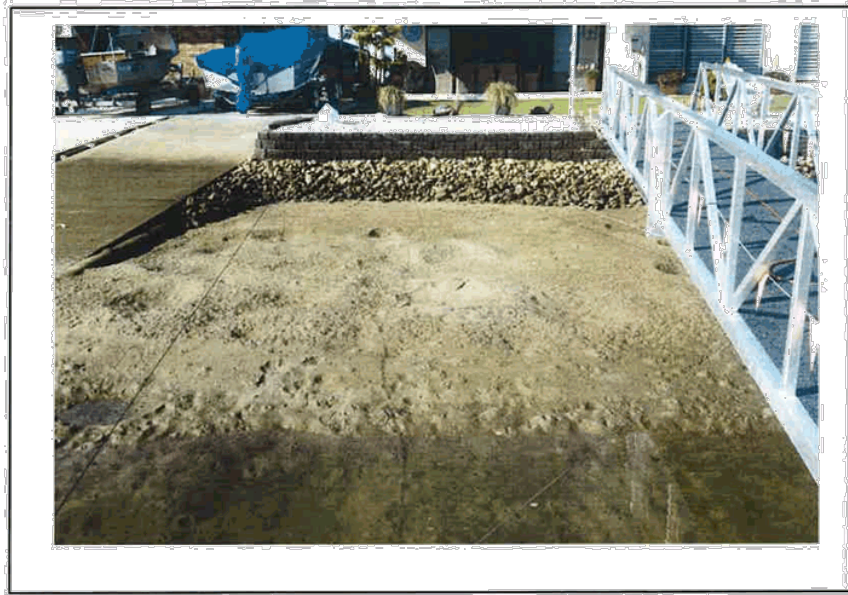
PHOTO 5 GENERAL VIEW OF FINISHED WALLING AND BEACH RESTORATION

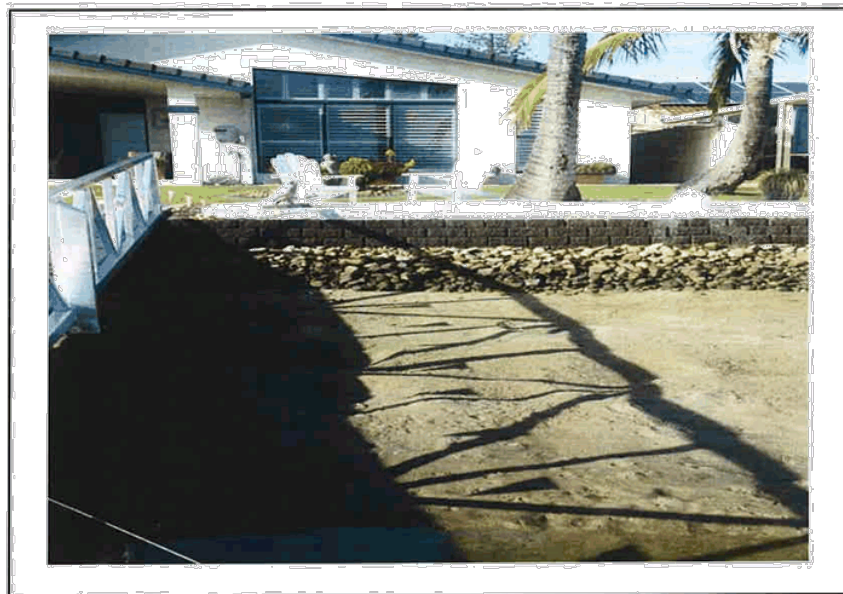
PHOTO 6 GENERAL VIEW OF FINISHED WALLING AND BEACH RESTORATION

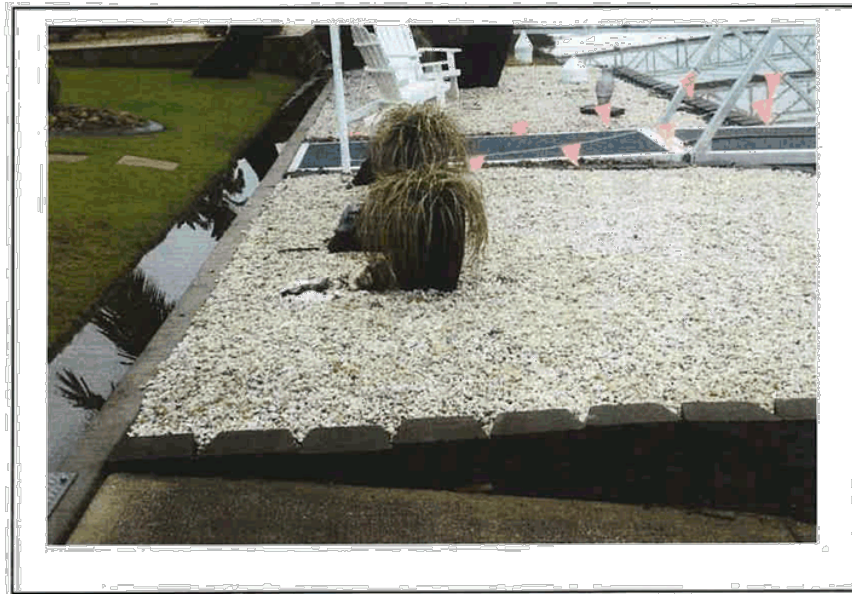
PHOTO 7 GENERAL VIEW OF COMPLETED WORKS.

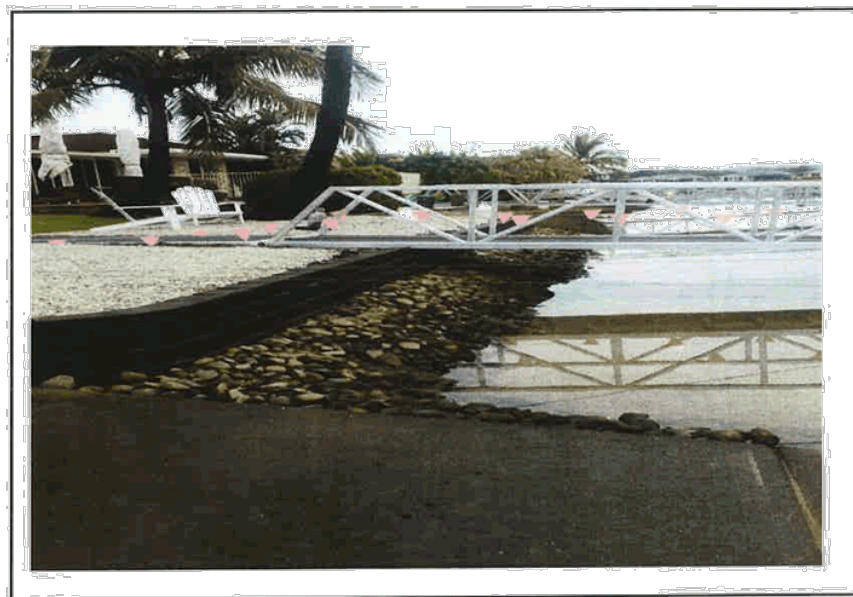
PHOTO 8 GENERAL VIEW OF COMPLETED WORKS

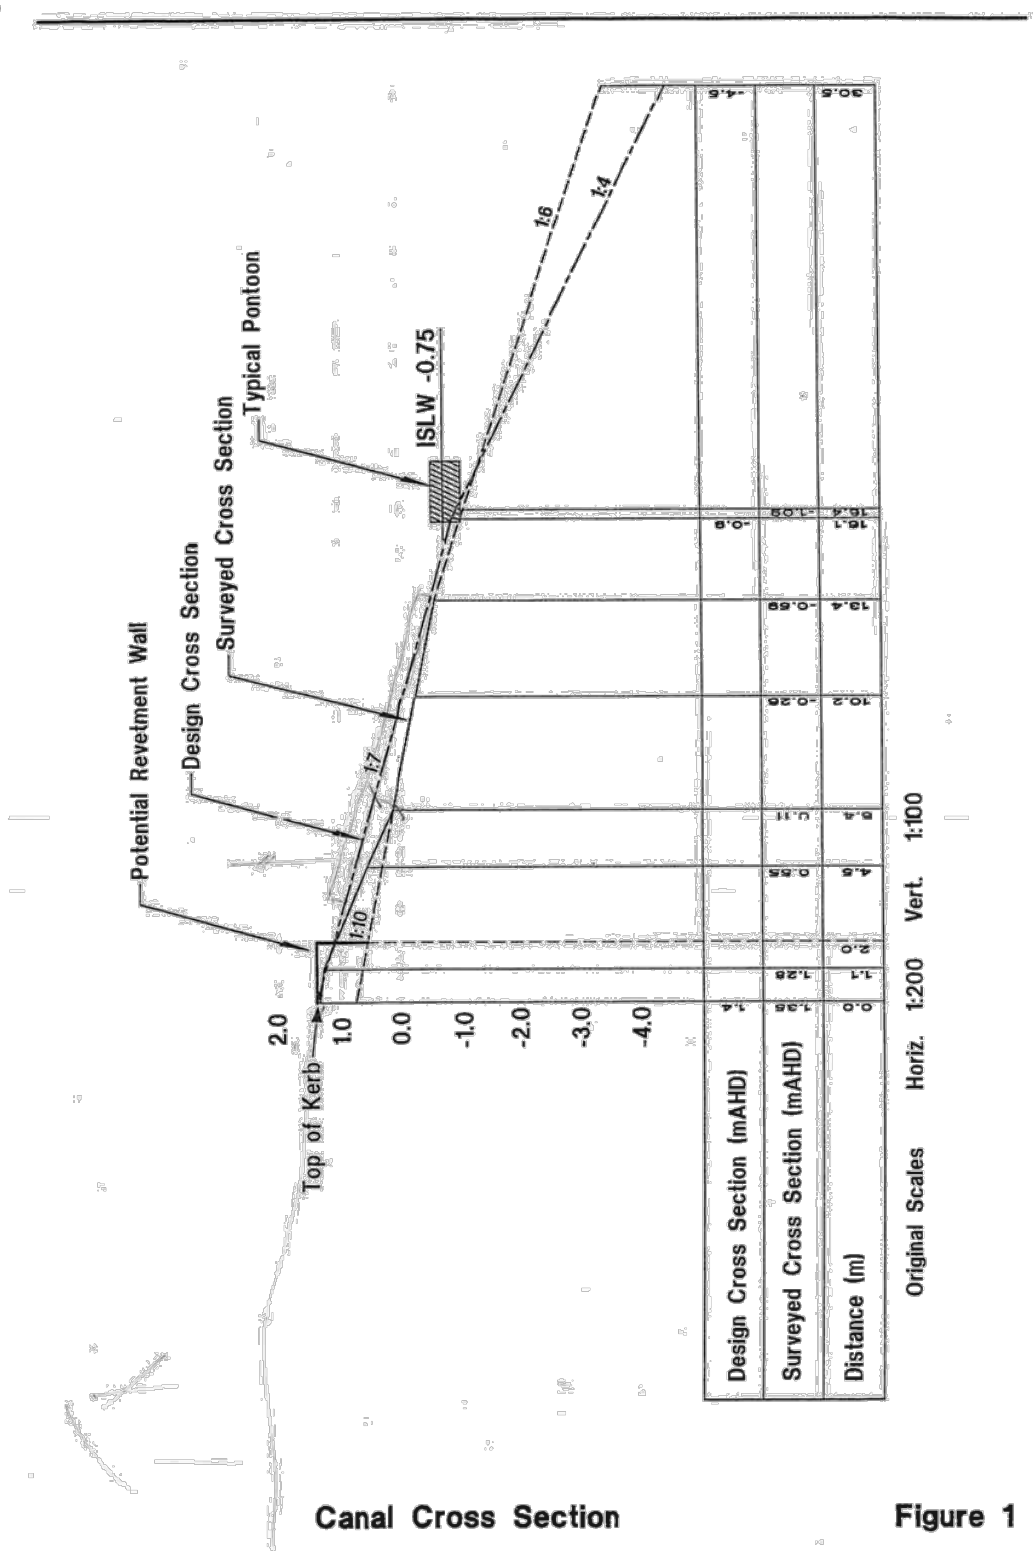
The Ballina Quays canals were initially constructed with a typical beach profile as shown in Figure 1. This profile extended down at a slope of 1 in 7 from a level of 1.4m AHD at the property kerb wall to RL -0.9m AHD. Below this a slope of 1 in 4 was adopted to the canal invert of -4.5m AHD.

the upper part of the profile and deposition in the lower part. Figure 1 illustrates a typical undisturbed cross section at Lot 20 Riverside Drive (as surveyed by Council 2/2/99).
