### **Lot 3 DP525783 Compton Drive, Ballina**

#### **Geotechnical Assessment for residential use.**

**RE: Slope Hazard Assessment: 23 Compton Drive, Ballina**

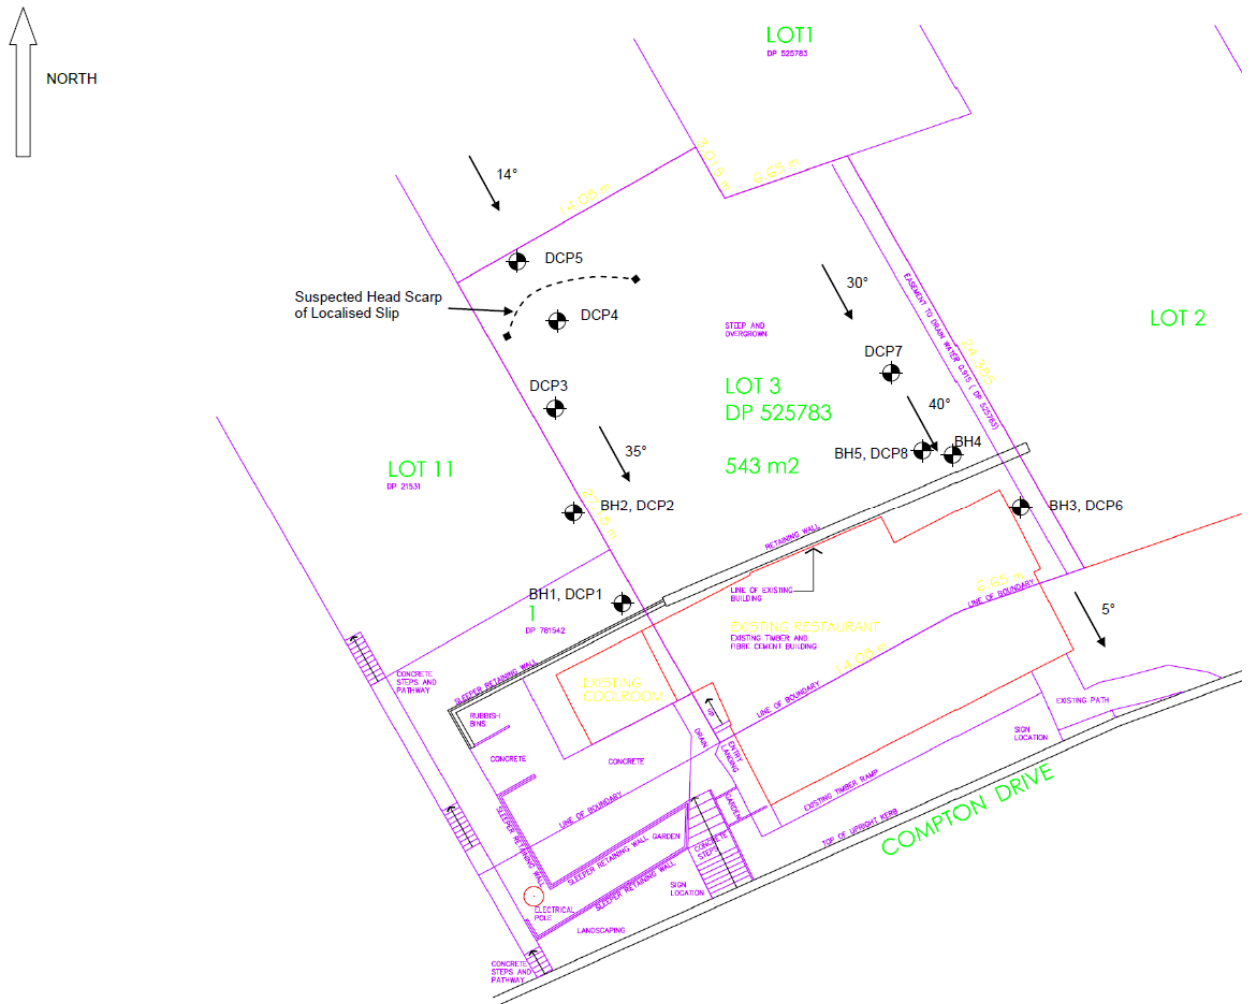
Figure 4-1 Site plan from 2013 report

The geotechnical report included subsurface investigations (5 boreholes drilled by hand auger with 8 dynamic cone penetrometer (DCP) tests) and developed a geotechnical cross section. The location of the investigations is shown in Figure 4-1. The geotechnical model interpreted from the conditions observed in the 2013 report is shown in Figure 4-2.

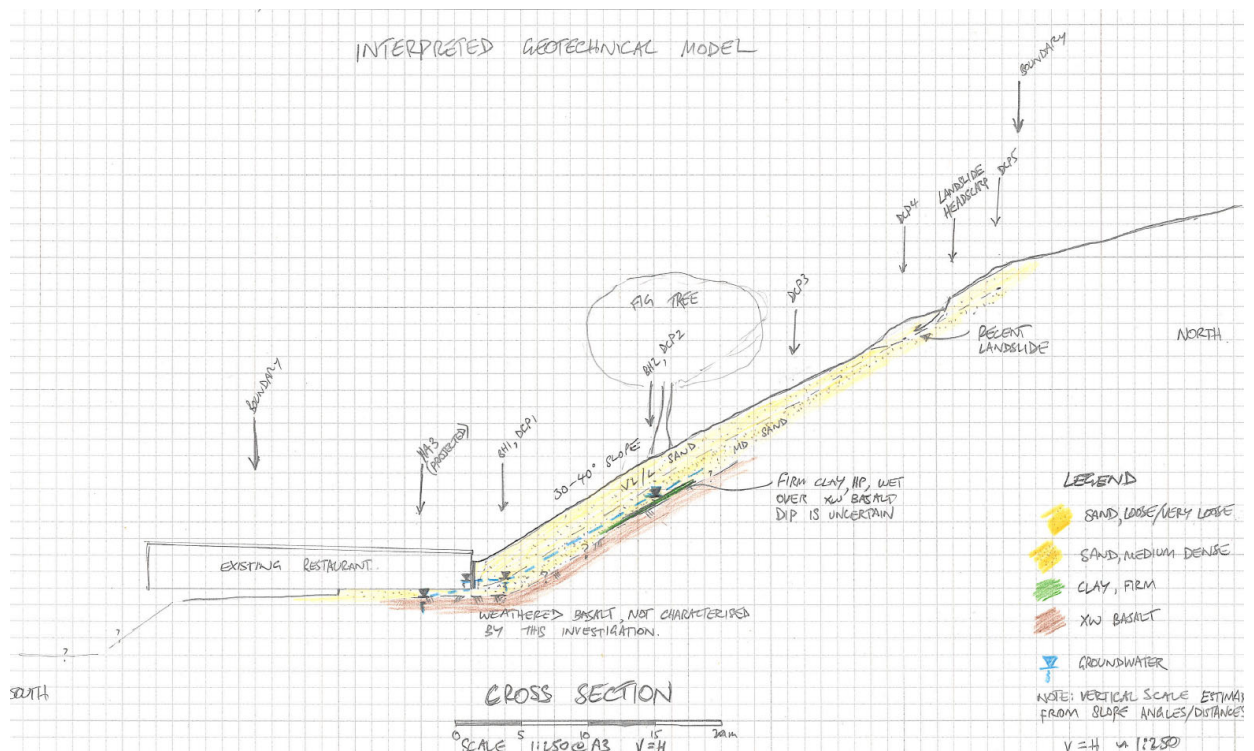
**Figure 4-2 Geotechnical model from 2013 report**

In summary, the geotechnical model comprises a weathered basalt basement material, mantled by loose and very loose sand. The sand comprises an older dune system and at its angle of repose. The sand slope dips down to the south east at 30° to 40° towards the current development and shows signs of slope instability in the form of a small landslide headscarp and soil creep. The sand slope is retained at the base by a retaining wall of two or more different types.

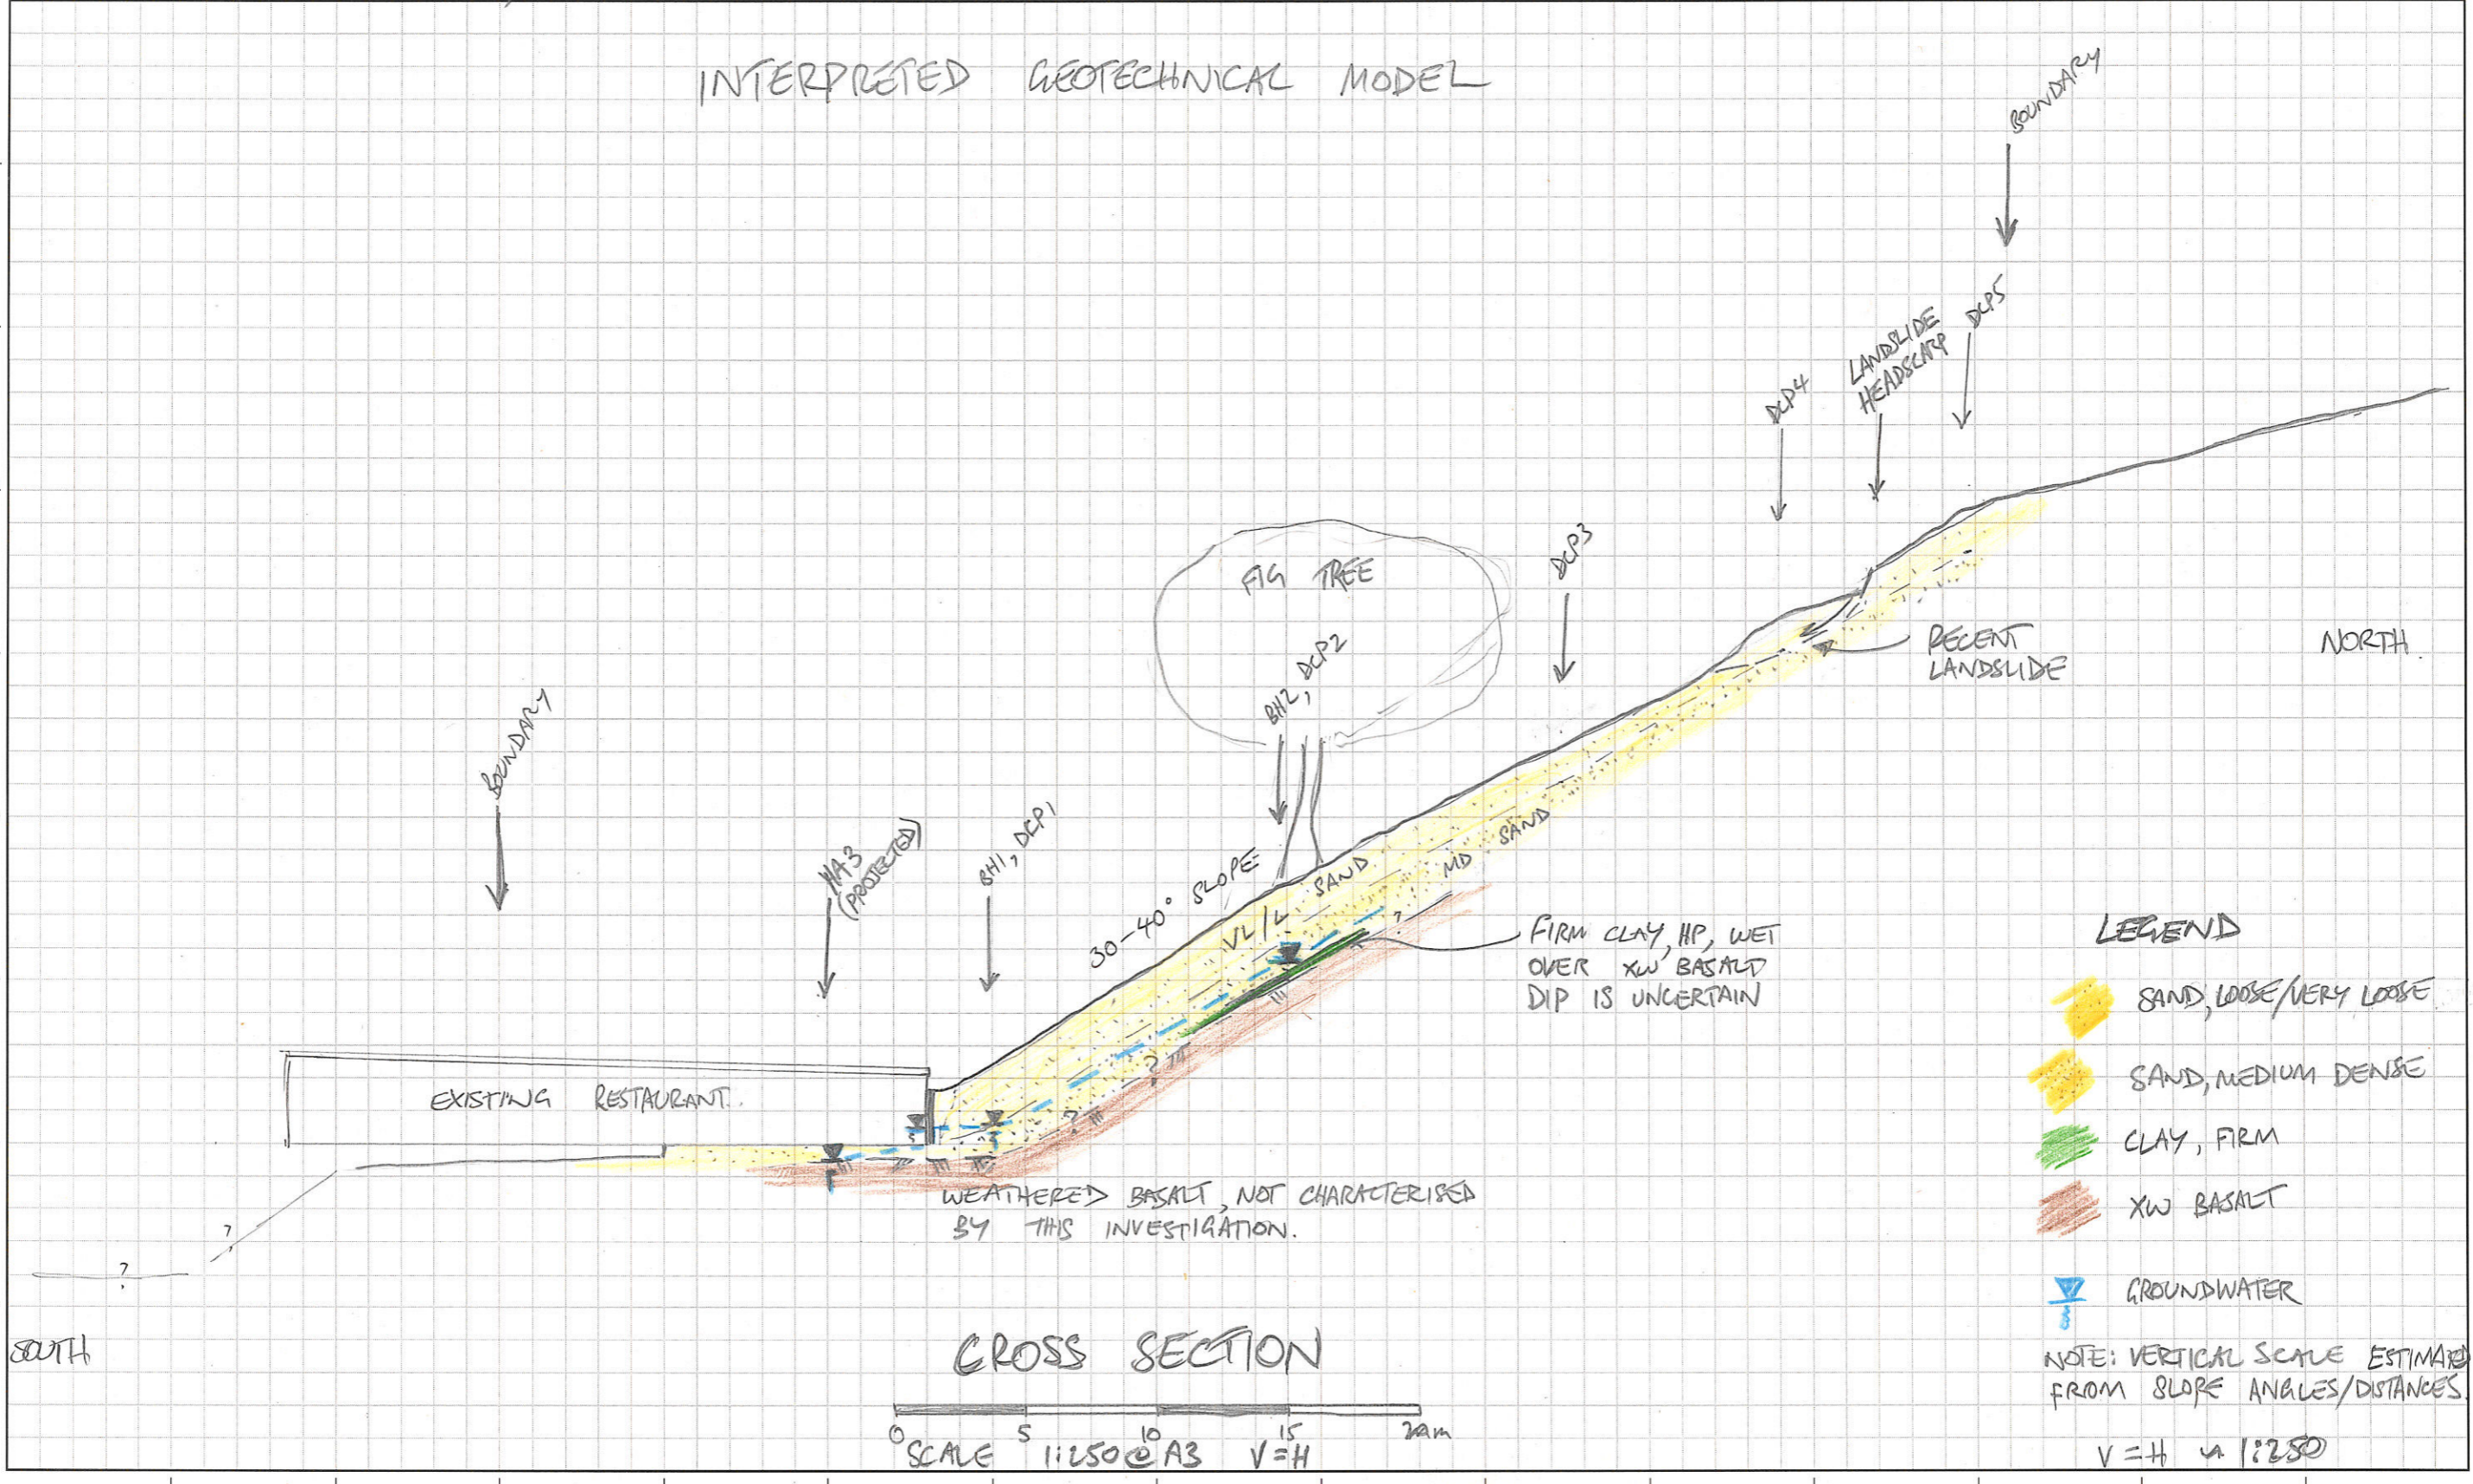
INTERPRETED GEOTECHNICAL MODEL

Our boreholes drilled on the site intersected fill and aeolian dune sand overlying weathered basaltic rock. In one borehole a firm clay of apparent alluvial/marine origin was observed overlying the weathered basalt. This clay could also be a weathered interflow layer from within the basaltic rocks that underlie the site.

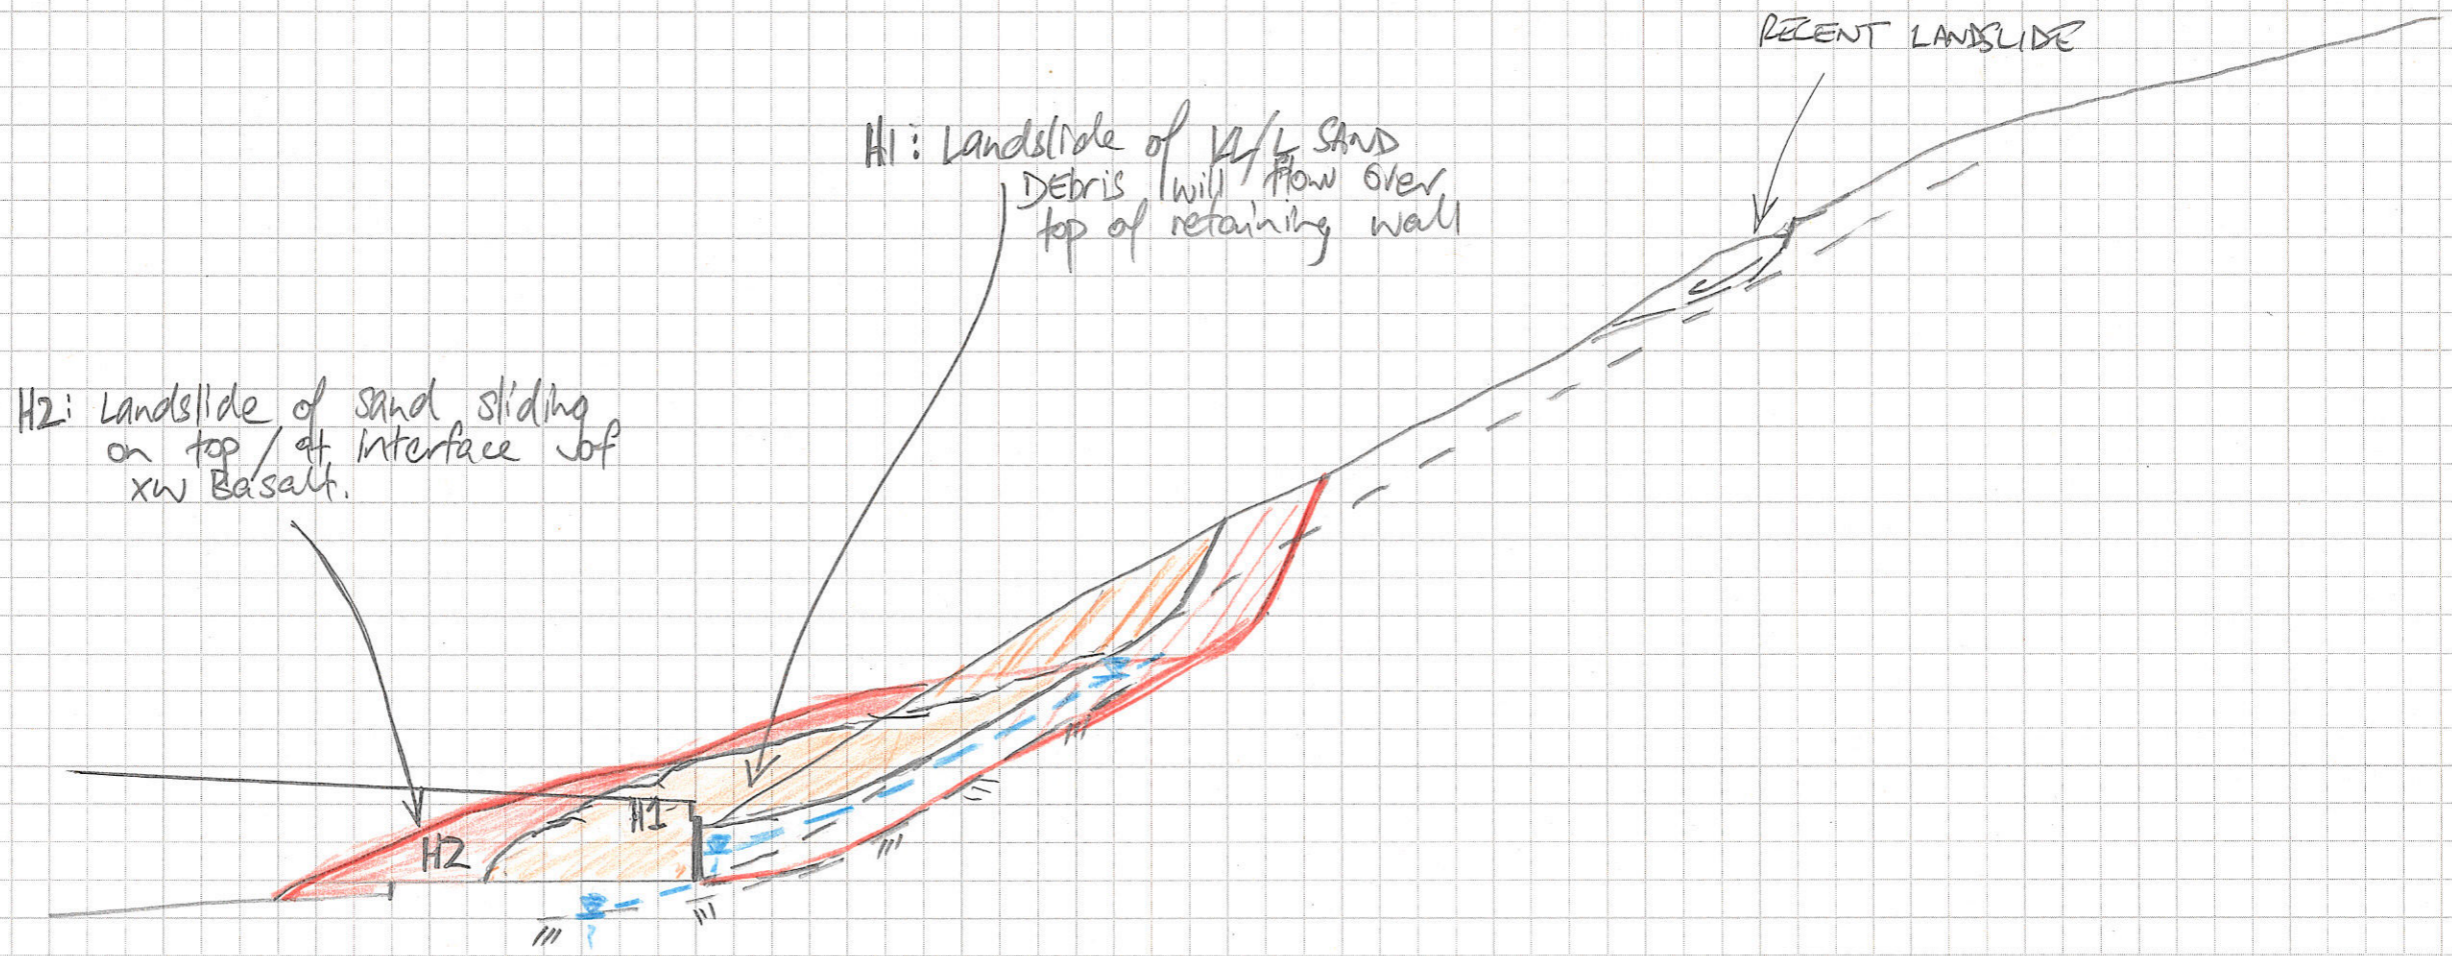
### CREDIBLE HAZARDS

Hazard	Likelihood	Possible Consequences	Potential Mitigation Options
<p><b>H1) Shallow landslide of the loose to very loose sand</b> (above the existing retaining wall).</p> <p>The landslide may be in the order of say 10m wide, 2 to 3m deep and say 10 to 15m long. When it slides down the slope we would expect it could overtop the existing wall, or topple it in part, and leave a debris pile that extends say 5m to 10m into the restaurant area.</p>	<p>The presence of an existing landslide of this type, coupled with deep loose sand and elevated groundwater indicates that this type of hazard is <b>likely</b> to occur.</p> <p>The trigger for the event could be minor rainfall or small changes to the slope vegetation and drainage.</p>	<p>If this hazard occurred, moderate volumes of soil could slide down the slope above the retaining wall, and spill over into the rear half of the restaurant. The debris could move faster than running pace with little or no warning.</p> <p>The consequences of the hazard are likely to be <b>moderate to major</b> with extensive damage to much of the existing structure possible, if no restraint of catch structure is built.</p>	<p>Retain the hazard in place or construct a catch structure above the development to provide protection</p> <p>H1+H2-a) Soil nailed retention systems,</p> <p>H1+H2-b) Piled retention systems installed within the slope above the existing retaining wall, stepped up the slope.</p> <p>H1+H2-c) A large retaining wall founded at the base of the slope with additional height to act as a catch structure or to provide a wall to backfill against to resist landslide forces. The wall could be an anchored piled wall or a gravity wall.</p>

<p><b>H2) Landslide of the soil above weathered rock</b> (above the existing retaining wall)</p> <p>The landslide may be in the order of say 10m wide, 3 to 4 m deep and say 10 to 15m long. When it slides down the slope we would expect it could topple or slide through the existing wall, and leave a debris pile that extends say 5 to 15m into the restaurant area. If the debris was very wet greater travel distances could be expected.</p>	<p>The presence of a moist to wet clay layer at depth (HA2), which potentially dips downslope, indicates that a moderate sized landslide that would encompass a large amount of the slope, is considered <b>possible</b>.</p> <p>The trigger for the event could be moderate rainfall or changes in the slope loading or support. (Such as developing the slope without taking this into account).</p>	<p>The event could occur rapidly with debris moving downslope faster than running pace, or slowly with movements occurring over a number of years.</p> <p>The consequence of such a landslide is considered to be <b>catastrophic</b> for the current restaurant, with debris extending out from the base of the slope in the order of some 5m to 15m. In some circumstances, debris could reach the roadway.</p>	<p>H1+H2-d) Accept the hazard and develop such that the hazard does not affect the proposed structure. Such a strategy could rely on a specifically reinforced structure designed to withstand the forces should soil slide into the building, or design the structure such the landslide could travel below the proposed structure without unreasonably endangering life.</p>

<p><b>H3) Large scale landslide through weathered rock mass</b> above the site, where the slide plane is located within weathered rock below the depth of the boreholes.</p>	<p>Data to indicate that a large scale landslide encompassing all of the slope is was not observed during the investigation (due to techniques used). Further, large scale instability such as this is not known to have occurred (by Coffey) in similar geological conditions within the Ballina coastal strip. The event is considered <b>unlikely to barely credible</b>. For such an event to be unlikely, a discontinuity or weakness within the rock mass within the slope would be required.</p>	<p>If such an event occurred, large scale destruction of the development would result. The consequences would be <b>catastrophic</b></p>	<p>H3-a) It is unlikely that mitigation of this hazard is warranted. Deeper drilling data below the proposed development would be required to rule this hazard out.</p>

Figure 3 presents a visual interpretation of Hazards 1 and 2.
