BALLINA SHIRE COUNCIL

**GEOTECHNICAL REPORT ON LANDSLIDE
REMEDICATION
COAST ROAD, LENNOX HEAD**

10644/1-C
July 2011

RE: LANDSLIDE REMEDIATION, COAST ROAD, LENNOX HEAD

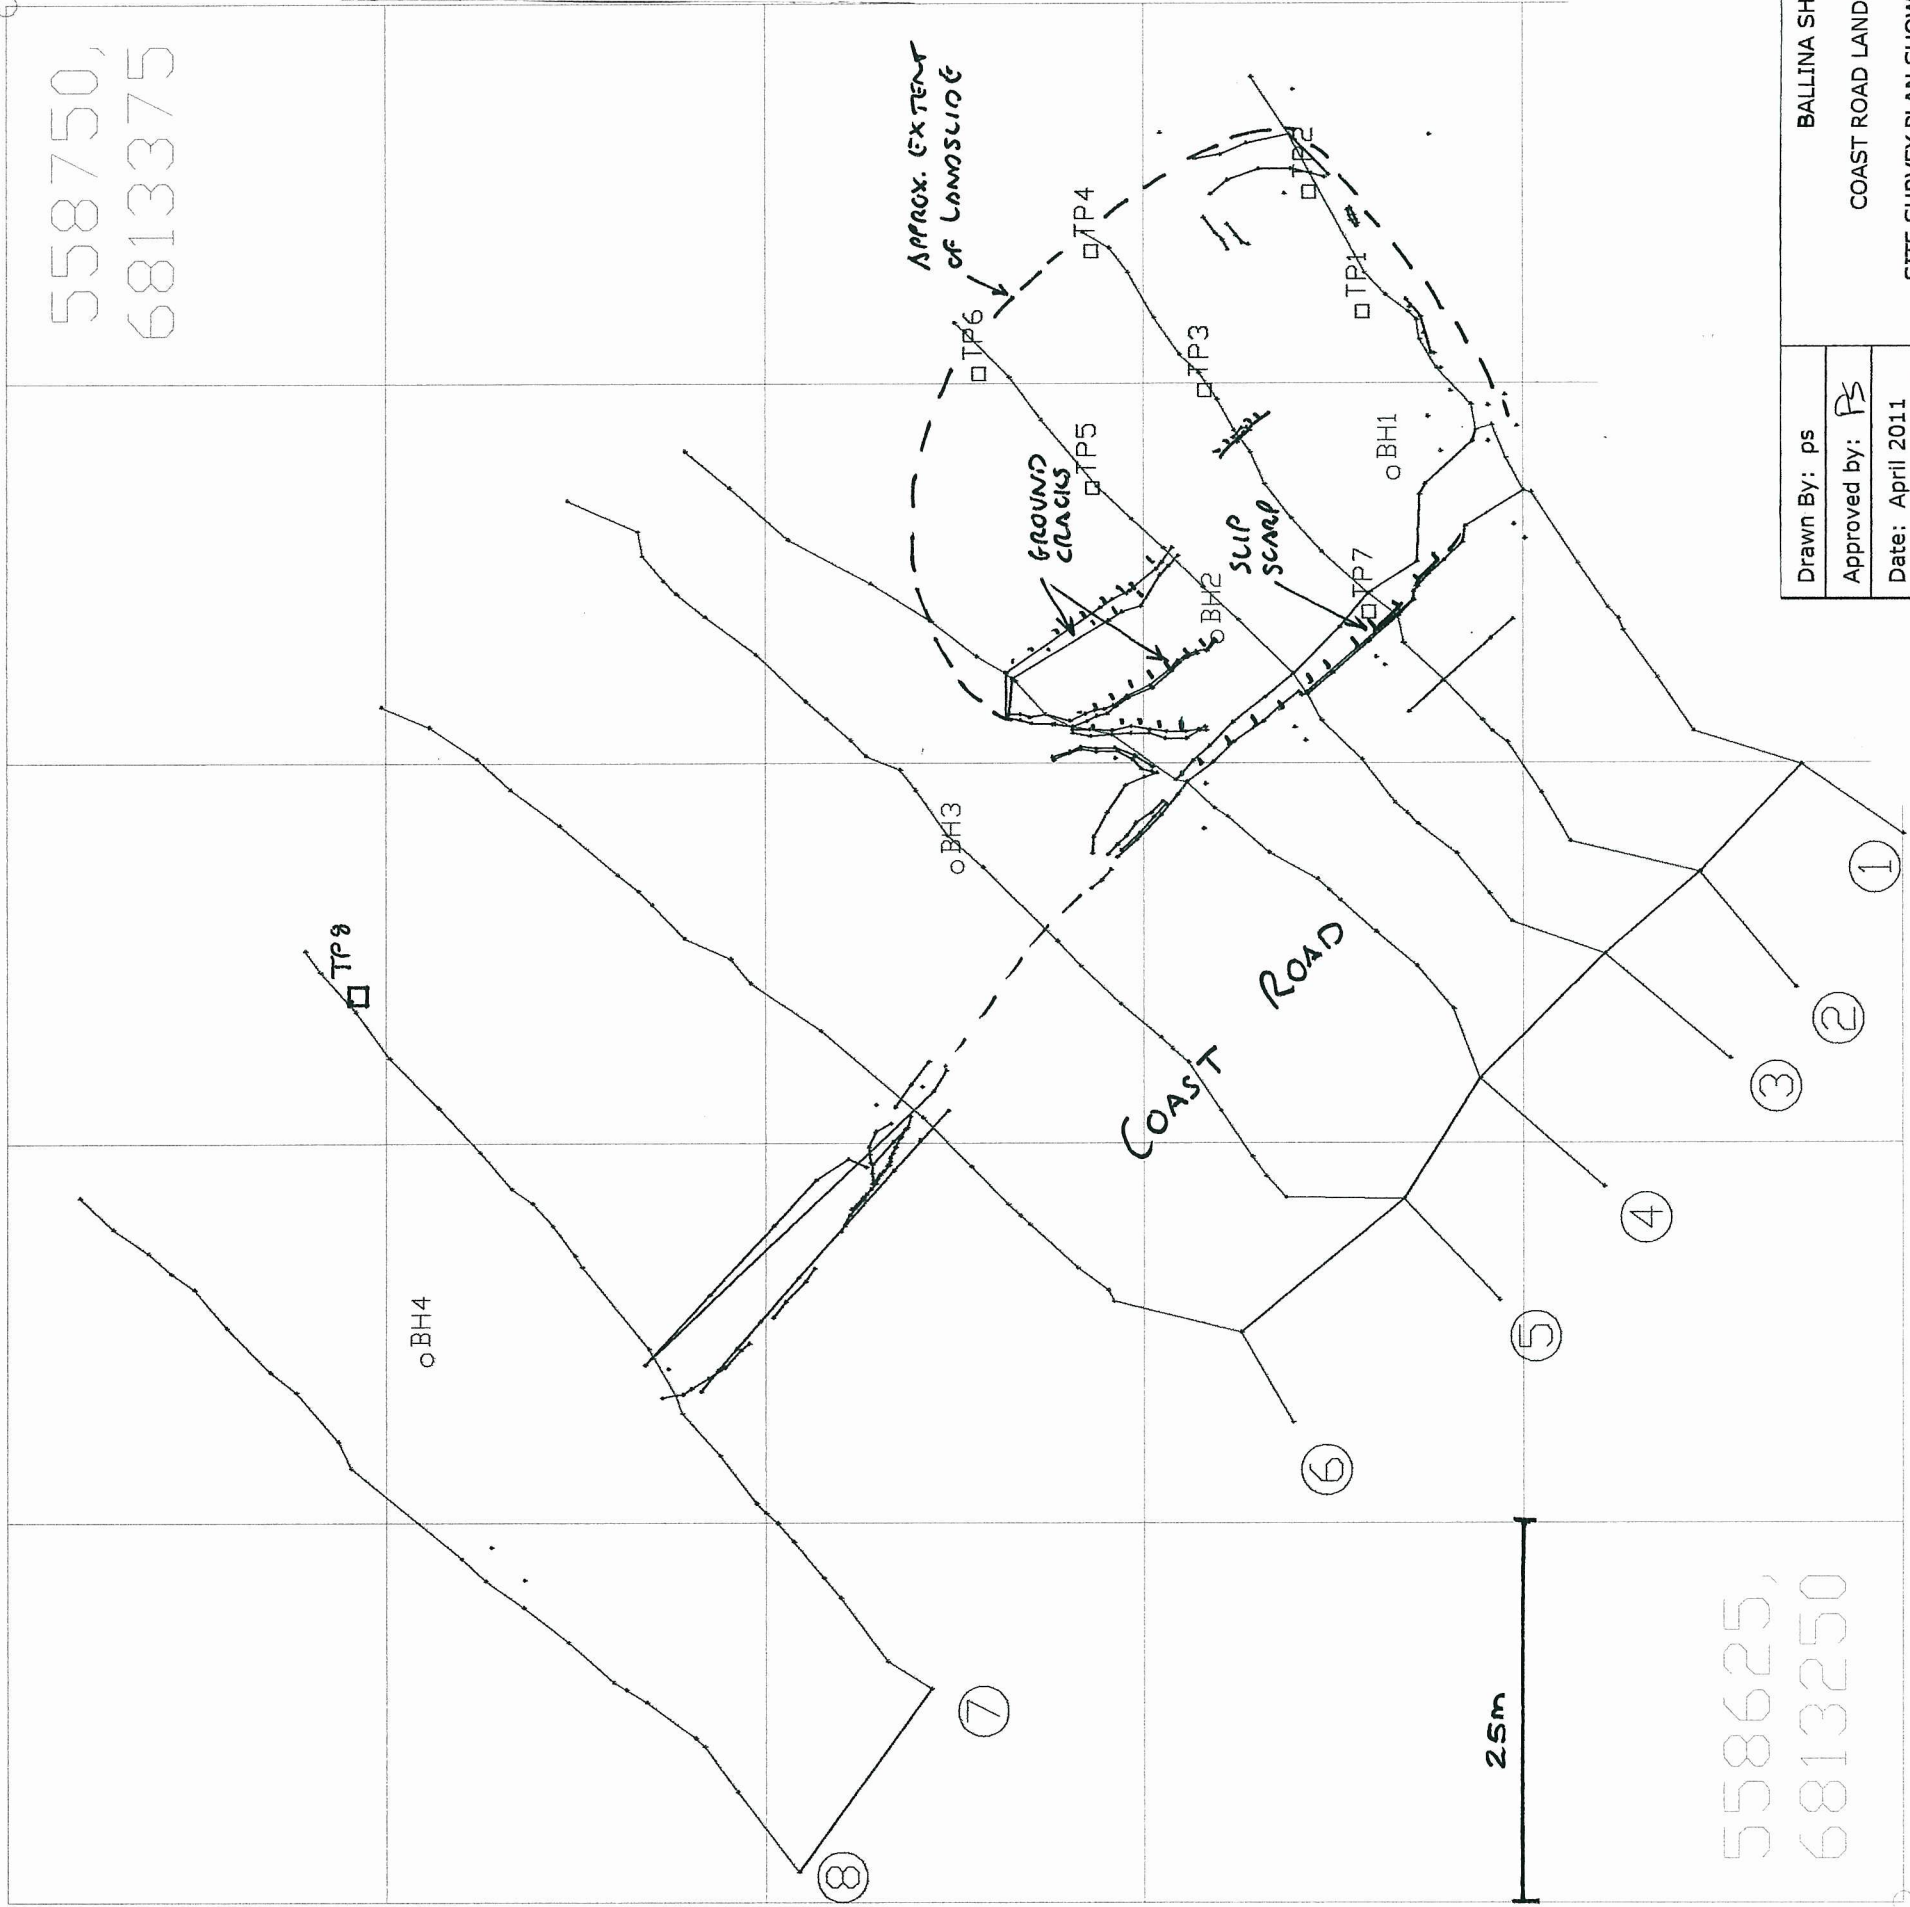
Tension cracks were observed in the road shoulder to the north of the landslide as shown on Figure 1.

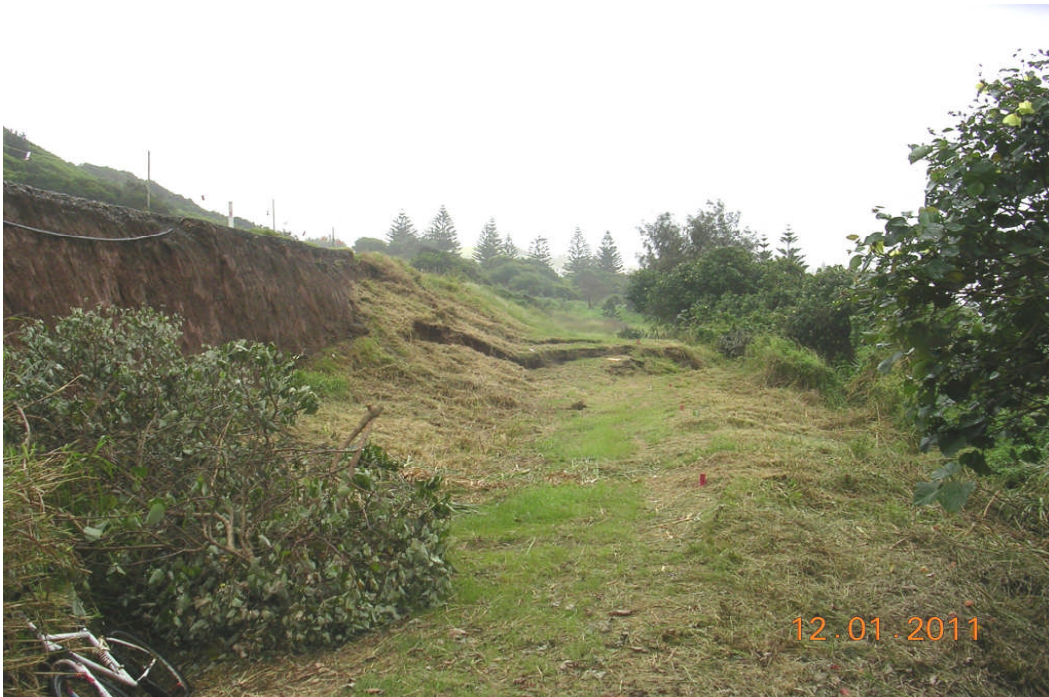
Photo 3: View of landslide head scarp and edge of road pavement, looking south east.
