BALLINA SHIRE COUNCIL

FIG TREE MANAGEMENT

51 Bentinck Street – Ballina  
*Ficus microcarpa var. Hillii*- Root  
Encroachment report

# **Tamar St *Ficus spp.* Root Encroachment Report**

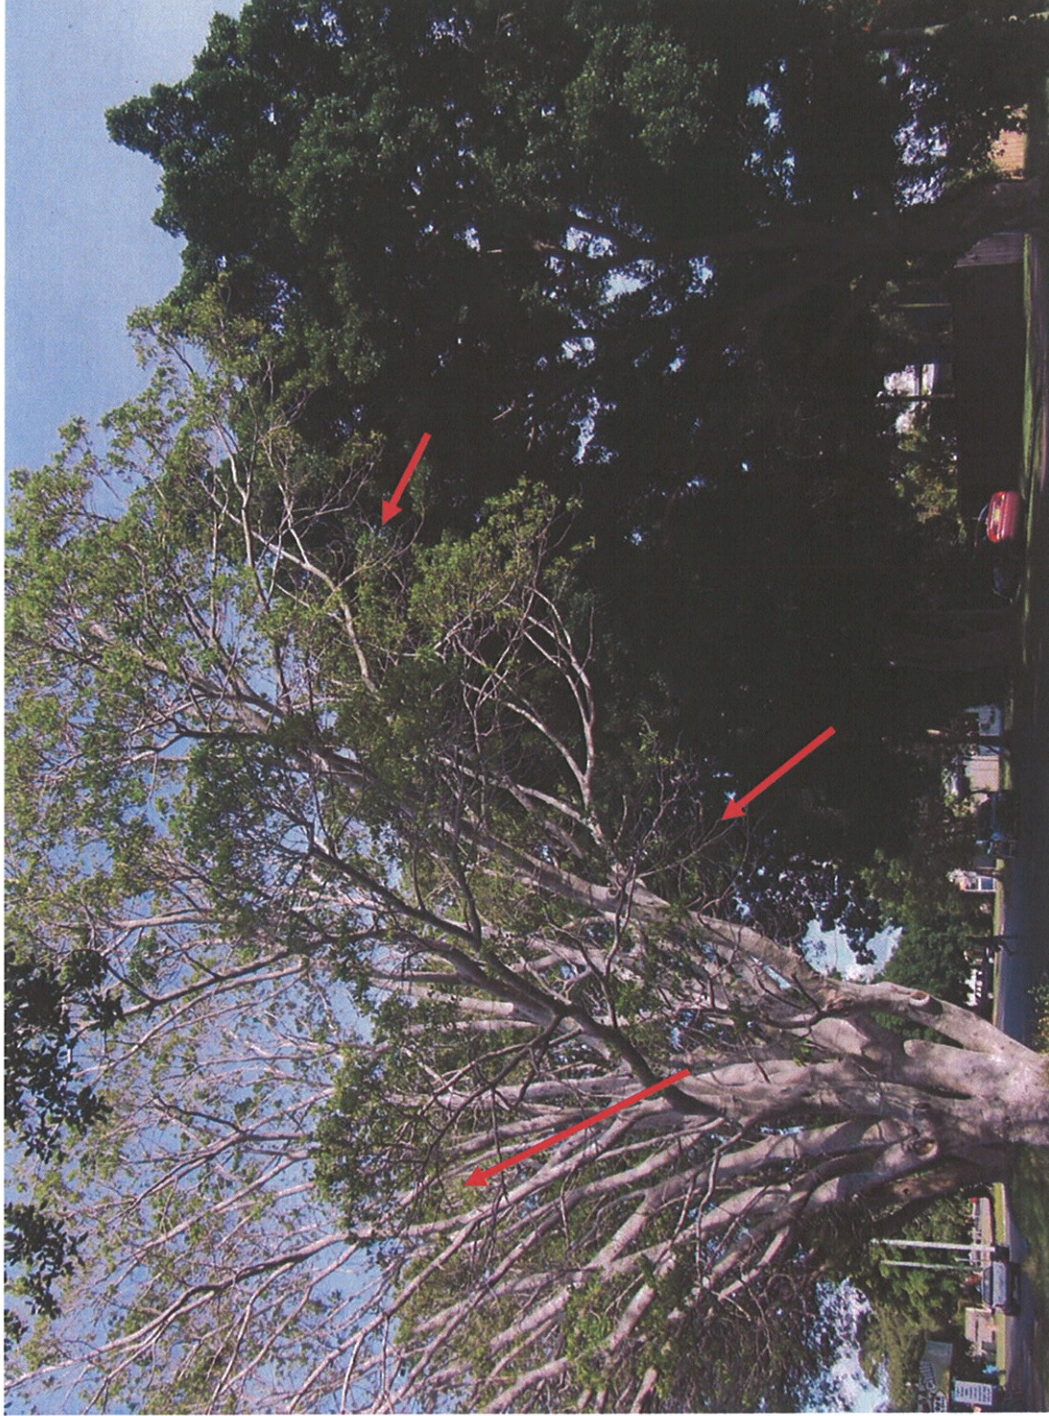
Figure 1: Bentinck Street Figs showing difference in canopy density between root severed trees and undisturbed trees

This photo shows the difference in Canopies between the trees (On Left) that were subjected to the installation of the root barrier, and those that are on the other side of the street.

Note also (Red Arrow's) the large amount of tip dieback. This tip dieback is usually related and identified as resulting from root issues and is a significant symptom in assessing trees.

In this case it is as a result of the severe root pruning that was necessary to enable the installation of the Bentinck Street root barrier.

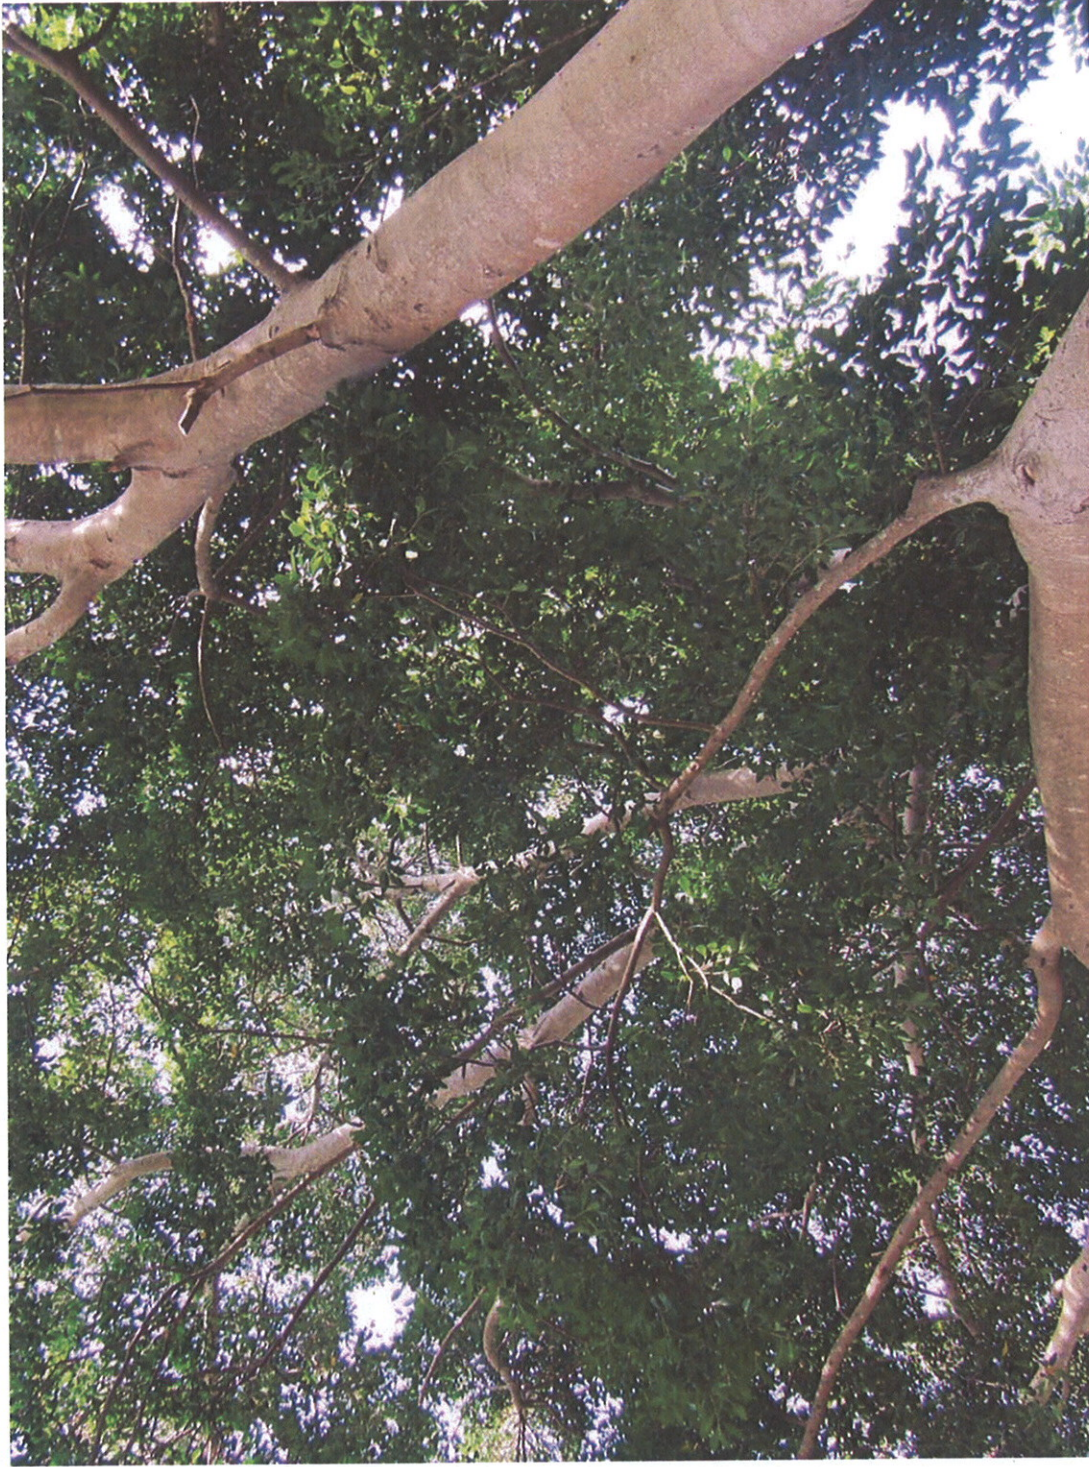
Figure 2: Crown density of undisturbed trees on northern side of street app 90% canopy density

This image shows the density of the canopy of the undisturbed trees on the opposite side of the street to the root barrier. Crown density of this tree is estimated at approximately 90% and the canopy is considered to be intact and in good condition.

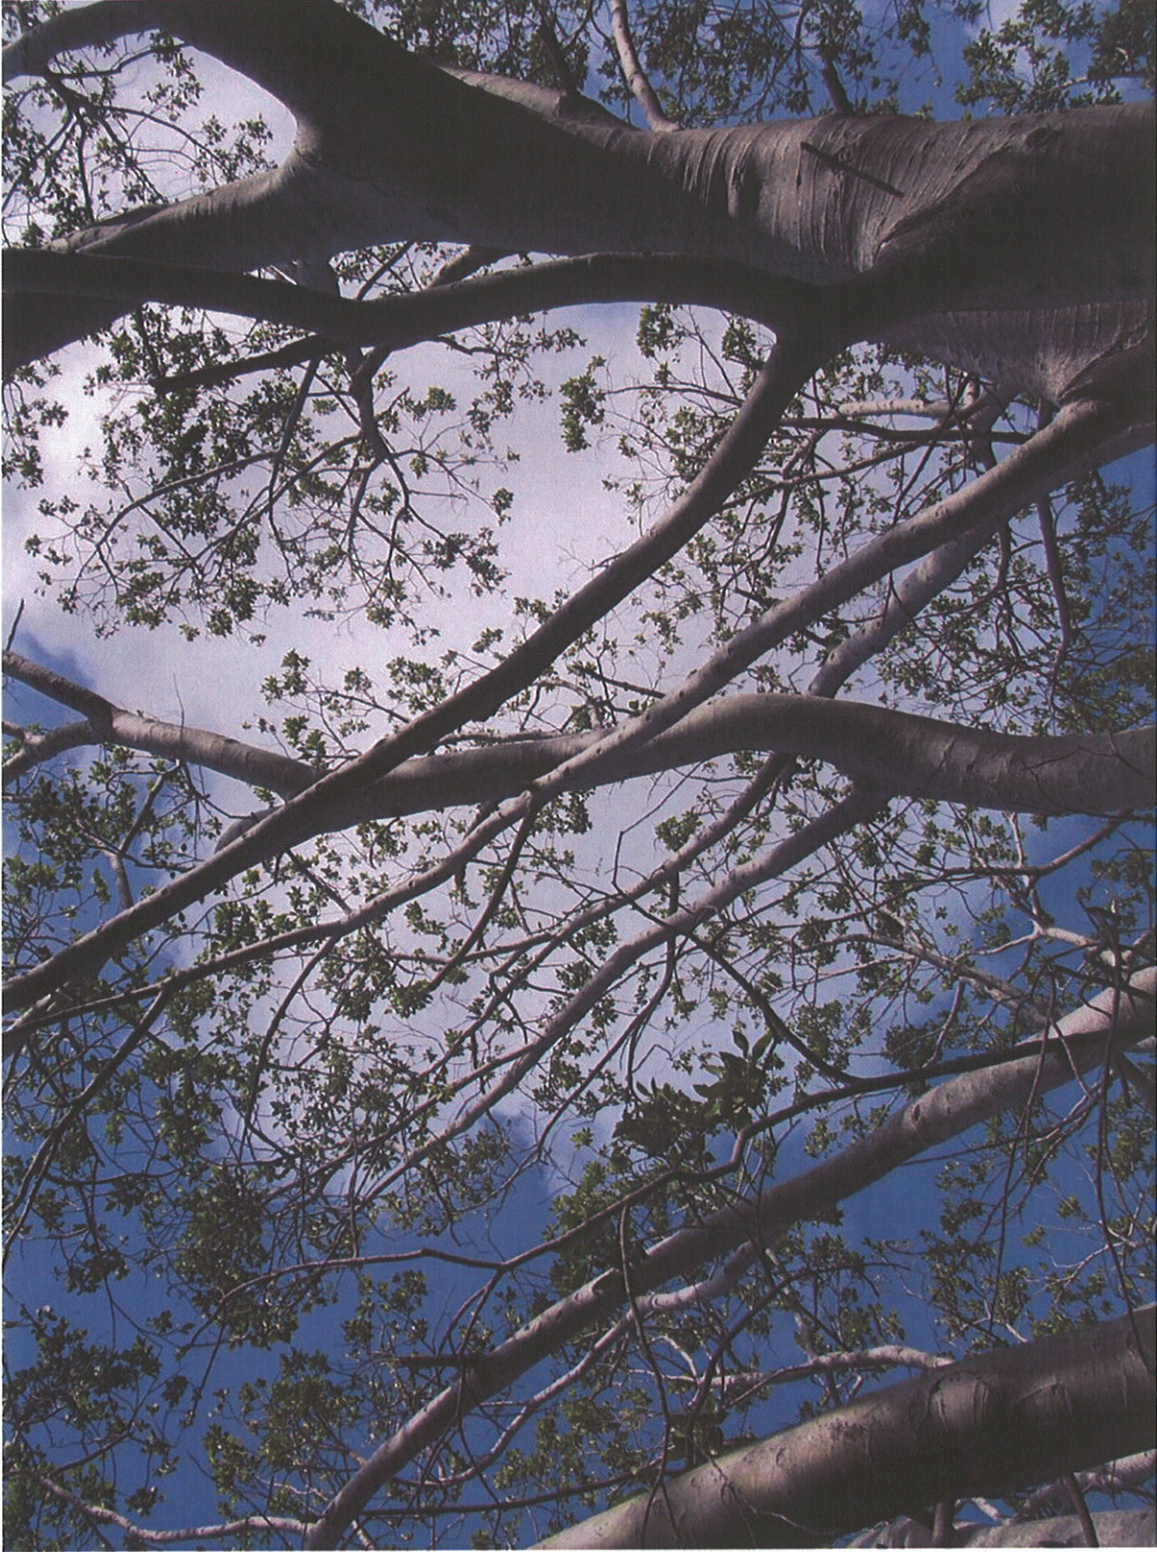
Figure 3: Crown density of trees on southern side of street (root barrier) app 30% canopy density

This image shows the same angled photograph taken from directly beneath the tree opposite to that shown in Figure 2.

This tree has suffered severe root severance, and has an estimated crown density of 30%. The loss of leaves is the tree's response to reduction in root mass and has dramatic effects on the photosynthetic rate of the tree and ultimately results in reduced energy production and a decrease in defence mechanisms within the tree's structure.

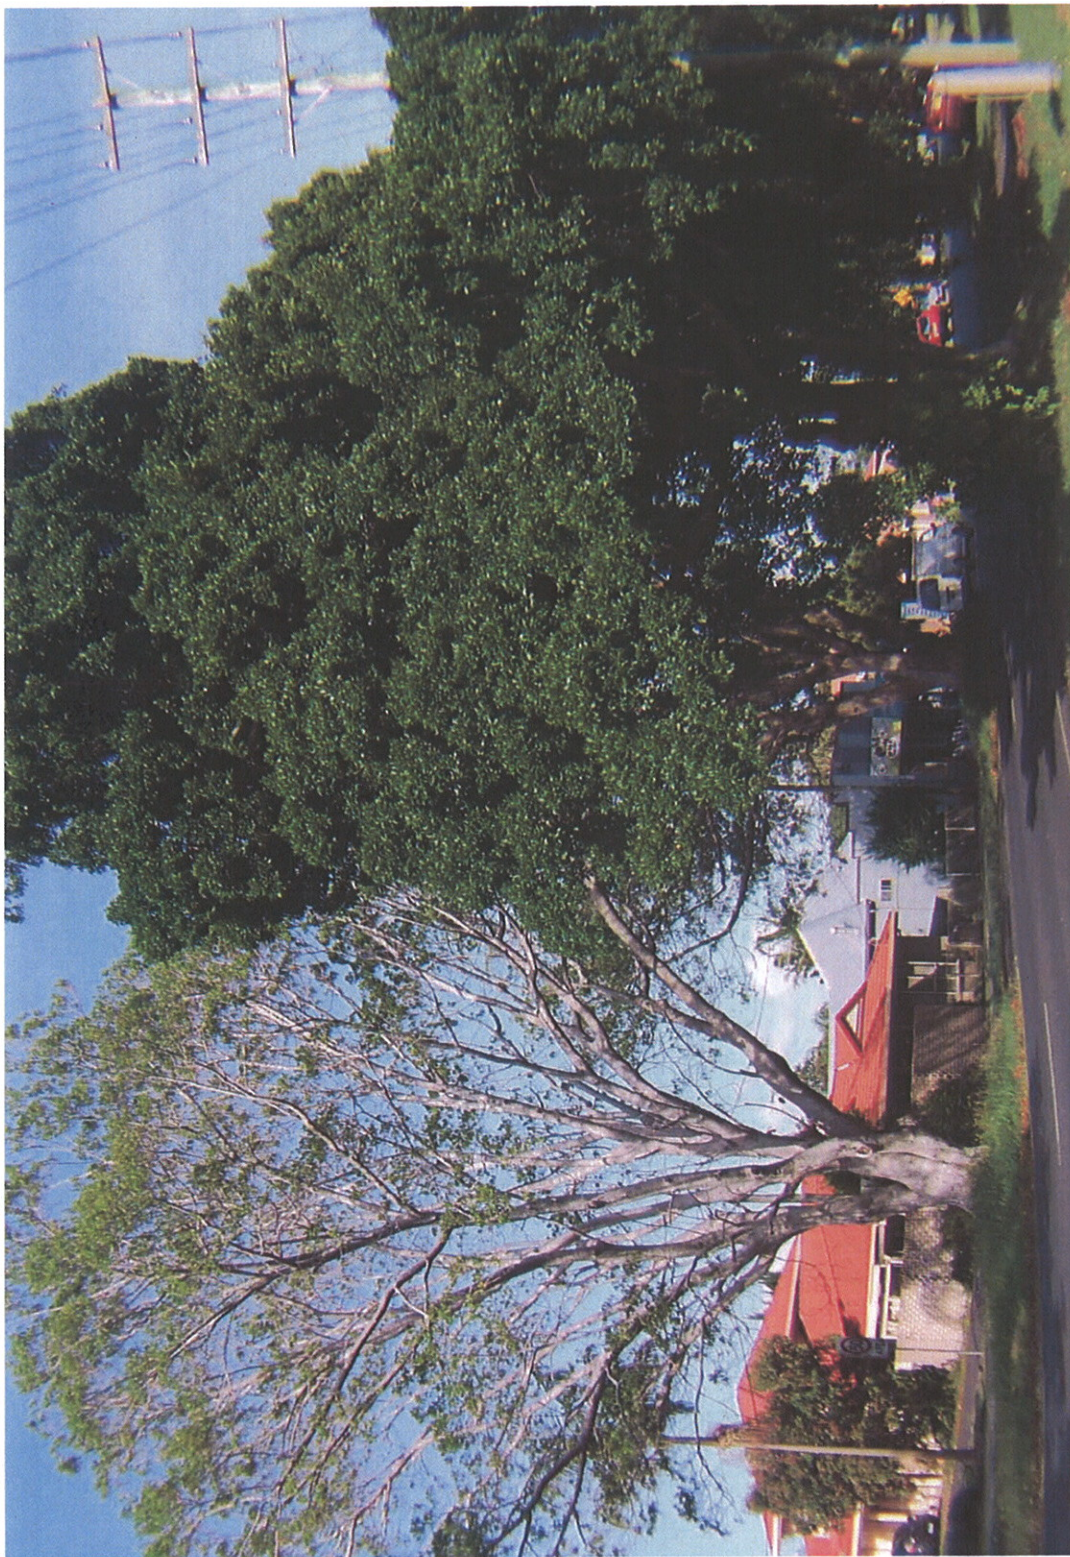
Figure 4: Comparison between trees subjected to root severance from root barrier installation and those that were undisturbed

This image shows the comparison between the trees (right) that were not subjected to the severe impacts of root barrier installations, as opposed to those trees (left) that were.

The trees are of the same species and age and have been identified as *Ficus microcarpa* var. *Hilli*

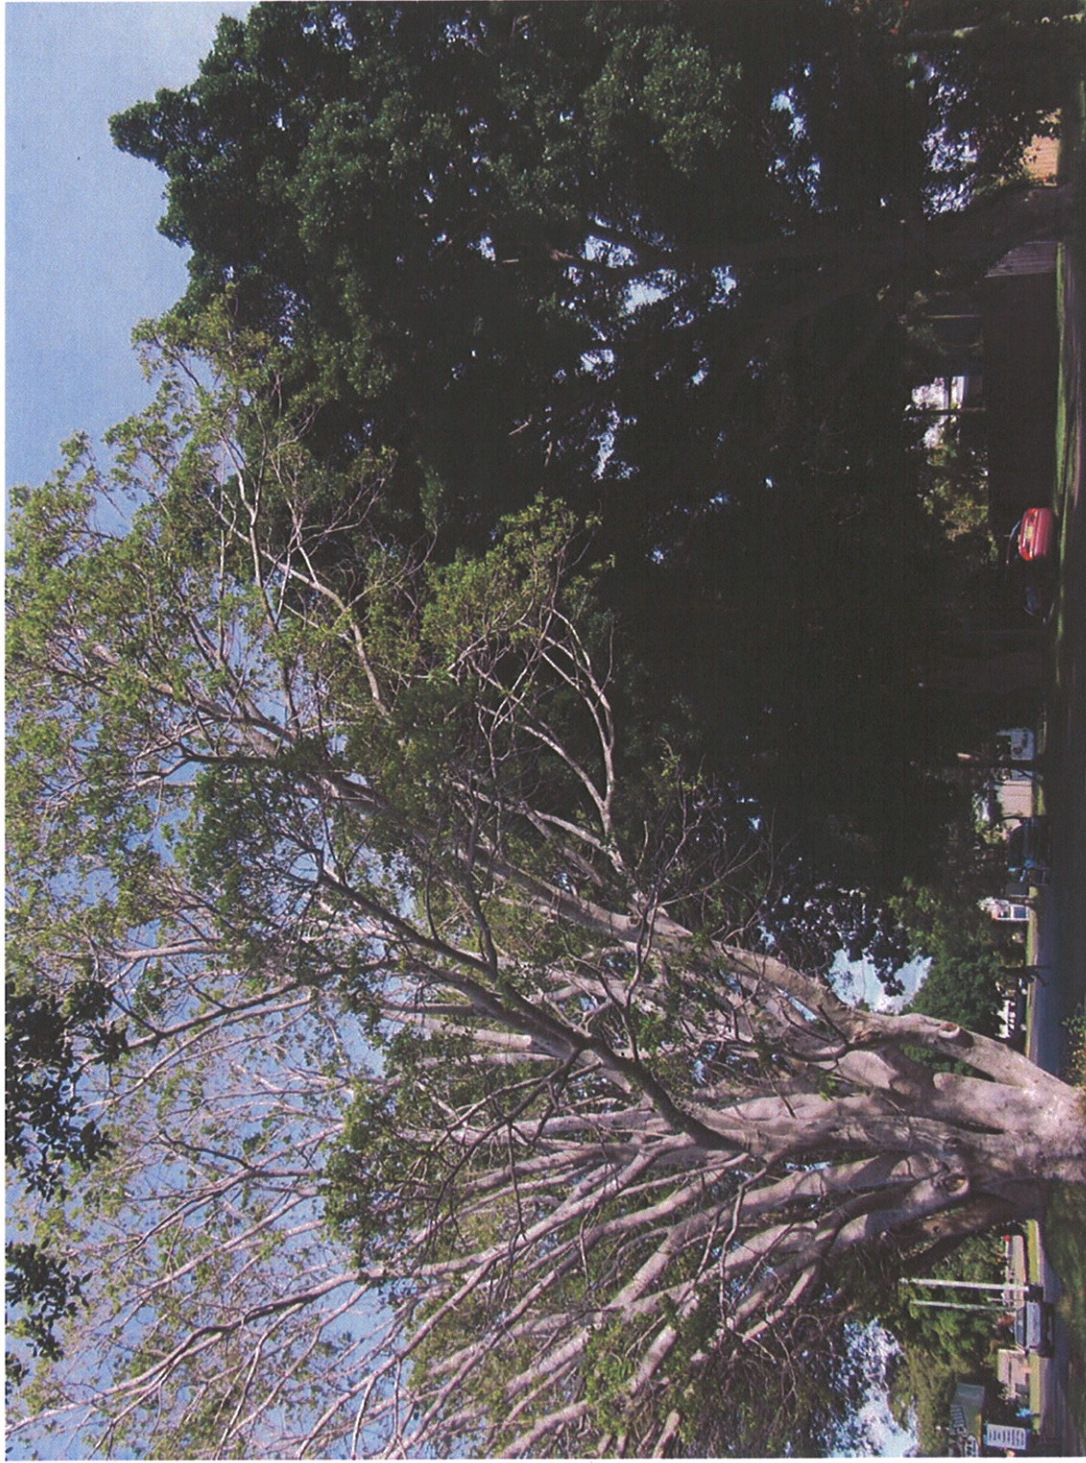
Figure 5: Further evidence of the Comparison between trees subjected to root severance from root barrier installation and those that were undisturbed

This image shows again the comparison in regards to canopy density of the undisturbed trees on the opposite side (right) of the street, to those on the side (left) where the root barrier was installed and severe root severance occurred.

**PLEASE NOTE:** these trees were of similar crown density prior to the installation of the root barrier and subsequent root severance.

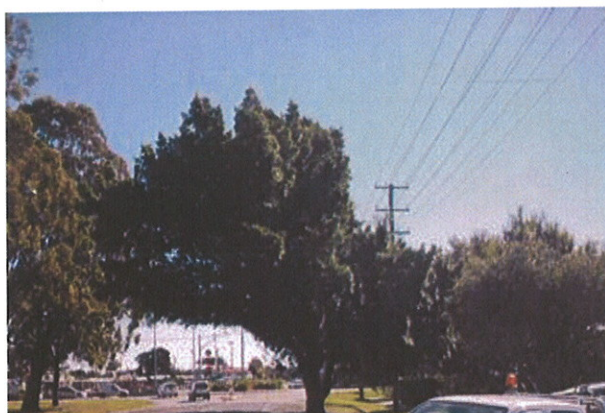
The tree is co-dominant with 1 main leader and a second smaller leader on the western side of the trunk

**Photo 1: *Ficus microcarpa* var. *Hillii*- 51 Bentinck Street Ballina**

The co-dominant stems have a minor inclusion at the branch union which is consistent with this species

There is an amount of sun scalding damage on the upper surface of exposed branches as a result of poorly timed overhead service line clearance.

It is therefore considered that in regards to the most cost effective and best outcome to remediate damage caused by this tree, and to eliminate the potential for future damage as a result of root encroachment both to private property and Council infrastructure that this tree be removed in its entirety.

It is the conclusion of this report that the tree be removed with consideration be given to replacing the tree with a more suitable species. In this location the recommendation is to replace the Fig tree with a Melaleuca sp. which is used elsewhere in this area as a street tree.

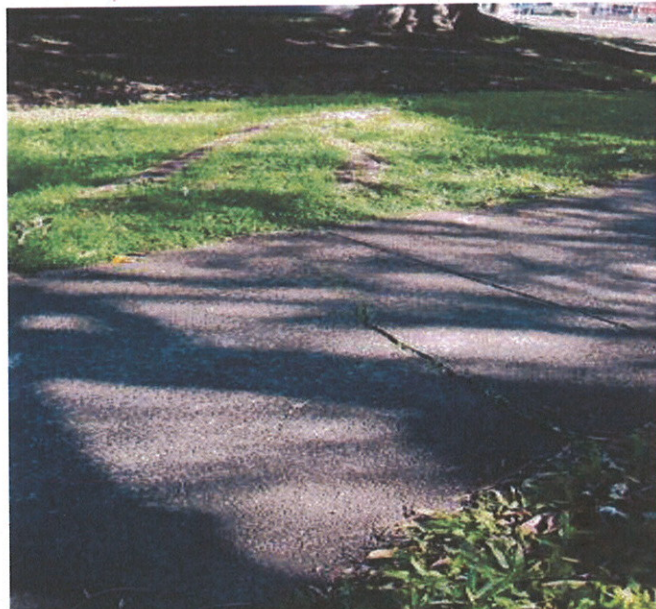
Several large (primary scaffolding) surface roots were observed extending into the gutter (roadside guttering has been damaged) as well as extending across nature strip fracturing concrete footpath and also extending through into the property.

Tree is growing in severely compacted soil in close proximity to the Bentinck street roadway.

**Photo 2: Shows extent of large roots to the north, as well as cracked footpath**

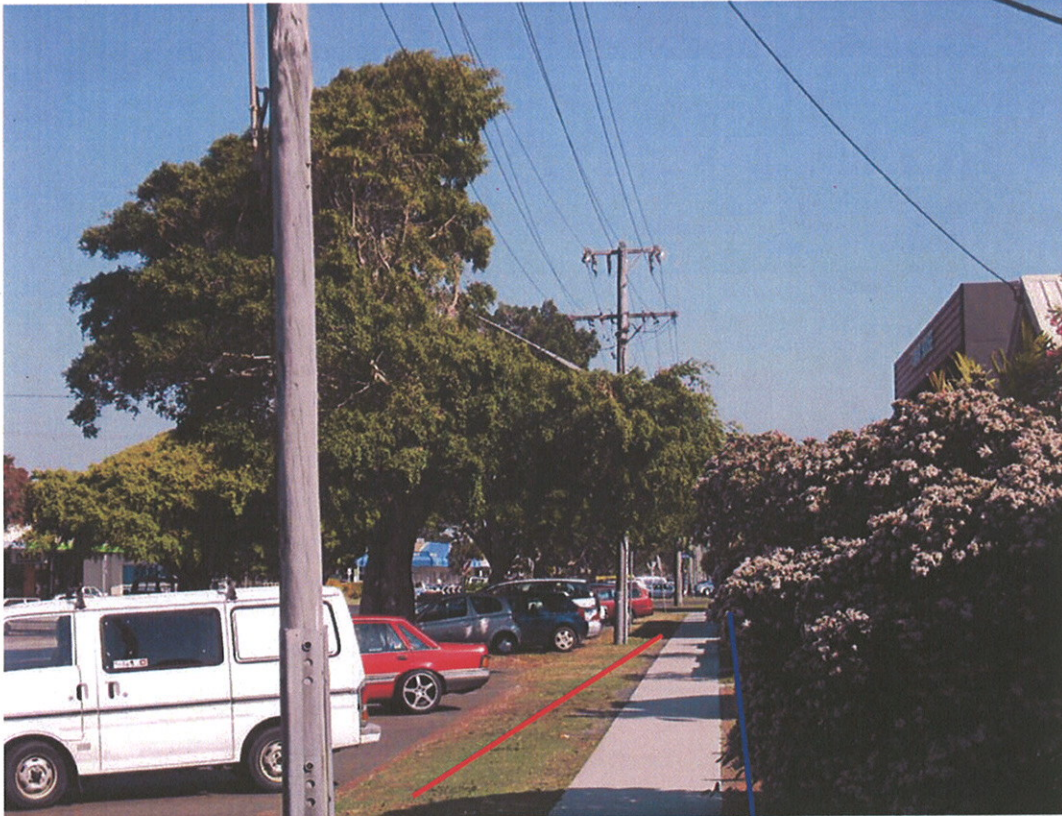
**Photo 2:** Red line indicates the only available position for a root barrier that does not interfere with services. Blue line indicates position that root barrier should be placed to ensure minimal impacts on trees.

In the Tamar Street situation the root barrier should be placed on the northern side of the foot path that runs parallel to the trees (Blue line Photo 2) and would be less detrimental to the health and vitality of these trees, however this would mean the de-energising, severance and reconnection of and underground electrical supply cable, as well as disconnection and reconnection of water services. Care would need to be taken not to sever the fibre optic or phone lines in this area. It should be noted that there is a cost to Council in the disconnection and reconnection of underground services.

Therefore the only other option would be to locate the root barrier as shown by the red line in Photo 2, as underground services severely limit its placement outside of this location. It is noted that there is a large 300mm trunk water main that runs through this location as well which will be a major impediment to locating the Root Barrier here. Trenching for the installation of a root barrier in this area also has the added concern of being in close proximity to the power pole shown in Photo 2, this will need further assessment as to the future stability of the pole should trenching be carried out in such close proximity

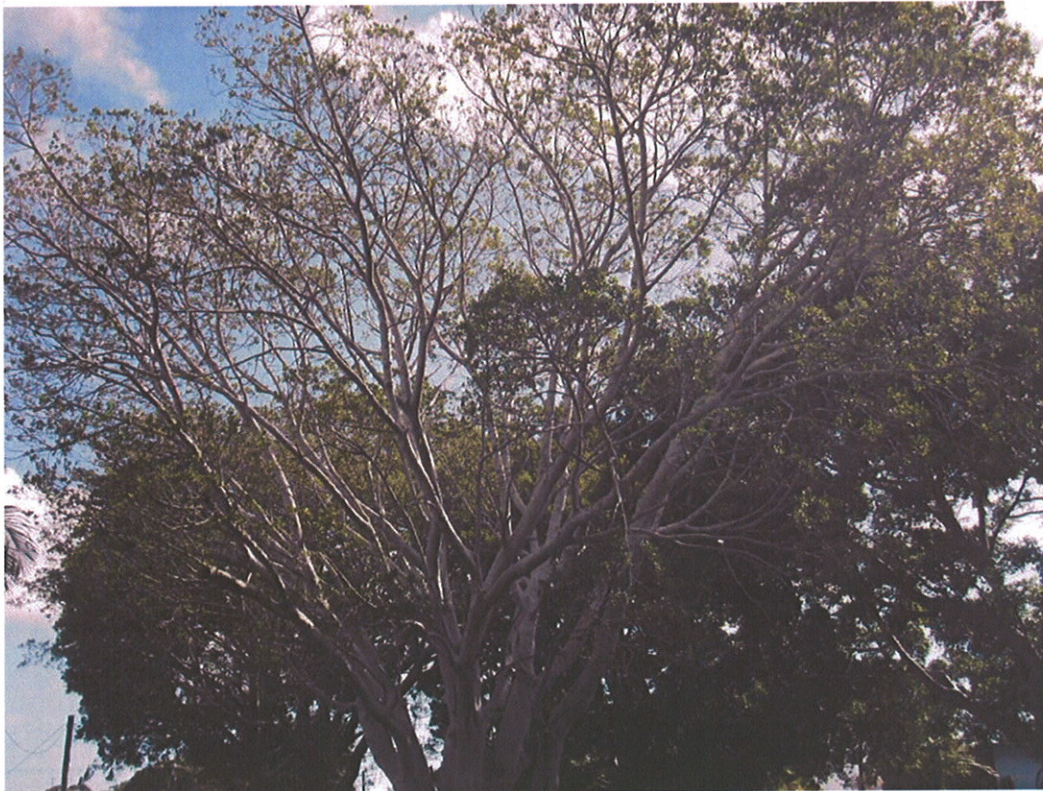
The trees were in a sound and healthy condition at the time of the root barrier installation, and have rapidly regressed since then to be in what is now considered a poor state of health, with the canopies on the 3 trees now in serious decline.

**Photo 3: Decline in canopy of Fig trees (Bentinck street - One Stop Shop) with root barrier installed 2008**

The above photo shows the tree in the foreground with considerably sparse canopy as compared to the trees in the back right hand side of the picture which did not have a root barrier installed. The canopy is now estimated to be 30% of total coverage as compared to almost 100% in 2008. This is a direct result of root severance from the installation of the root barrier installed in 2008.
