CONDITION ASSESSMENT REPORT

WARDELL DISTRICT WAR
MEMORIAL HALL
LOT 1, DP 312334
49 RICHMOND STREET, WARDELL

DATE: 3 OCTOBER 2012

BALLINA SHIRE COUNCIL
PO BOX 450
BALLINA NSW 2478

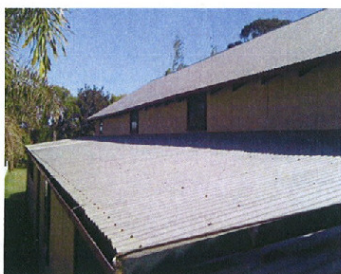
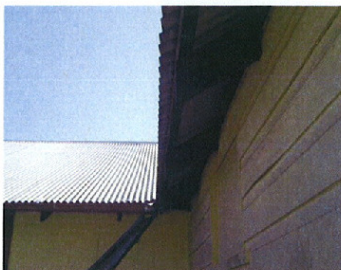
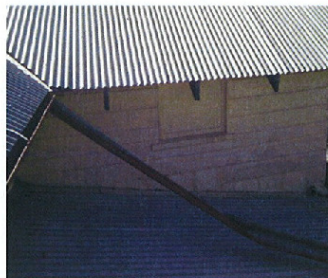
The roof covering is considered to be in fair condition. The inspection noted that a number of the roof screws were subject to minor corrosion and will require replacement within a 12 month time frame.

The inspection also noted that sections of the roof guttering require refixing and the provision of additional brackets to provide uniform support to the gutter and maintain continuous fall to the down pipes.

At the time of inspection access to the box gutters over the office and entry could not be fully inspected due to the position of the roof cladding.

It is recommended that replacement of the roof screws be undertaken within a 12 month time frame in order to prevent further corrosion of the roof cladding and increase the longevity of the roof cover.

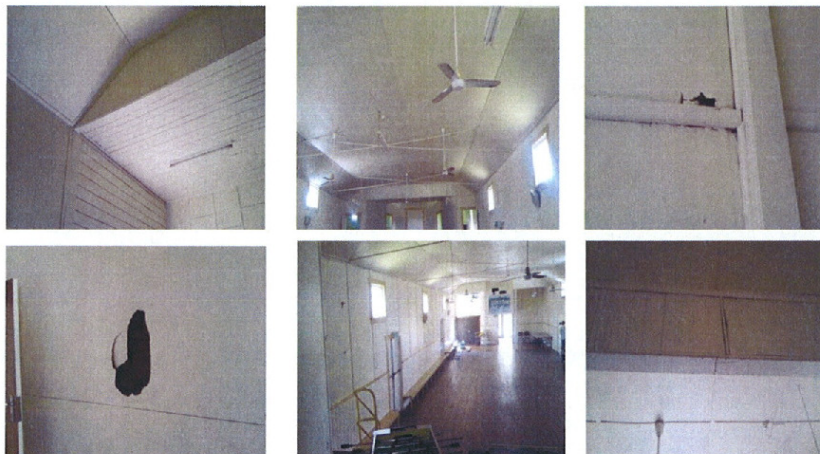
The inspection noted that the internal building elements were in fair condition. The inspection also noted that a number of the building elements were subject to physical damage and wet rot and timber decay damage.

It is recommended that on going maintenance of the building elements be maintained and where necessary replacement of defective and water damaged linings be replaced in the short term.

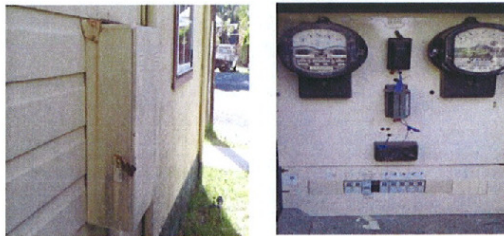
In addition to the above the inspection noted that the electrical meter box was subject to corrosion and warrants replacement.
