**Arborist report on *Ficus macrophylla* for Ballina Shire Council**  
**7th of December 2015**

Integral Tree Care was requested by Ballina Shire Council (BSC) to provide an Arborist report on a *Ficus macrophylla* located in front of 7 and 9 Castle Drive, Lennox Head on council land. A site visit and tree inspection was carried out on the 03/12/2015 by Consulting Arborist Mark Gistitin over a period of about 45 minutes. Tree roots in a stormwater pipe at 7 Castle Drive had prompted this tree inspection. The weather was overcast and windy.

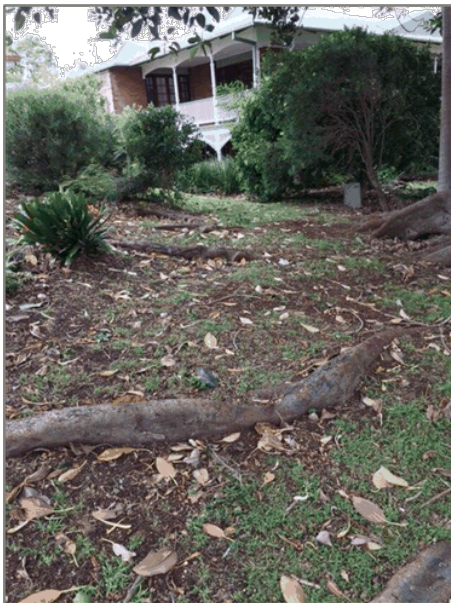
Photo 3

Location – Located in front yard / nature strip approximately 11m from the building footprint of 7 Castle Dr and 12 metres from the building footprint of 9 Castle Dr.  
 Roots – Sound. There was minor mower damage to surface roots (no decay visible). Major surface roots visible up to 7m from trunk (See Photo 3). Roots interfering with storm water pipe.  
 Trunk/s – Sound. Central main trunk has been lopped previously, decay present. Large wound on other main trunk, sound reaction wood adjacent (See Photo 1).  
 Crown/Branches – Sound. Wounds from previous pruning, sound development of wound wood (See Photo 2). Minor deadwood 50>mm present.  
 Leaves – Sound. Leaf density through crown normal. Size and colour normal.
