## PROVE Water Meter Testing Laboratory

Reference: BA1-19-1-SUM-99B163161-1

Meter serial number 99B163161 – 20mm Elster water meter was tested in accordance with clauses 8 and 9 of NMI publication NITP 14 as per our NATA scope of accreditation.

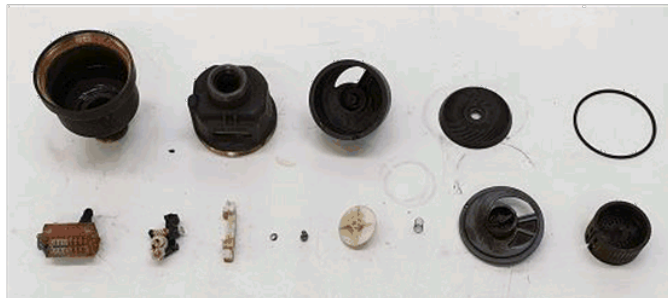
Figure 1- Exploded view of meter 99B163161

After completion of the accuracy test a full mechanical inspection of meter 99B163161 (see Figure 1 below) was conducted, with the results as found below;

Meter Serial No:	99B163161					
Seals	<input checked="" type="checkbox"/> Manufacturer	<input type="checkbox"/> Missing	<input type="checkbox"/> N/A			
Meter Body	<input checked="" type="checkbox"/> Intact	<input type="checkbox"/> Damaged				
Meter Index	<input checked="" type="checkbox"/> Intact	<input type="checkbox"/> Damaged				
Number Wheels	<input checked="" type="checkbox"/> Intact	<input type="checkbox"/> Damaged	<input type="checkbox"/> Excessive Play	<input type="checkbox"/> Faulty		
Under Gears	<input type="checkbox"/> N/A	<input checked="" type="checkbox"/> Good Condition	<input type="checkbox"/> Excessive Play	<input type="checkbox"/> Damaged	<input type="checkbox"/> Faulty	
Chamber	<input type="checkbox"/> N/A	<input type="checkbox"/> No Wear	<input checked="" type="checkbox"/> Normal Wear	<input type="checkbox"/> Major Wear	<input type="checkbox"/> Reverse Wear	<input type="checkbox"/> Damaged

Rotor/Impellor	<input type="checkbox"/> N/A	<input type="checkbox"/> No Wear	<input checked="" type="checkbox"/> Normal Wear	<input type="checkbox"/> Major Wear	<input type="checkbox"/> Reverse Wear	<input type="checkbox"/> Damaged
Corrosion	<input checked="" type="checkbox"/> None	<input type="checkbox"/> Minor	<input type="checkbox"/> Major			
Non Return Valve(s)	<input type="checkbox"/> None	<input checked="" type="checkbox"/> Intact	<input type="checkbox"/> Damaged			
Inlet Strainer	<input type="checkbox"/> None	<input checked="" type="checkbox"/> Intact	<input type="checkbox"/> Damaged			
Comments	No mechanical faults were found, and the meter appeared to be in good working order.
