BALLINA SHIRE COUNCIL

**ATTACHMENTS TO
LOCAL TRAFFIC COMMITTEE
MEETING BUSINESS PAPER**

Wednesday 10 June 2020

Traffic Signal Warrants Study

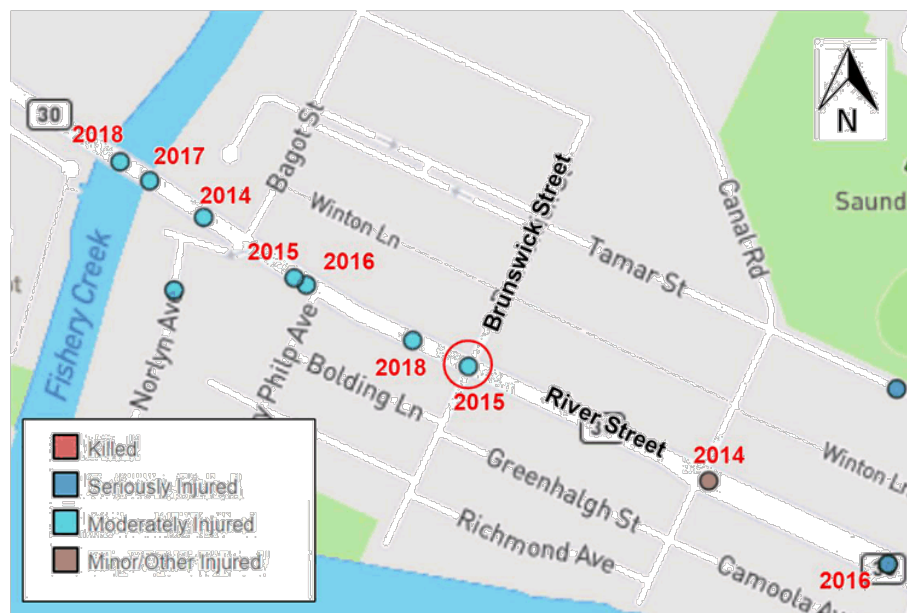
Figure 3.1: Crashes Surrounding the Subject Intersection

From Transport for NSW's Centre for Road Safety website, for the five-year period between 2014 and 2018, there were nine (9) crashes along River Street within 400 metres of the subject intersection. In particular, there was a crash at the subject intersection resulting in a moderate injury, as shown in Figure 3.1. Most of the crashes along River Street are prior to 2016, when the median divide was installed.

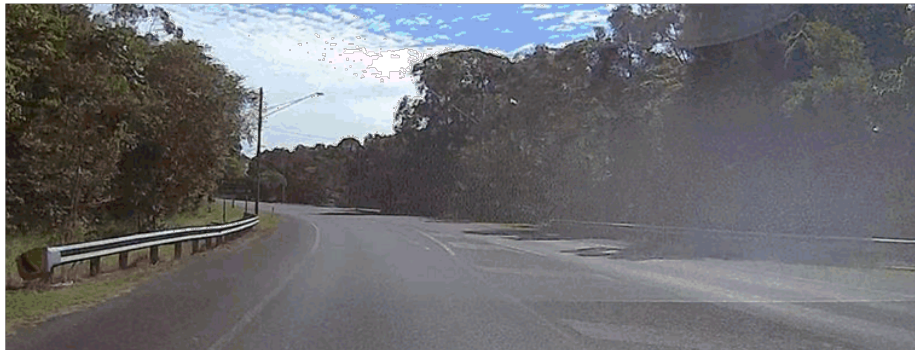
Photo No. 1: Condition of line marking

- Provide advance warning signs ('Side Road Intersection' or similar) in both approaches on Byron Bay Road.
- To improve intersection delineation, repaint intersection line-marking. This should include painting the median kerbs in Byron Street. Replace retro-reflective pavement markers as required.

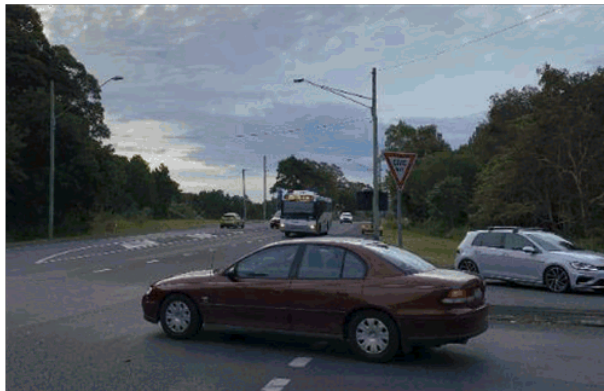
Photo No. 2: Sight distance to the north with turning vehicle (note through vehicle beside rear of bus)

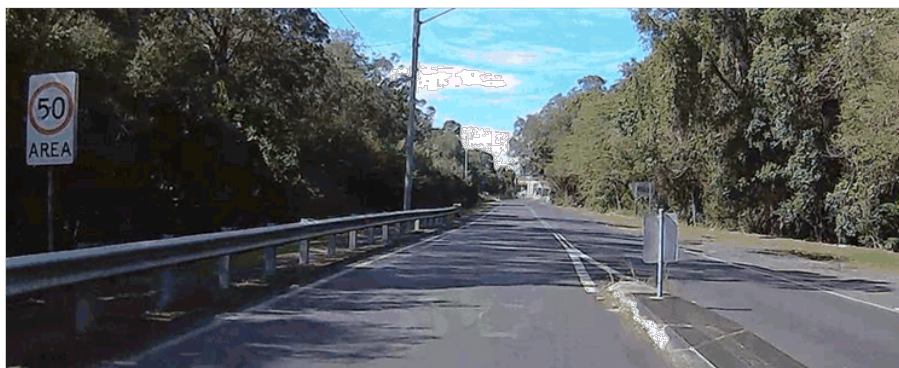
Photo No. 3: Condition of pavement marking at 50 zone

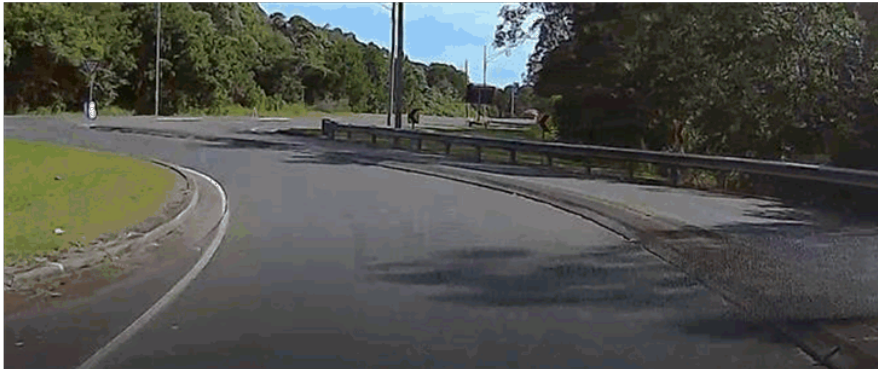
Photo No. 4: Lack of visibility of median – Byron Street
