# ADDENDUM to the Richmond River Estuary Processes Study

For Richmond River County Council

PROJECT NUMBER: BB074

11/05/2009

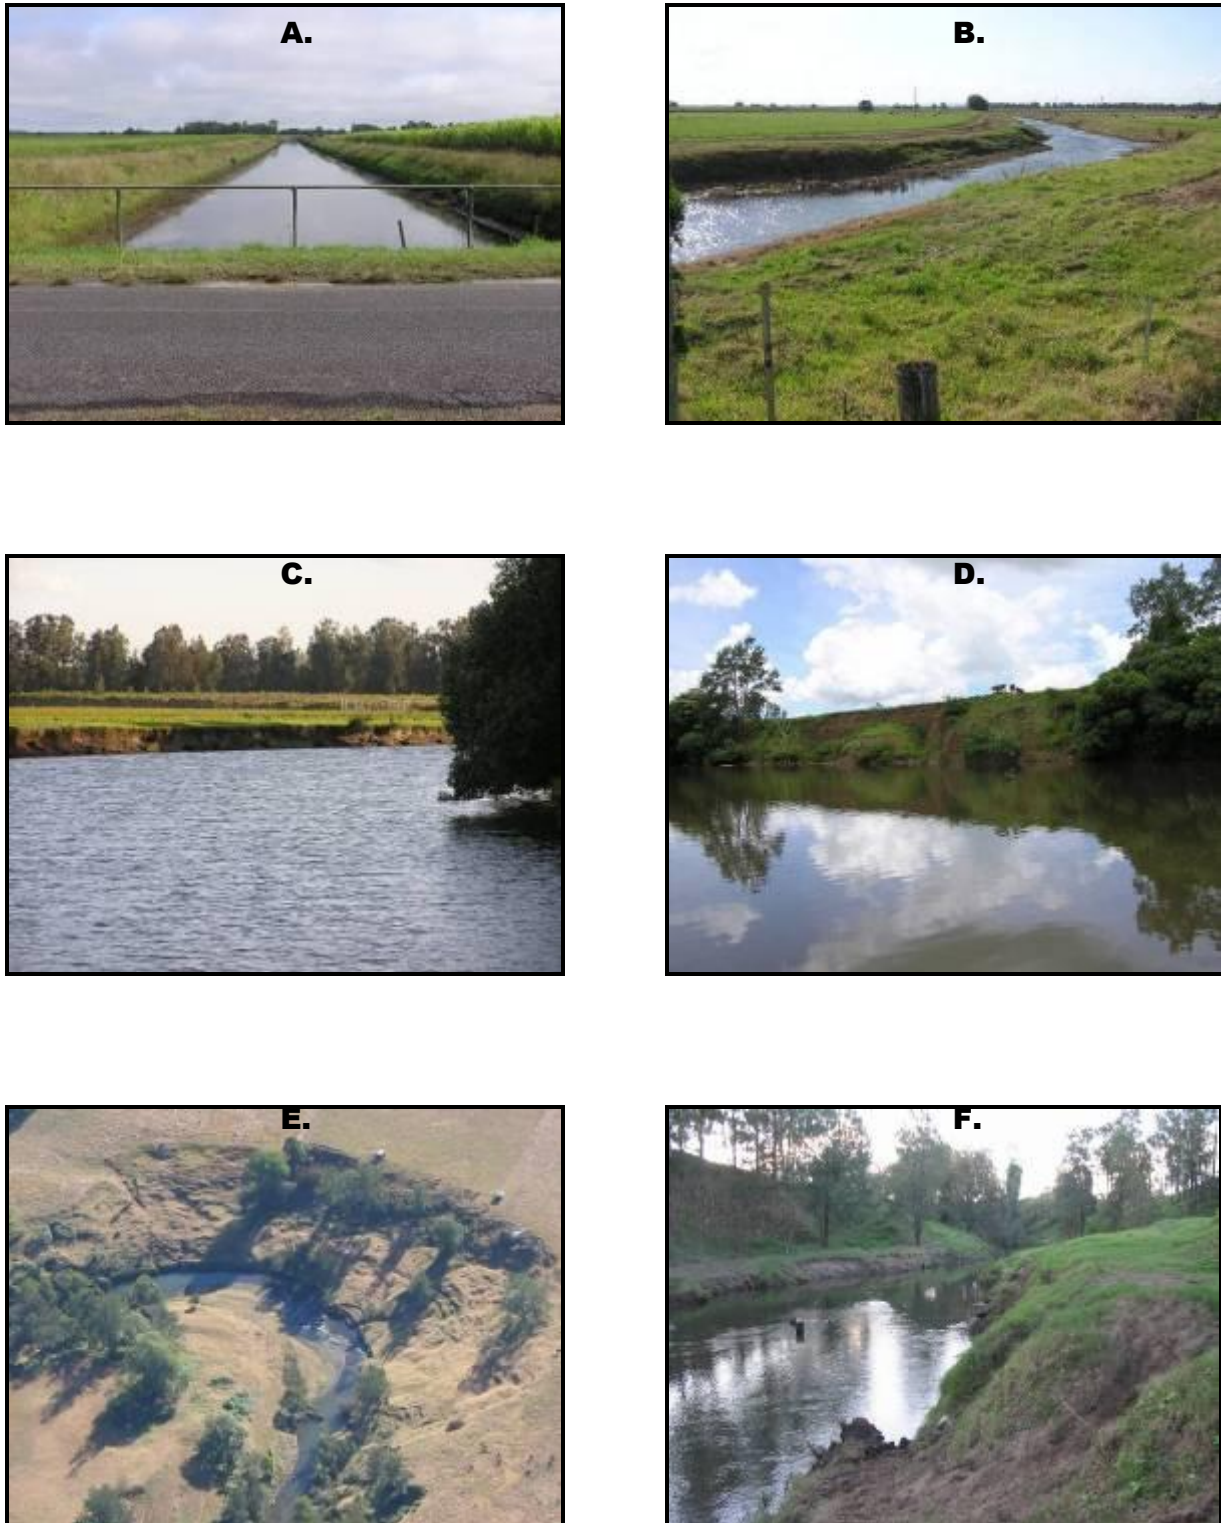
**Figure 2.1: Examples of major geomorphologic issues in the Richmond River Floodplain.**  
A. Drainage modification for agriculture (Management Zone 9), B. Drainage modification with steep sided banks (Management Zone 11), C, D, E and F. Examples of bank slumping and erosion caused from removal of riparian vegetation (Management Zone 12).

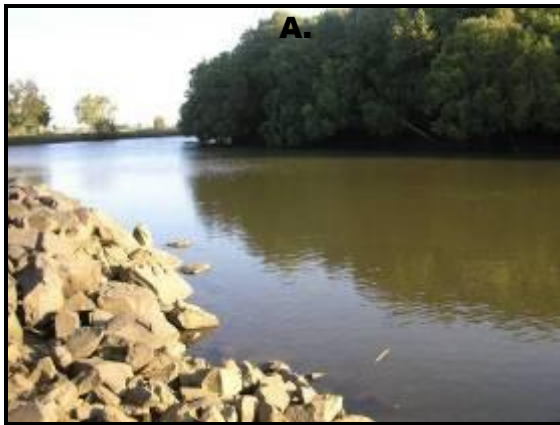
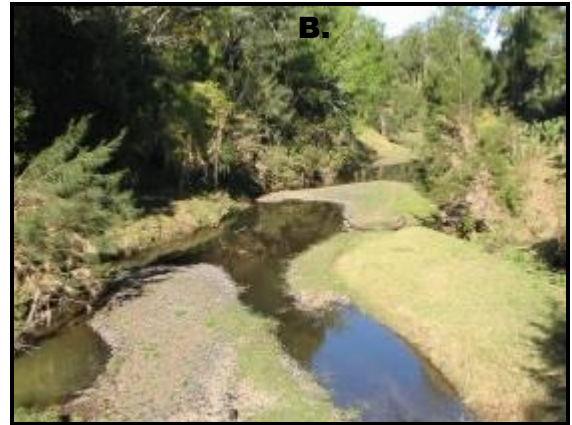
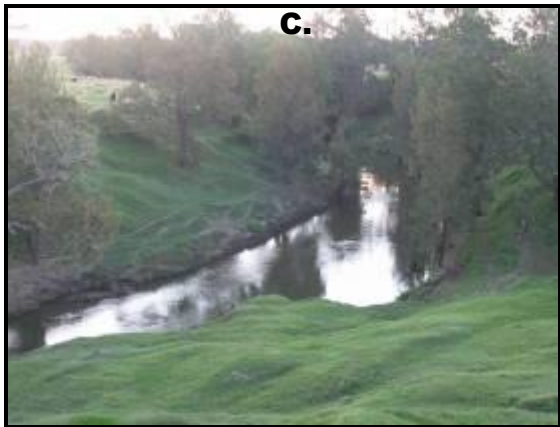
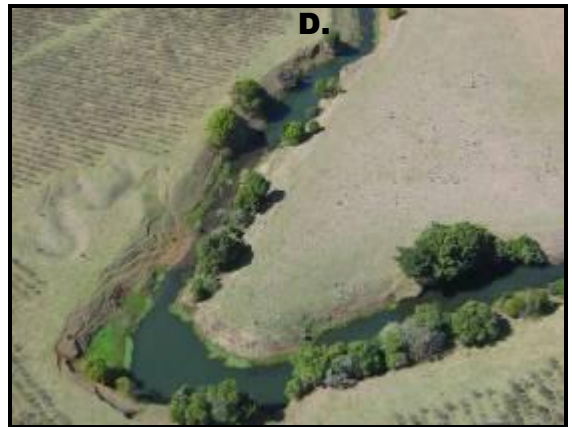
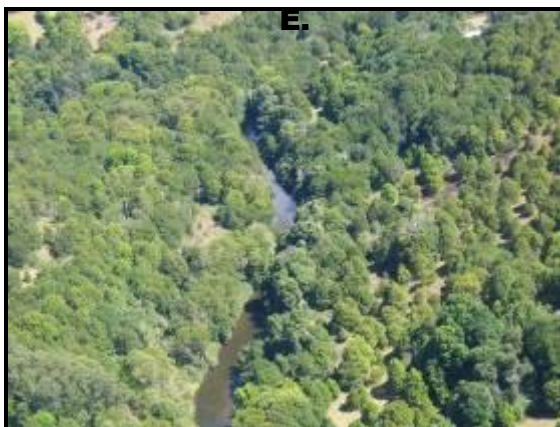
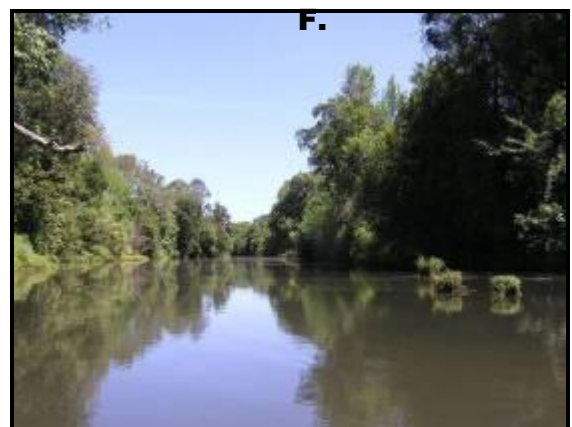
**Figure 2.2 Examples of major geomorphologic issues in the Richmond River Floodplain.**  
 A. Loose rock bank protection (Management Zone 1); B. In channel sediment build up; C. Cattle access to watercourse; D. Denuded section of bank and encroaching agriculture; E. Stream section with healthy riparian vegetation; F. River section with healthy riparian vegetation.

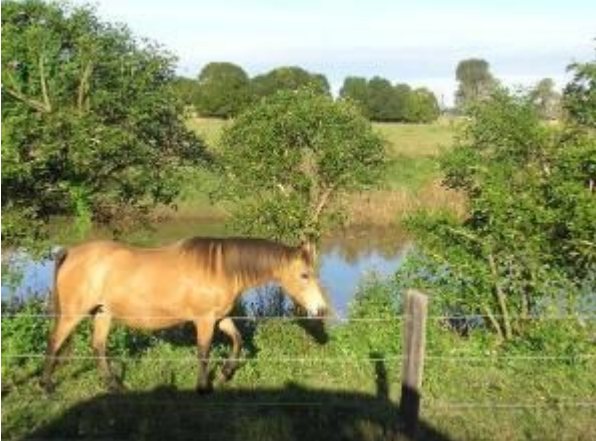
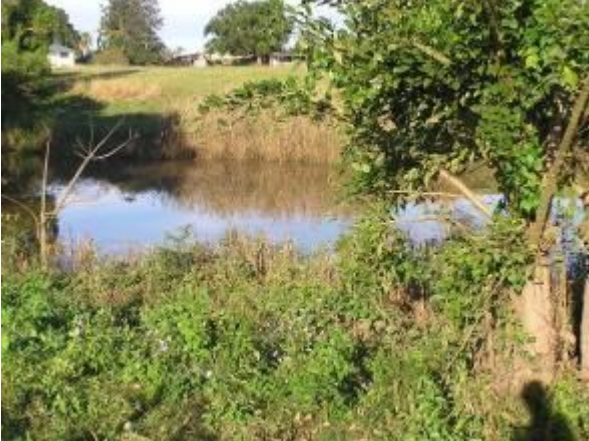
Figure : An overview of images from Management Zone 7 –Rocky Mouth Creek and on ground assessment site RC17.

<p>Narrow riparian zone being used as a horse paddock at site RC17. Note the coral tree weed abundance. This landowner expressed interest in riparian revegetation</p>	<p>Weed infestation along Rocky Mouth Creek site RC17</p>

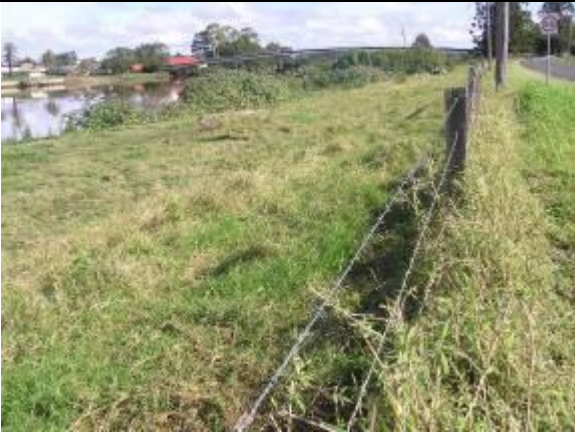
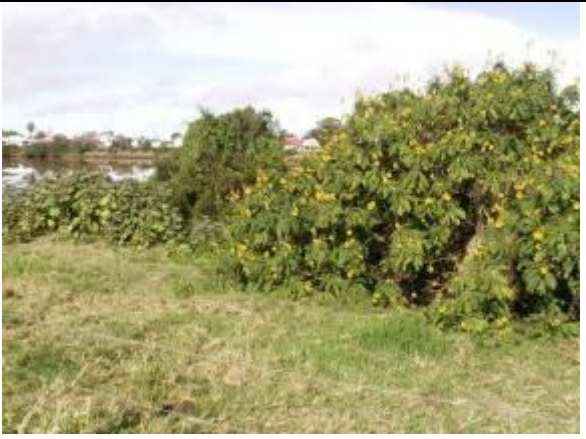
Figure : Images from site KB15

<p>High potential exists for revegetation with limited weed removal required. Need land holder support for this site.</p>	<p>Weed invasion in grazing paddock</p>

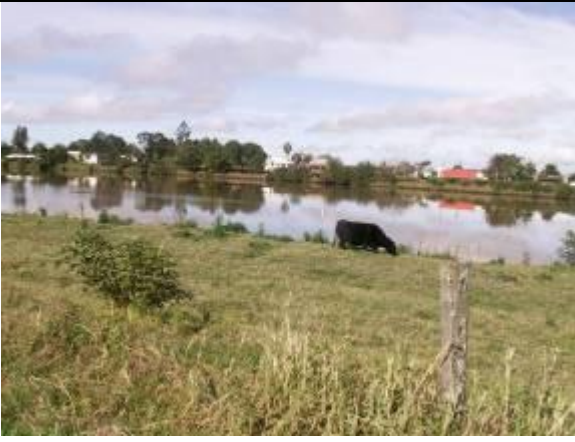
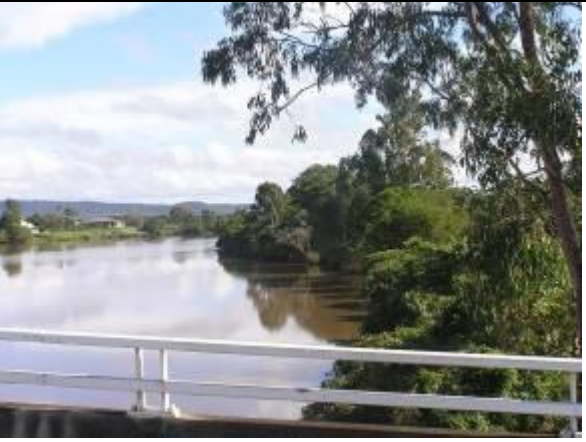
<p>Cattle grazing in the riparian zone</p>	<p>Some good riparian vegetation upstream from this site.</p>

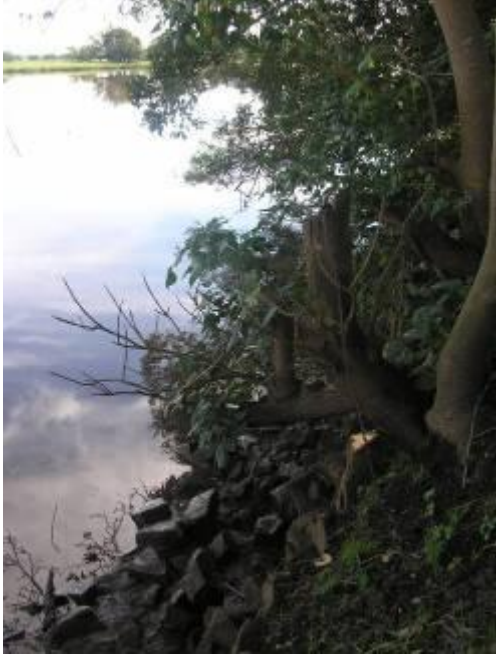
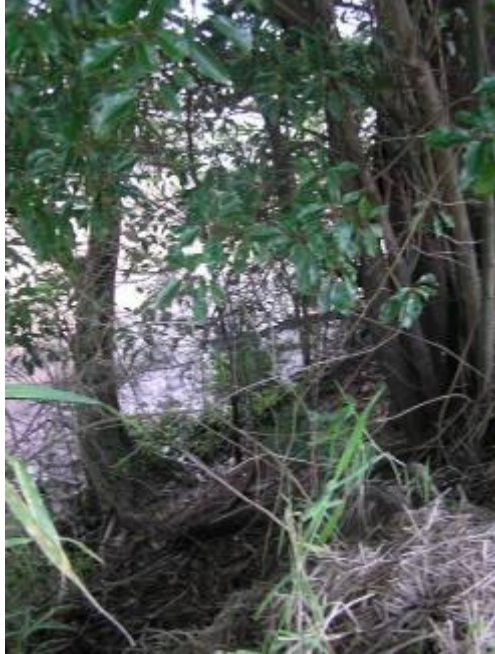
Figure : Images from site KB18

<p>Rocks used to retain bank and tree pruning is evident.</p>	<p>Riparian vegetation on Oakland Road bank</p>

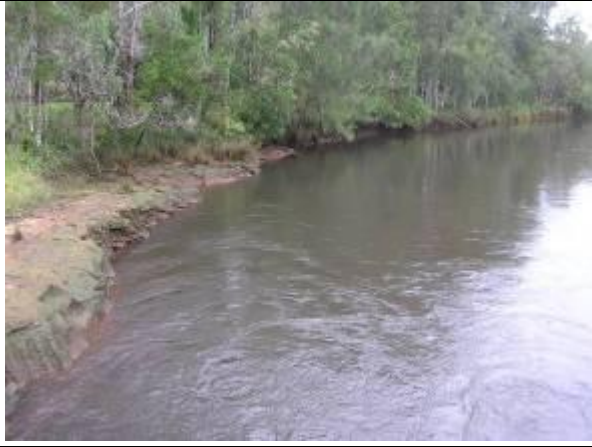
Figure : Images from site T12

<p>Google image of the site</p>	<p>Rocky outcrop on the northern side of the barrage inhibits immediate erosion. Downstream erosion is notable (background)</p>

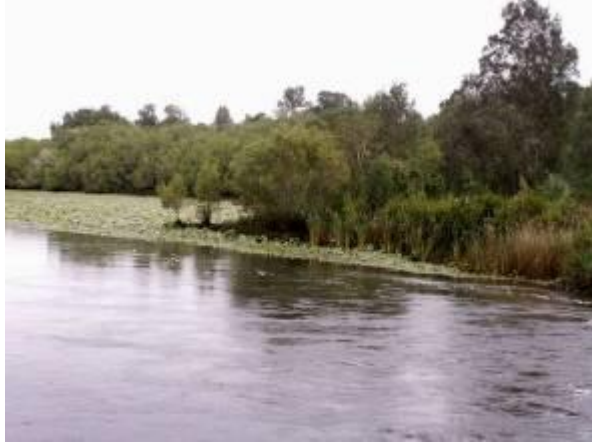
<p>Abundant water lilies on the estuary side of the barrage.</p>	<p>Southern side of the barrage on the estuary side</p>

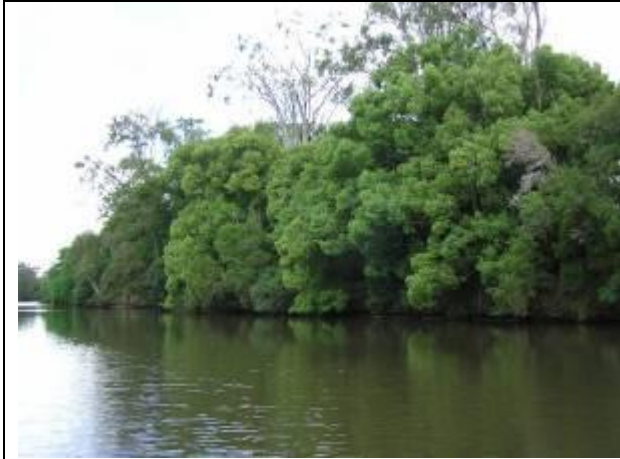
Camphor Laurel a large woody weed prominent in the management zone. Although a noxious weed they provide structural support for the riparian zone.

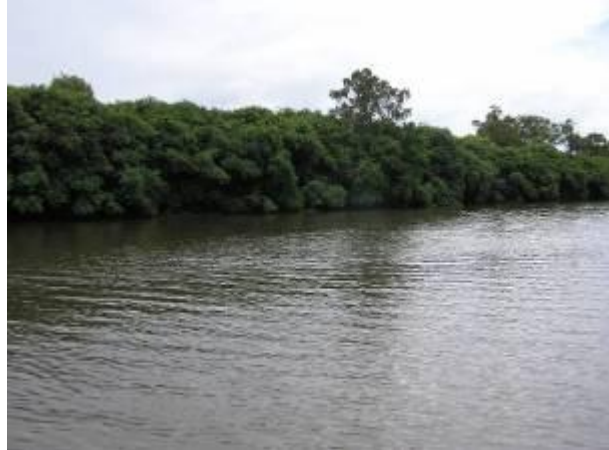
Coral tree infestation along the Wilsons River near Lismore. Some structural support is provided by these weeds.

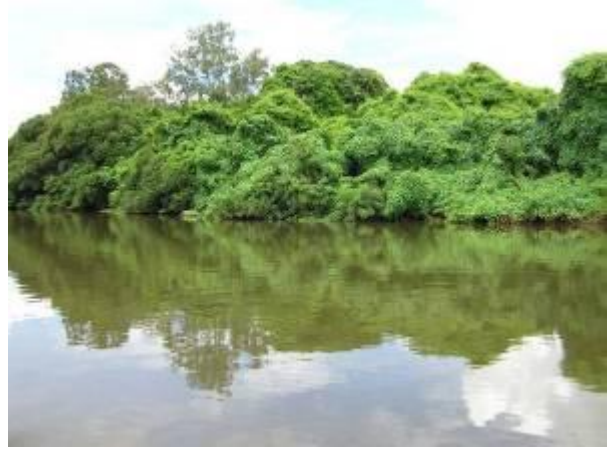
Riparian weed issues, Wilsons River.

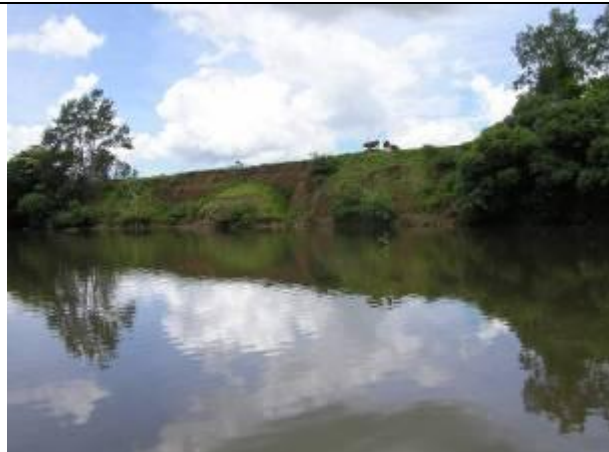
Severe bank slumping, Wilsons River.

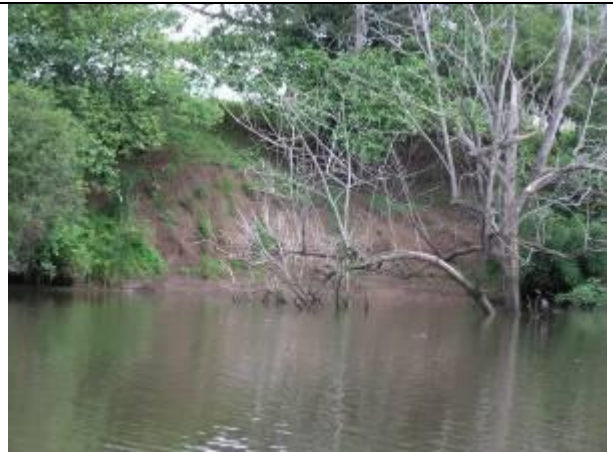
Slumping causing tree fell into the River, Wilsons River.

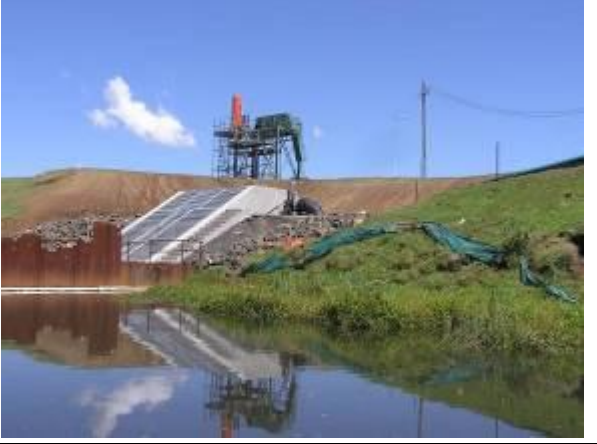
<p>Water extraction at the Lismore Source has the potential to compromise downstream water quality.</p>

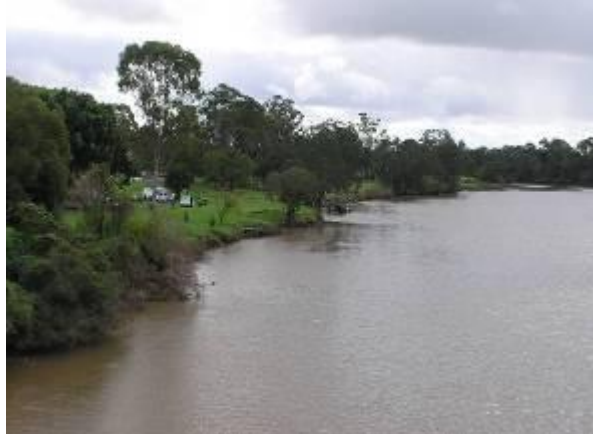
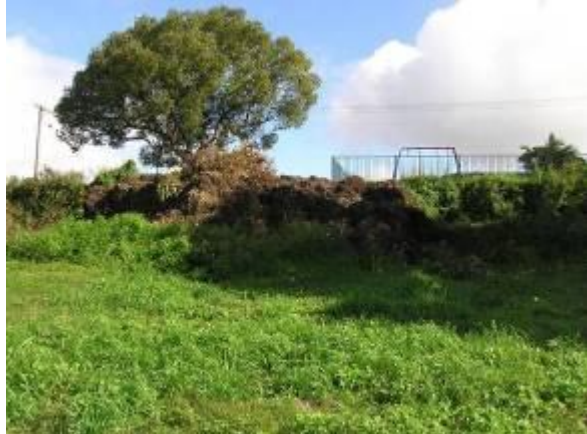
Figure : Images from site 21/22

<p>View from the bridge downstream from Coraki</p>	<p>Fill dumping at the playground in the river side park, Coraki.</p>

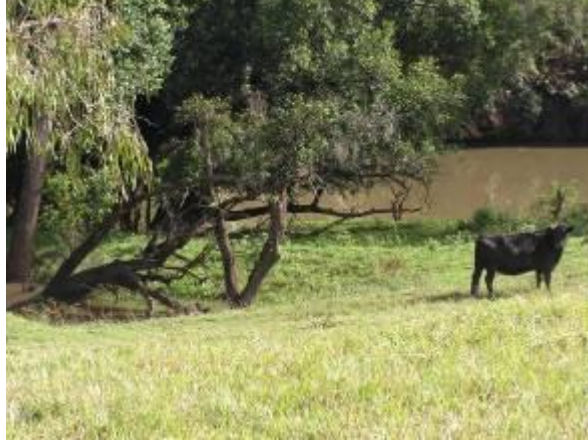
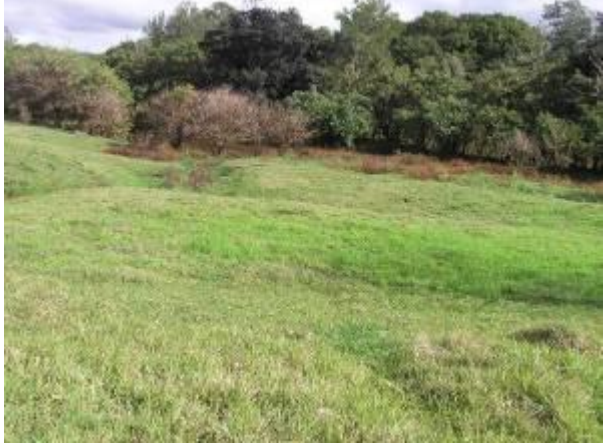
Figure : Images from site 24

<p>Grazing occurs at this site</p>	<p>Riparian grazing land with coral tree infestation on the river bank.</p>

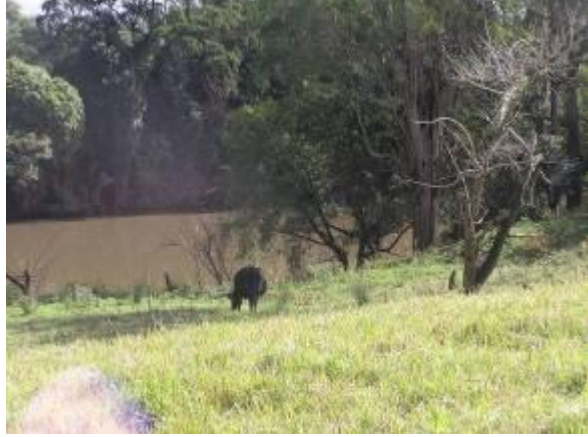
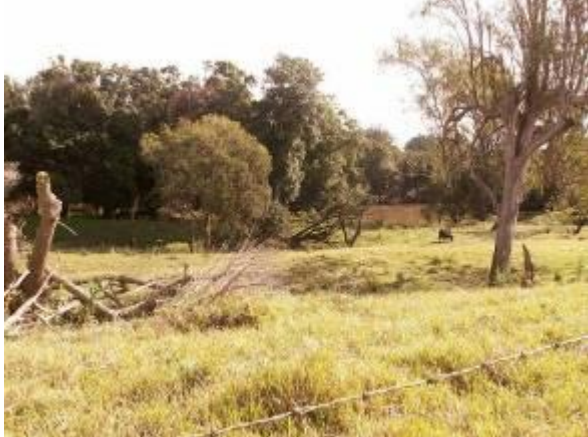
<p>Some structural vegetation occurs at this site among intermittent exposed river bank areas.</p>	<p>Private riparian land</p>

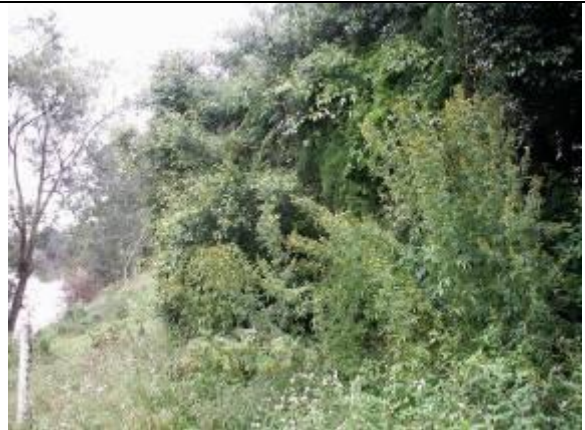
Some weed management would benefit this site.

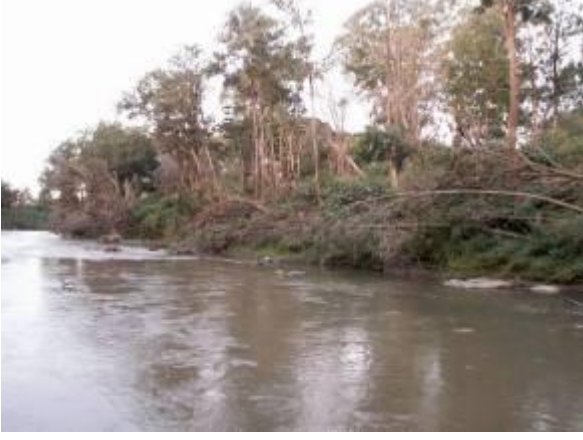
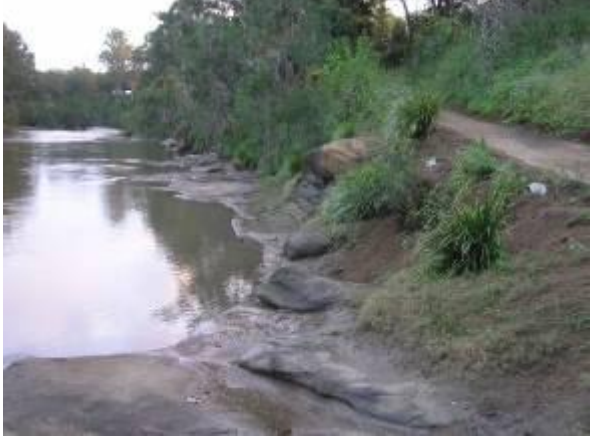
Figure : Images from site 31

<p>Riparian vegetation went some way to helping stabilise banks in recent flooding (2008).</p>	<p>Rocky substrate occurs at the foot bridge downstream from the weir. Some notable riparian plant has occurred along the path and Lomandra help stabilise the bank in the foreground.</p>

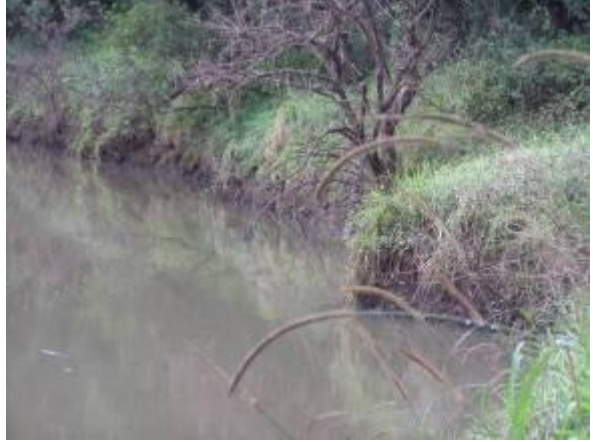
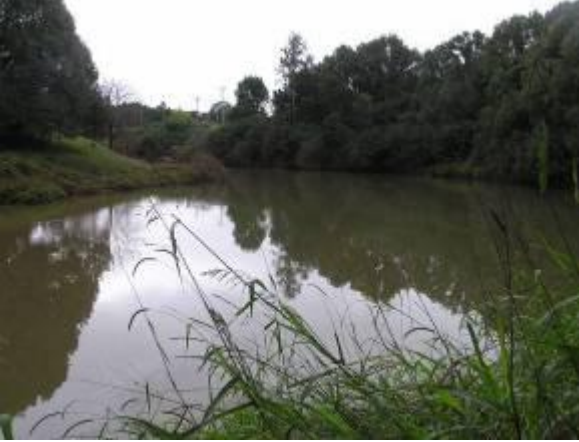
Figure : Images from site 32

<p>Undercutting of banks</p>	<p>Upstream of the site</p>

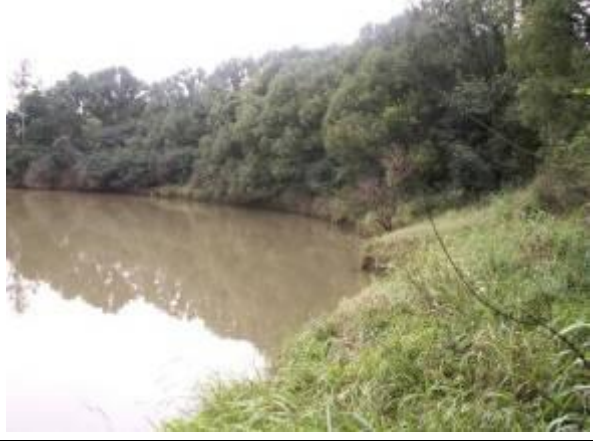
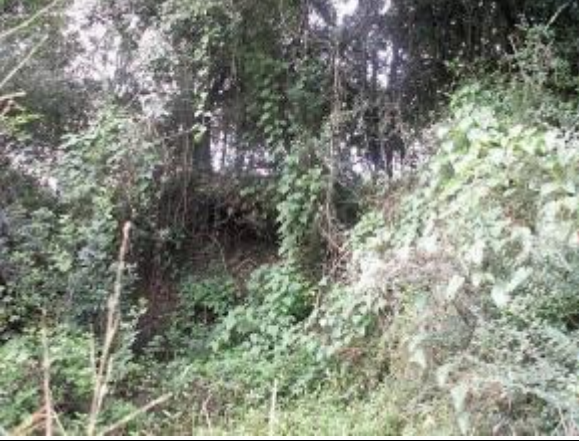
<p>Site vegetation and bank view.</p>	<p>Some threatening vines</p>
