# *Arboricultural Impact Assessment Report*

## 37 Henderson Drive

## Lennox Head

***Prepared on: 29 April 2020***

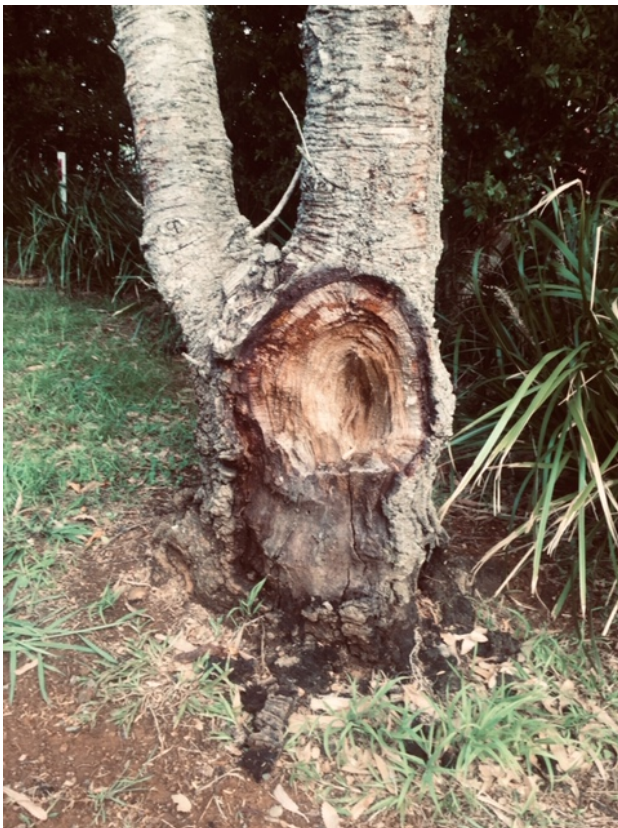
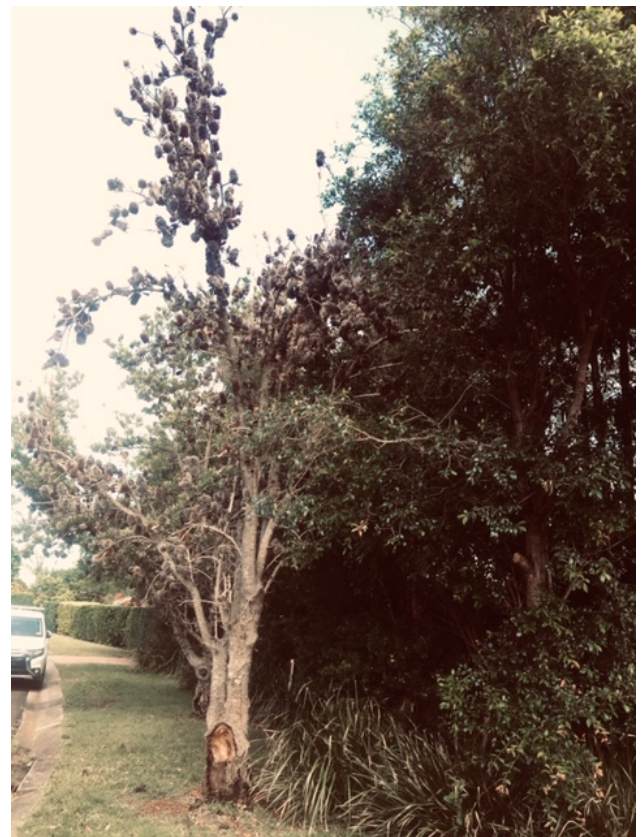
## Appendix 2.0 Tree Images

The tree is located in public road reserve to the east of the property and 2.5m from the curb. A second tree of the same species and age is located several meters to the south, both are presumed to have been planted at the same time. The subject tree suffered a limb failure in 2019 resulting in a tear of the lower trunk of the tree. A wound 700mm x 400mm across and 150mm deep. This constitutes just under a quarter of the trunks circumference (150mm) The tree is now dead.

The tree represents a level of risk to passers-by and to cars parking on the street beneath. The tree requires removal in accordance with Ballina Shire Council Management of Urban Vegetation Policy (Dead Trees) the policy requires that tree removal signage be placed upon the tree prior to any works taking place and an additional public notification process should also precede removal. This report forms part of the notification process.
