Arboricultural Impact Assessment Report

24 Stewart Street, Lennox Head

Prepared for: Ballina Shire Council

Doc No: 22/57505

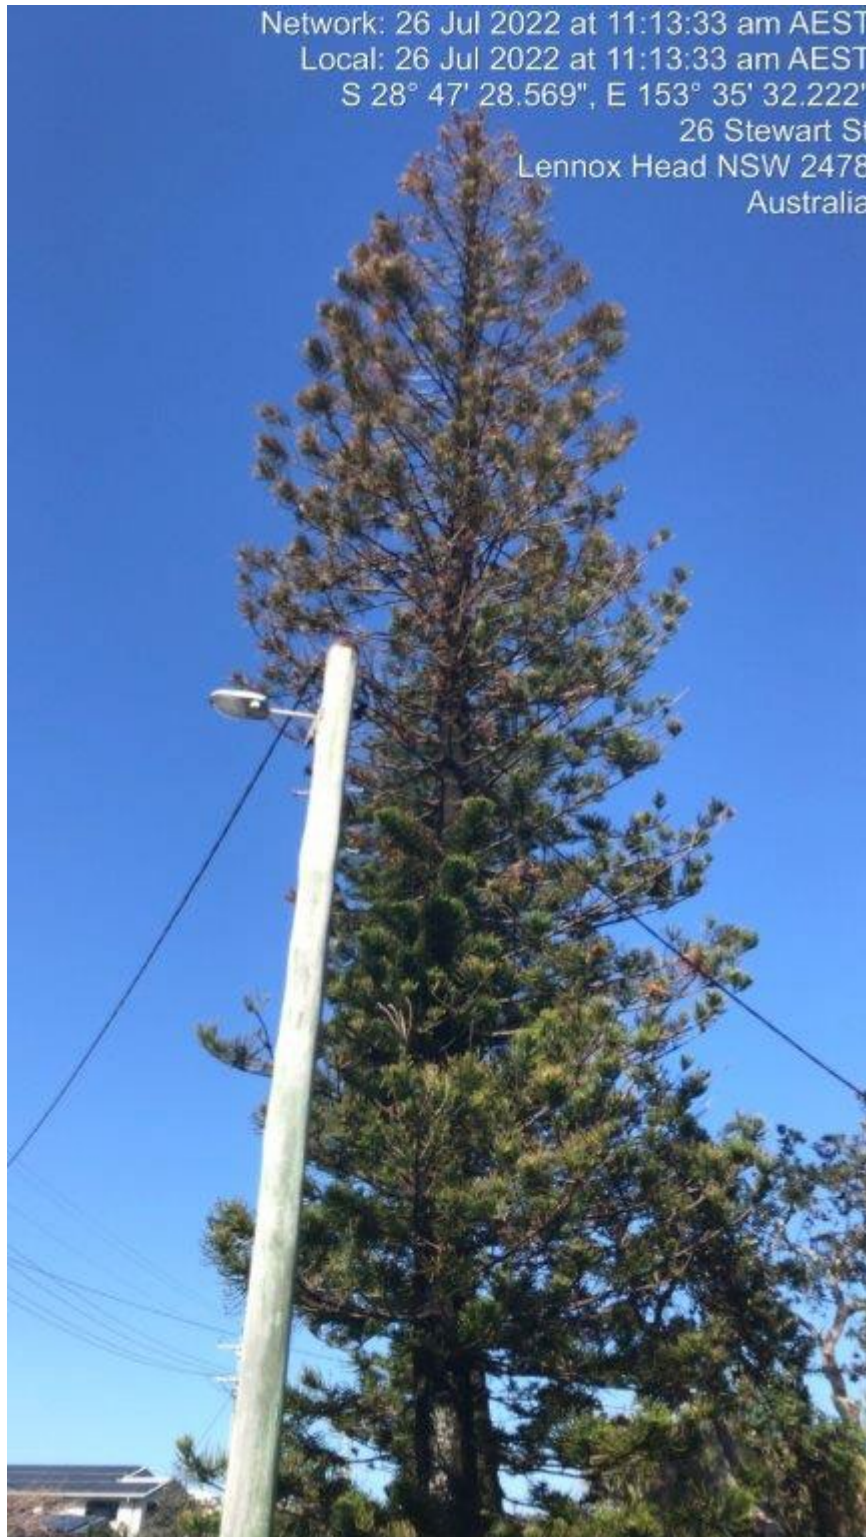
Tree 1: Looking southeast

Tree No. 1 the northern tree is showing progressive indications of decline extending 50 % of tree height, dead and dying foliage.

Tree 1: Tree removal is recommended under BSC Policy Urban Vegetation on Public Land part A (tree with unacceptable public risk)

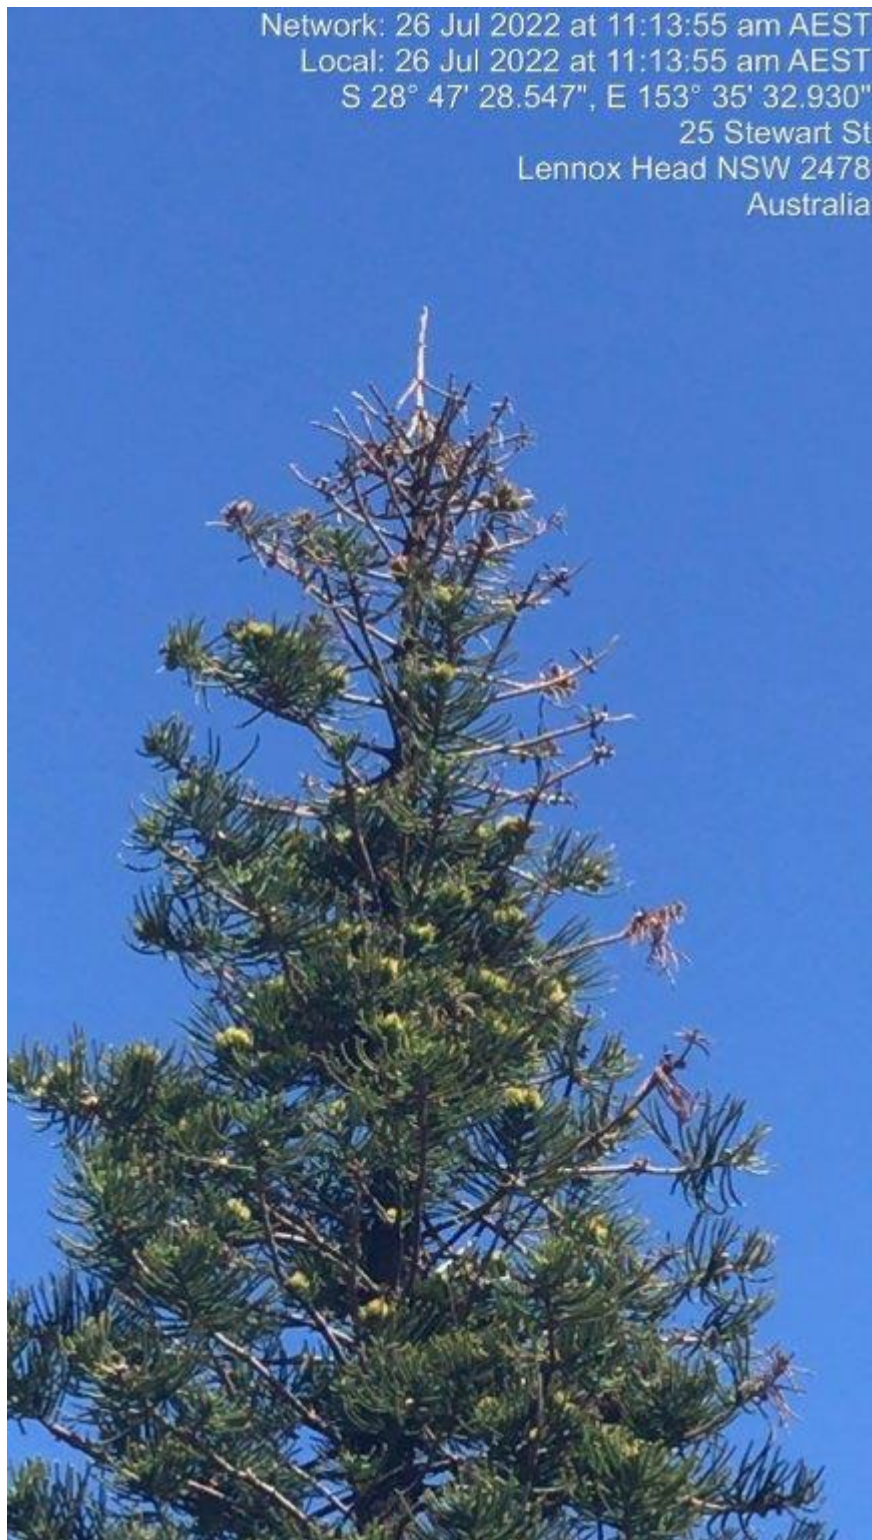
Tree No. 2 the southern tree has die back in the apical tip approximately 10% of total canopy showing signs of decline at this stage. It assumed the lightning has transferred thru the ground water at the time of the strike and impacted both trees.

Tree 2: Dieback in apical tip and upper third of crown.

Tree 2: Height reduction pruning to remove apical damage in tip of tree.
Continued monitoring at 3-month interval or less to observe for further decline. This tree is very likely to require removal in the future.

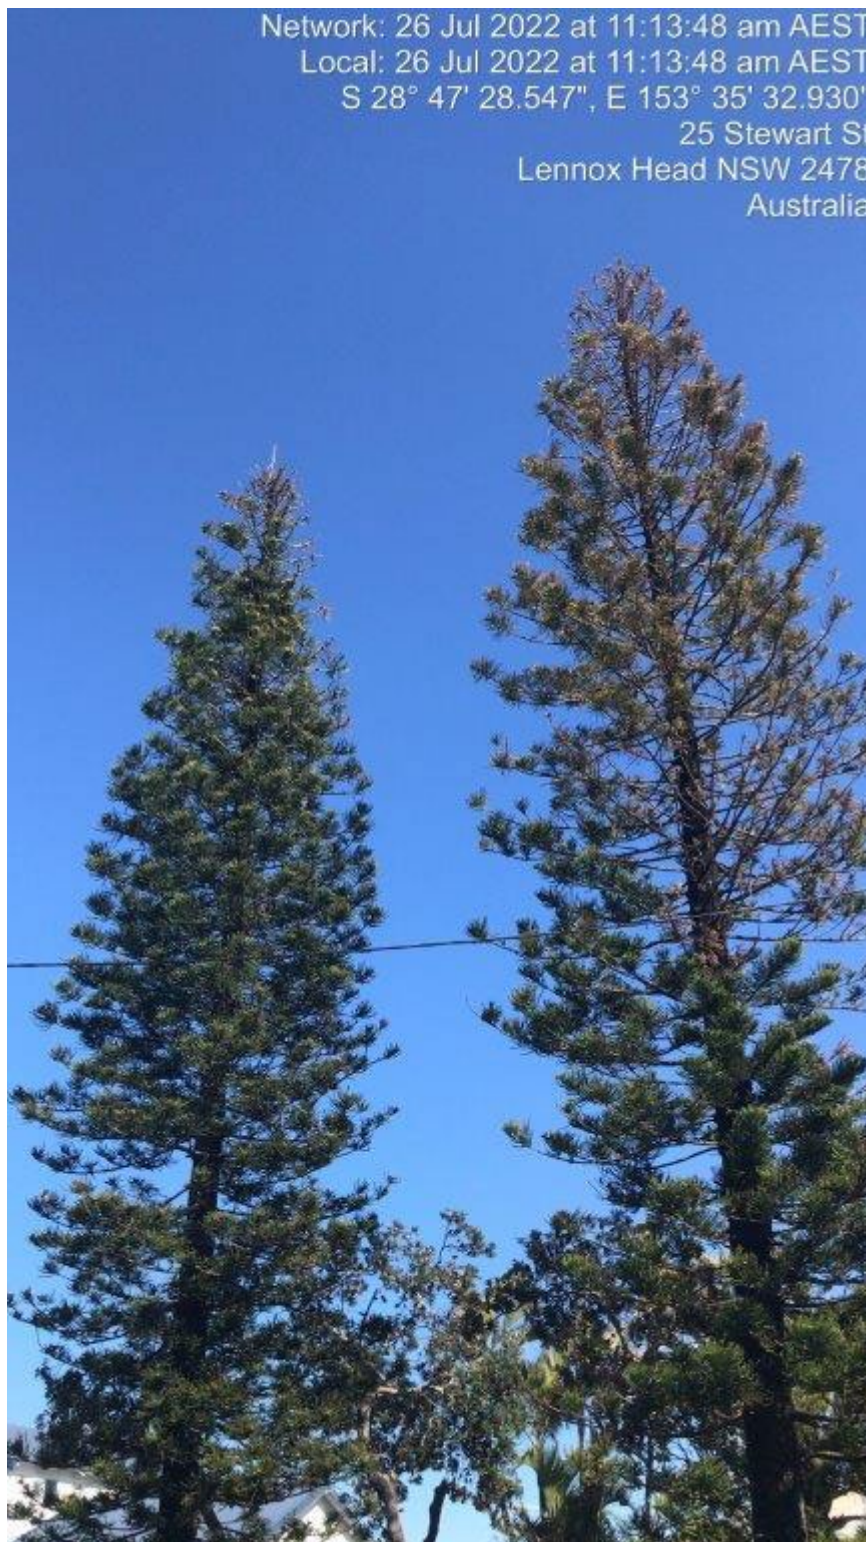
Trees 1 & 2 looking west

The trees have previously been observed as being in good health with no defects prior to the storm event / lightening strike. The trees are now declining in health with necrotic foliage from the apical tip down, this would indicate that cellular damage has occurred interrupting water flow between the roots and the crown. Bark discoloration is also evident however there are no signs of bark splits or cracks in the trunks of the trees.

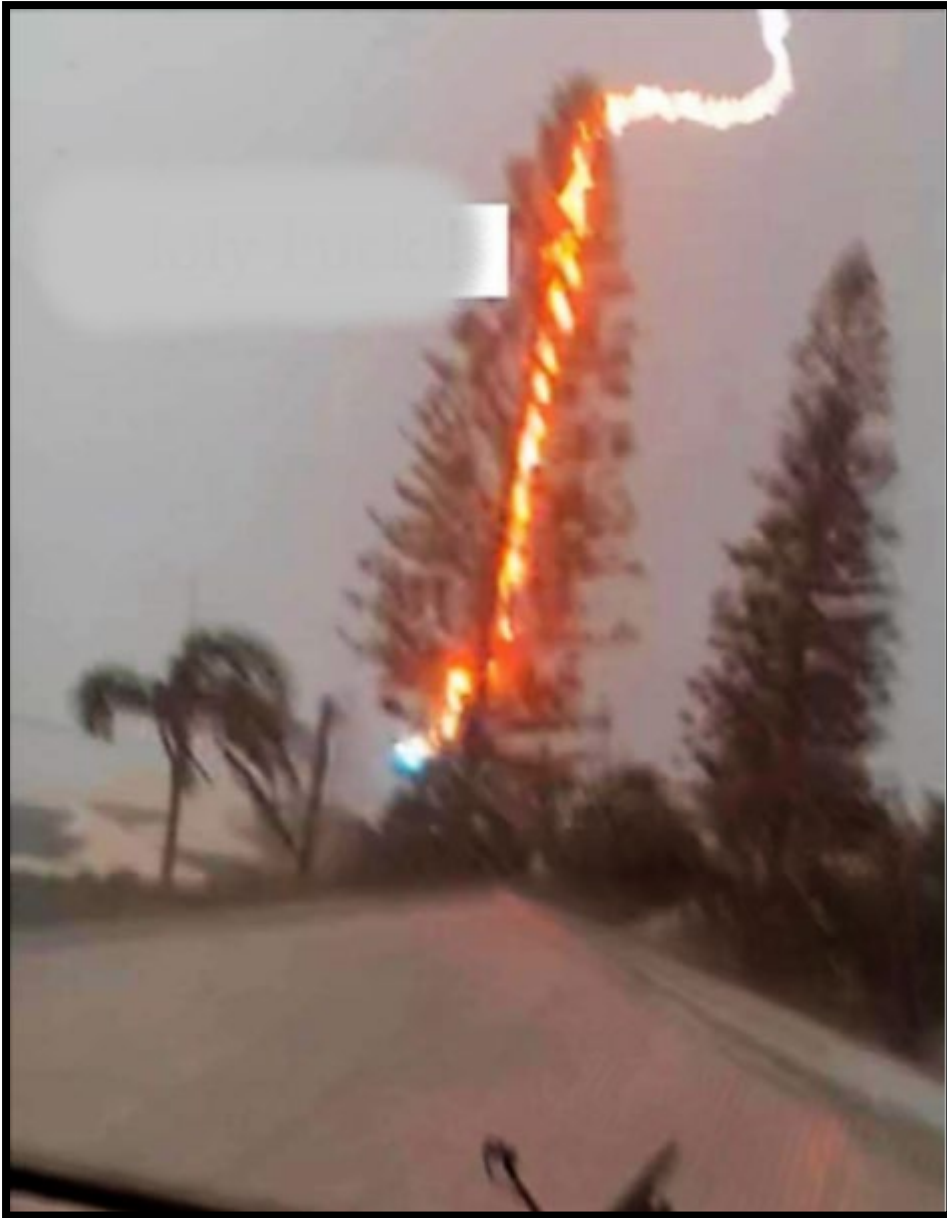
Video footage of the strike was captured and posted on social media. I have viewed the video (see appendix 4) and the strike appears to traverse through the tree and transfer into the power pole 1.5m away where the strike earthed into the ground, this has allowed the energy to dissipate instead of exploding out of the tree. It is assumed that the lightning strike has damaged internal and external tissues of the trees.

Image taken 6 March 2022 extracted from Facebook.
