Arboricultural Impact Assessment Report

81 Tamar Street

BALLINA NSW 2478

Prepared on: 18 June 2020

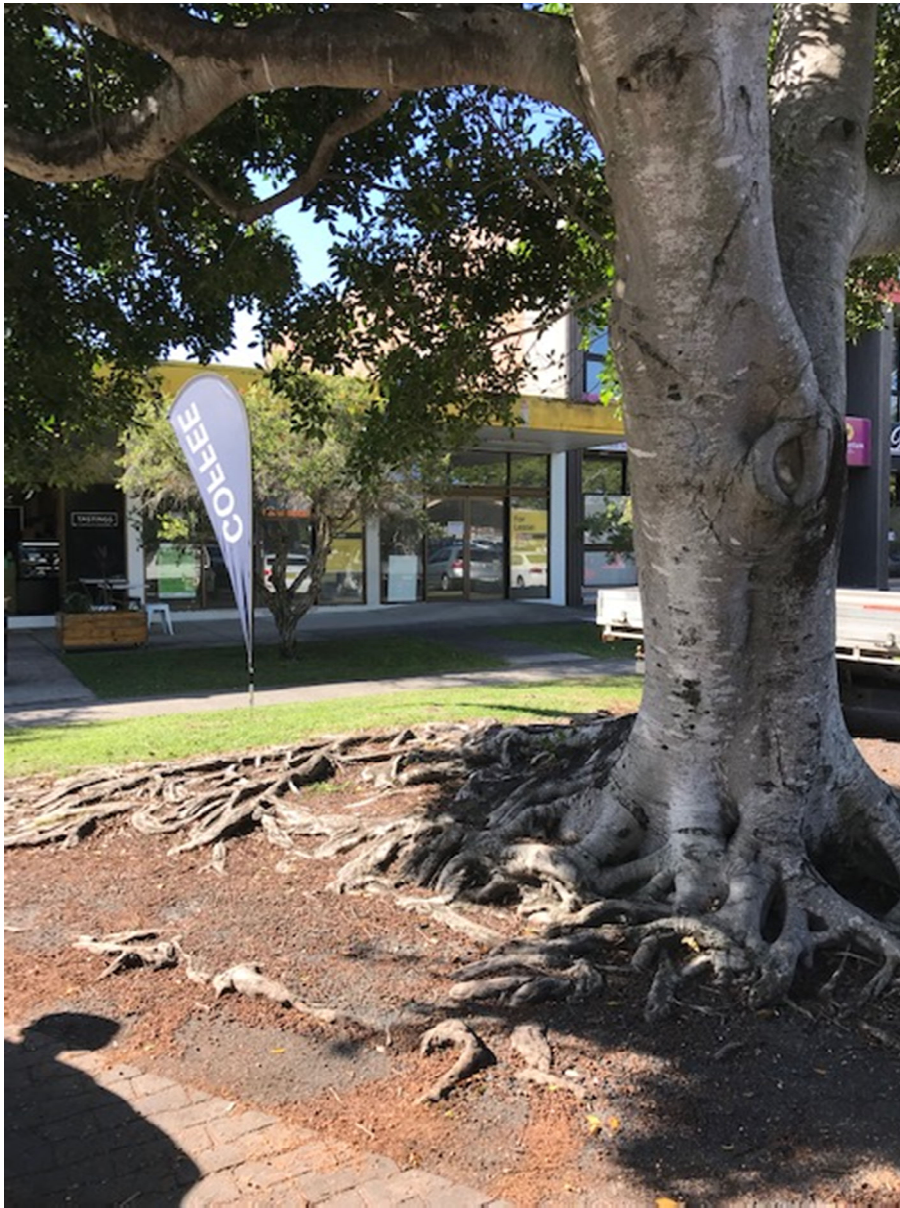
Several roots with an estimated diameter of 100-150mm are present in the turfed areas south of the foot path. These roots have been scalped by mowing or foot traffic. No roots are visible in the turf between the foot path and the concrete slab of the shop front further to the north. Significant upheaval can be seen in the slab heading in the direction of the shop doorway.

Root system, foot path and turfed areas looking north towards work site. B. Branch 16/06/2020

To reduce the impacts from machinery upon the roots encountered it is proposed to firstly identify the location of roots by using careful excavation techniques, such as vacuum excavation. A 300-500mm wide section of the turfed area adjacent to the concrete slab could be trenched and any roots encountered then neatly severed using clean sharp tools such as a reciprocating or hand saw. AQF level 5 Arborist is required to supervise all works and ensure they are carried out to Australian Standards.

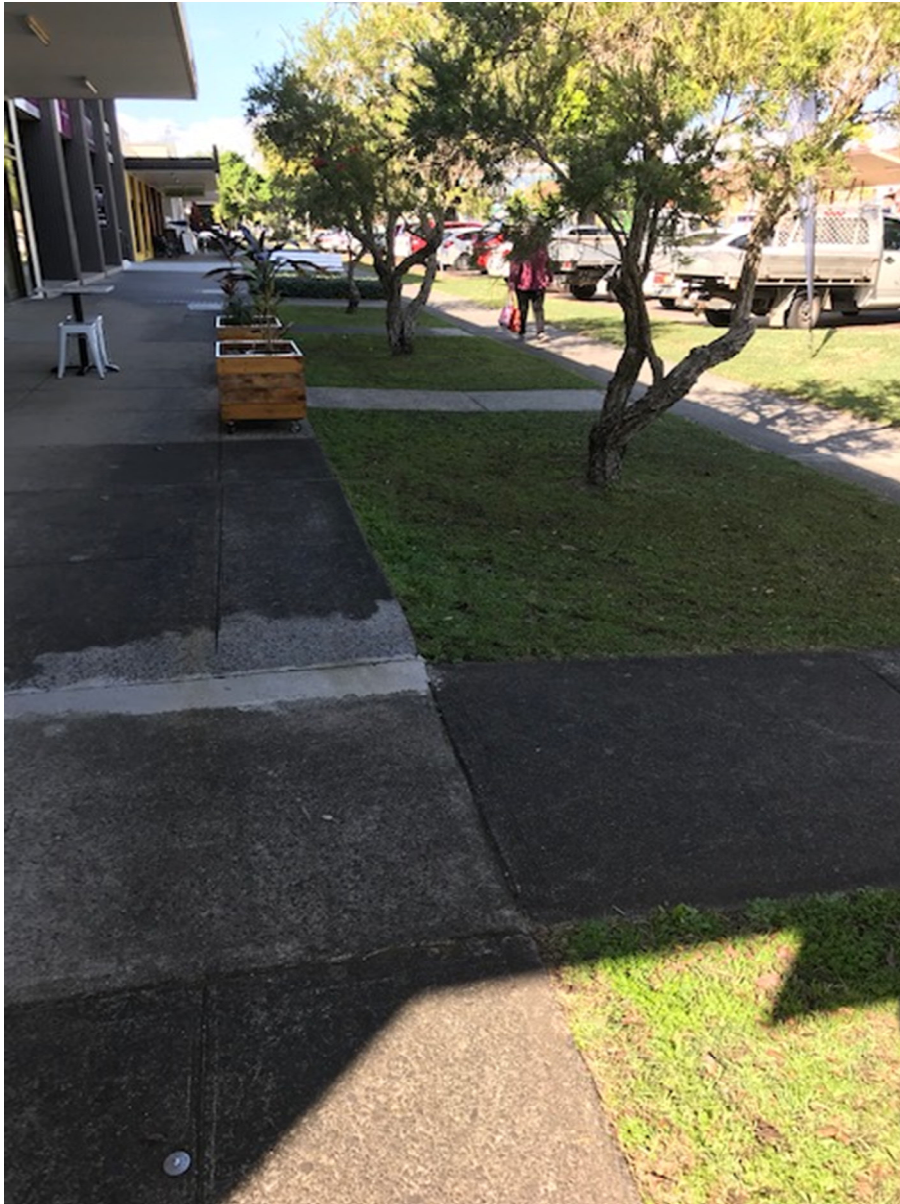
The foot path has repaired damage that aligns with the tree and the slab damage. Disruption further west to the drive way and foot path may or may not be pertaining to the subject tree.

Fig tree roots are known to extend far beyond the drip line and may be found at a distance several times greater than that of the crown extent. It is difficult to say that the damage to the shop is caused by the subject tree. However the upheaval in both the slab and the footpath aligns to the tree and is considered very likely to be pertaining to the tree.

Concrete slab damage. B. Branch 16/06/2020

Works to repair the damage in the slab will involve the removal of existing concrete using heavy machinery. The closest extent of the works is estimated to be between 9.1 to 9.6m from the base of the tree. This would mean that all works would be outside the Tree Protection Zone. Tree roots are likely to be encountered and damaged in the process. Fig trees are known to have a high tolerance to disturbance and the ability to adapt to changes in the landscape. It is my opinion that the tree will cope with the disturbance and loss off roots provided correct tree protection measures are adhered to as outlined in Australian Standard 4970-2009 Protection of trees on development sites.

By creating a 500mm wide buffer zone in the turfed area along the southern edge of the slab, programmed inspections could detect and re-severe any regrowth roots encountered by means of minor excavation using hand tools to probe, expose and cut. This method is not guaranteed to detect all roots and the installation of a root barrier should be considered. Without the installation of an impermeable barrier to deter root growth the problem is likely to reoccur.

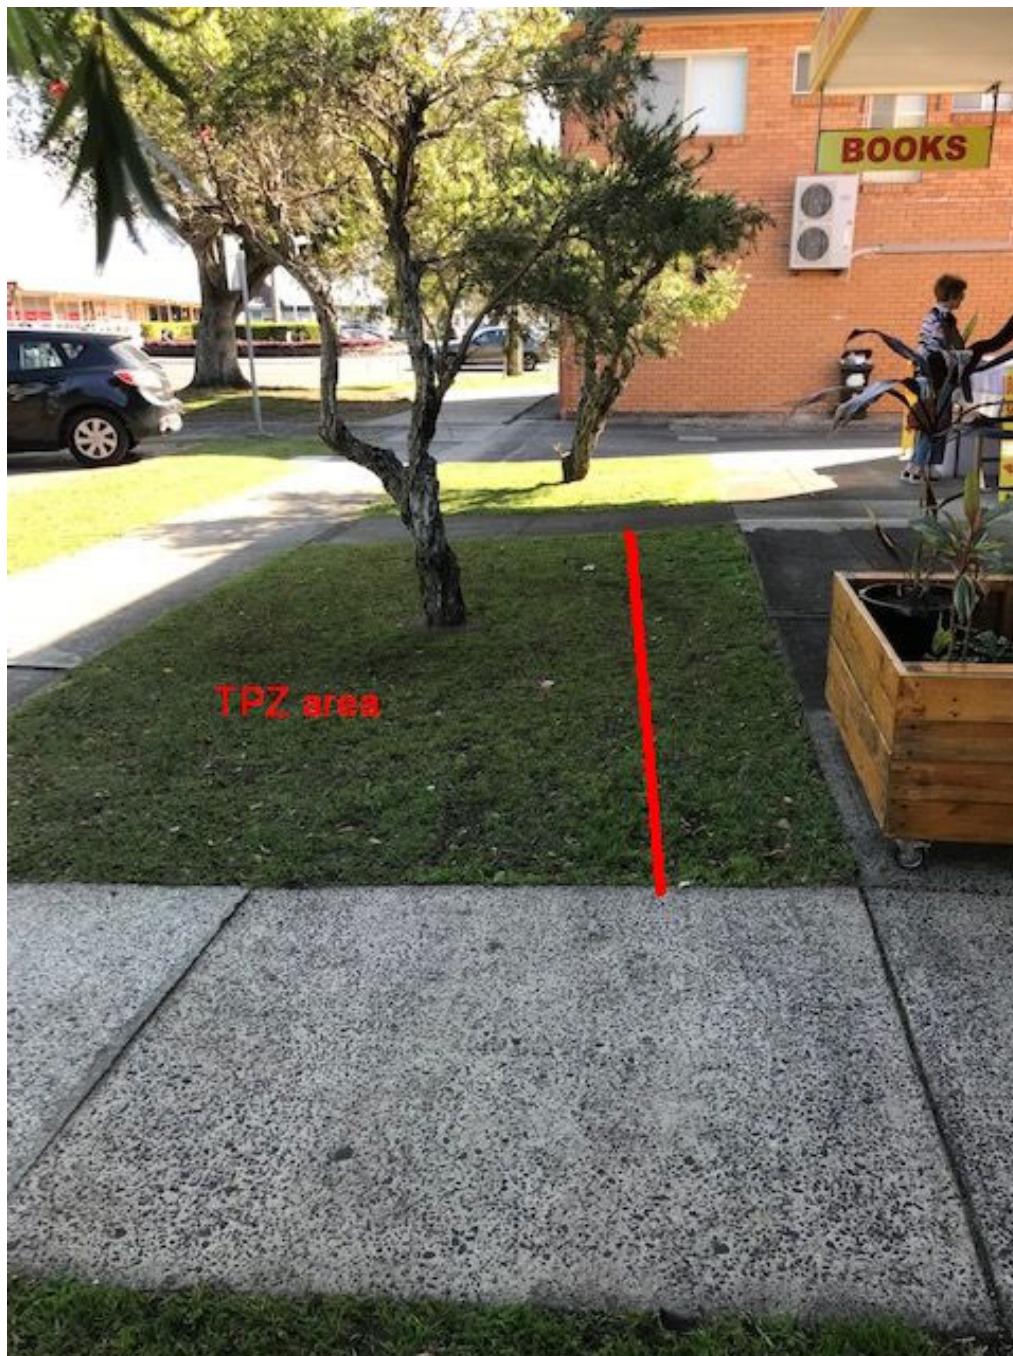
TPZ 9.0m from base of tree. B. Branch 16/06/2020

It is important to observe the tree protection measures required in the 9m radius and described in appendix 2. The grassed area will contain Fig tree roots and should be protected from the compaction of heavy machinery. The area must either be excluded or ground protection mats (Track Mats) used to minimise the impacts.
