PRELIMINARY CONTAMINATED LAND ASSESSMENT

PROPOSED WILDLIFE HOSPITAL

LOT 237 DP 755745,

46 Lindendale Road, Wollongbar

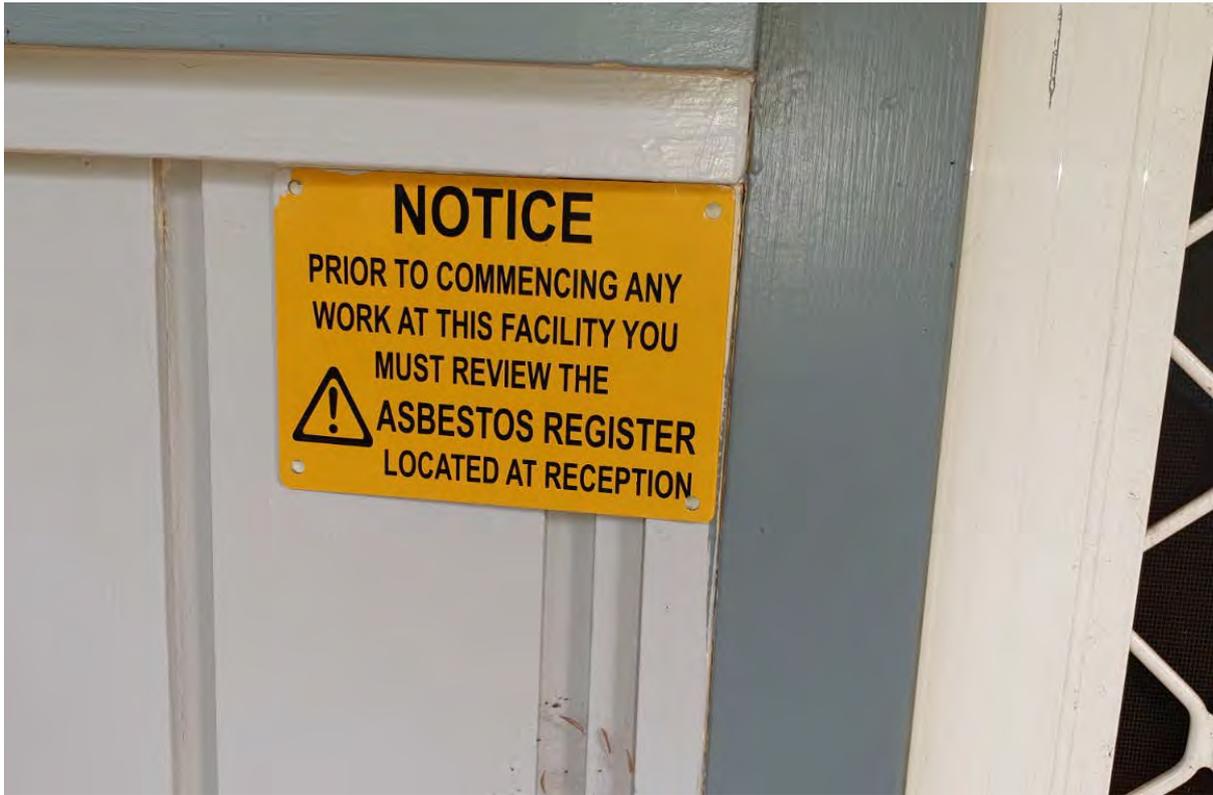
It is noted however, that the building itself is most likely to contain asbestos, and therefore any building work must be in accordance with Workcover and Ballina Council requirements. No fragments of fibro cement were observed on the ground and therefore no investigation was undertaken.

Photograph 1: Plate adjacent to front door of the building

Asbestos in building - undertake a hazardous buildings material survey prior to undertaken alterations/additions to the dwelling
