Arboricultural Impact Assessment Report

Cherry St. Fox St. Roundabout BALLINA NSW 2478

Prepared for: Ballina Shire Council

Prepared on: 08 July 2020

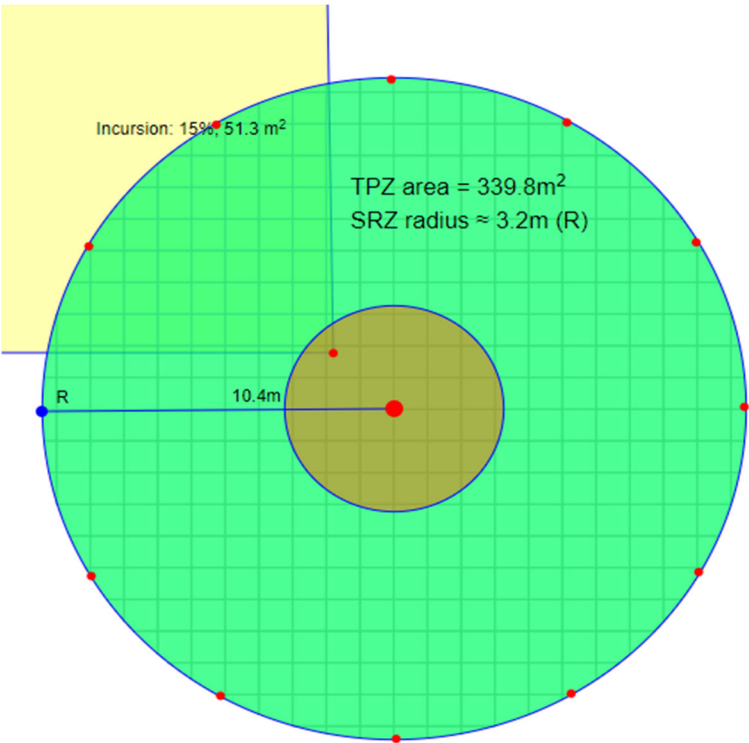
TPZ incursion calculator showing development Tree 2. Road works

In the case of Tree 2. Excavations for underground services (water) have been redirected outside the calculated TPZ. Road works encroach upon the north-western quadrant of the TPZ by 15%, a major encroachment.

Shaded areas indicate extent of existing development. Source: proofsafe.com.au

It is important to observe the tree protection measures required in the 10.4m radius and described in Appendix 2. The grassed area south of the tree, along with the parking bays to the east will contain roots and should be protected from the compaction of heavy machinery. The area must either be excluded or ground protection mats (Track Mats) used to minimise the impacts.

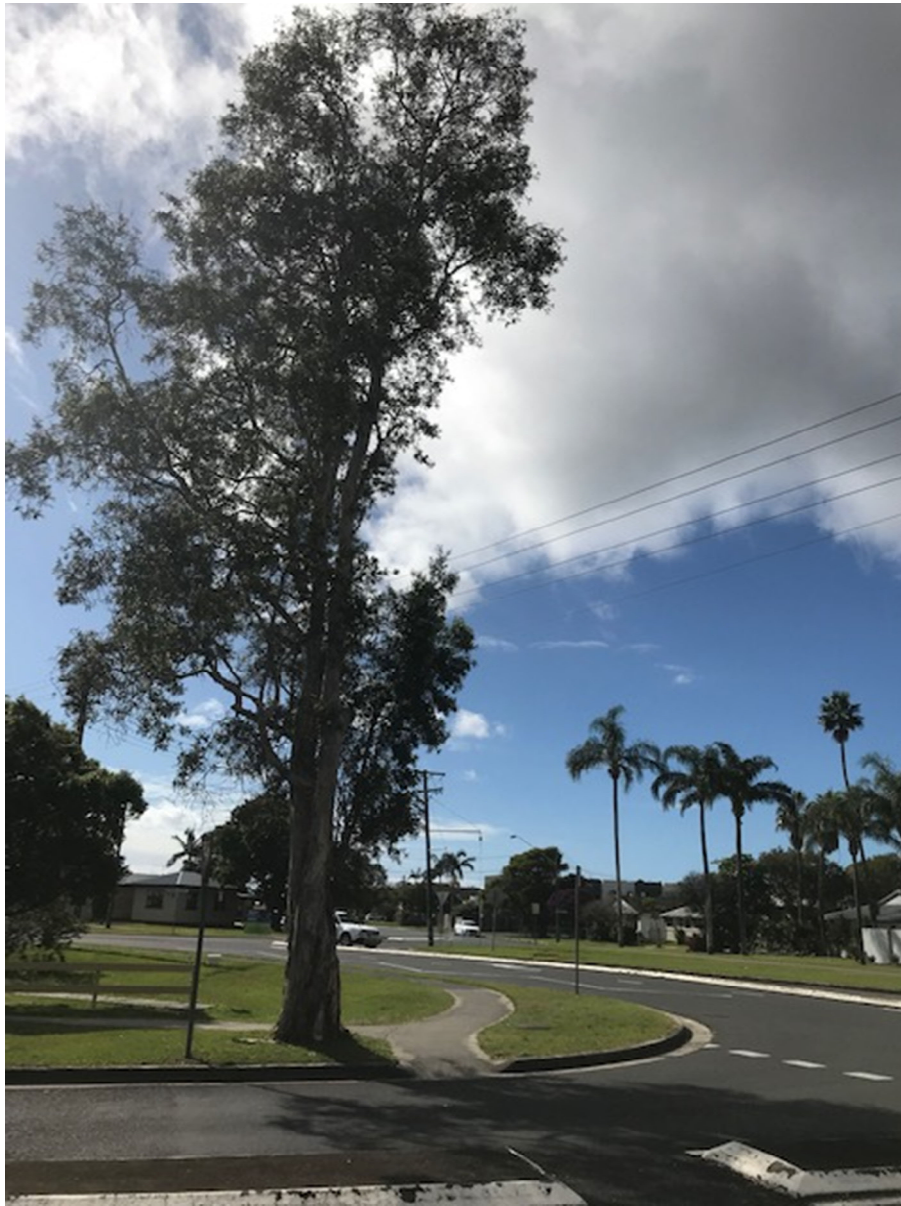
The tree appears in average to below average health. Foliage is normal and dense with no indication of pests or disease present at the time of inspection. The canopy is asymmetrical towards the North West due to heavy reduction pruning for overhead power line clearances on the eastern side. The tree has developed an adventitious shoot from the lower trunk as a result of pruning. It is assumed that the majority of the trees roots exist in the grassed area of the road reserve and may have been impeded upon over the years by works to the footpath. The root system is observed mounding at the base of the tree and not visible within other parts of the road reserve. It is assumed that the tree has a deep rooted system.

Excavations will take place approximately 700mm from the base of the tree, effectively severing all roots in the northern and western quadrants of the TPZ and incurring by approximately 45%. The encroachment for the road works is an additional 45% in the southern and eastern quadrant. A total encroachment of 91% has been calculated.

It is my opinion that the tree cannot cope with an encroachment of this scale and will not remain viable in the long term.

Additionally the tree also interferes with the safe intersection sight distance (distance to detect vehicles approaching in conflicting traffic streams) according to Austroads Standards. This is a mandatory criteria under the RMS & Austroads guide to road design Part 4b: Roundabouts (2015) To ensure safe gaps in traffic can be detected. Refer to appendix 1.2 for sight line justification. To comply with current Austroads and Australian Standards the tree is proposed for removal.

Tree 1: Proposed for removal. *B. Branch 30/06/2020*

Tree 1. The tree requires removal under Ballina Shire Council Policy Urban Vegetation on Public Land Acceptable Reasons Part A: To comply with planning legislation being RMS sight line requirements and section 88 of NSW Roads Act 1993 number 33. In compliance with section 2f of the policy, council must provide a letter of notification to property owners adjoining the significant tree. Notification of the removal is to be added on council's web page and a minimum exhibition and comment period of 14 days. Removal works are to be carried out under the councils Contractor Management System using suitably qualified arborists adhering to site safety and industry best practices.

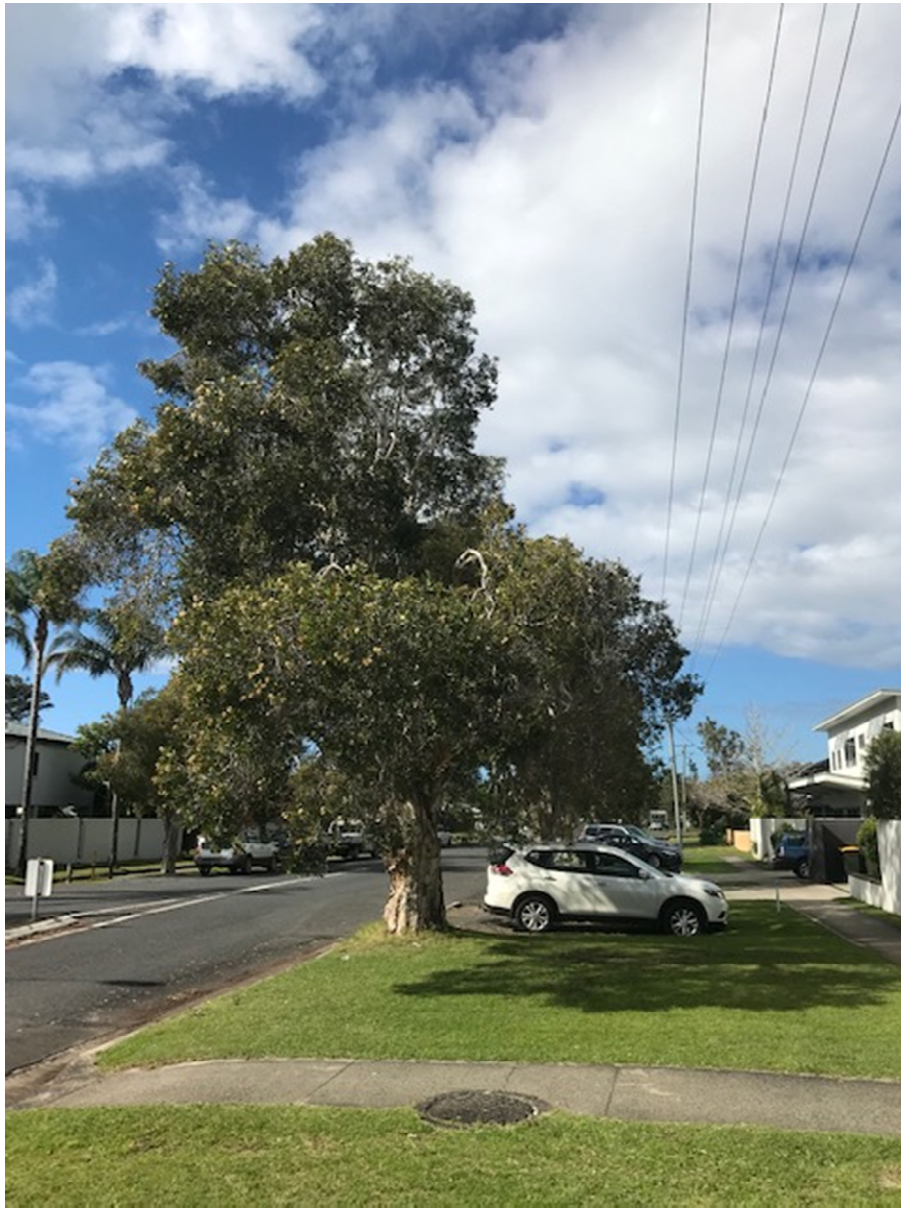
Tree 2: Looking east and showing grassed area for compensation. B. Branch 30/06/2020

In accordance with AS4970-2009 section 3.3.3 an area of compensation equivalent to 15% is required to be added to and continuous with the remaining TPZ. The turfed area extending west to the road side curb is proposed and the equivalent of 51 m must be designated for the benefit of the tree and its root system. Any further development should be restricted to exclude hard surfacing and compaction in these areas as they are important sources of water and nutrients to the tree.

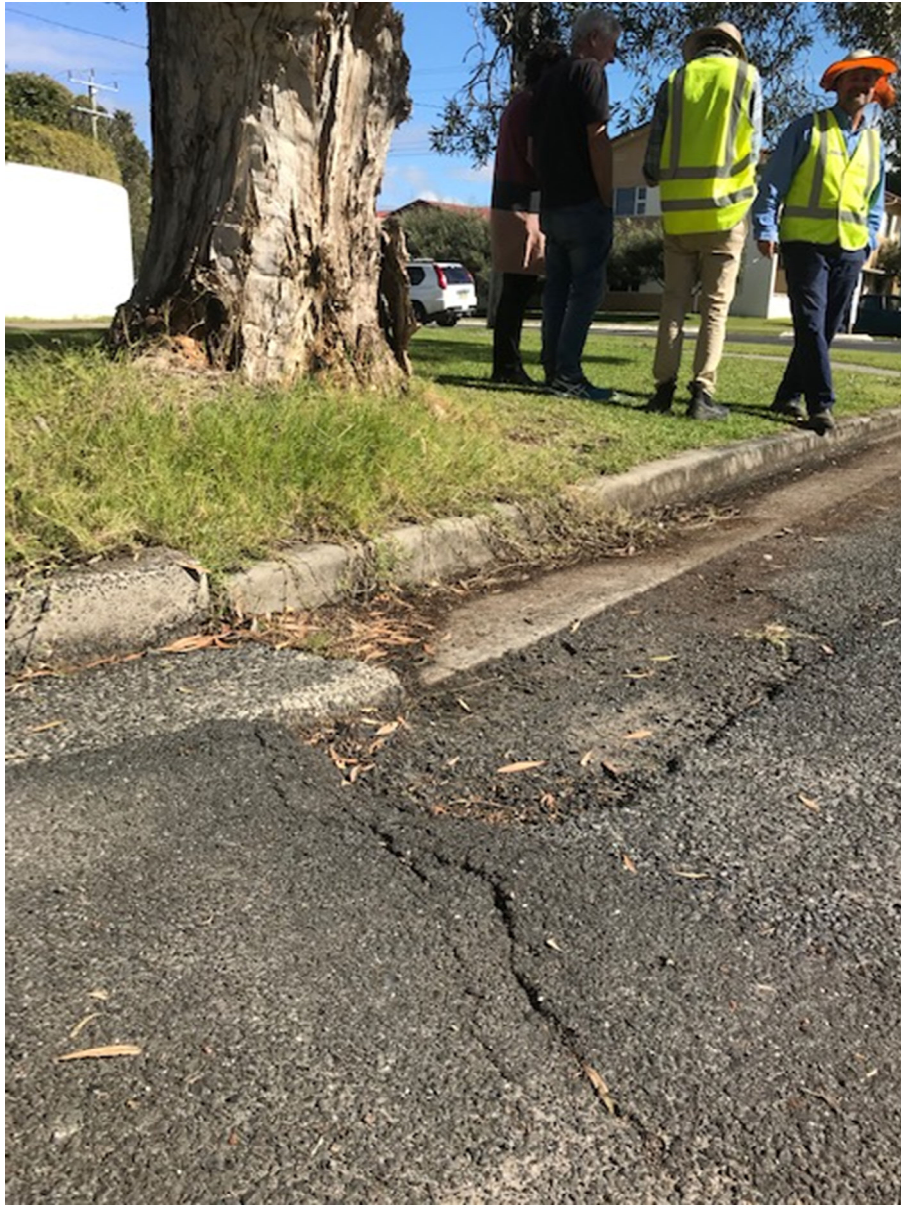
Indications of tree roots such as mounding in the roads surface, were not detected in the 15% encroachment area.

Repairs to the curb are a greater risk to the tree and encroach upon the Root Protection Zone. The RPZ is an area required for tree stability. The close proximity to the trunk implies that structural roots may be encountered beneath the concrete. Evidence of this can be seen to the south east where the curb has lifted by 50mm. The curb may also be acting as a root barrier, deflecting tree roots and restricting their growth into this area.

Tree 2: Indications of tree roots just outside the scope of works. B. Branch 30/06/2020

Works to the north of the tree encroach upon the Root Protection Zone. If excavation is required to replace the existing curb then roots in this area should firstly be identified using careful excavation techniques (such as vacuum excavation) AQF level 5 Arborist is required to supervise all works and ensure they are carried out to Australian Standards.
