Arboricultural Impact Assessment Report

40 Richmond St.

Wardell, NSW 2477

Prepared for: Ballina Shire Council

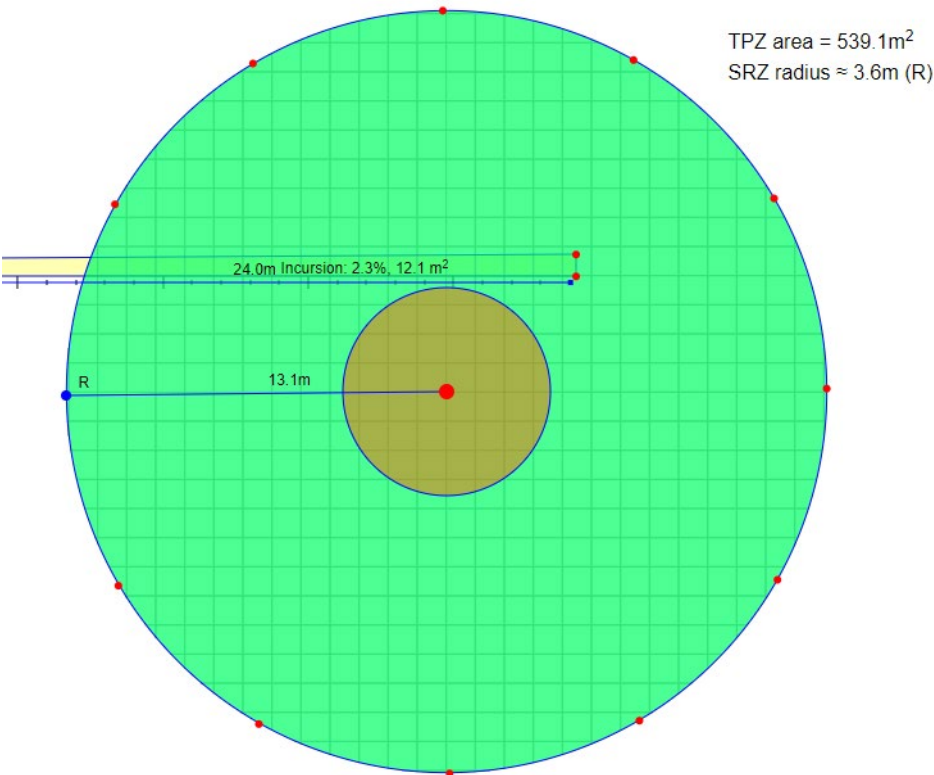
Appendix 2: TPZ incursion calculator showing proposed trenching

Excavations required to carry out the works would encroach upon the TPZ of the tree but remain outside the SRZ. The proposed site to excavate and severe the roots would be between 3.7m & 4.2m from the tree, a trench 500mm wide and 24m in long. This equates to a 12.1m² or 2.4% incursion of the total area available within TPZ radius and would be considered a minor encroachment by Australian Standard 4970-2009 Protection of trees on development sites.

TPZ incursion calculator showing extent of proposed root barrier works.

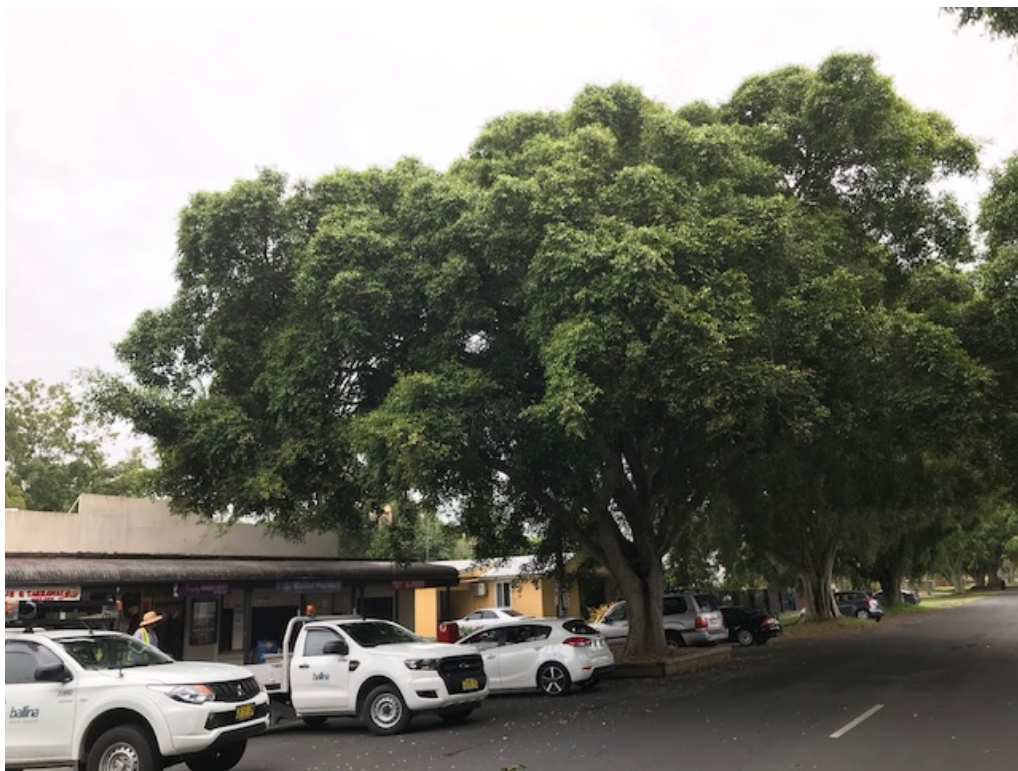
The tree appears in good health, abundant with fruit and healthy new growth, minor indication of pests (mites on new growth) and no diseases or fungal pathogens present at the time of inspection. The canopy is dense with no signs of dieback and less than 5% dead wood present.

Fig tree and site looking north east. B. Branch 04/02/2020

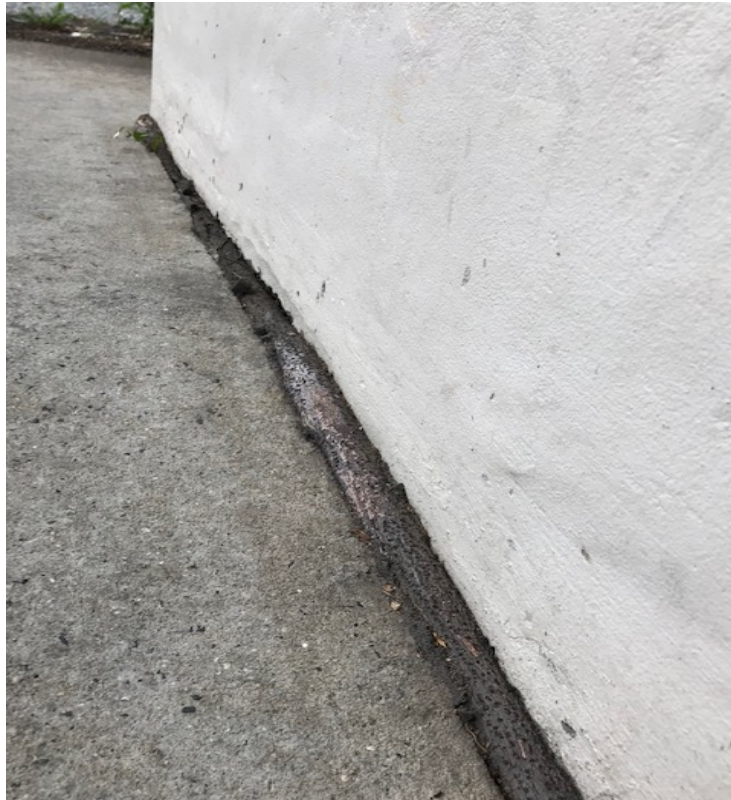
The area from the shop fronts to the curb is concreted in several individual slabs and serves as a public footpath. Tree roots are visible in numerous locations in between the slab joins

and interfaces between the slab and walls. The diameter of these roots varies between 20-40mm. The roots cannot be visibly traced back to the tree and there is no indication of roots breaching the tree pit. The roots are identified by the author of this report as roots pertaining to the subject tree.

Fig tree root between slab and wall B. Branch 04/02/2020

Tree roots noted in between the slab joins and interfaces between the slab and walls, will begin to dieback and dry out, this should induce some shrinking or reduction in size and diameter. The visible roots should be inspected by AQF L5 arborist 6 weeks after completion of works to determine the success of the procedure. The roots causing damage to the

structures may require removal for repair of the building. This works is suggested to be carried out by competent trade's people.

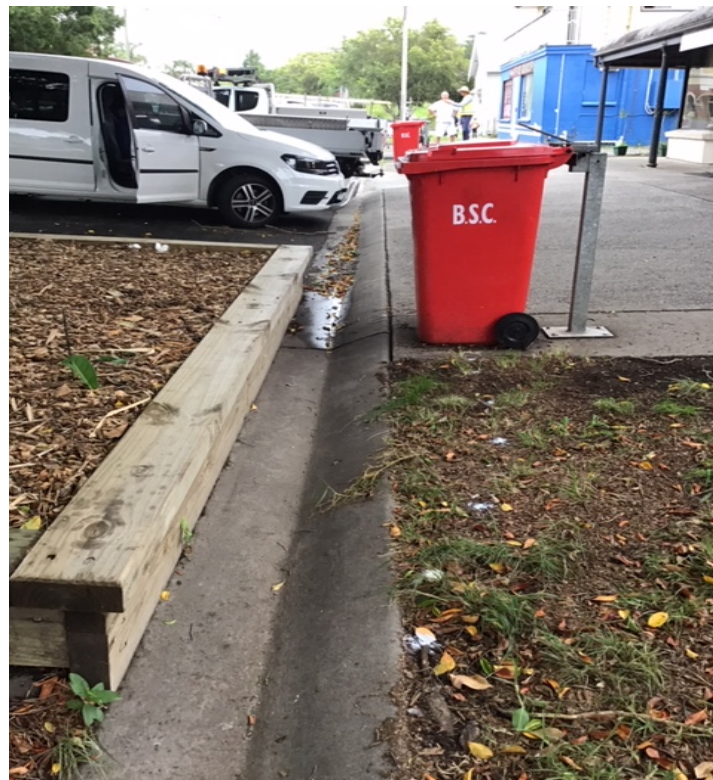
Tree pit and guttering looking down proposed line of root barrier. B. Branch 04/02/2020

Severing the roots outside the SRZ to install an impermeable root barrier would be the only feasible way to prevent further damage in the long term.

Installing the barrier will require cutting the concrete and trenching beneath the concourse to a depth of 1m. With regards to underground services the proposed site of the works would be along the south eastern edge where it meets the curb and drainage of the road. At its closest point the excavations would be 4.7m from the trunk of the tree. The trench should be between 300-500mm in width, beginning in line with eastern property boundary and 1-2m from the power pole. The trench will run adjacent to the gutter traversing in a south east direction for approximately 24m to stop in line with the western boundary. Dial before You Dig plans must be adhered to. The barrier should be installed flush along the southern side of the trench (or roadside) backfilled and compacted. Bentonite clay must line the bottom of the trench to a minimum depth of 50mm. This prevents root growth and inhibits roots from creeping under the barrier. The top of the barrier should remain visible but is recommended to be concreted into the join flush with the surrounding surfaces in the final phase of the works. Completion of the works is to be carried out by councils engineering department to repair the curb and walkway back to its original condition, leaving the top edge of the barrier enclosed but just visible below the concrete surface.

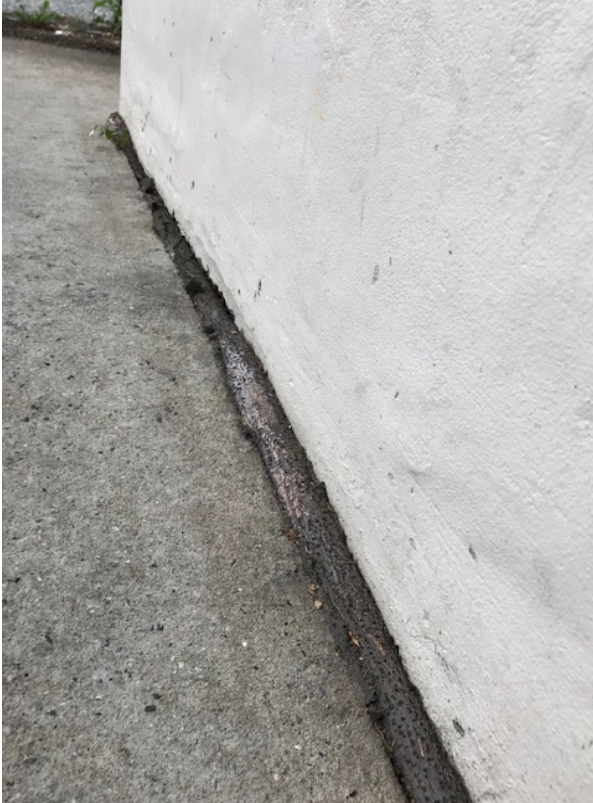
Fig tree root between slab and wall B. Branch 04/02/2020
