# Water Quality Management Plan

North Lakes  
Ballina

Prepared for: Ballina Shire Council

Date: November 2008 – FINAL

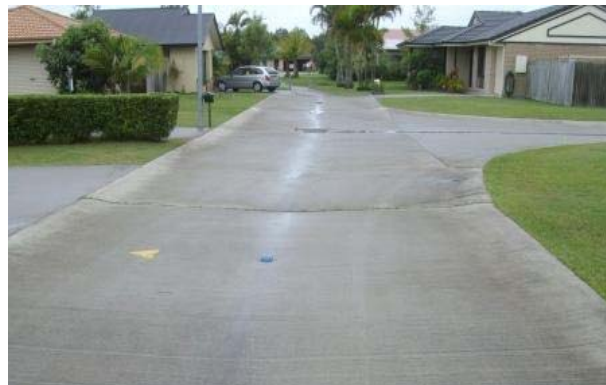
A typical concrete reverse crown road within the North Lakes Estate

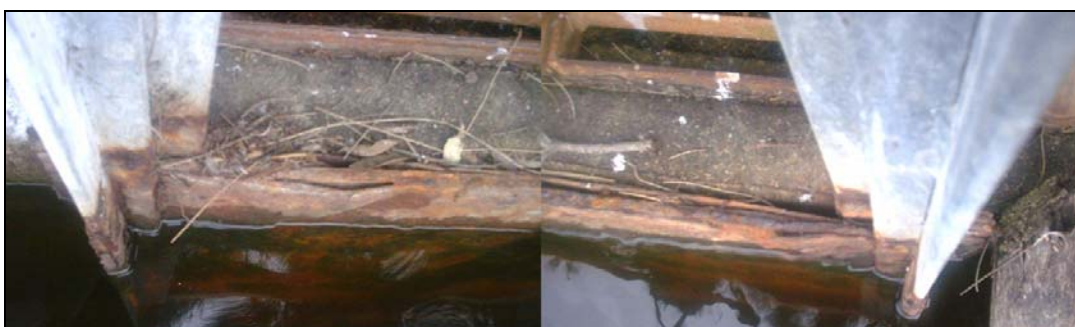
An emergency discharge, manually operated gate has also been provided at the weir outlet structure within Lake No. 1. The purpose of this gate allows for adjustment of the lake water level if required while also providing additional outlet capacity in the event of increasing lake water levels. While it has not been operated in approximately 8 years the gate appears to have become rusted in the closed position and it is doubtful if the gate can be opened in its current state.

Looking down at the emergency discharge sluice gate which has become rusted closed over the past few years.
