11.1 **Fig Tree Management**

Objective To report on a tree management issue and seek the endorsement of Council on the preferred course of action.

Fig Tree Castle Drive, Lennox Head

Arborist report on *Ficus macrophylla* for Ballina Shire Council
7th of December 2015

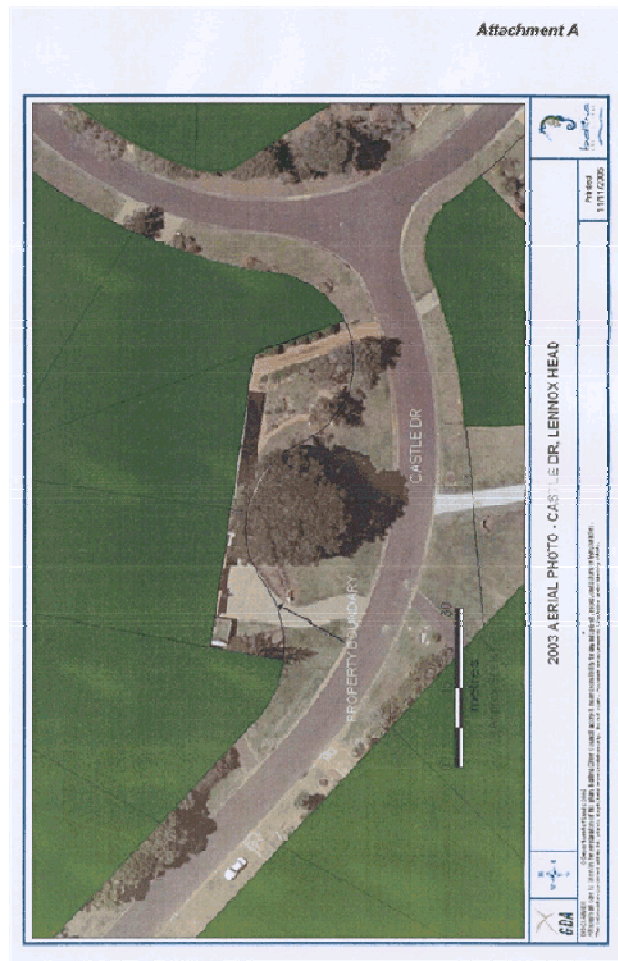
Tree 1 is located in Castle Drive, Lennox Head. Attachment A shows the location of the tree in relation to adjacent properties. It should be noted that the photo was taken in 2003 and since then the tree has been pruned to the property boundary.

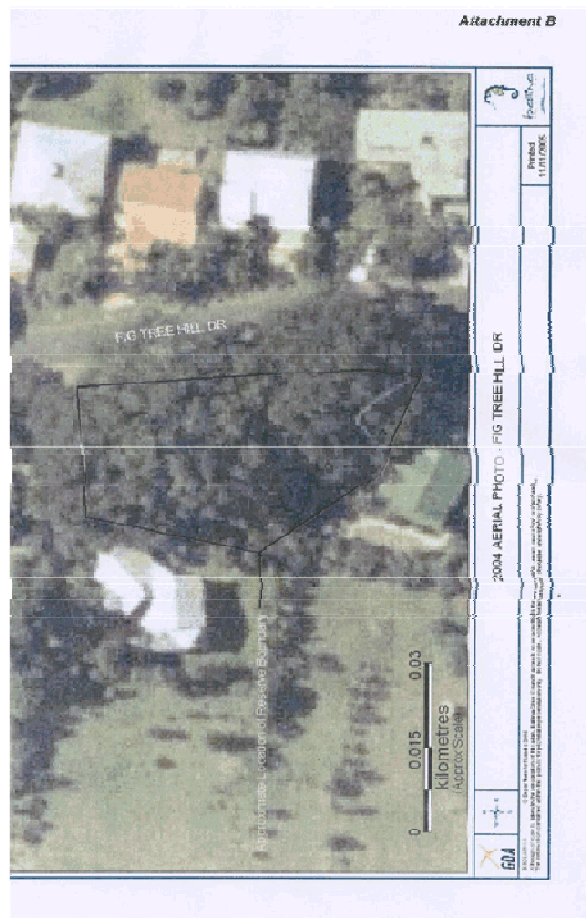
Tree 2 is located in a park at Fig Tree Hill, Lennox Head. Attachment B shows the location of the Fig tree and other Fig trees in relation to the adjacent property. Again significant pruning has taken place since the photo was taken.
