Killen Falls Plan of Management

Part A

Prepared for Ballina Shire Council

8 June 2017

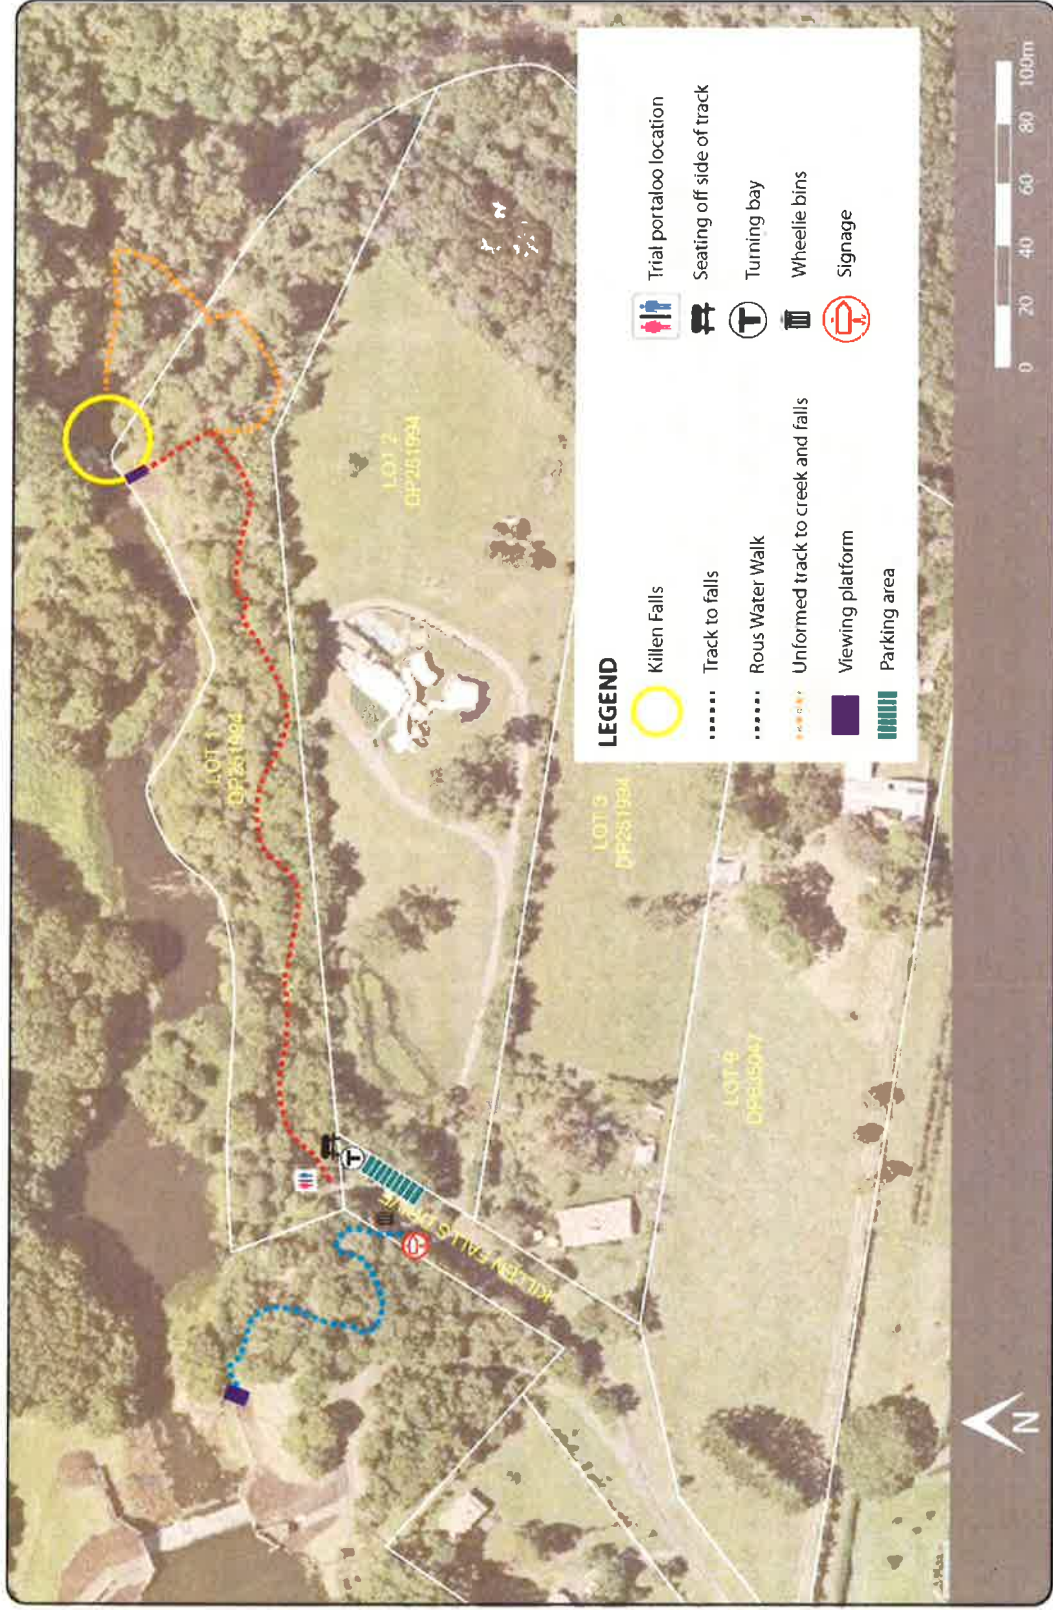
Figure 3: Infrastructure on the subject land

The condition of the walking track is poor other than for an elevated boardwalk across a shallow gully, which is in good condition. The track surface is compacted dirt and heavily affected by exposed tree roots. It is slippery when wet and has minimal directional signage. The warning signage at the eastern end of the track is in good condition. The viewing platform was built in 2015, is galvanised metal and wood, and is in good condition. The single wooden seat located on the subject land is in poor condition as it is affected by wood rot. The fencing is generally in fair condition. Some boundary fencing has been affected by rot. Some track fencing has been removed by visitors to gain access to the creek. Some fencing may be able to be restored and reused.

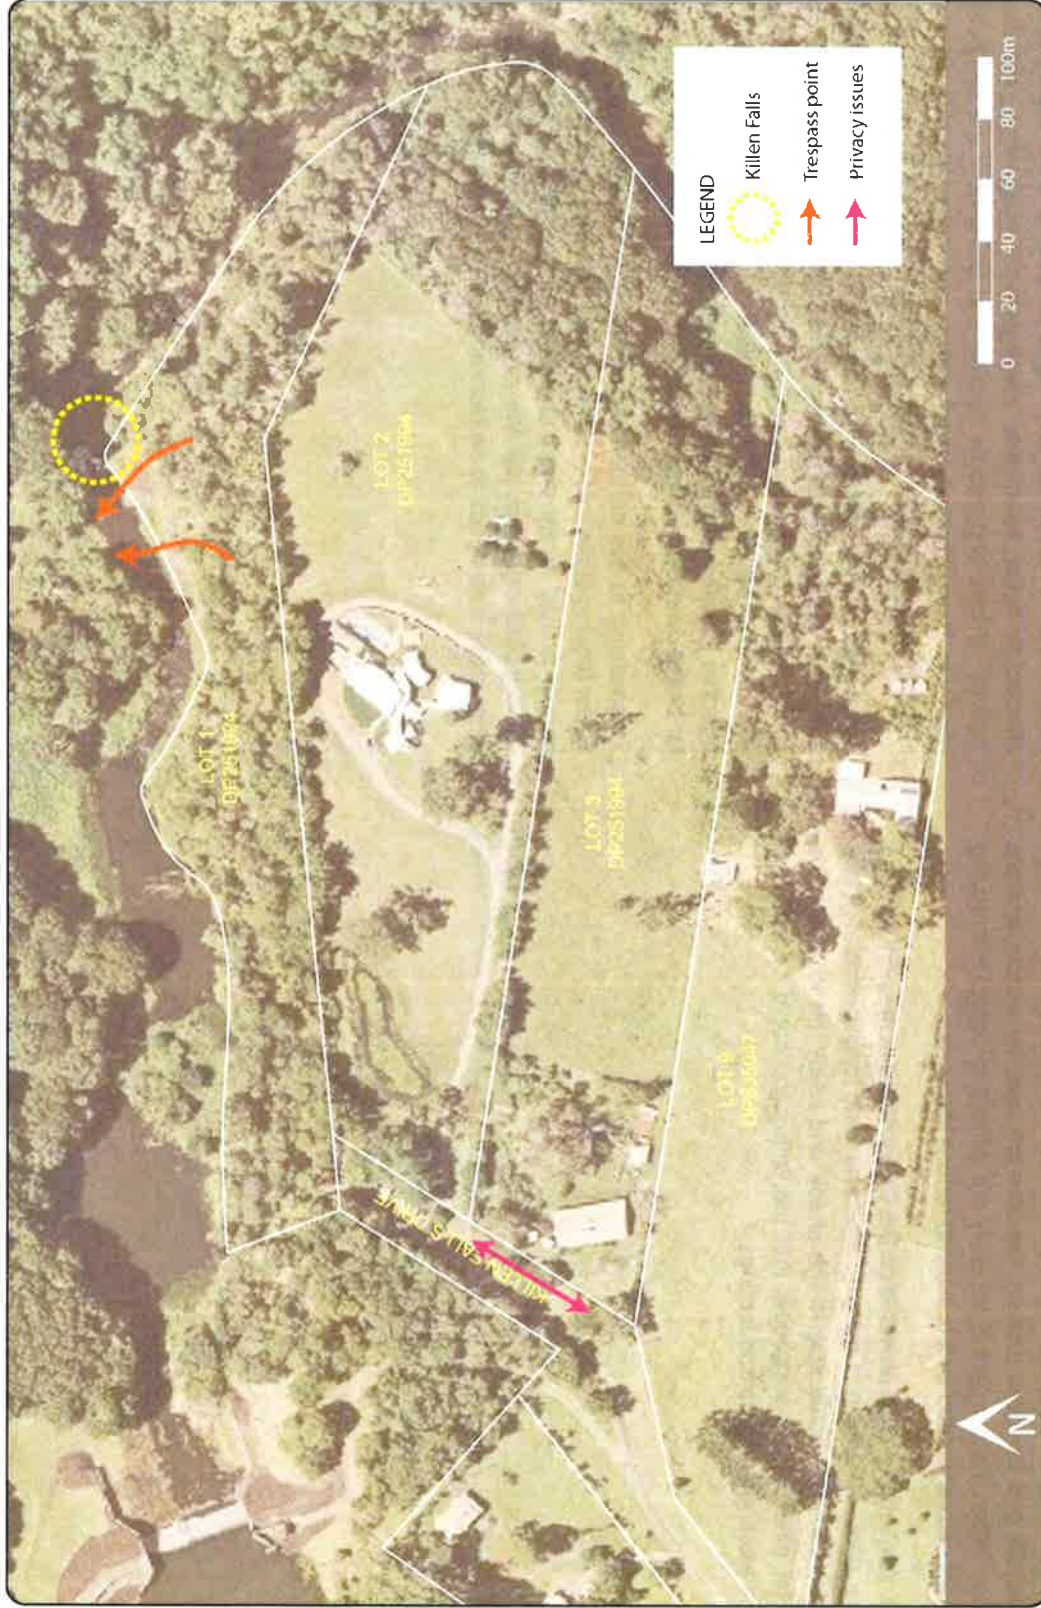
Figure 7: Trespass and privacy issues related to accessing Killen Falls

Trespassing to the northern side of Emigrant Creek has been an issue. Better fencing of the track to the viewing platform, with clear signage asking people to stay on the track should assist with this. The gap beside the viewing platform, which still allows access on to the top of the falls (and the other side), also needs to be blocked off and signposted.

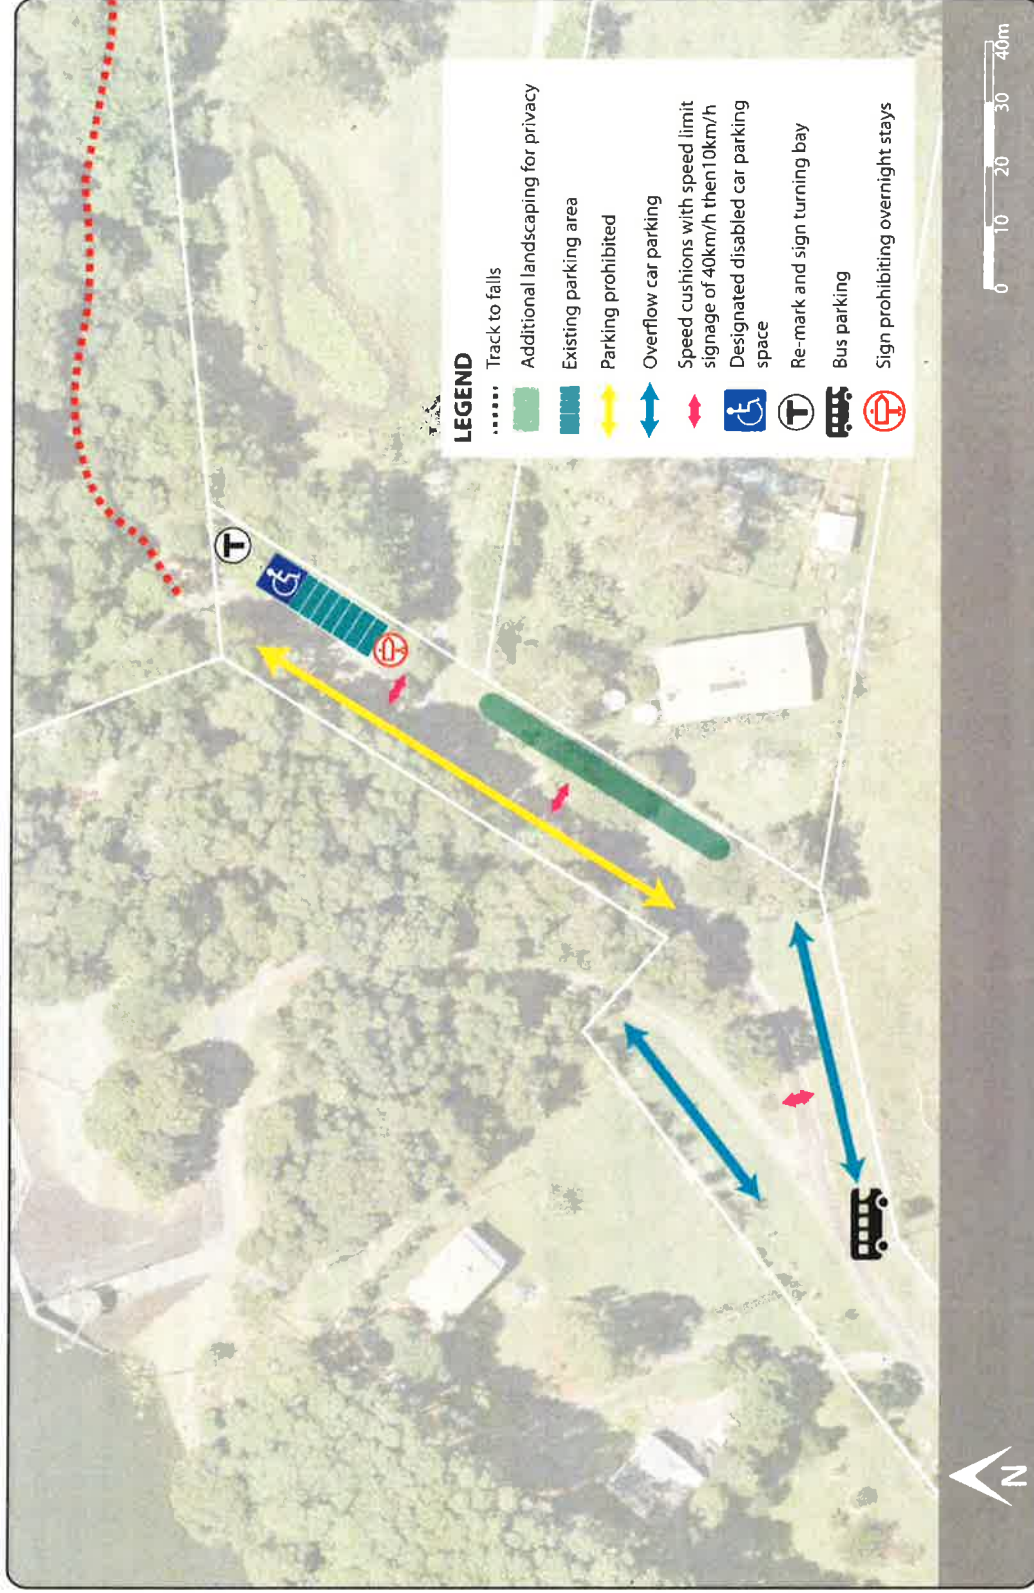
Figure 8: Car parking improvements

Overflow parking occurs in unmarked parts of the road reserve south of the car park, along Killen Falls Drive. Parts of the verge have been damaged by this action and this needs to be addressed. Permeable products such as “Geohex” can be easily laid in the road verge at signposted locations to provide overflow parking that can still be mowed, is permeable to rainfall, and retains the look of a rural road verge rather than a large car park. These areas should be located along Killen Falls Drive in locations where the road reserve is wide enough. These overflow areas could also be used by any buses that access the site, to prevent them driving into a full car park. Figure 8 shows the location of the suggested car park improvements. No land acquisition is required to achieve the overflow parking.

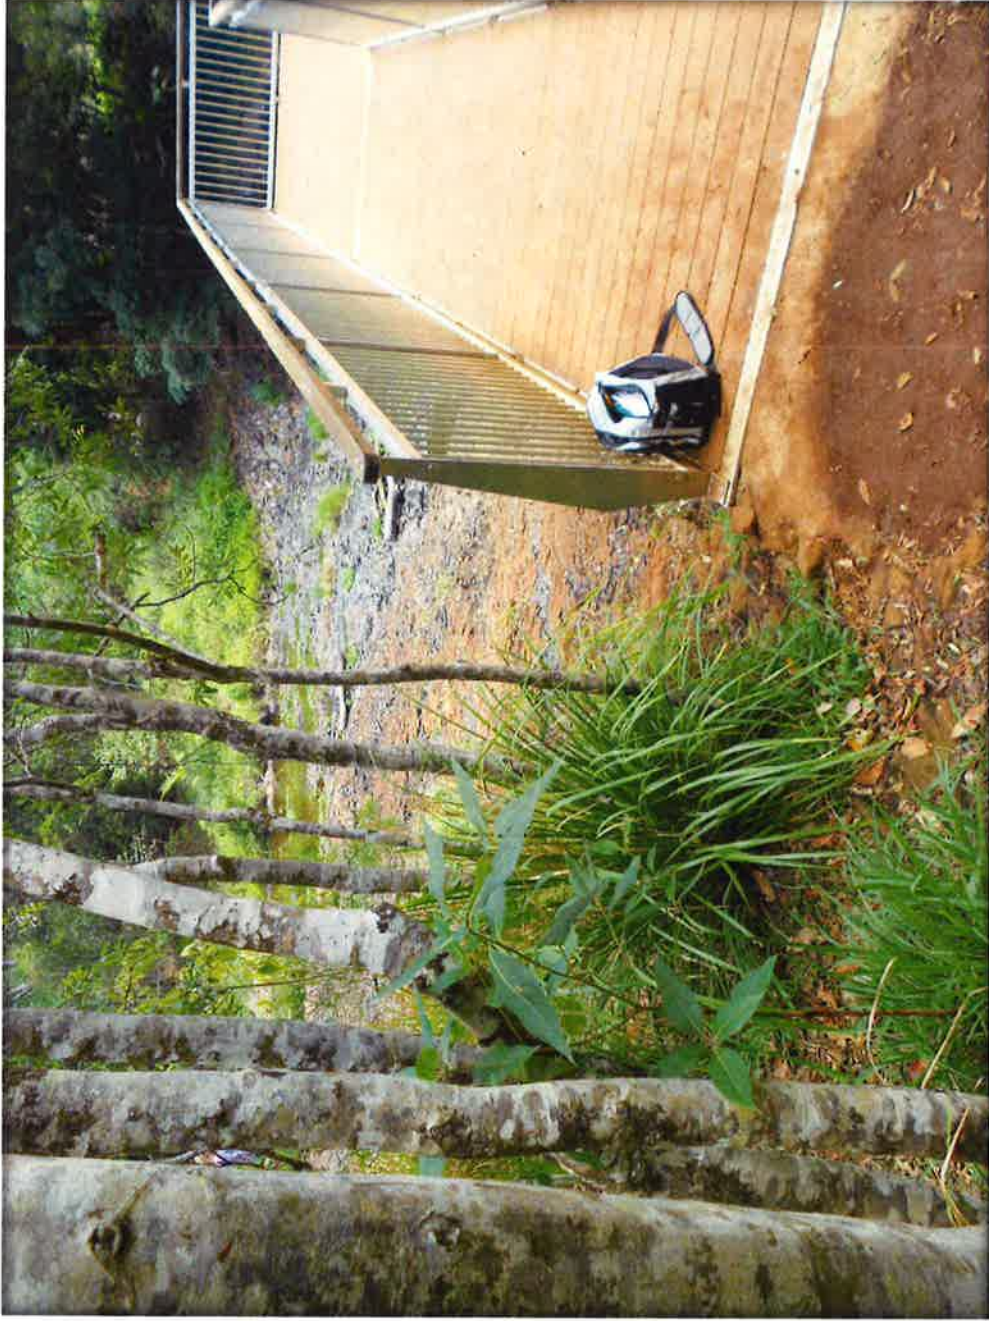
Figure 3: This gap next to the viewing platform needs to be fenced and signposted

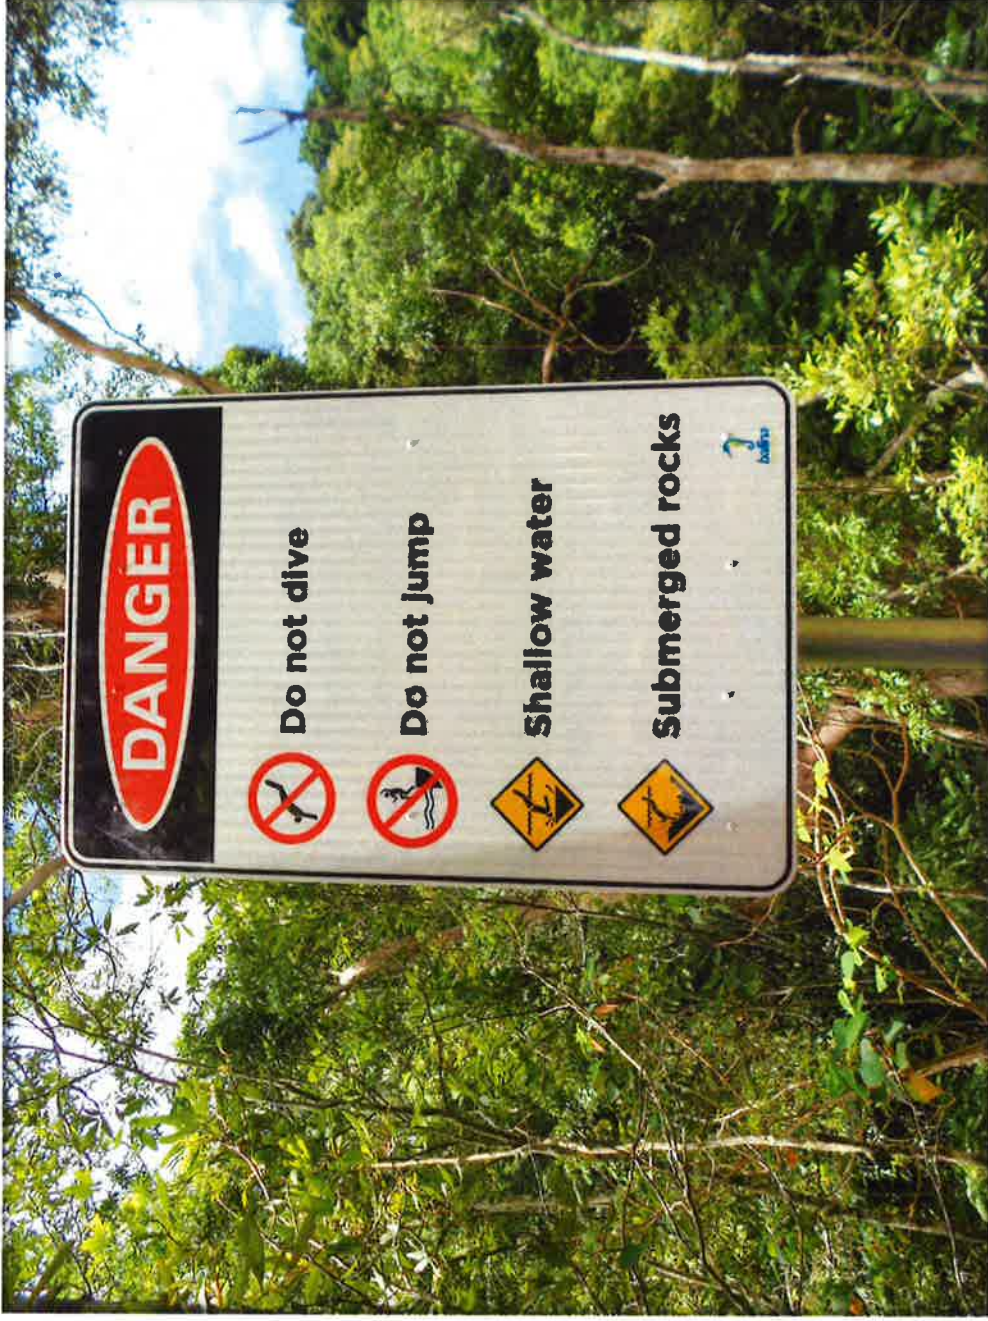
Figure 5: Safety sign that needs to also warn about water quality and swimming

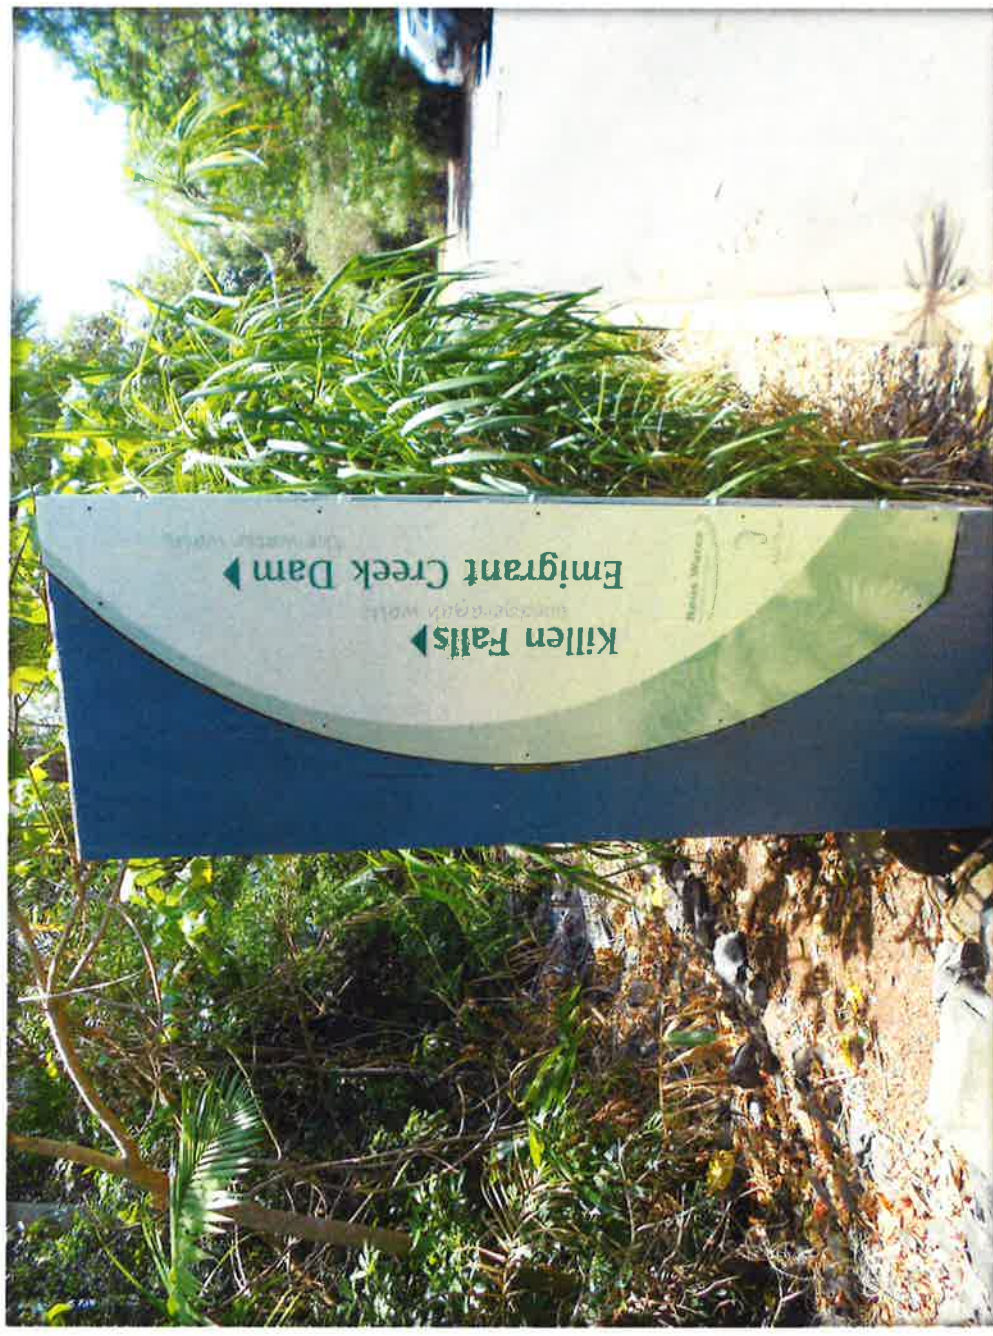
Figure 6: Existing signage has limited information

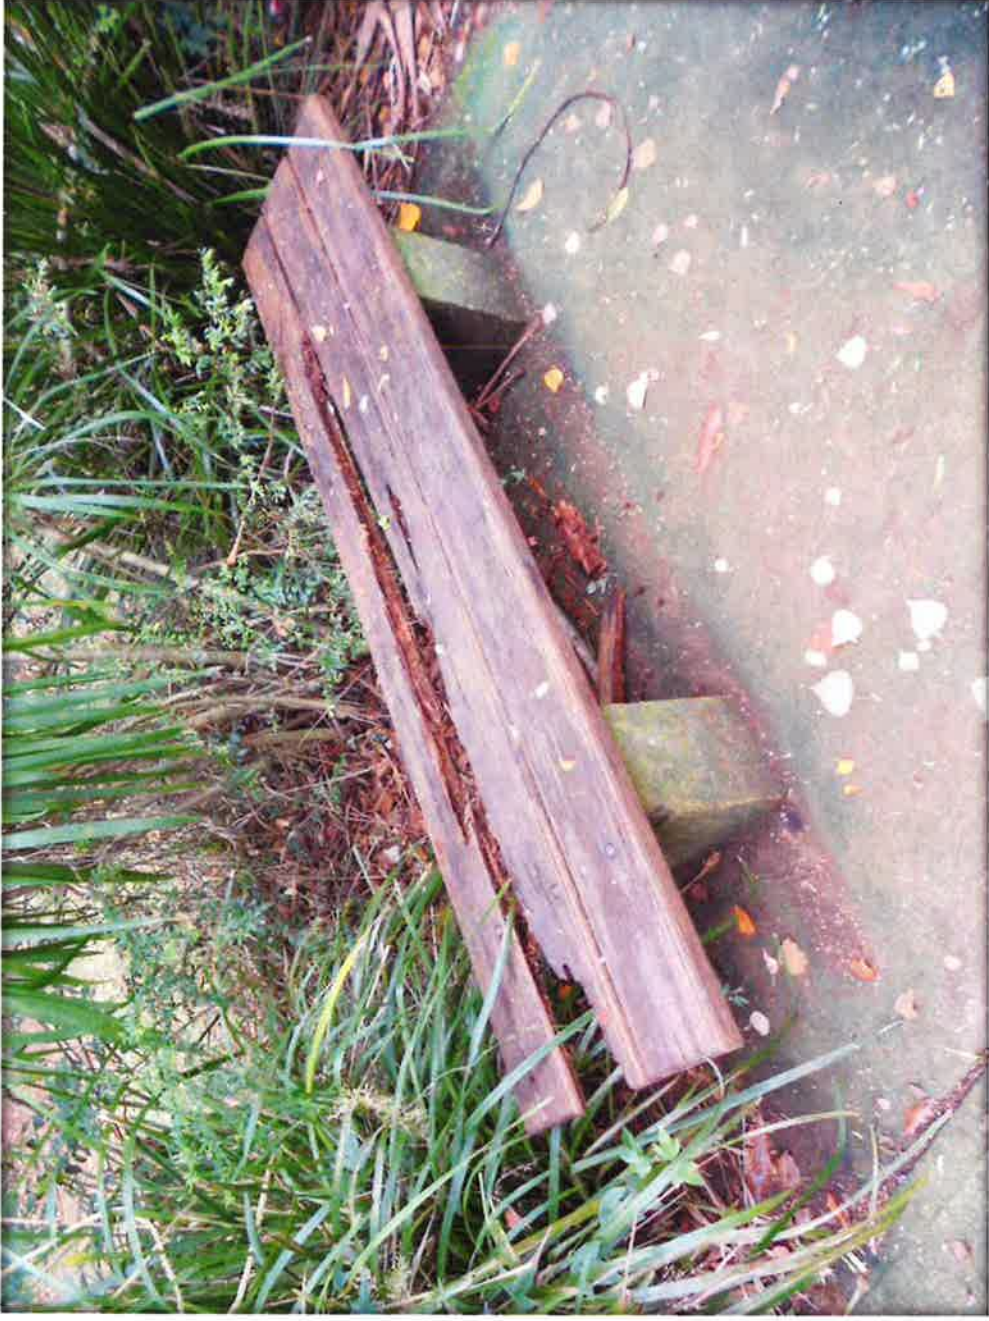
A single, low bench seat is provided on the Council land at the northern end of the car park. It has rotted out over time and is no longer usable. It is a place where visitors could stay in the shade and enjoy the locality while waiting for others. It is suggested that the timber top could be replaced using the existing brackets and footings.

Figure 7: Replace rotten top on existing seat

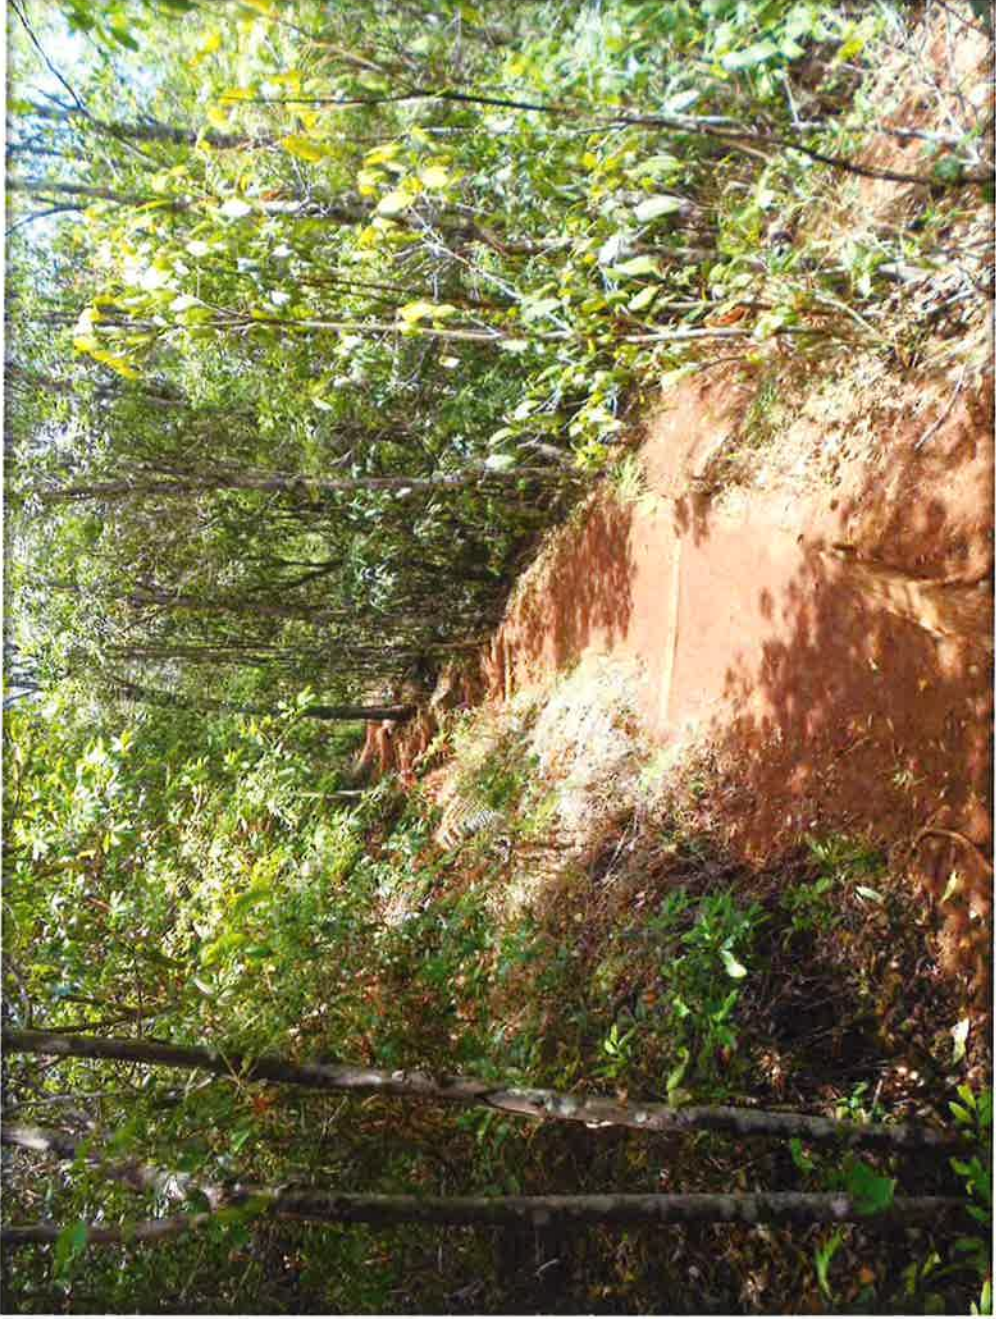
Figure 12: Heavily used track has a poor surface when wet and no fencing

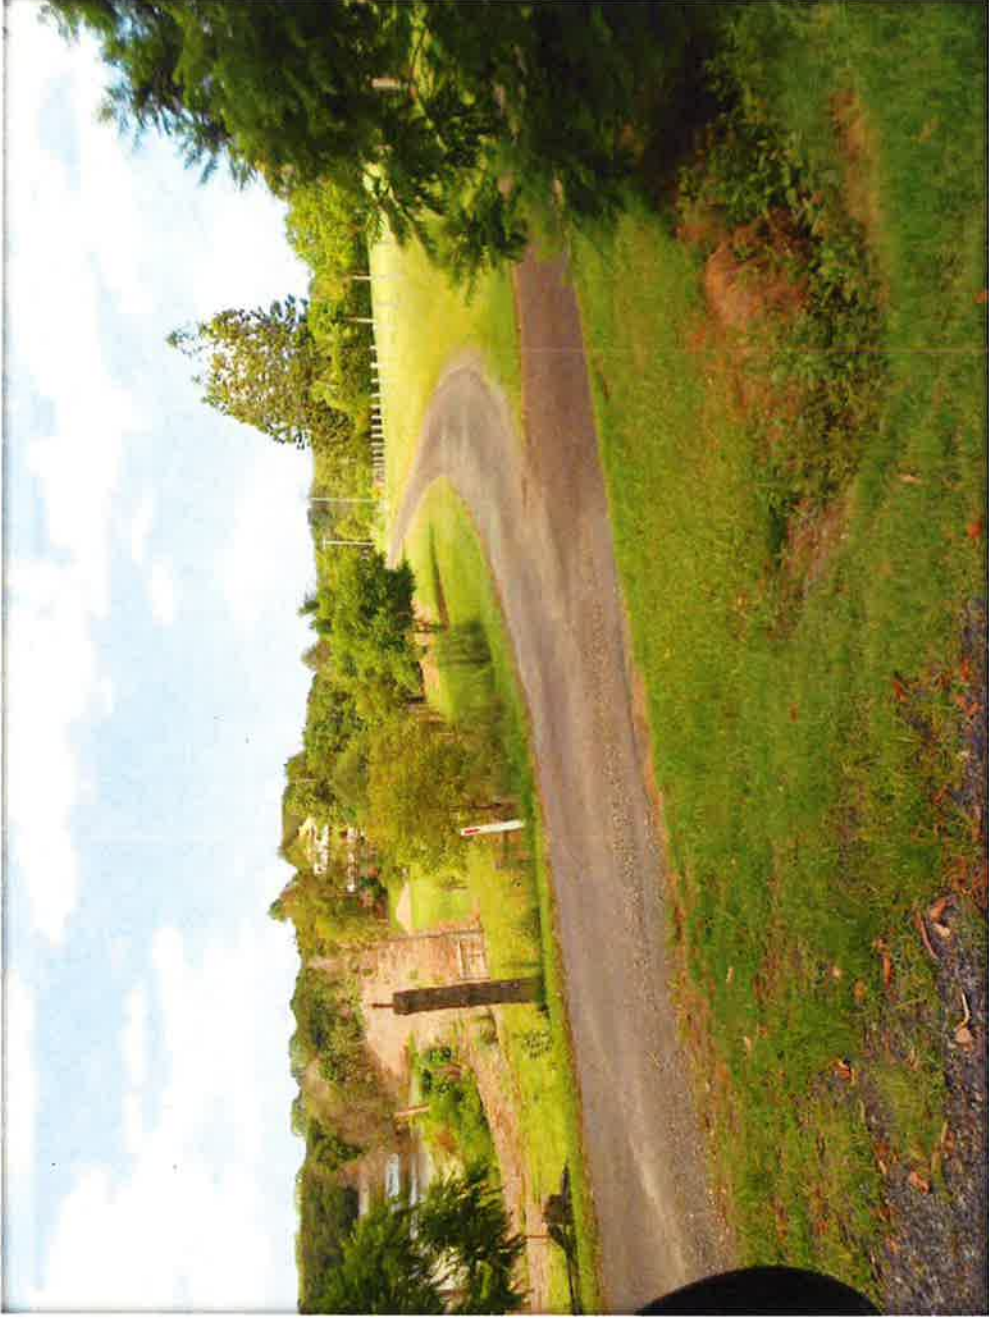
Figure 15: Killen Falls Drive is narrow and needs traffic calming to slow vehicles

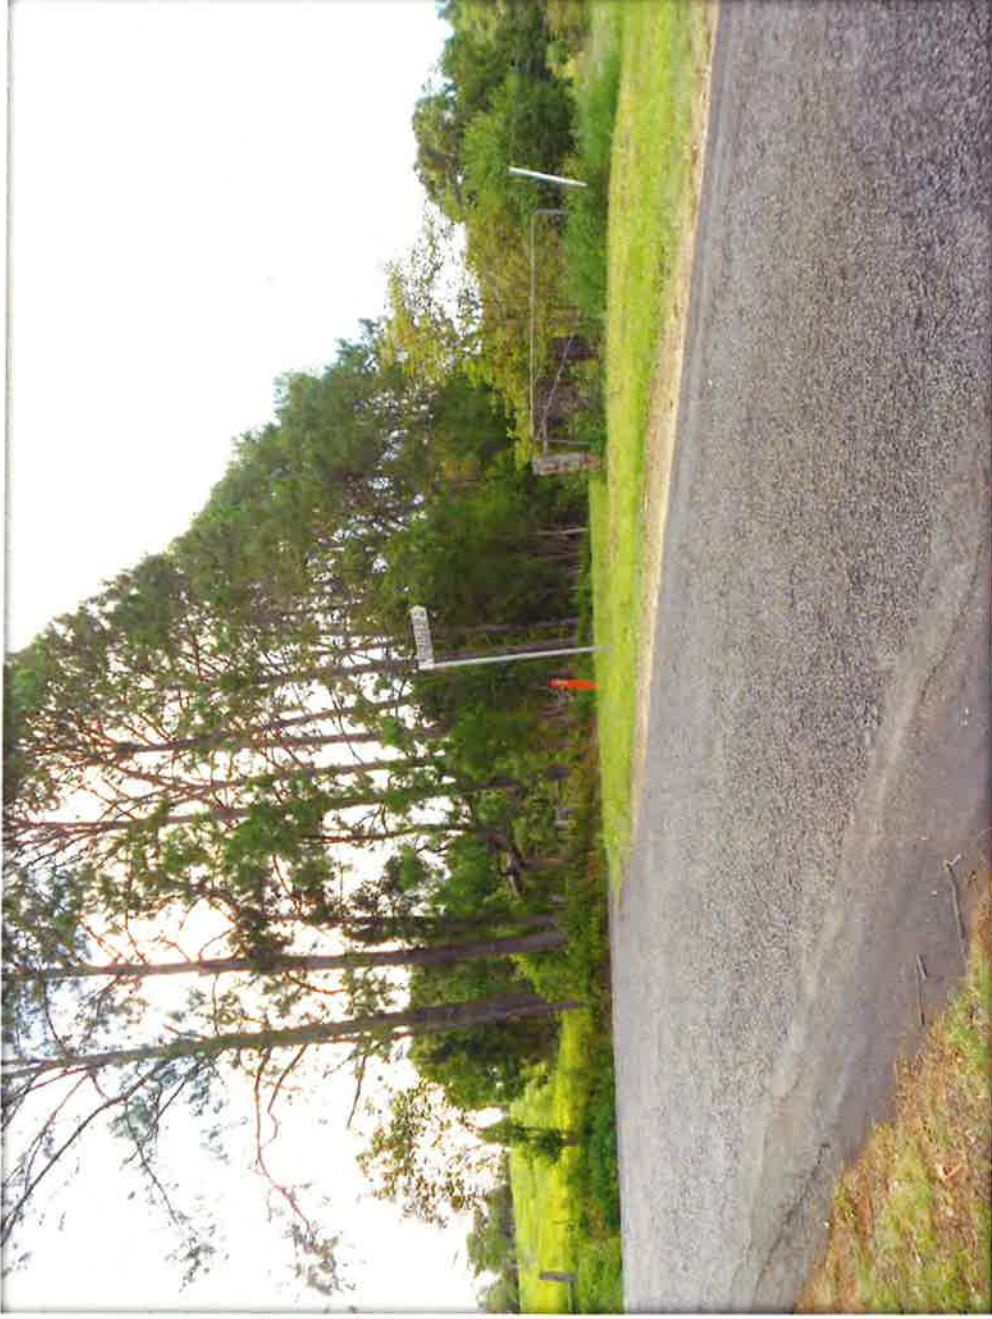
Figure 18: Killen Falls Drive and Friday Hut Road intersection should be assessed

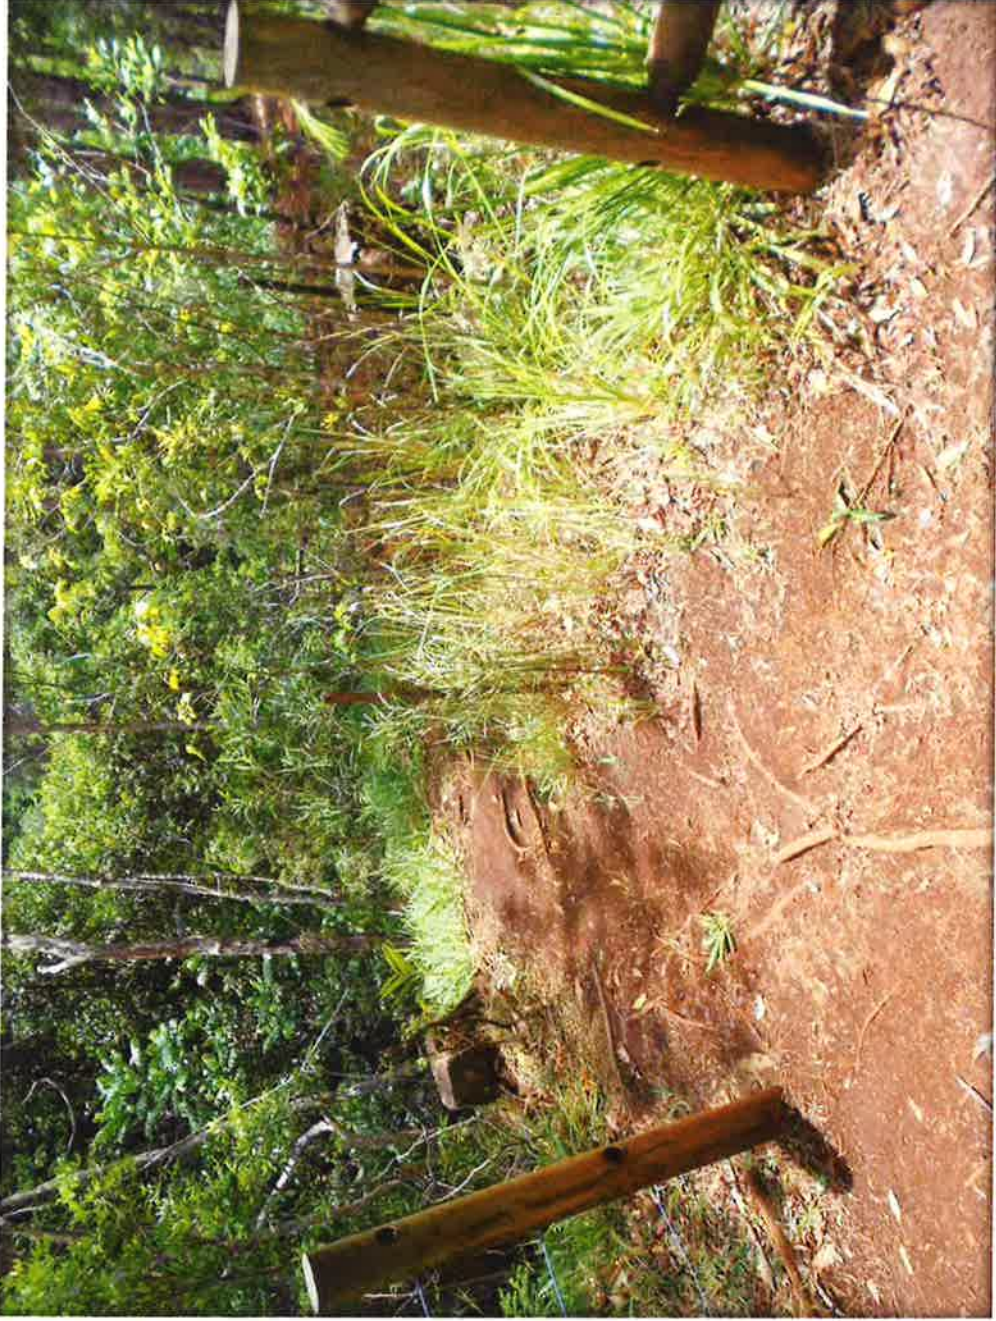
Figure 20: Fence that once blocked track to creek has been removed
