## Notice of Local Traffic Committee Meeting

a Local Traffic Committee Meeting will be held in the Ballina Shire Committee Room, 40 Cherry Street, Ballina on **Wednesday 11 October 2017 commencing at 10.30am.**

## ROAD SAFETY AUDIT

Existing School Zone  
Wollongbar Public School, Simpson Avenue

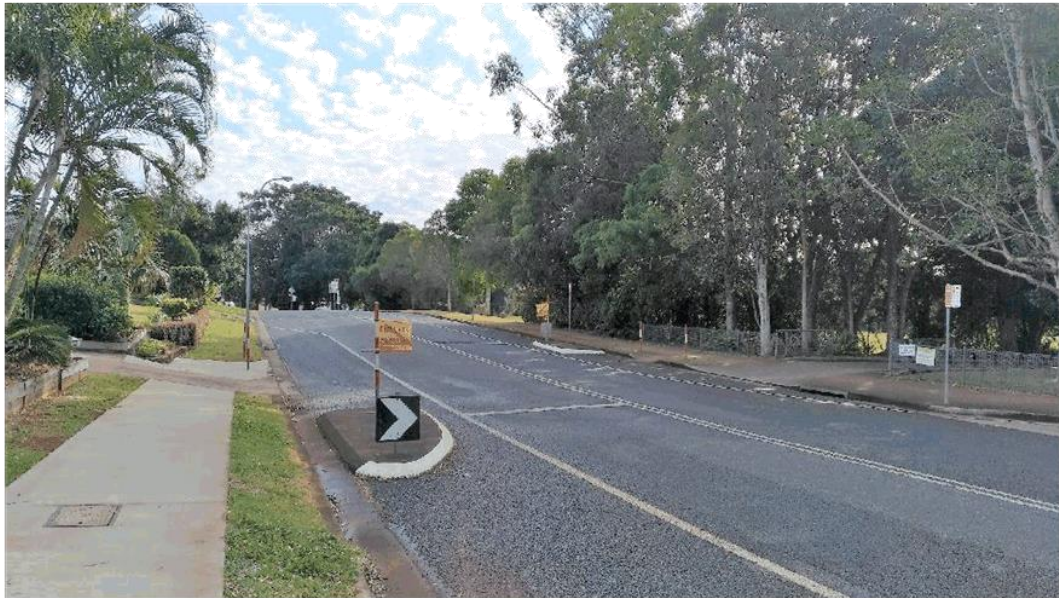
**Photo No. 1: Location 1 AM: Children's Crossing, view to the North**

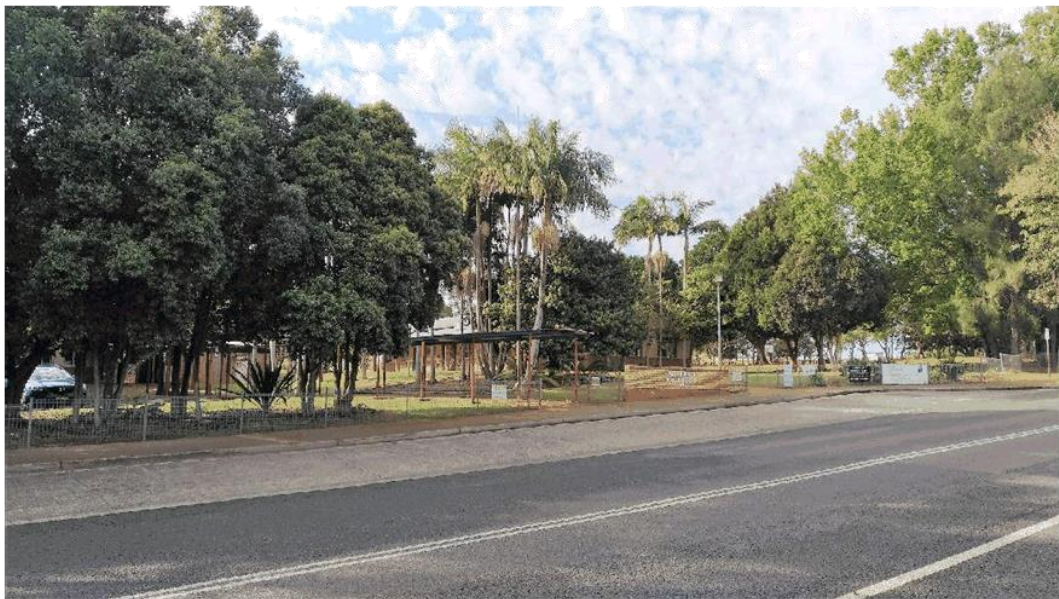
**Photo No. 2: Location 1 AM: Bus Zone, view to the East**

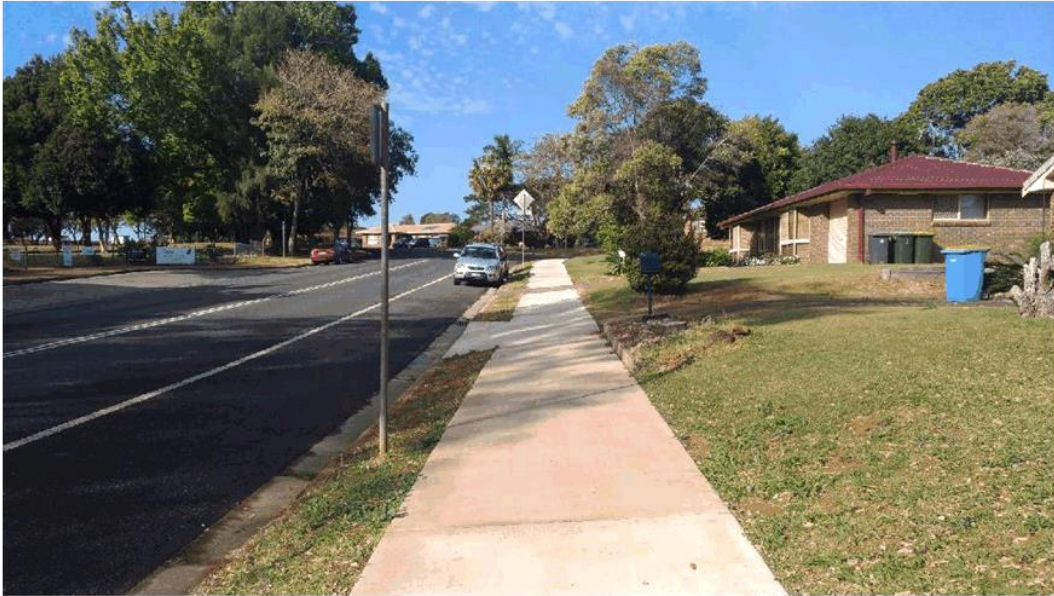
**Photo No. 3: Location 1 AM: Footpath on western side of Simpson Avenue, view to the South**

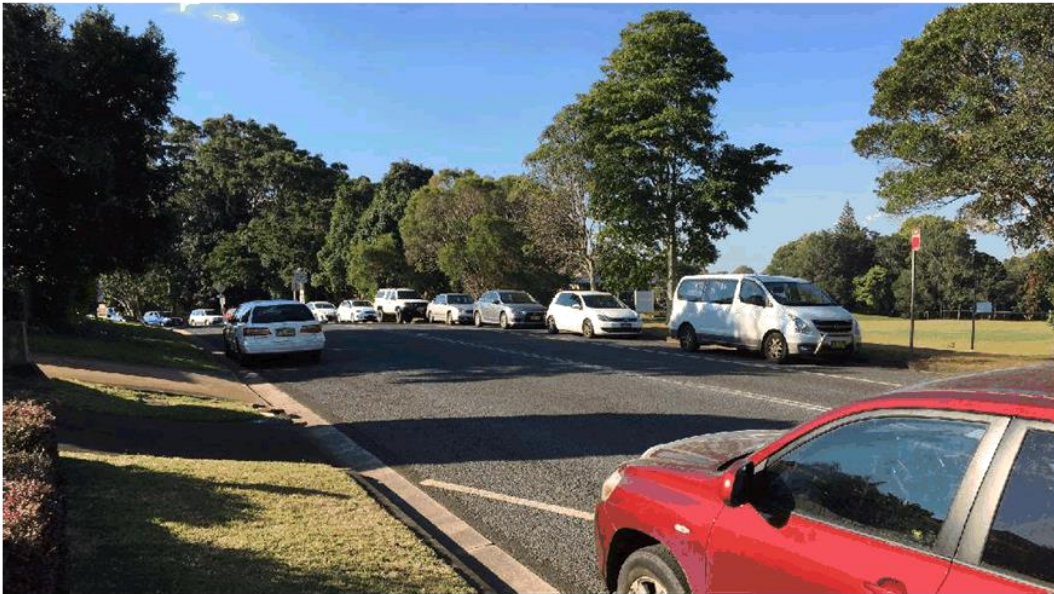
**Photo No. 4: Location 1 PM: Parked vehicles, view to the North**

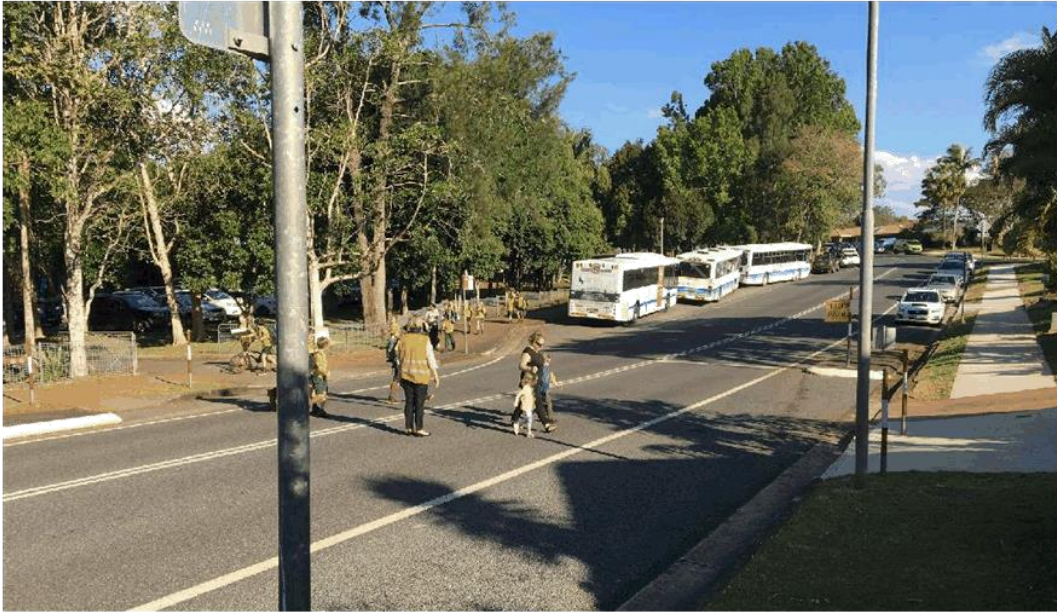
**Photo No. 5: Location 1 PM: Buses in bus zone and supervisor at crossing, view to the South**

- It was noted that the crossing supervisors observed during the afternoon audit did not have a 'Stop – Children Crossing' sign. Such a sign would increase the visibility for vehicles approaching over the crest from the north by adding height when pedestrians are crossing.

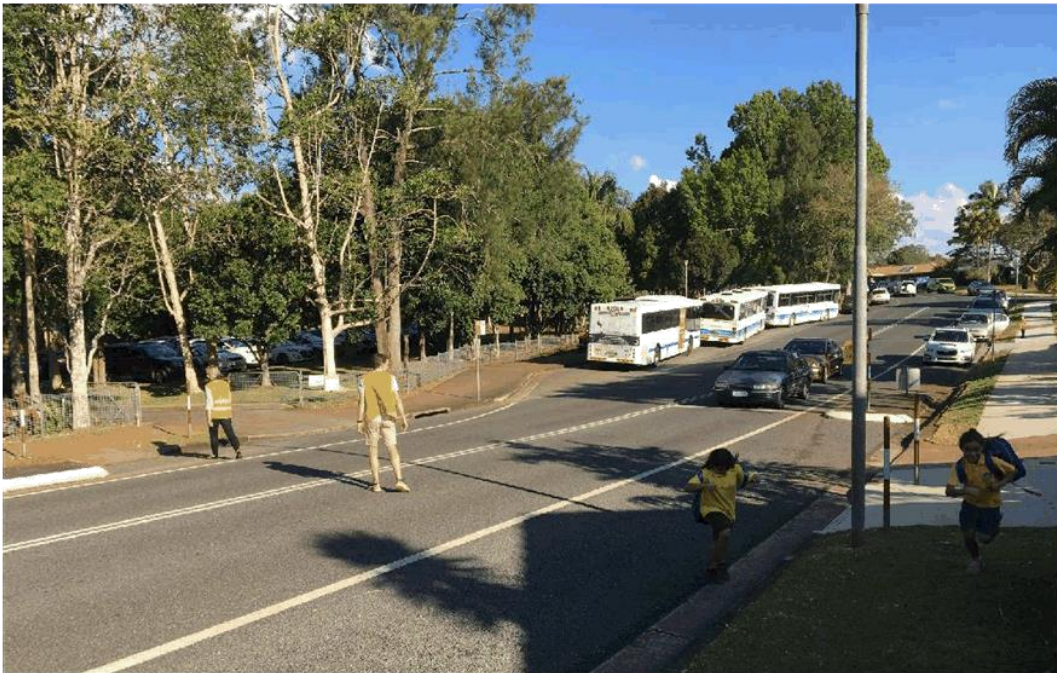
**Photo No. 6: Location 1 PM: Buses in bus zone and supervisor at crossing, view to the South**

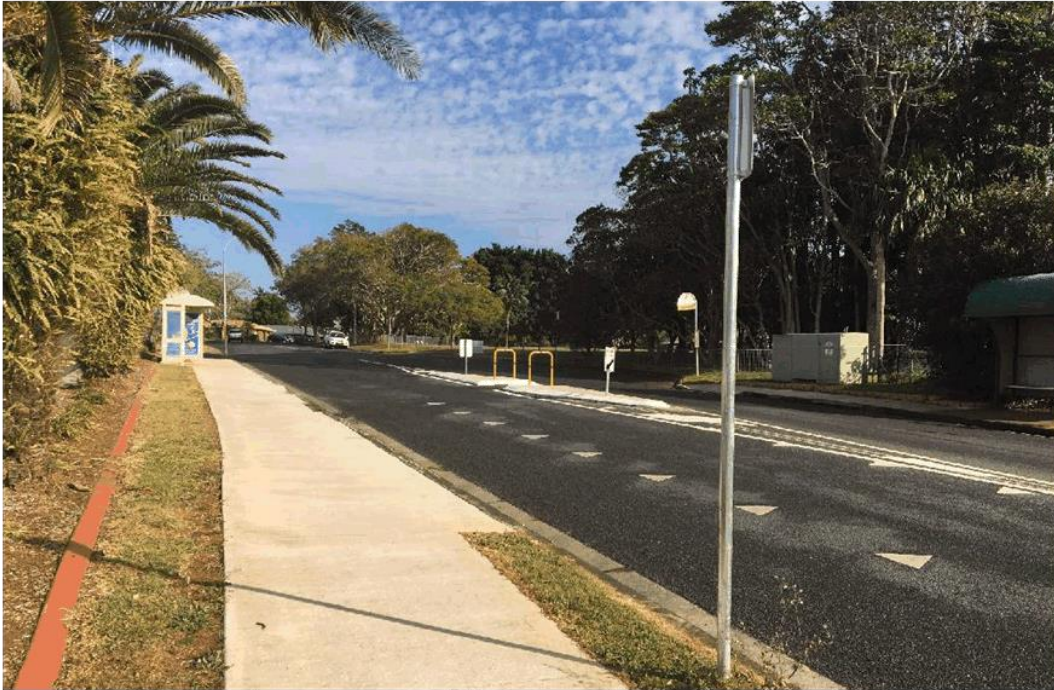
**Photo No. 7: Location 2 AM: Footpath, bus zones and pedestrian refuge, view to the West**

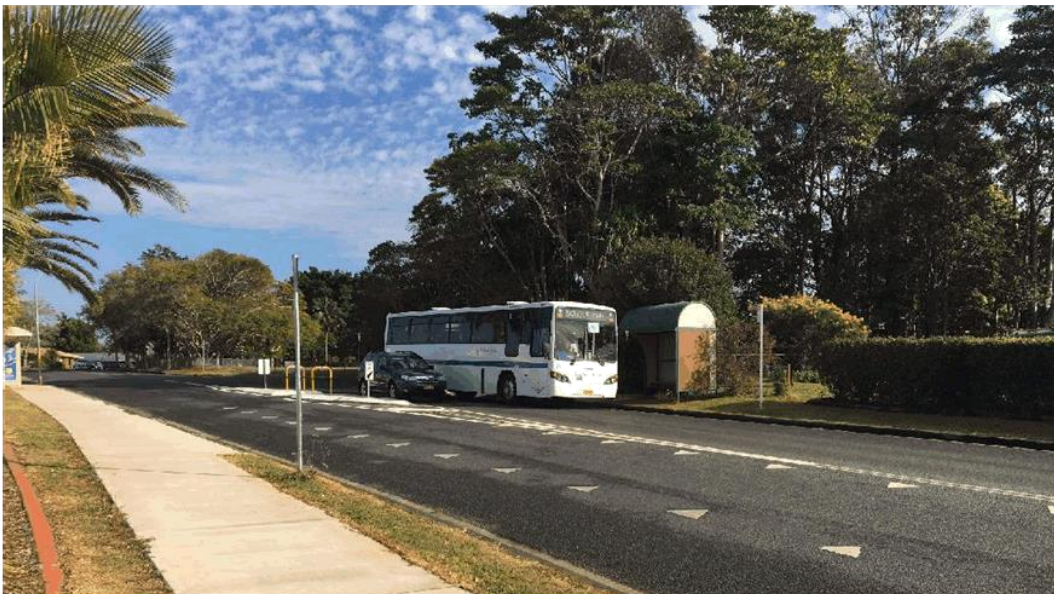
**Photo No. 8: Location 2 AM: Bus at shelter with car passing, view to the West**

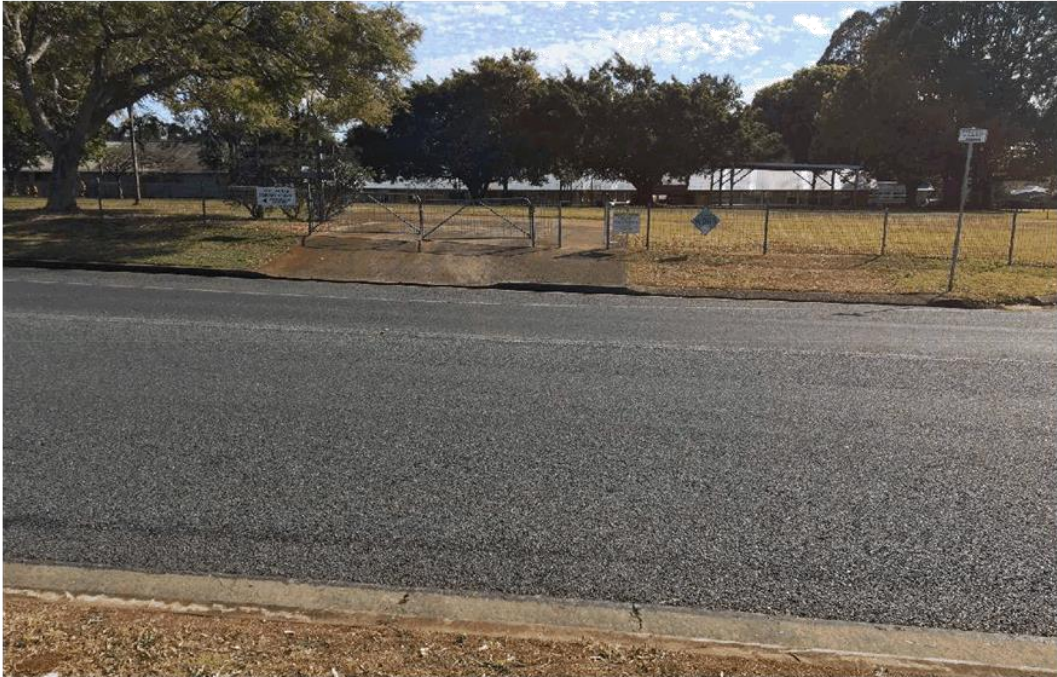
**Photo No. 9: Location 2 AM: Playground gate, view to the North**

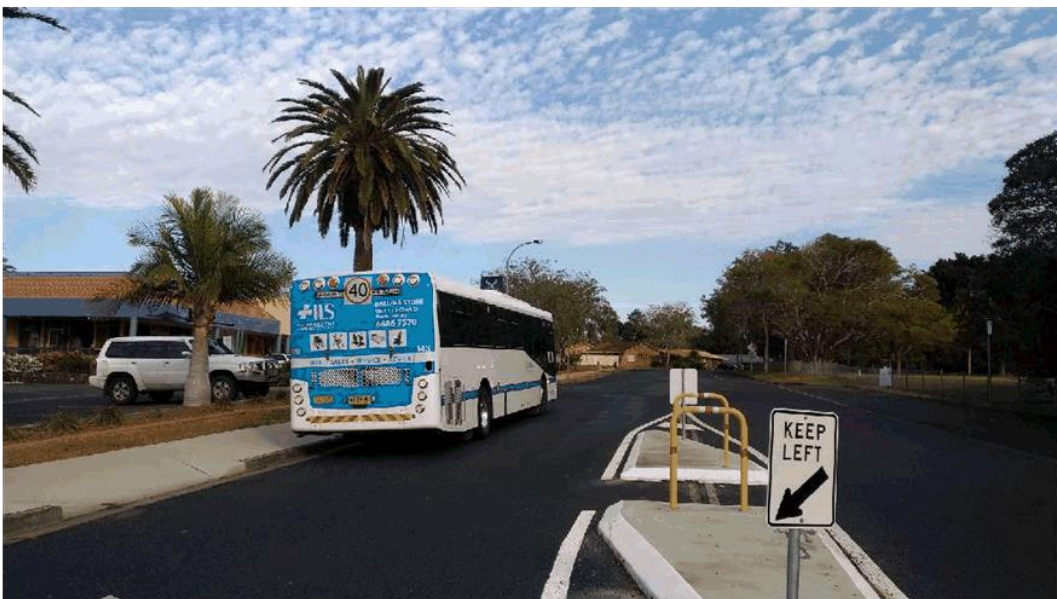
**Photo No. 10: Location 2 AM: Bus at bus stop with space for vehicles to pass, view to the West**

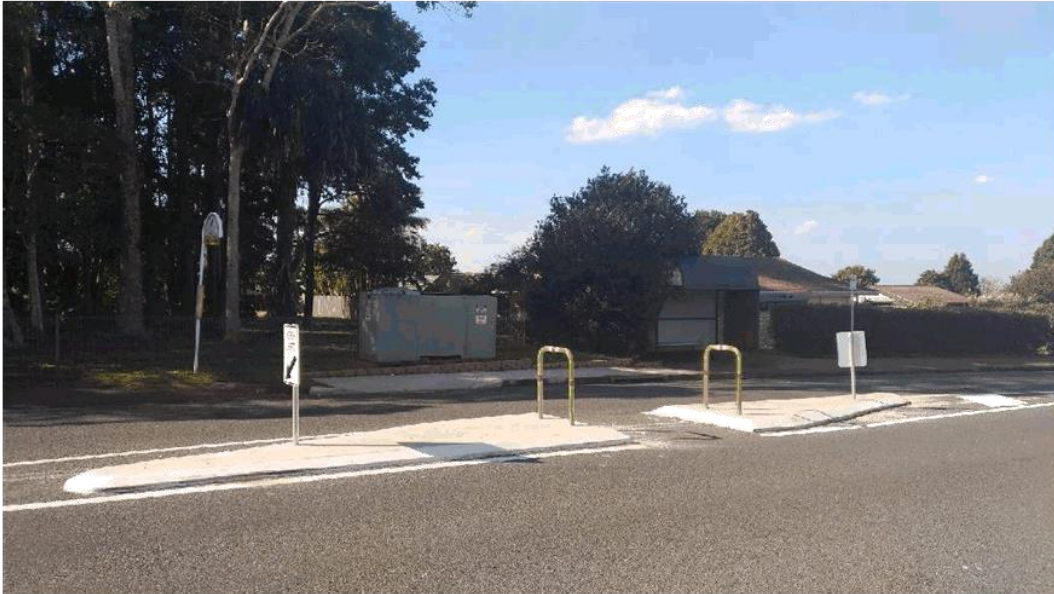
**Photo No. 11: Location 2 PM: Pedestrian refuge and bus shelter, view to the East**

- White painted pavement markings are recommended to designate priority at the driveway entrance to the school staff parking area.
- The location of the pedestrian refuge in Location 2 appears to be chosen to serve pedestrians crossing between the shopping centre or tavern on the southern side of Simpson Avenue and the bus shelter on the northern side. However, the location is too far from the school gate in Location 2 to be sufficiently convenient to serve the majority of pedestrians associated with the school. Relocating or extending the refuge to align with the school gate would cause problems for right-turn manoeuvres into and out of the driveways within Location 2. Thus it is recommended that a children's crossing is established at the school gate, similar to the crossing at Location 1, including two small blister islands and appropriate signage and pavement markings.

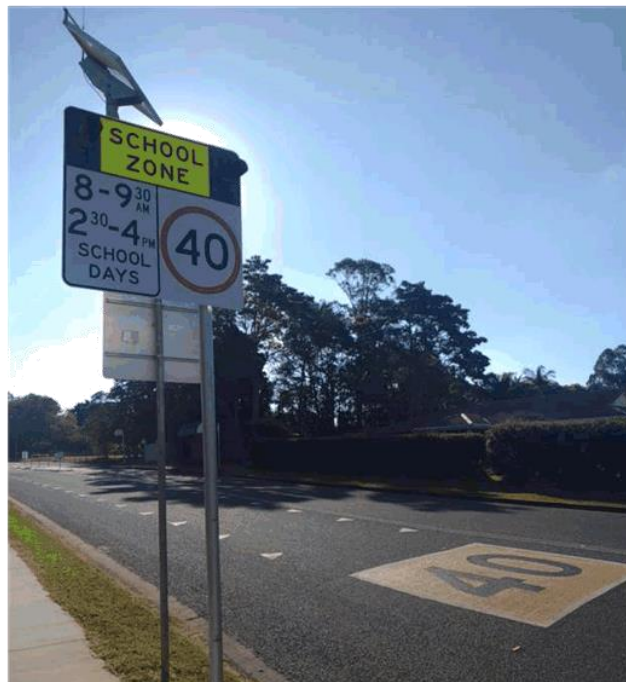
**Photo No. 12: Location 2 PM: School zone signage, view to the West**

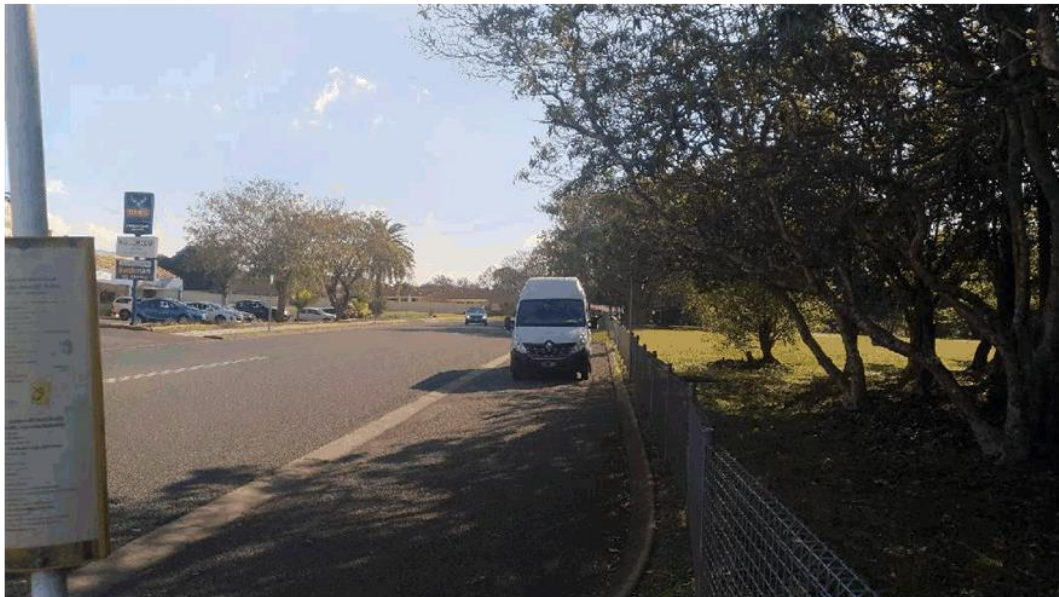
**Photo No. 13: Location 2 PM: Bus zone and parallel parking area, view to the West**

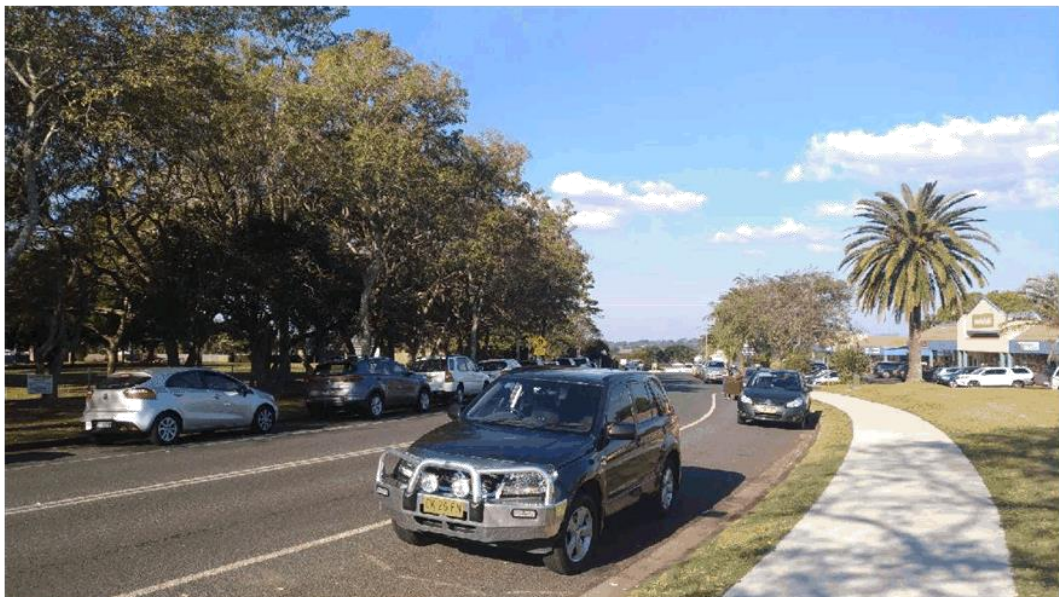
**Photo No. 14: Location 2 PM: Parked vehicles, view to the East**

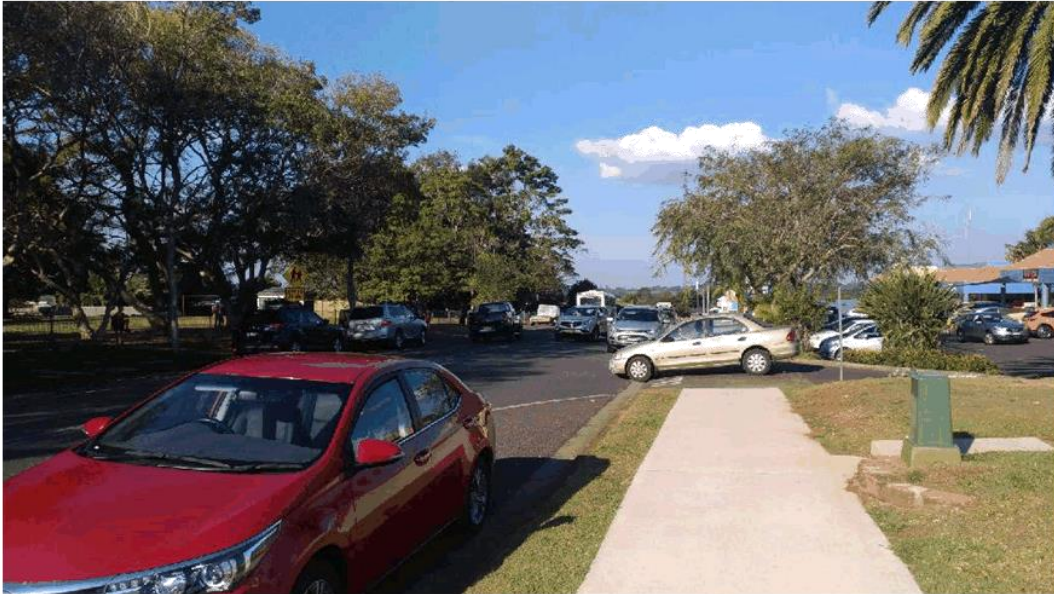
- At Location 2, parked vehicles east of the shopping centre's western exit severely limited the sight distance for motorists exiting the car park and there were a number of near-collisions observed.

**Photo No. 15: Location 2 PM: Limited sight distance for vehicles exiting car park, view to the East**

- Prohibiting parking on the southern side of Simpson Avenue along the 40m stretch between the western and central driveways to the shopping centre/tavern (or part thereof) is recommended to significantly improve the available sight distance for vehicles exiting the shopping centre/tavern from the western-most driveway.

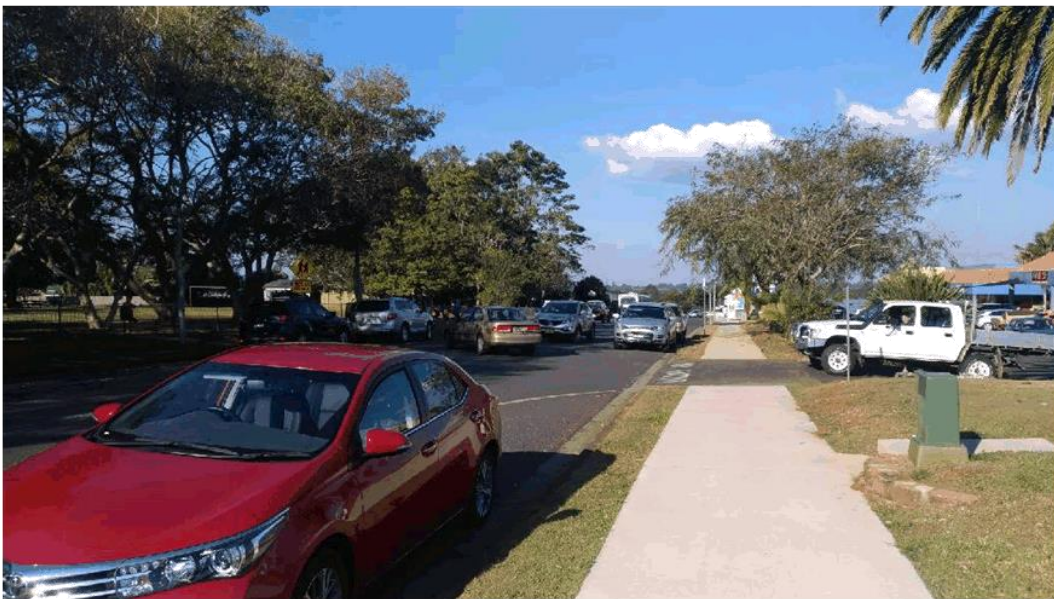
**Photo No. 16: Location 2 PM: Near-collision for vehicle exiting car park, view to the East**

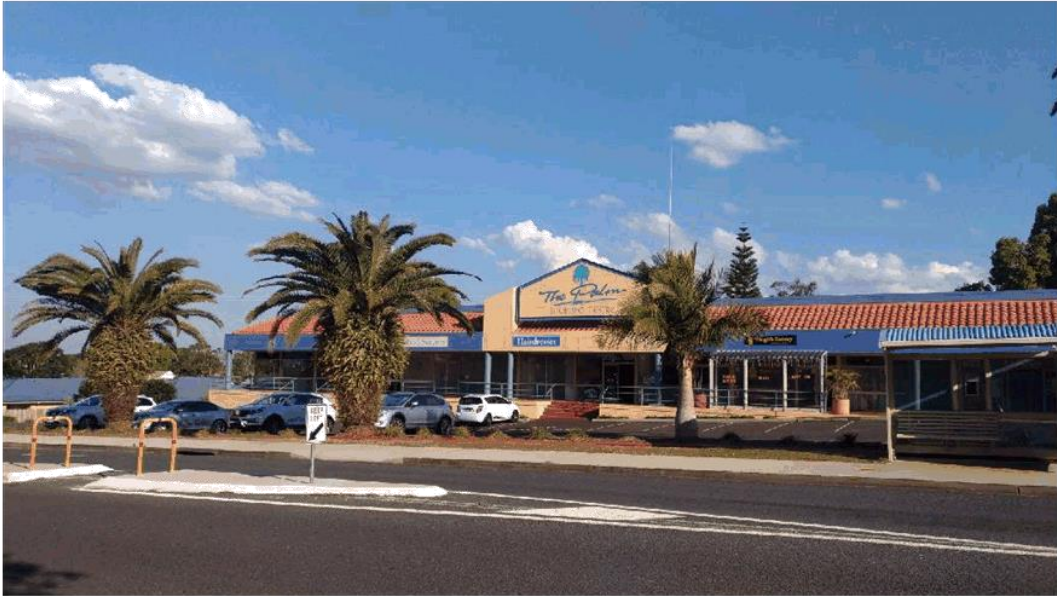
Photo No. 17: Location 2 PM: The Palm Shopping Centre, view to the South

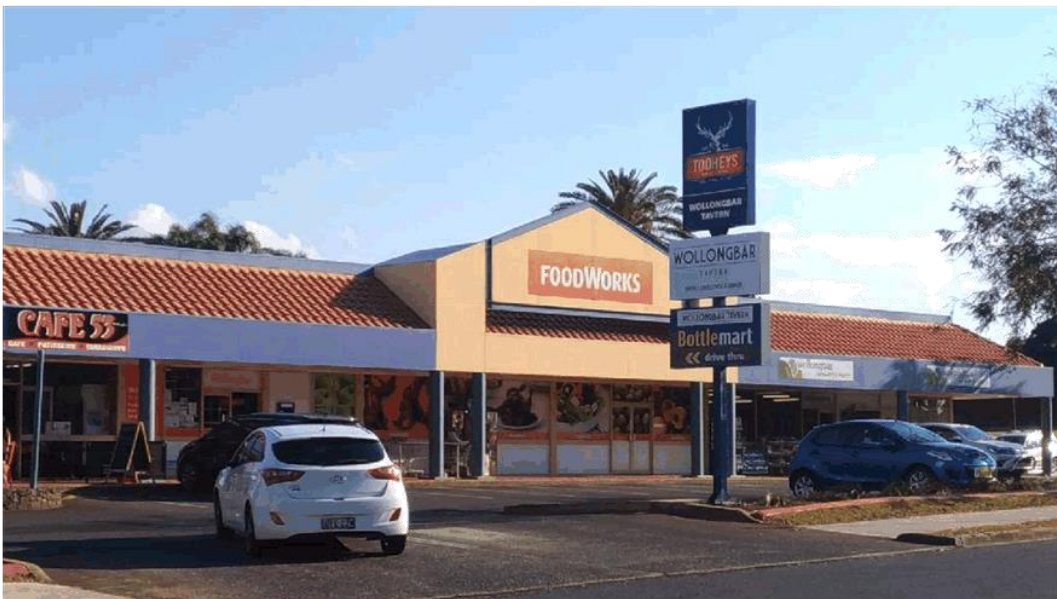
Photo No. 18: Location 2 PM: Foodworks Shopping Centre, view to the South
