Killen Falls Plan of Management

Part A

Prepared for Ballina Shire Council

8 June 2017

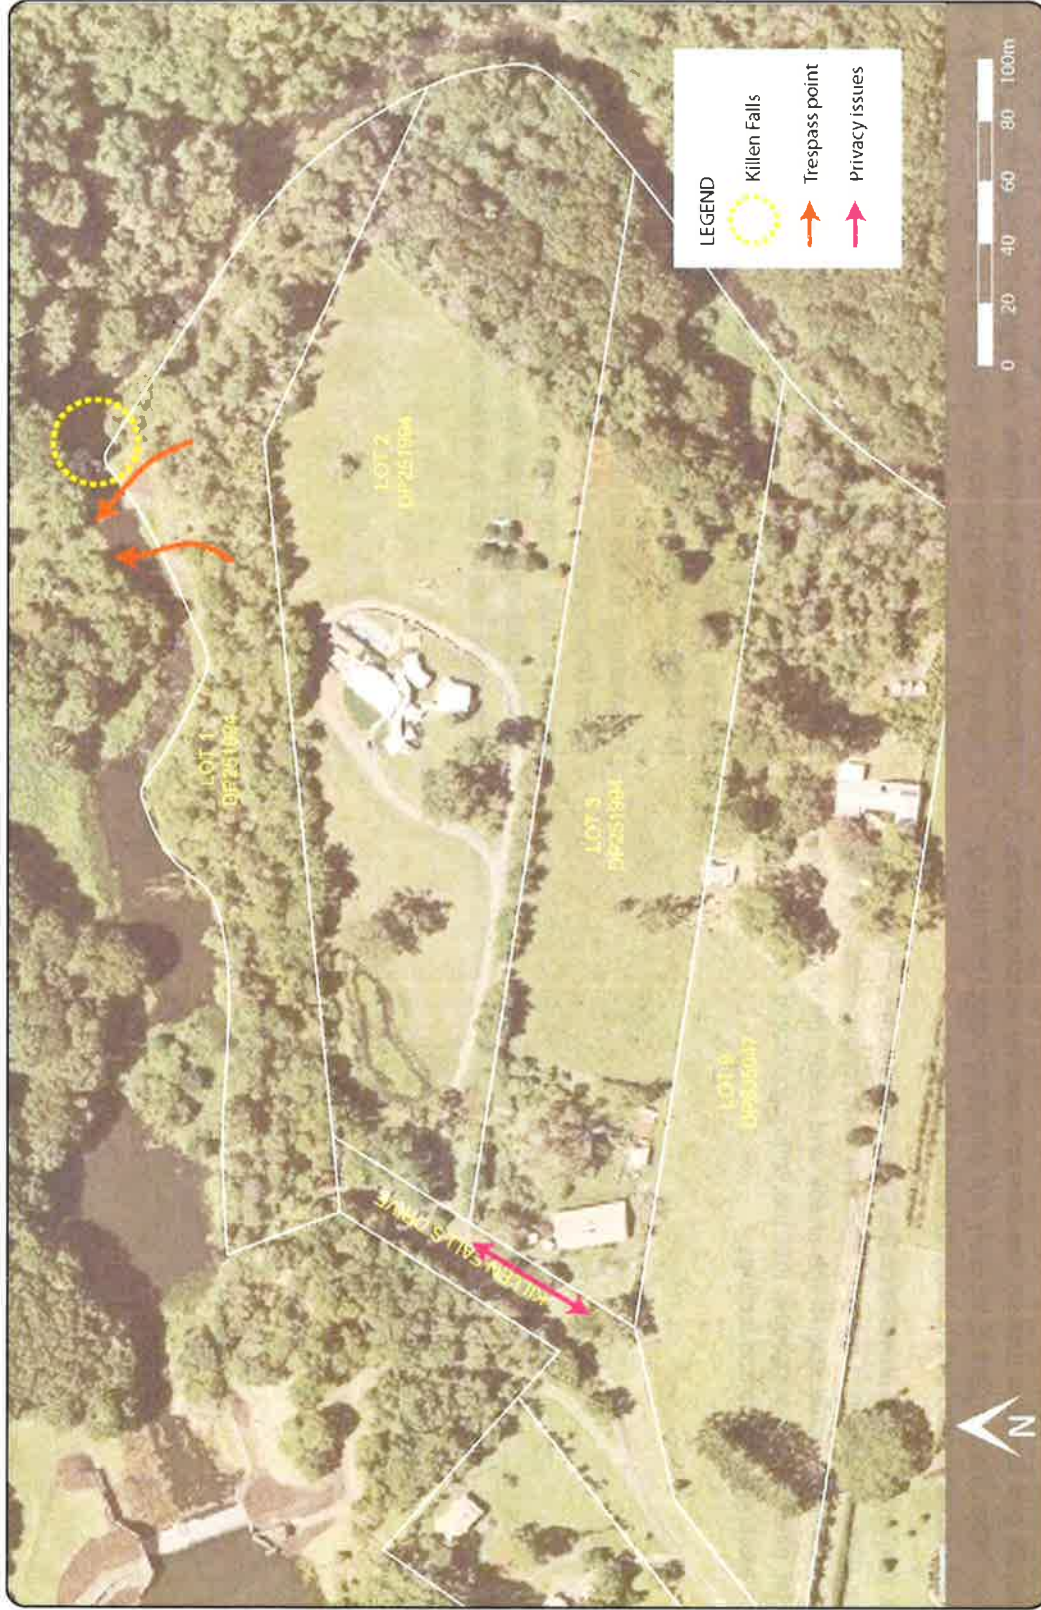
Figure 7: Trespass and privacy issues related to accessing Killen Falls

Trespassing to the northern side of Emigrant Creek has been an issue. Better fencing of the track to the viewing platform, with clear signage asking people to stay on the track should assist with this. The gap beside the viewing platform, which still allows access on to the top of the falls (and the other side), also needs to be blocked off and signposted.

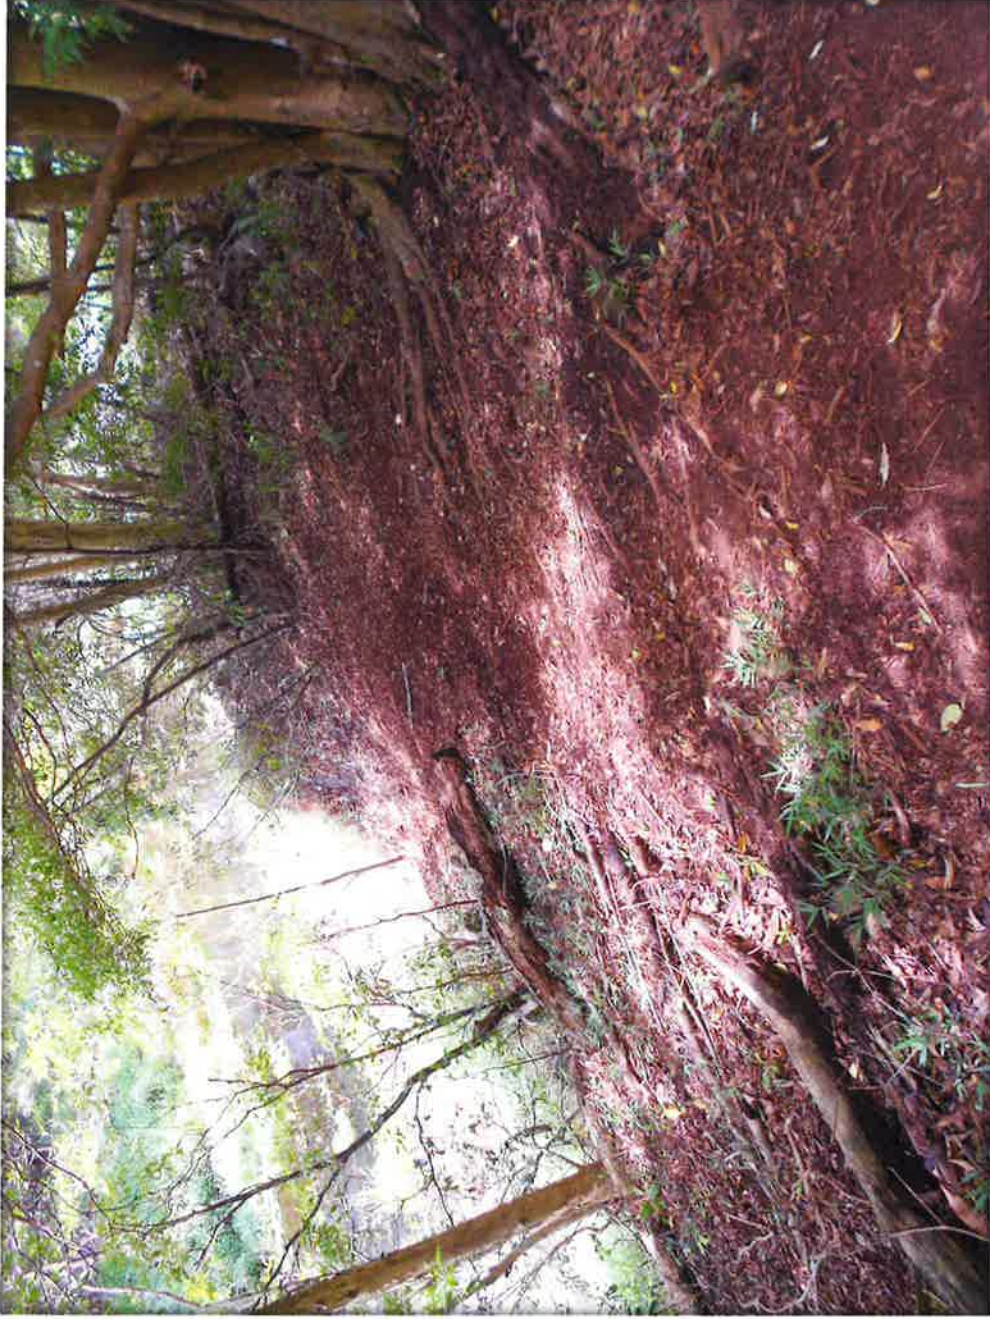
Figure 4: Side track to creek that needs to be fenced and signposted

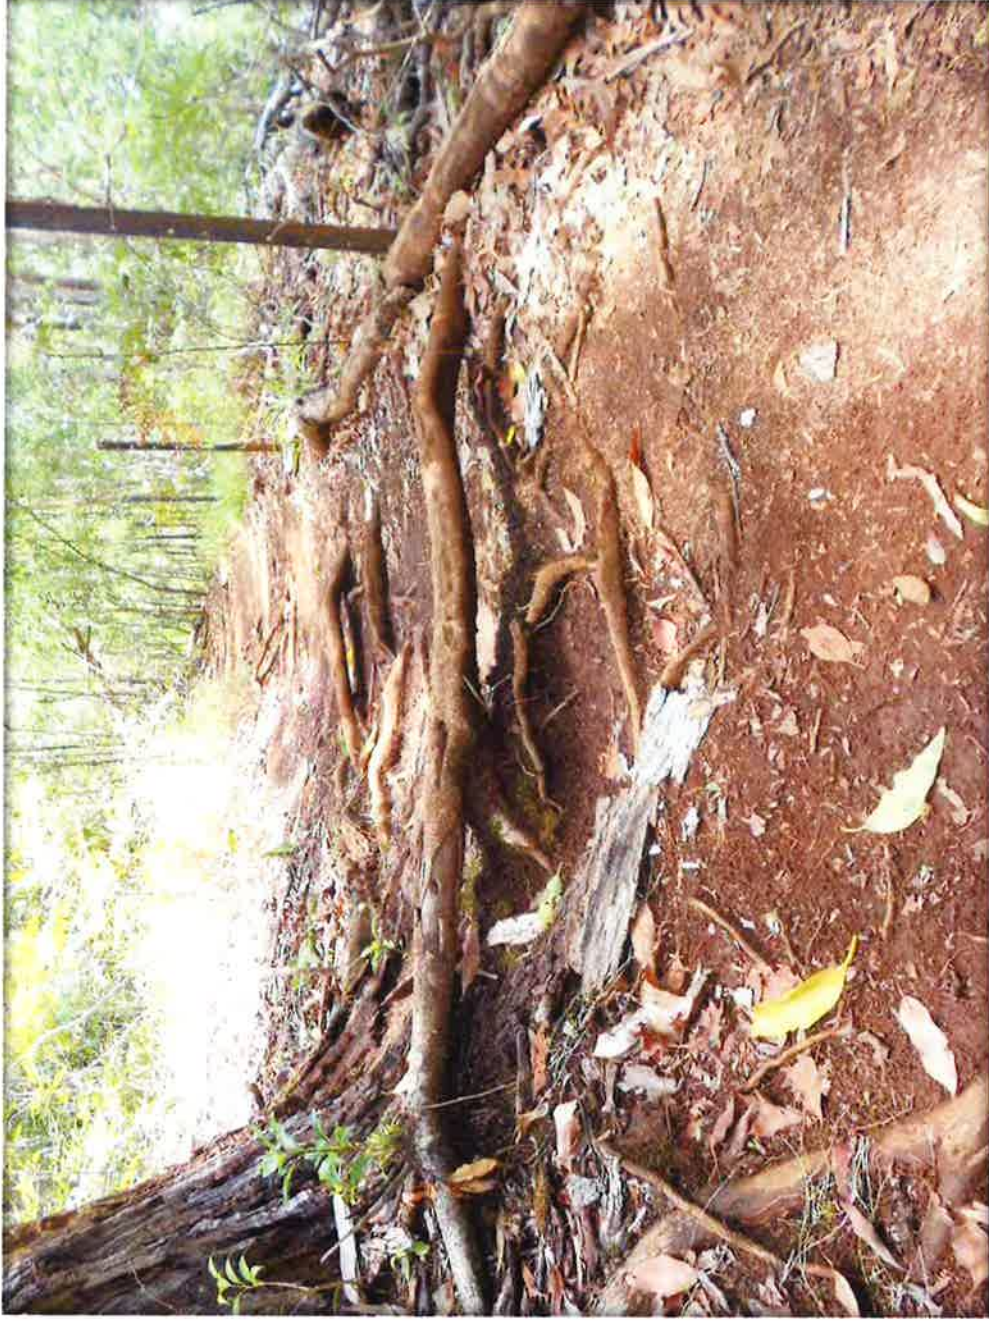
The track to the viewing platform is in fairly poor shape. It is compacted earth and therefore slippery when wet. The track is heavily affected by surface tree roots, which present a trip hazard in many spots. It is not properly fenced along parts of its length, which allows users to easily leave the track. A small gully overflow has been fixed with a short boardwalk and rocks for erosion control. It is recommended that this track be fenced from the car park to the viewing platform to stop 'rat runs' to the creek or private property and to protect rehabilitation areas. It should also be signposted, asking people to stay on the track for environmental reasons. The track should be up to 1.2 metres wide, fully constructed along its current alignment, with no substantial vegetation clearing. It should be a crushed rock surface with timber edge to contain the material or *Geohex* if it is cost effective. The goal should be to upgrade the track to Australian Walking Track Grading System (Part B – Appendix F) Grade 2 – “No bushwalking experience required. The track is hardened or compacted surface and may have a gentle hill section or sections and occasional steps. Walks no greater than 10km.”

Figure 11: Heavily used track has significant trip hazards

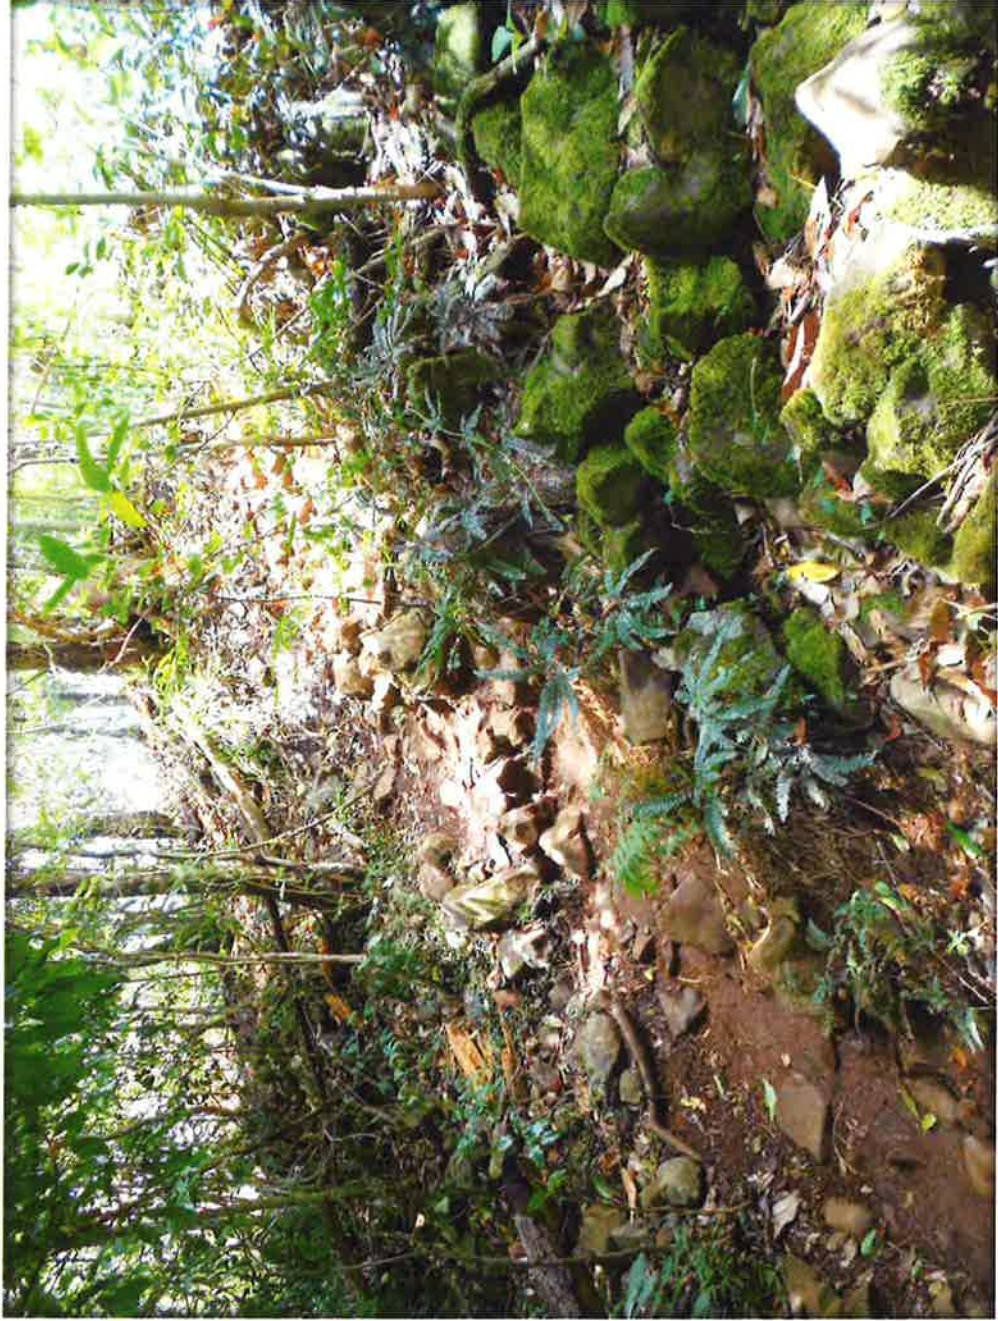
Figure 14: Track to creek is steep, rocky and has no hand holds

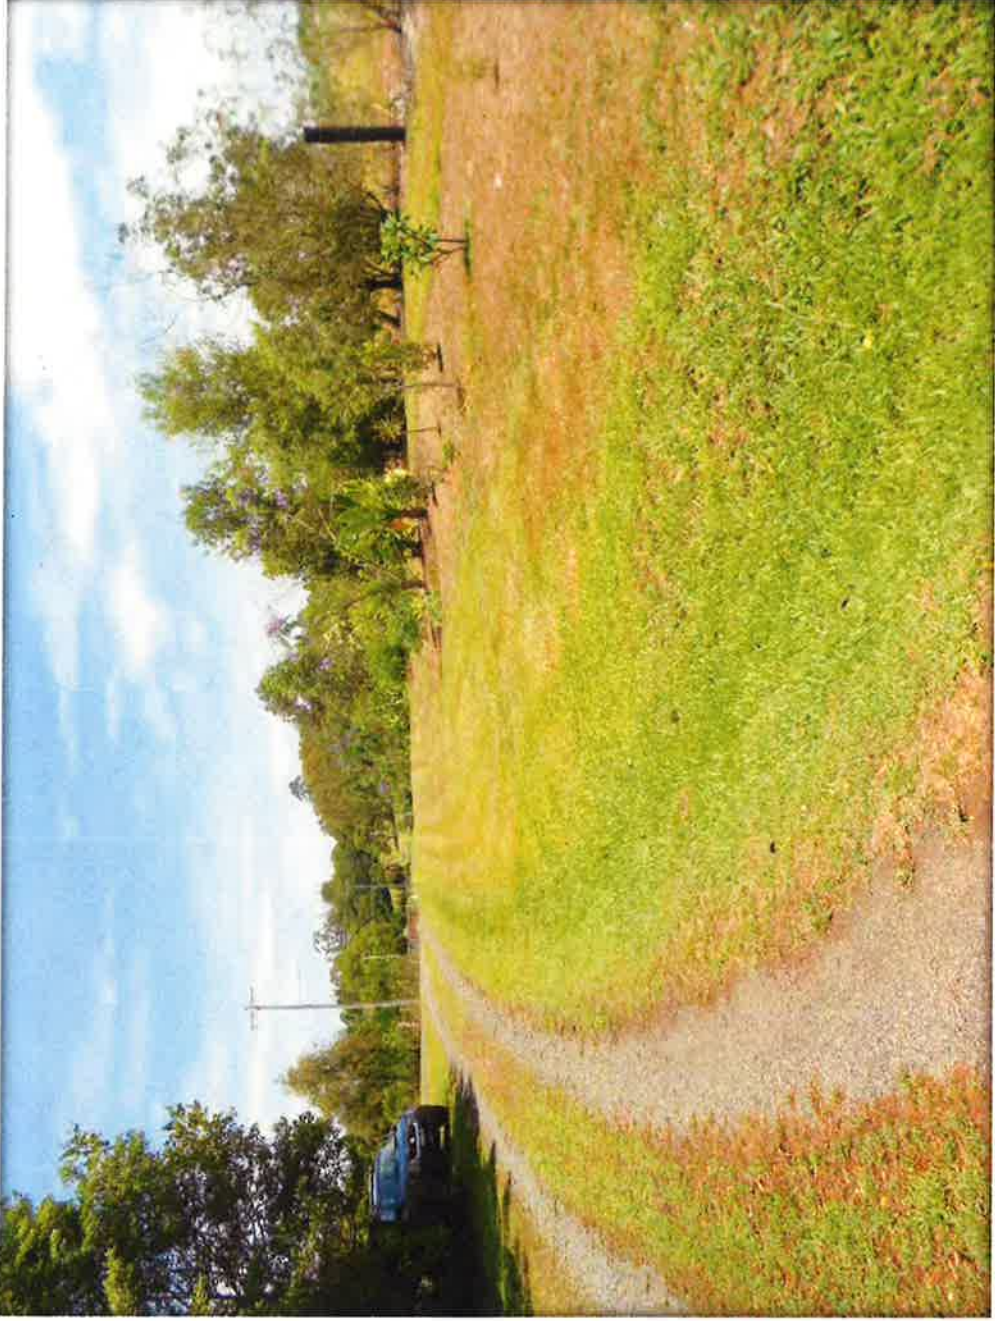
Overflow parking occurs in unmarked parts of the road reserve south of the car park, along Killen Falls Drive. Parts of the verge have been damaged by this action and this needs to be addressed. Permeable products such as “Geohex” can be easily laid in the road verge at signposted locations to provide overflow parking that can still be mowed, is permeable to rainfall, and retains the look of a rural road verge rather than a large car park. These areas should be located along Killen Falls Drive in locations where the road reserve is wide enough. These overflow areas could also be used by any buses that access the site, to prevent them driving into a full car park. Figure 8 shows the location of the suggested car park improvements. No land acquisition is required to achieve the overflow parking.

Figure 16: Parking overflow area on western side of Killen Falls Drive
