Our Ref: L.A10061.003.docx

5 May 2020

RE: BALLINA QUAYS

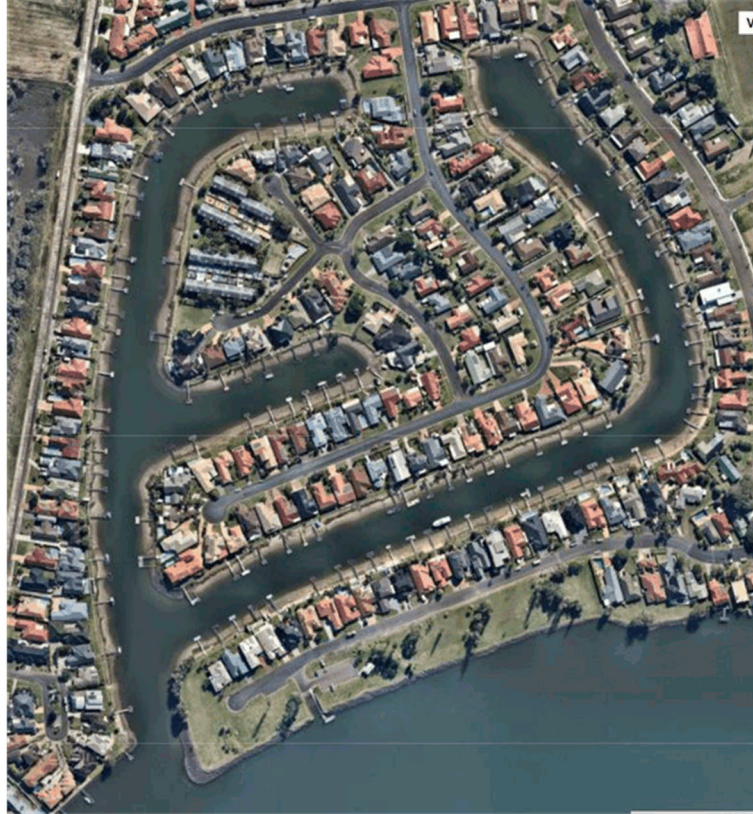
- Longshore transport is evident along the canal adjacent to Burns Point Ferry Road e.g. scalloped beaches and sand buildup at stormwater outlets, and is most likely due to wind fetch across the river and possibly boat wake;
- There is little evidence of longshore transport in the other canals as evidenced by relatively straight beaches;
- Therefore, the consistent revetment line approach is most appropriate for the Burns Point Ferry Road canal.

Figure 1 Ballina Quays Overview (Nearmap 11 June 2019)

In conclusion, this review has found that evidence of longshore transport is present along the Burns Point Ferry Road canal but not in the secondary canals. Profile flattening appears reasonably consistent throughout the system. Therefore, it is recommended that a consistent revetment alignment of 2m from the kerb be maintained for the straight section of the Burns Point Ferry Road canal. For the secondary canals a consistent revetment alignment is not as critical, however significant extension past the 2m alignment may involve more formal revetment design considerations and some loss of equity where major variations between adjacent blocks causes aesthetic issues.

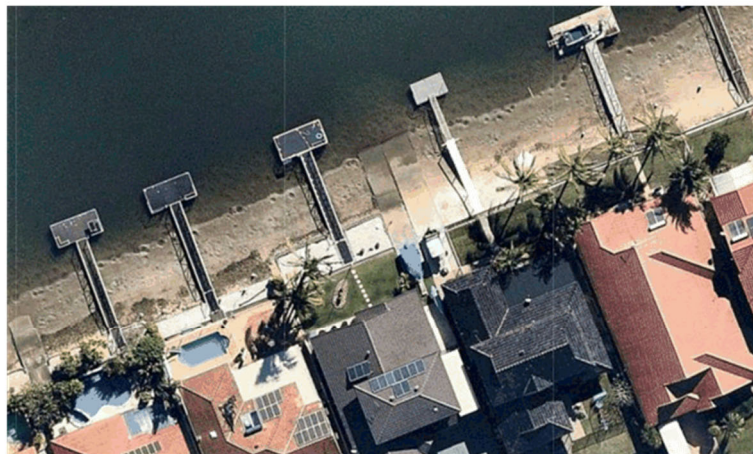
- The prominent quay line is unlikely to affect the beaches on adjacent properties due to the absence of appreciable longshore sand transport;
- There is likely to be a restricted usable beach width at the property and the existing scarp may deepen as the bank slope flattens. If future maintenance is delayed beyond the normal 5 years this may result in undermining of the revetment;
- It is noted that the Engineer's reports say the previous timber wall was built around 2014, however it was located 4.4m from the kerb which appears in contravention to the 25-8-1999 Council resolution.

Figure 2 135 Riverside Drive (Nearmap 11 June 2019)
