Notice of Commercial Services Committee Meeting

a Commercial Services Committee Meeting will be held in the Ballina Shire Council Chambers, 40 Cherry Street, Ballina on **Tuesday 18 February 2014 commencing at 4.00 pm.**

4.2 Ballina Naval Museum - Deteriorating Asbestos Cladding

Asbestos Report

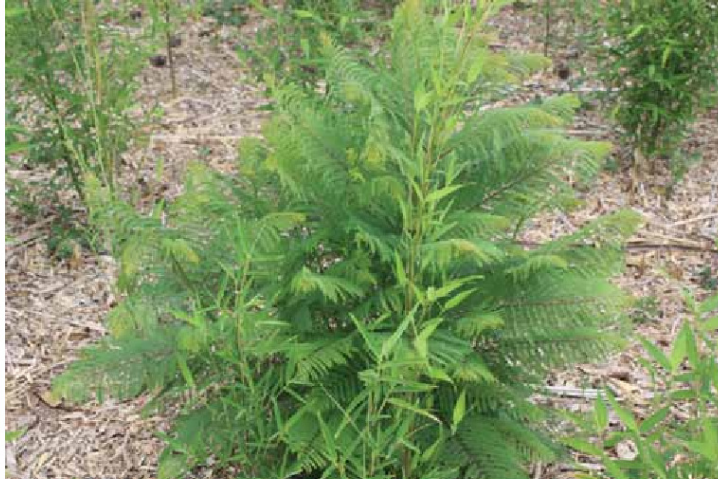
Plate 1 Bamboo and Jacarandah regrowth

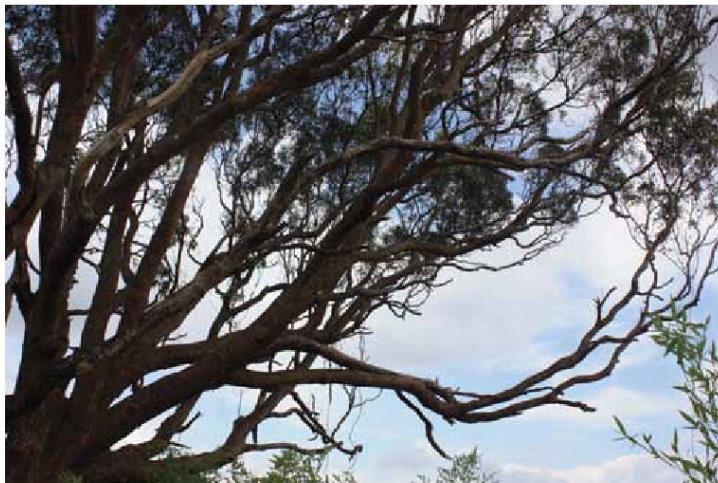
There are approximately 20 branches from 75 to 200mm that have died (see Attachment 2. Plate 2). It is considered likely that the competition from the bamboo has contributed to the death of the branches. There is some sunburn and decay in the tops of 3 major branches. The decay area has occluded and the damage to the branches is stabilizing (see Attachment 2. Plate 3).

Plate 2 Dead branches in the crown

If the tree is retained it is recommended that the dead branches be pruned off in accordance with the Australian Standard AS4373-2007 Pruning of amenity trees. The aesthetic appeal of the tree will be enhanced by the removal of the dead limbs. The pruning should be carried out by an arborist qualified to a minimum AQF 3. The bamboo regrowth in the TPZ should be poisoned with a herbicide that will not persist in the soil and in such a way as to minimize any damage to the root system of the tree.

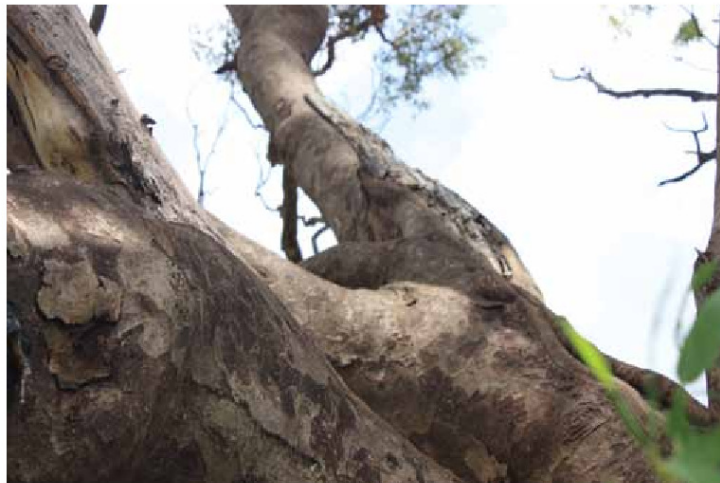
Plate3 Sunburn and decay on the tops of 3 major branches

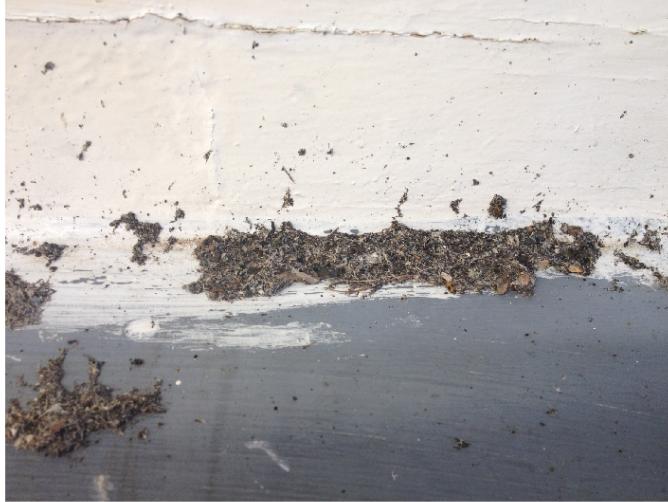
Photograph 3: Asbestos contaminated debris to south elevation top of S.V Richmond (Vessel)

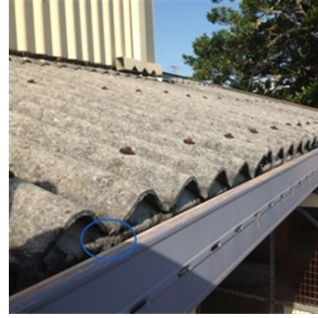
BNM 13 Roof on original section

Super six northern side, photo taken of lower roof, evidence of loose fibre

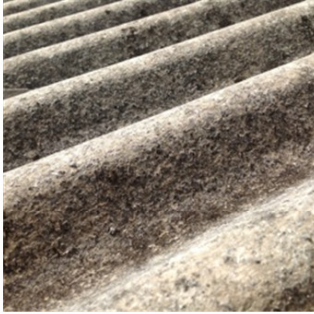
BNM 11 Roof on original section Northern side

Lichen small pieces of acm 50mm x12mm broken off, most of roof intact. Roof is not painted & subject to further deterioration

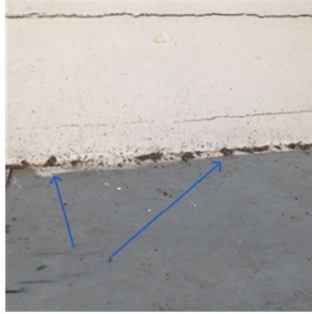
BNM 2 Top of PV Richmond

Friable acm on top of Richmond board sourced from adjacent roof. Residual friable acm was removed by dingo demolition 12 months ago, then sprayed with pva.

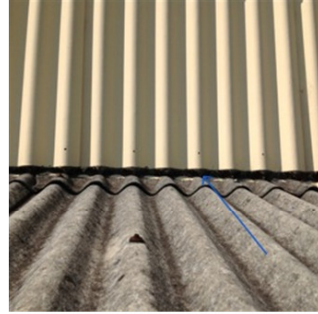
BNM 3 Wall & Roof Northern side

Deterioration at base of wall, evidence of friable acm and lichen

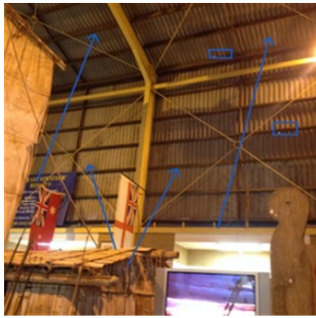
BNM 7 Walls & Roof Internal new section

AcM wall not lined, 2 small holes, 1 in ceiling, 1 in wall, most likely due to hail damage.

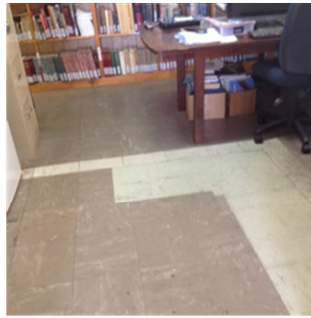
BNM 8 Internal office vinyl floor tiles

Vinyl floor, potential acm in adhesive within office, 20sqm approx.

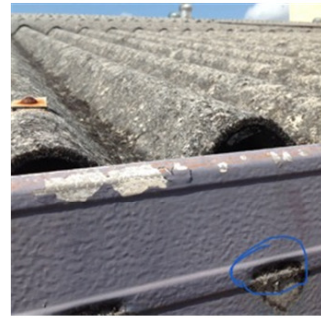
BNM 9 Roof of old building, north east

Deteriorated unpainted acm, evidence of friable acm, breaking through weep holes in metal guttering

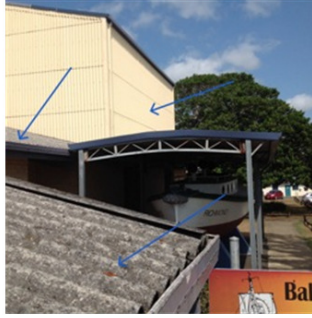
BNM 11 MV Richmond

The MV Richmond is Located under metal carport adjacent to acm roof. Friable asbestos is being washed off the adjacent asbestos roof onto the top of the MV Richmond.
