Killen Falls Plan of Management

Part B

Prepared for Ballina Shire Council

Adopted by Ballina Shire Council on 26 October 2017

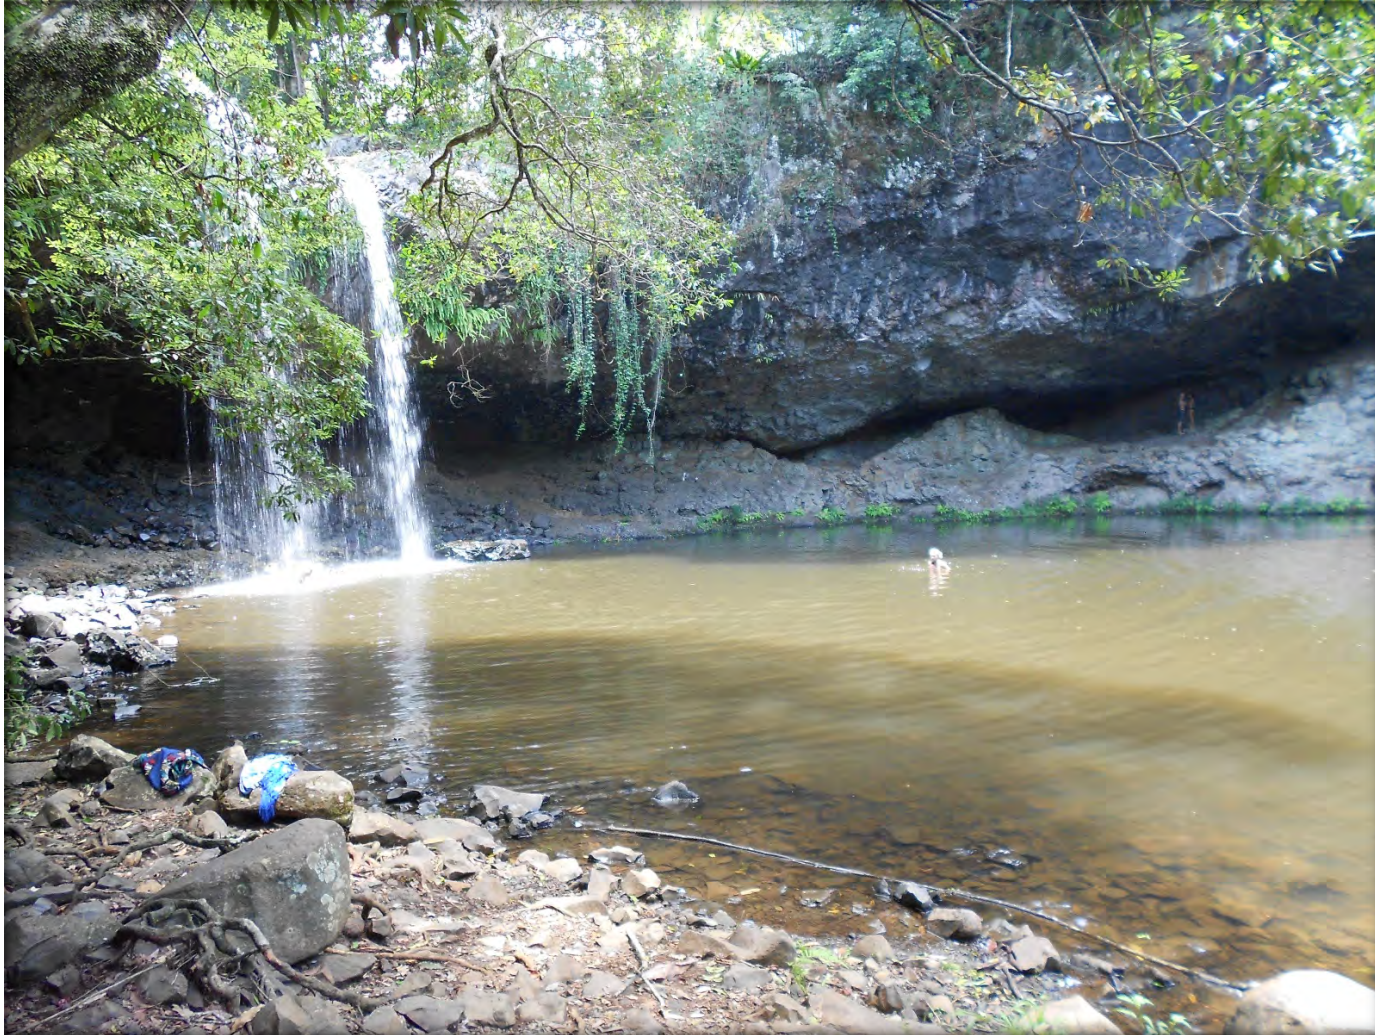
Figure 1: Swimming in the shallow pool is popular, despite the access and water quality

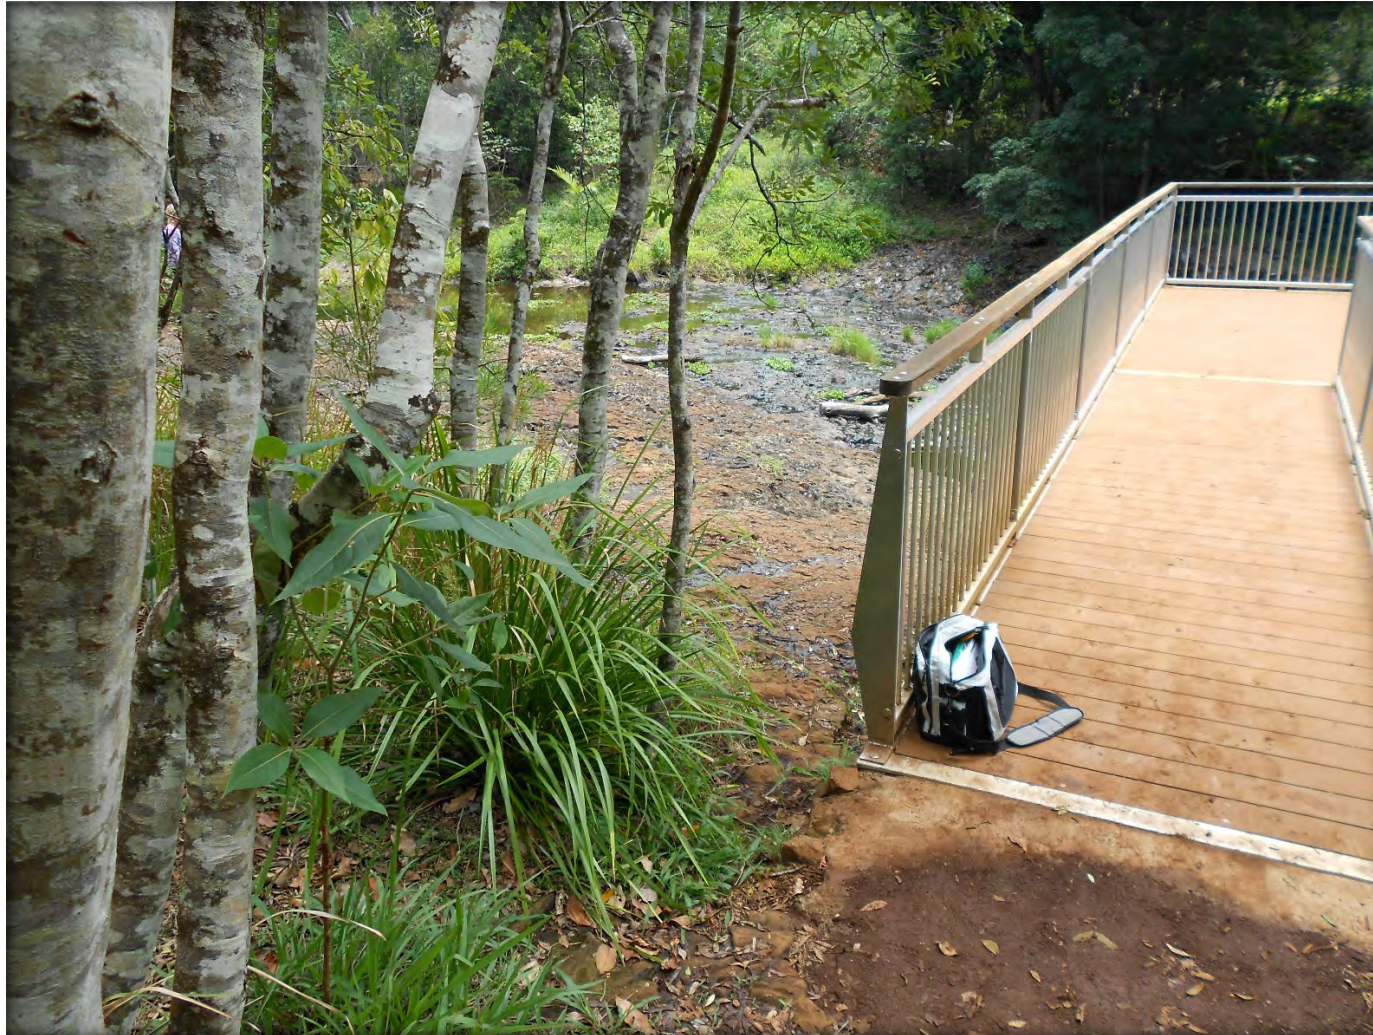
Figure 3: This gap next to the viewing platform needs to be fenced and signposted

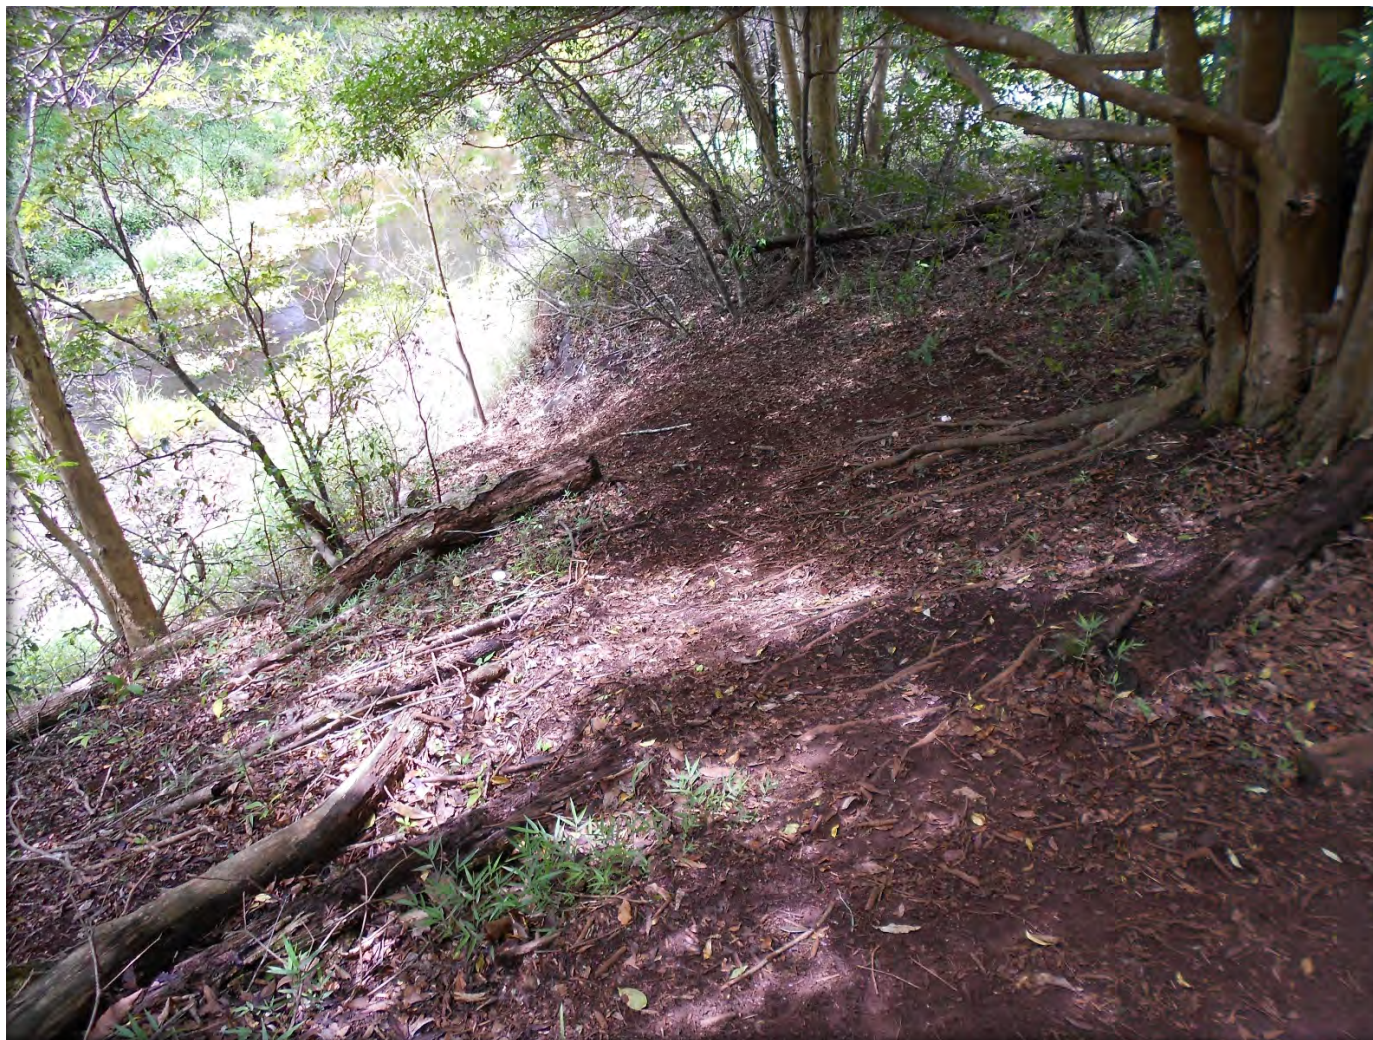
Figure 4: Side track to creek that needs to be fenced and signposted

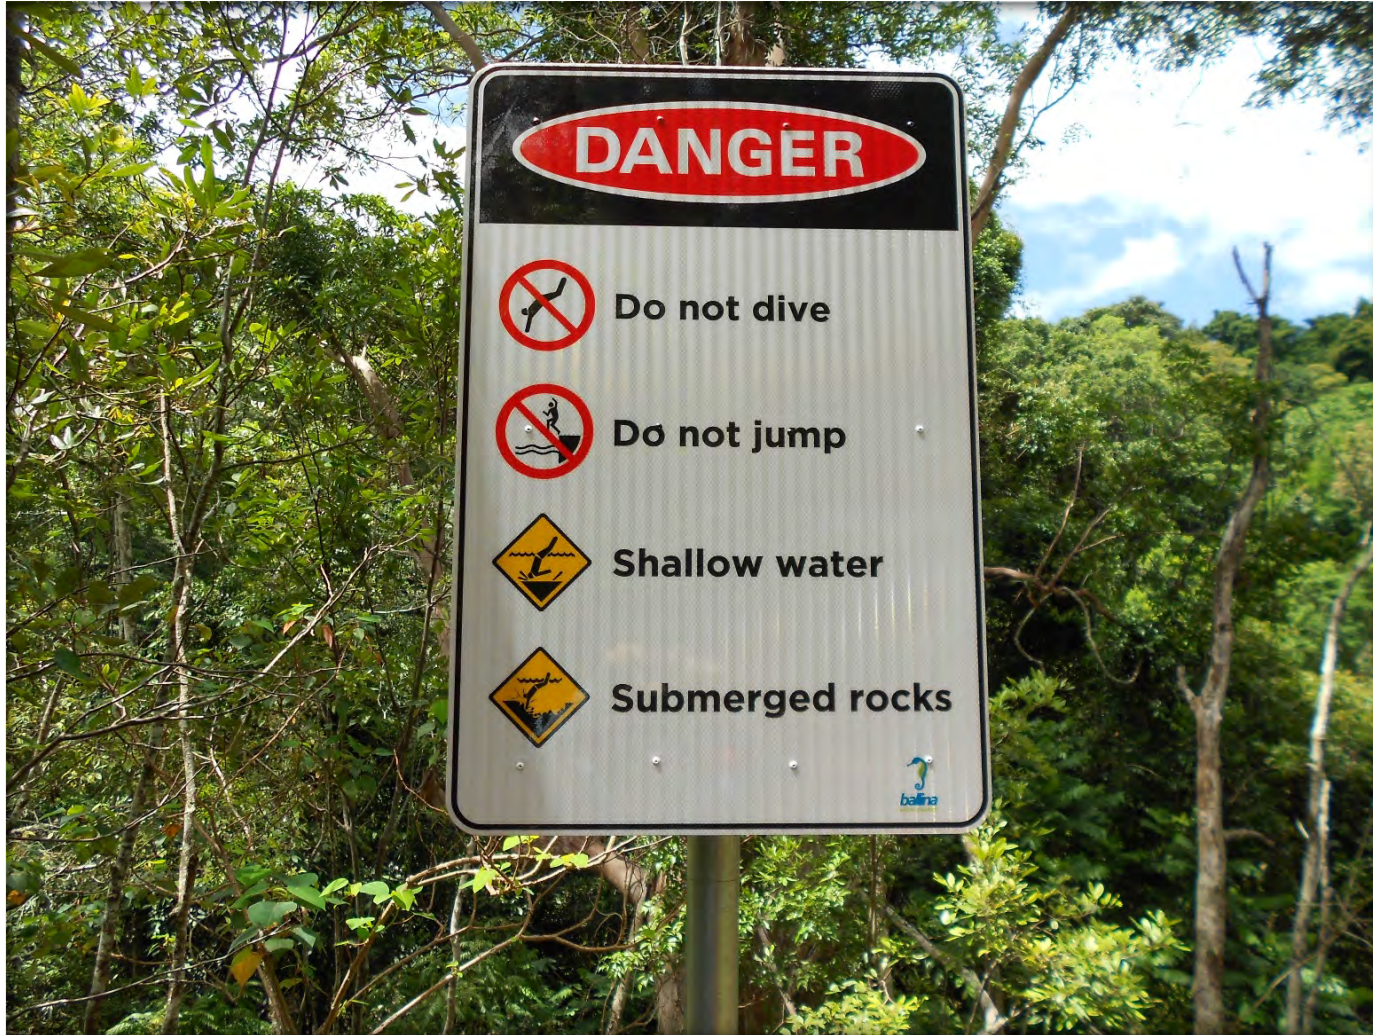
Figure 5: Safety sign that needs to also warn about water quality and swimming

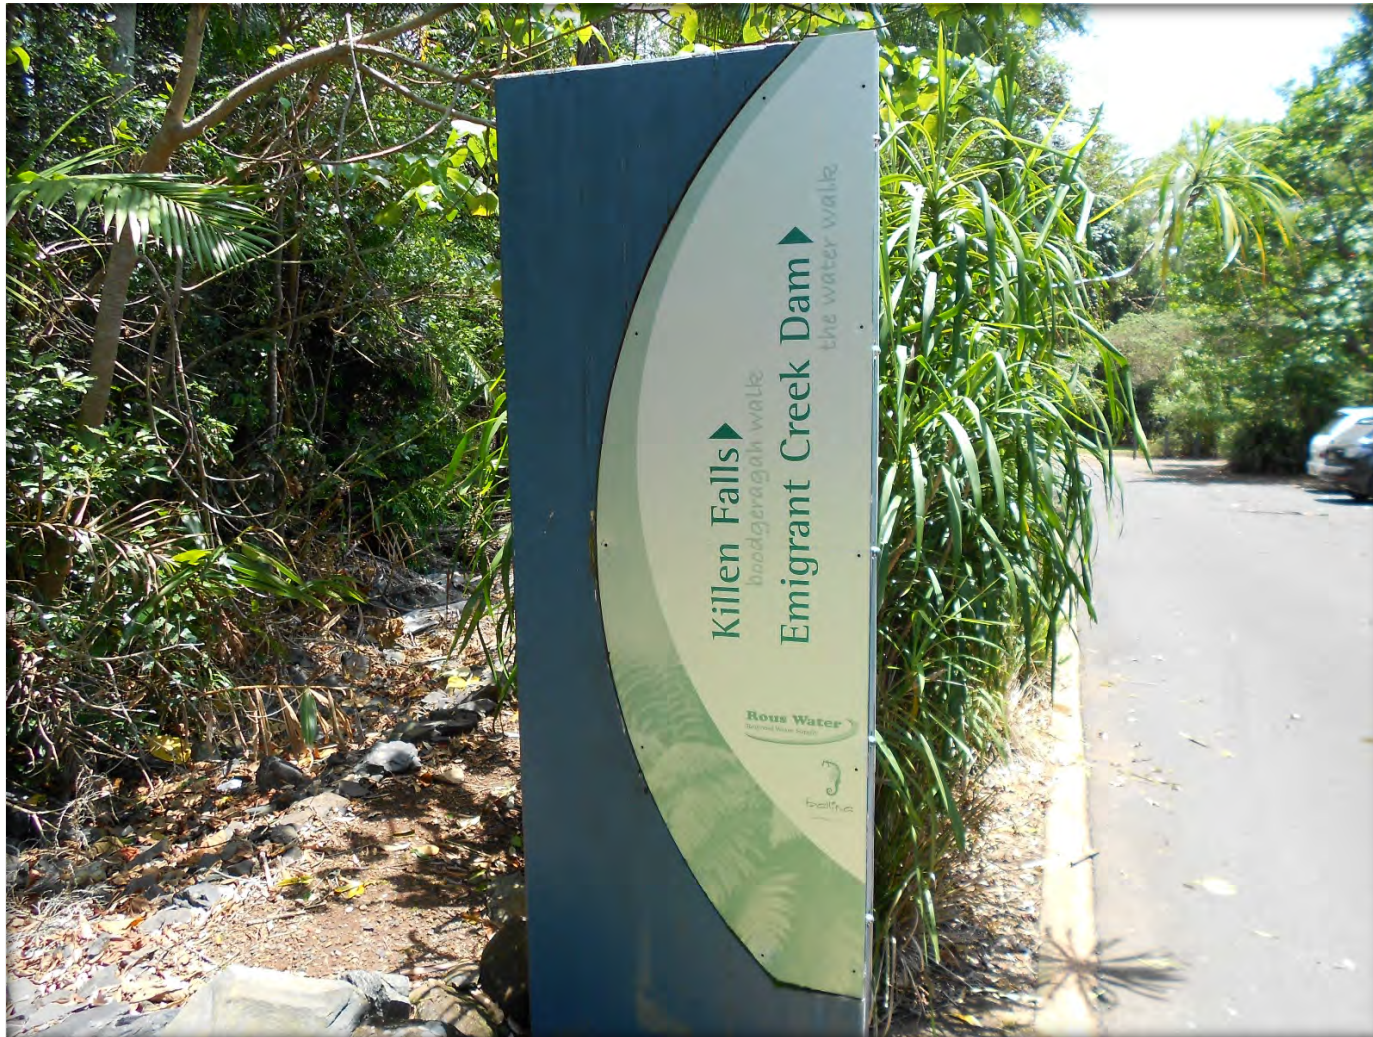
Figure 6: Existing signage has limited information

| Signage | <p>Council signs that warn or advise the public (in accordance with Australian Standards) cost \$250 per sign installed. These will be used for a variety of purposes and warnings including dogs and alcohol prohibited, swimming is not advised due to water quality, snakes, slips, trips and falls. Up to four signs are required for a total cost of \$1,000.</p> <p>Smaller signs advising visitors to stay on the track and protect the rainforest can be affixed with clips to the track fencing about every 50 metres on both sides. They cost approximately \$40 installed, and up to twelve are required from the car park to the viewing platform above the falls, for a total cost of \$480.</p> <p>Provision of signage at the northern end of the car park to identify the walk to the viewing platform and supply information regarding its suitability for different ages or abilities, as well as distances and hazards. Estimate is \$500 for one large information sign.</p> |

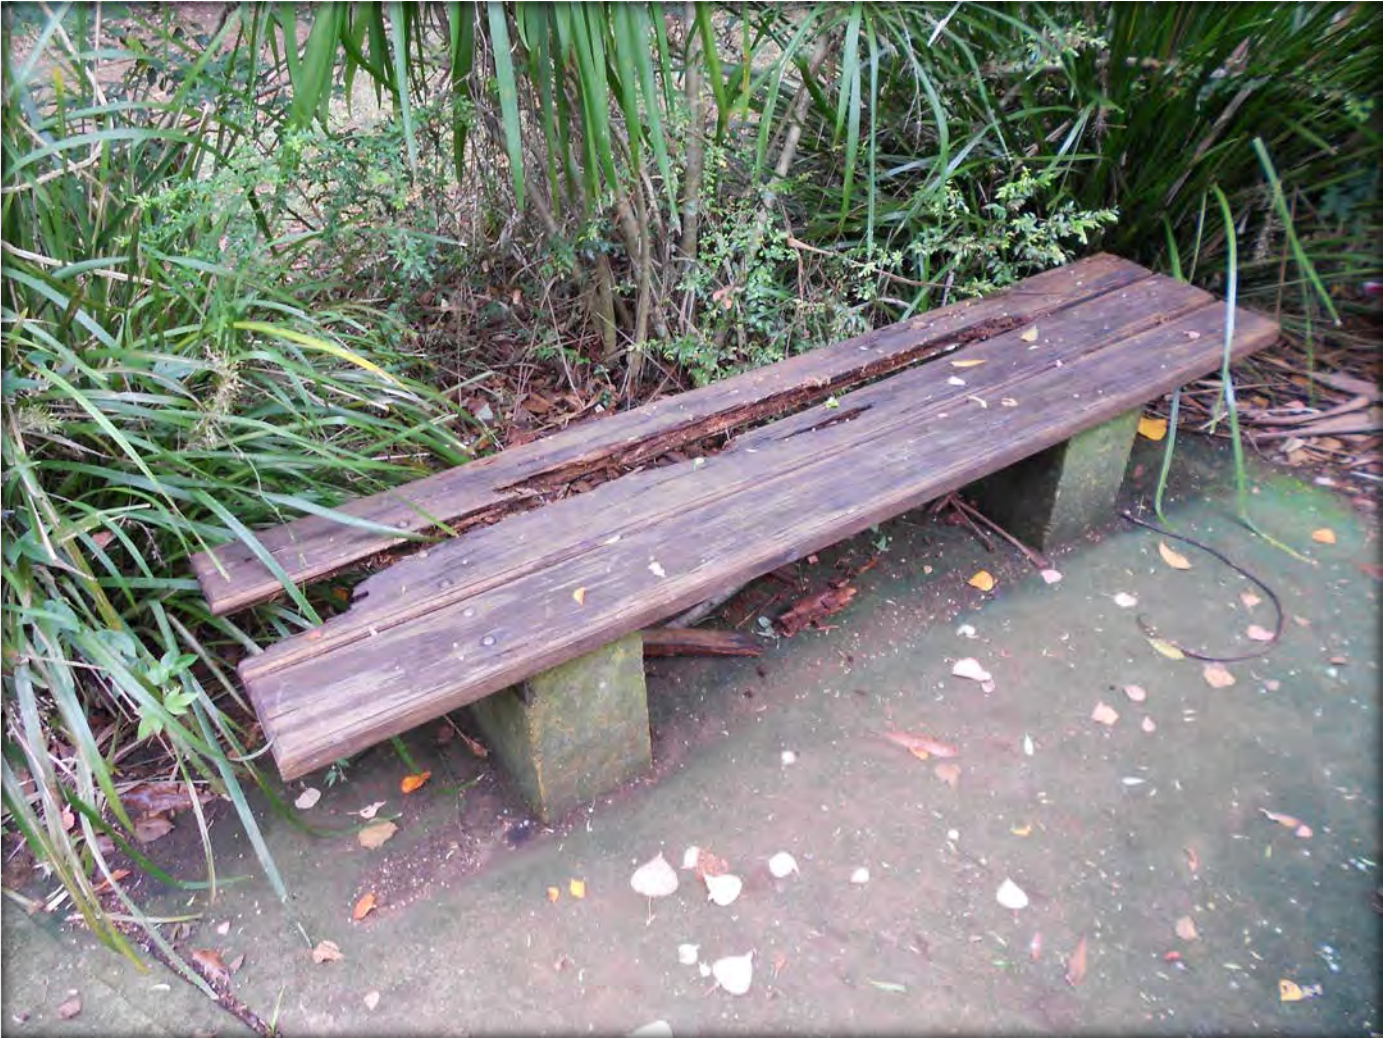
Figure 7: Replace rotten top on existing seat

| Seating | The existing seat at the northern end of the car park has a timber top that has rotted out. <i>Ekodeck</i> composite material (UV and rot resistant) is \$65 for the equivalent of three (3) pieces each 1.8 metres long. Cost of installation would be \$150, for a total cost of \$215. |

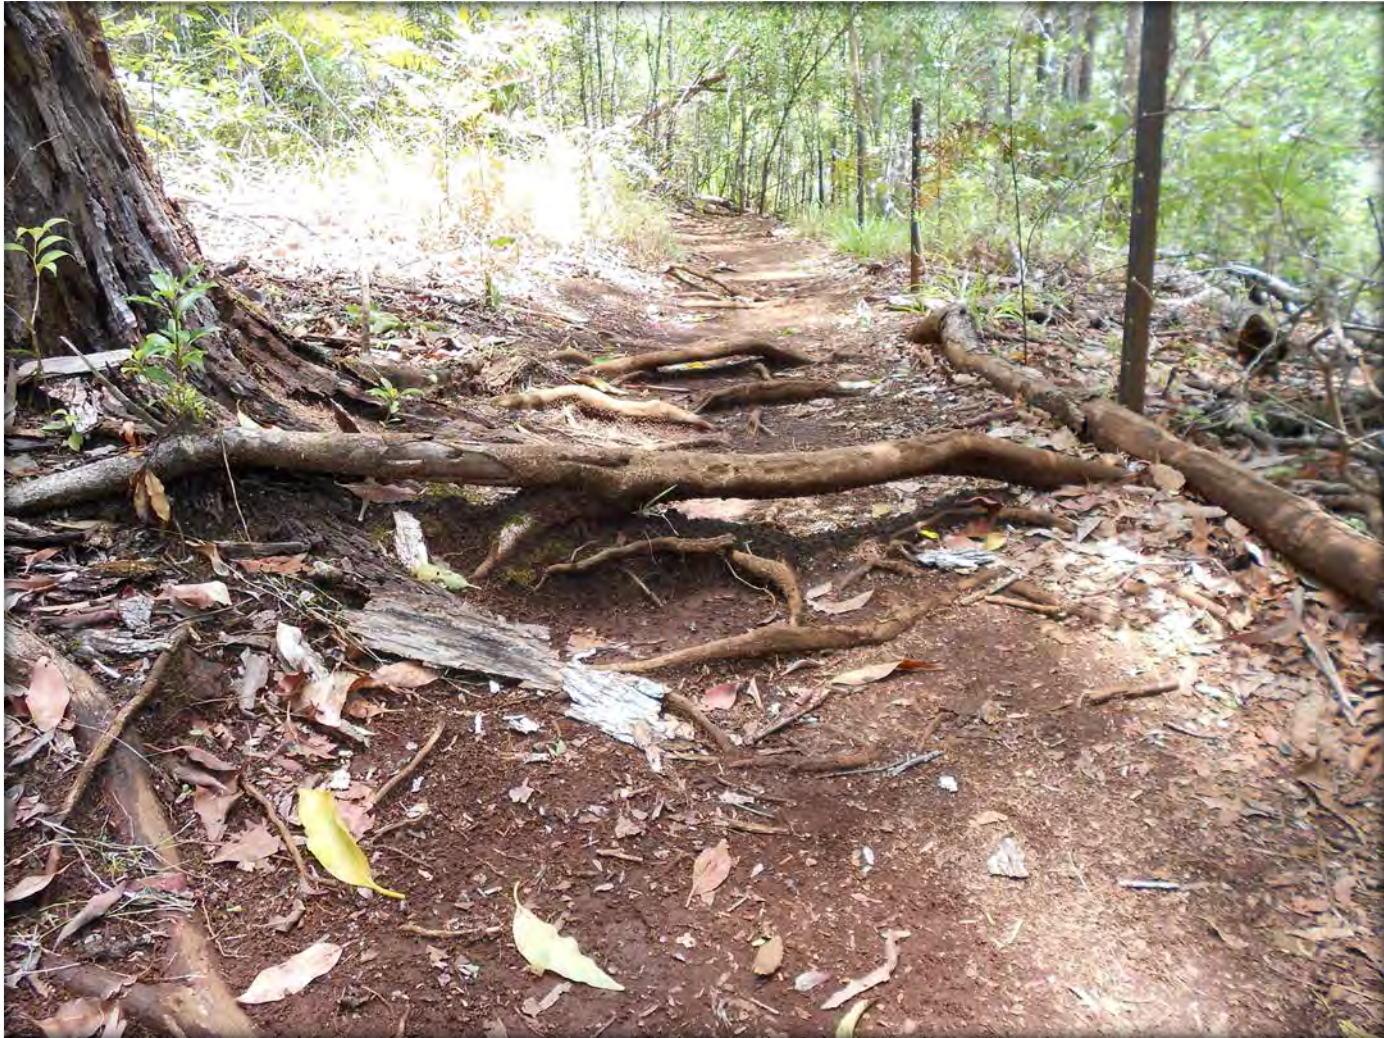
Some neighbours commented that the track to the viewing platform is in poor condition, is slippery after rain and has numerous trip hazards. Others consider it is adequate as is. The track from the viewing platform down to the creek is worse because it is rough and steep. An ambulance has been called for an injured person in the past (no details provided of injury or date).

Figure 11: Heavily used track has significant trip hazards

| <p>Tracks</p> | <p>Upgrade the walk to the viewing platform along its 330 metre length to make it safer for visitors of varying abilities. A standard 1.2 metre wide track with a crushed rock surface and timber edge would cost \$115 per metre installed, for a total cost of approximately \$40,250. However, due to its topography, it would be a difficult track to construct without some steps. Retaining the crushed rock on the track may be difficult in high rainfall events if it is not flat, so track maintenance may be an issue. Another option would be to use 1 metre wide <i>Geohex</i>, which is a permeable ground stabilisation material that is manufactured in Australia from 100% recycled material, and is quick to install and low maintenance. It has a load rating of over 1,200 tonnes per square metre and is suitable for heavy traffic areas. <i>Geohex</i> costs \$33 per metre and can be laid directly on the ground. Some earthworks would be required. Allowing a further \$40 per metre for preparation earthworks, labour and some fill material, the total cost would be approximately \$25,550.</p> |

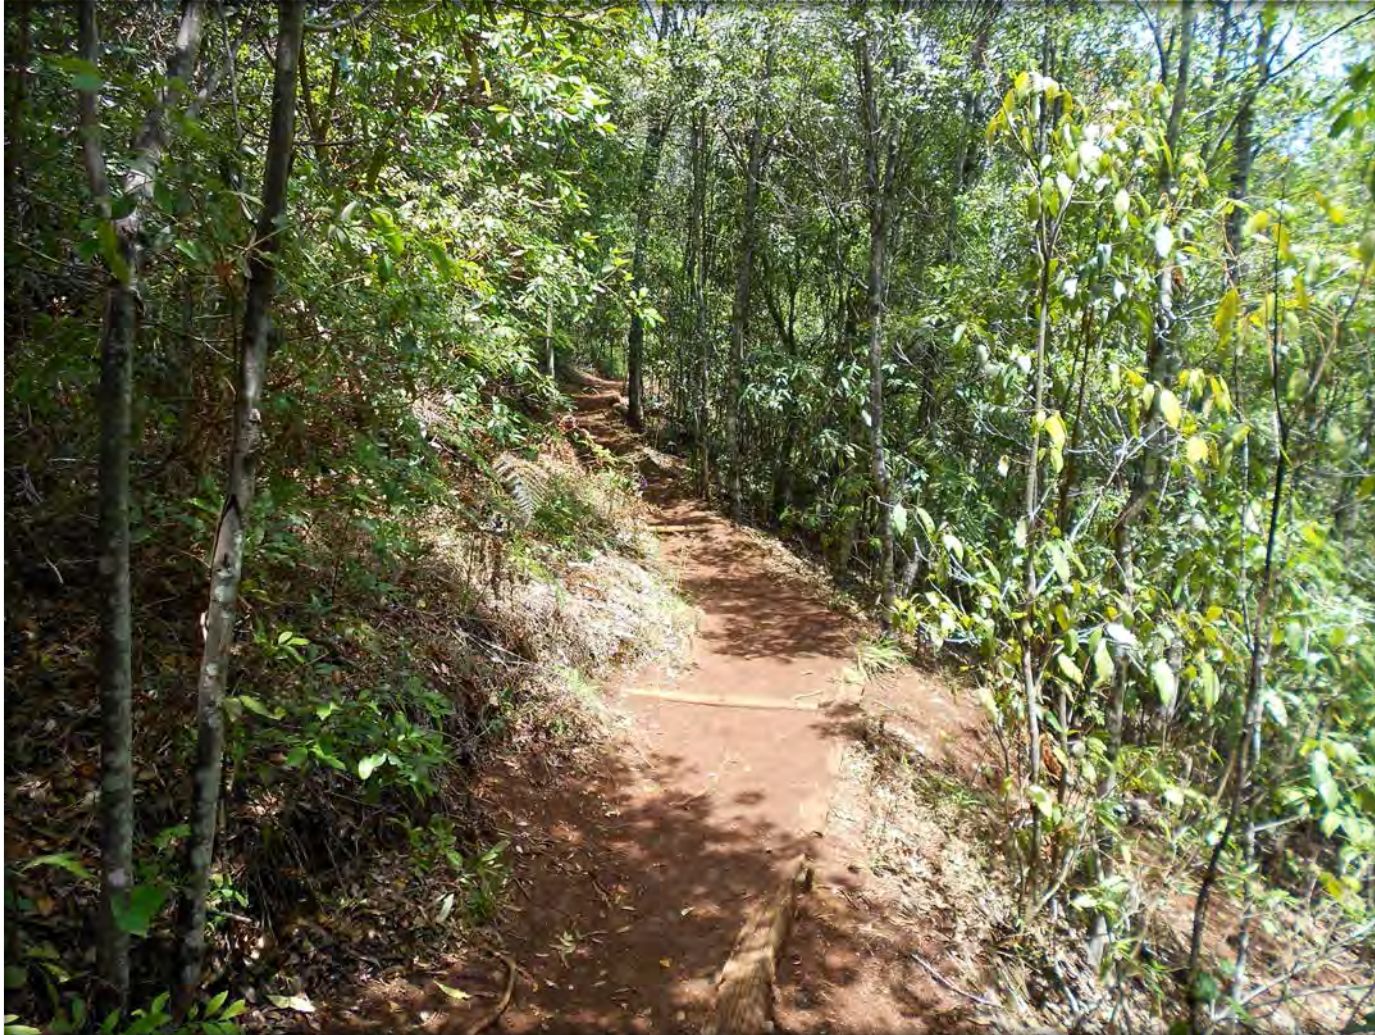
Figure 12: Heavily used track has a poor surface when wet and no fencing

| Fencing | Fence both sides of the walk to the viewing platform along its 330 metre length. Could use standard hinge lock fencing with a single strand of wire above, supported by steel pickets plus stringers. At \$15 per metre (assume 700 metres) installed, fencing would cost \$10,500. |

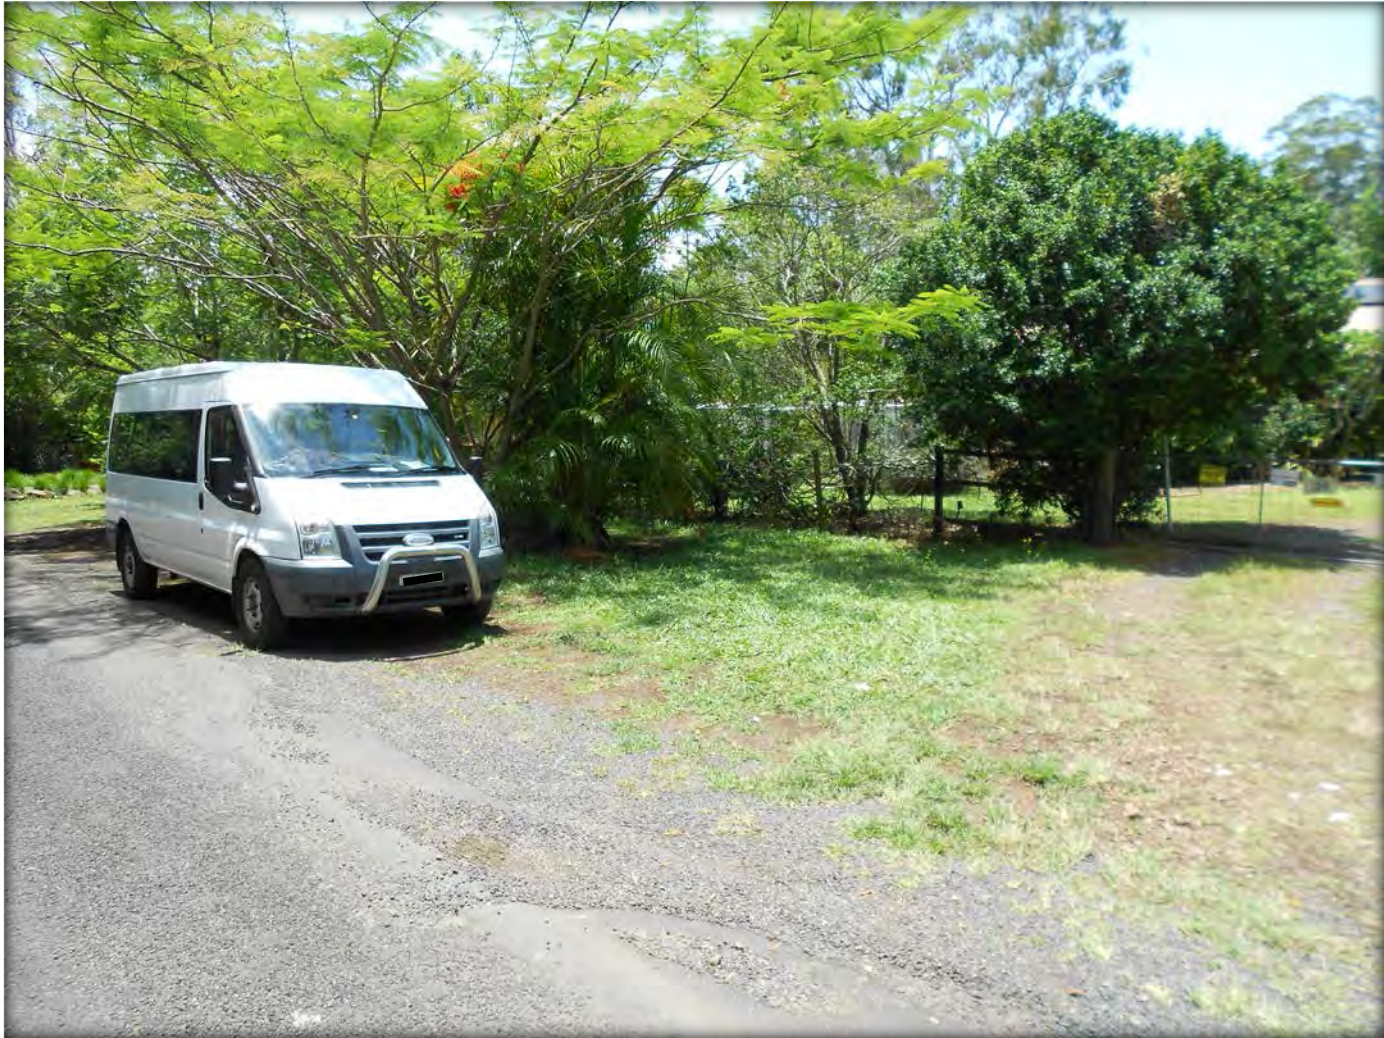
Figure 13: Area where landscaping will improve privacy for residents

| Landscaping | Establish additional landscaping near the front boundary of Lot 3 DP 251994 to increase privacy for the dwelling on this lot. Layout and design should be the same as other parts of the car park edge. Use only low maintenance native plants. Approximately \$3,000 for plants and labour. |

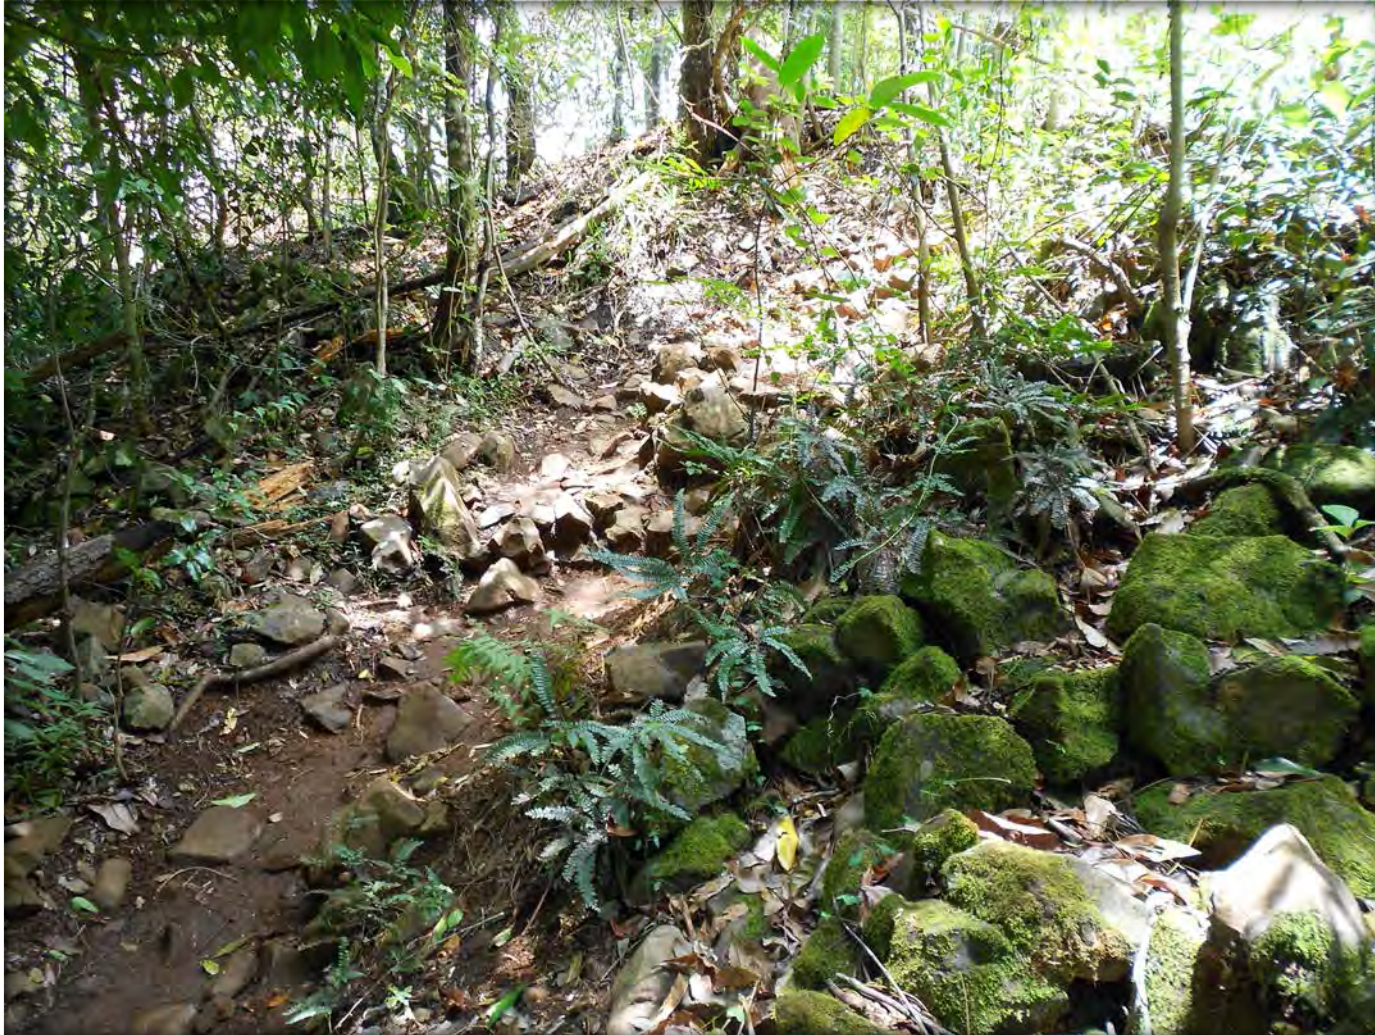
The modified path to the viewing platform while sometimes slippery is adequate for the purpose. The informal path beyond the viewing platform involves a steep and treacherous descent over sharp rocks and boulders to the creek level below. This represents a real and present risk of falls and serious injury to members of the public who may be ill equipped and inexperienced for such a dangerous activity. In fact there have been recent reports of serious injuries including broken limbs that required the attendance of the ambulance. It is only a matter of time before someone is fatally injured.

Figure 14: Track to creek is steep, rocky and has no hand holds

| <p>Handrail to Emigrant Creek</p> | <p>A “Tubeclamp” handrail system can be designed by suppliers to meet the site requirements of accessing Emigrant Creek. All components are manufactured from hot dip galvanized steel tube. The length of the handrail would be approximately 20 metres. Material supply cost is \$60 per lineal metre. Securing the handrail will be difficult without access to power tools and because of the rocky nature of the slope. Allow a further \$60 per metre for installation costs, for total cost of \$2,400.</p> |

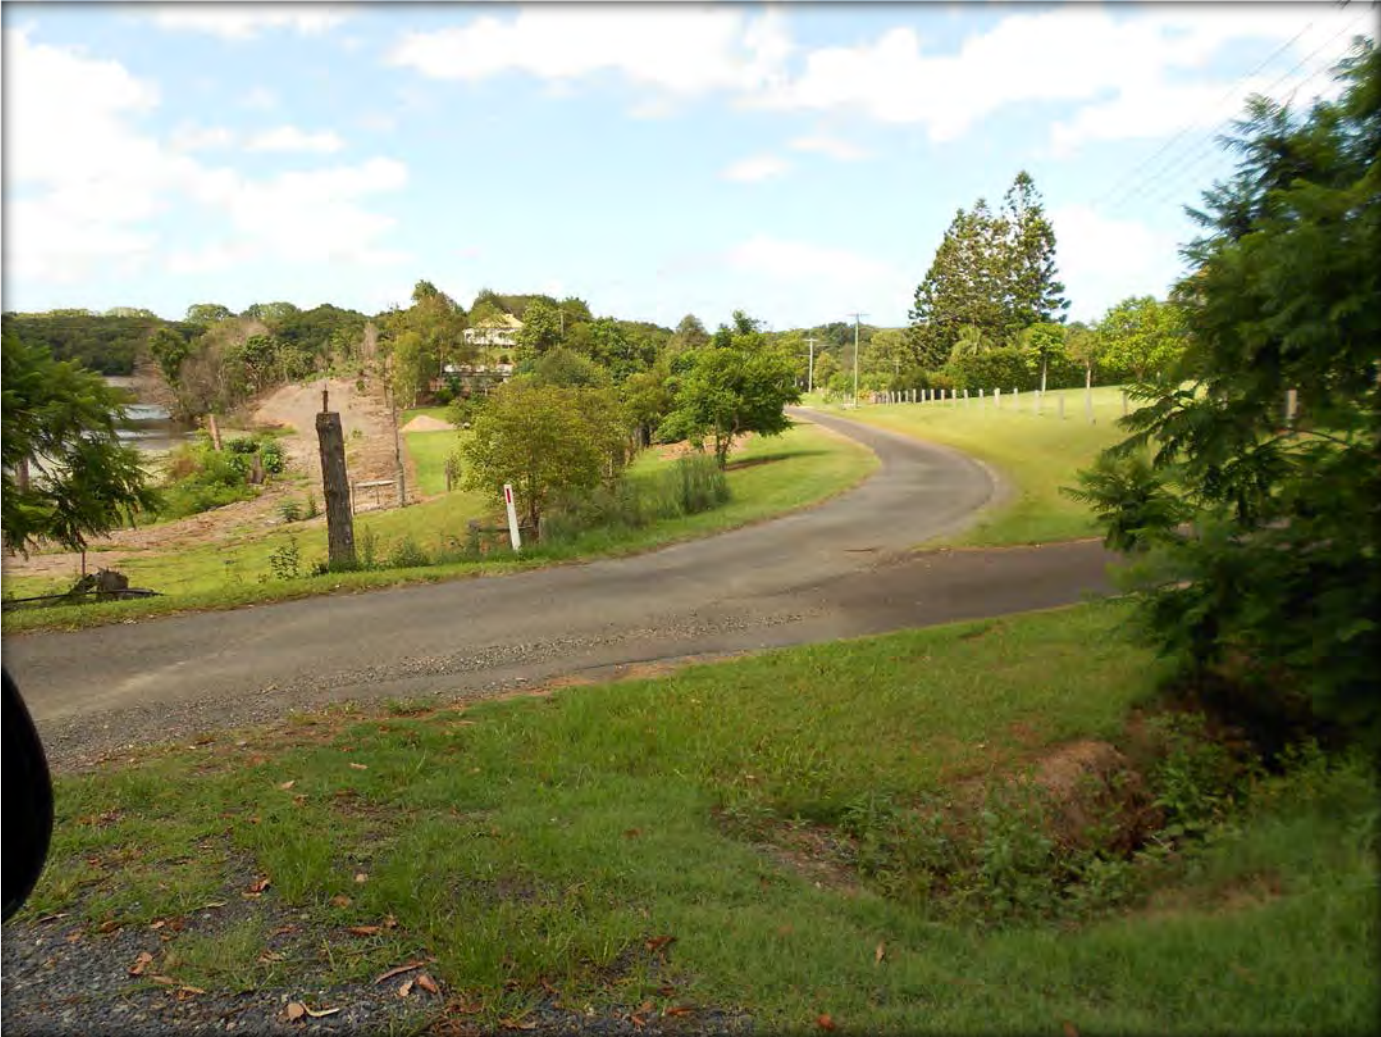
Figure 15: Killen Falls Drive is narrow and needs traffic calming to slow vehicles

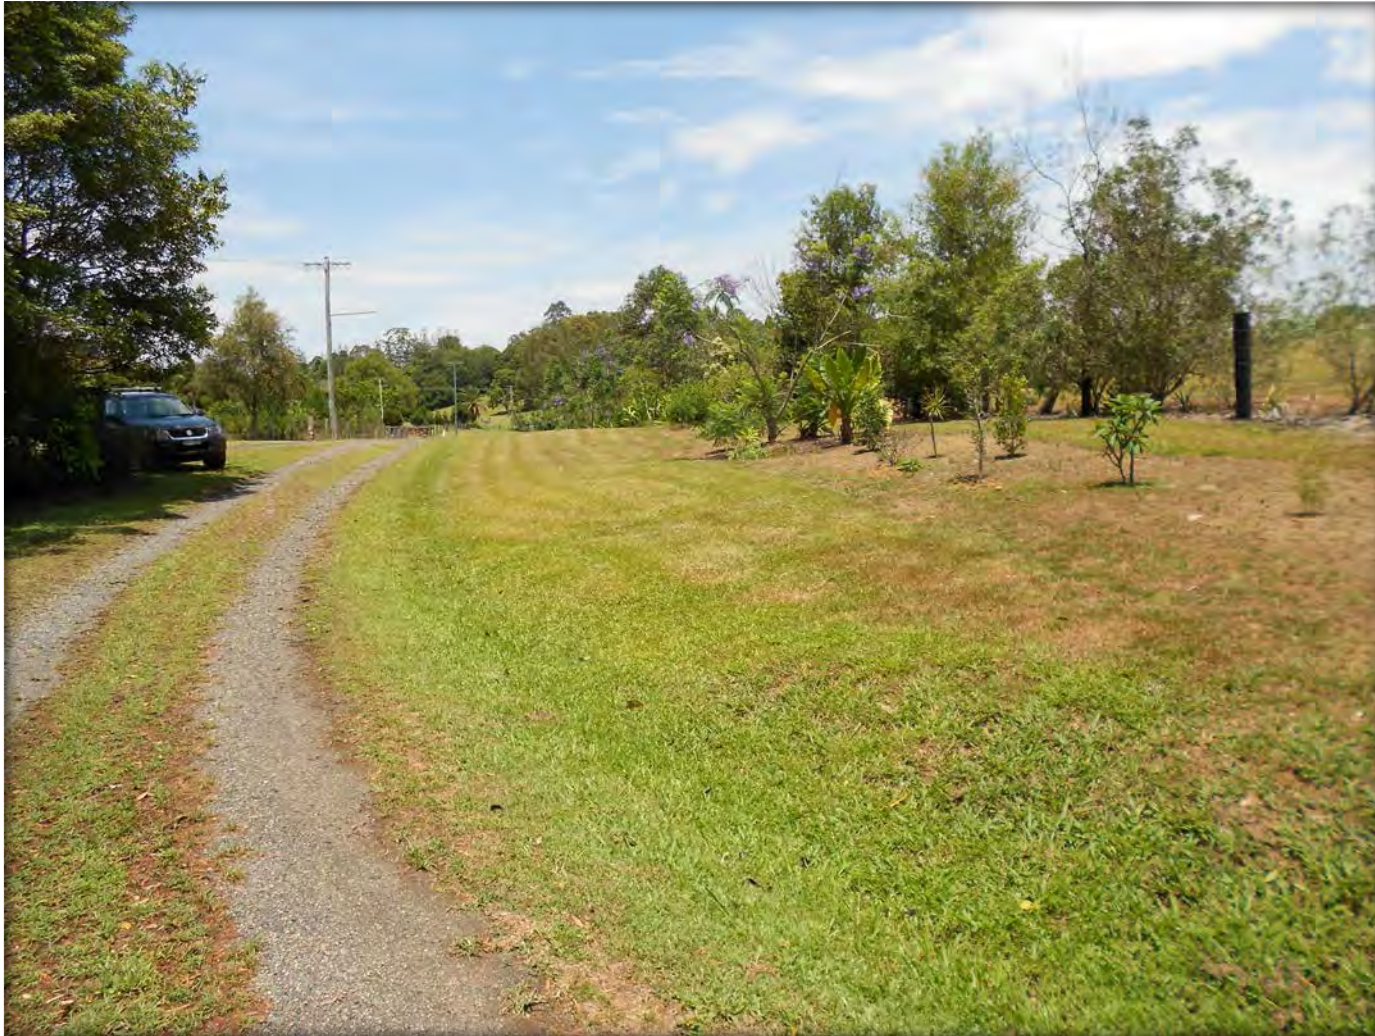
Figure 16: Parking overflow area on western side of Killen Falls Drive

Identify parking overflow areas along Killen Falls Drive as well as bus parking. Use *Geohex* or similar material to control erosion and damage to the road verge in these locations. Use signage to identify the preferred locations and parking patterns.

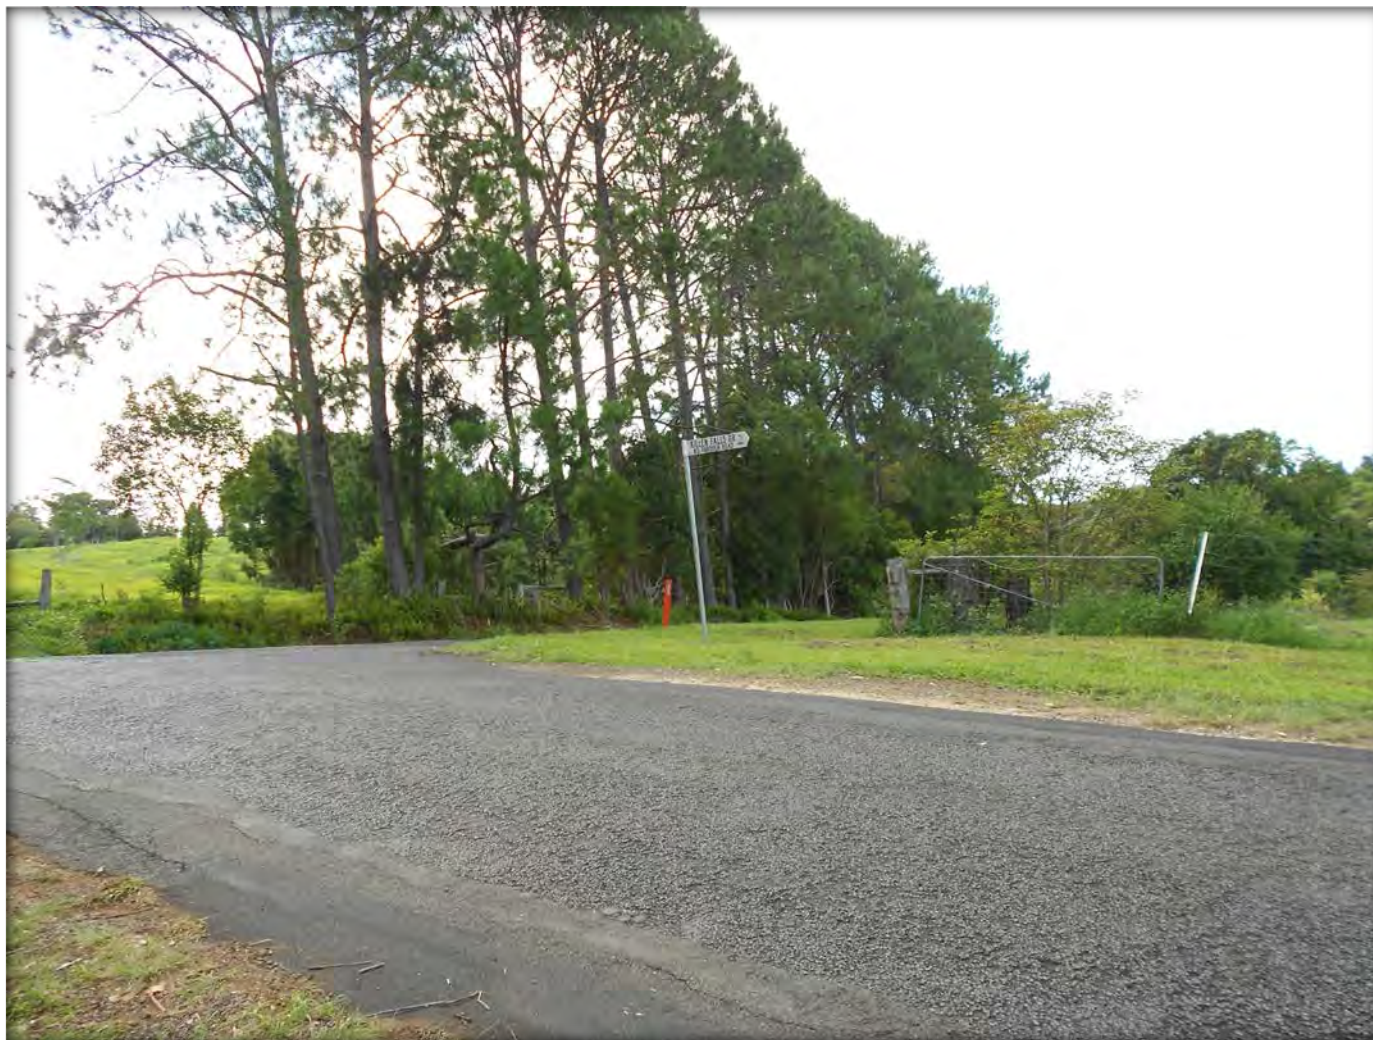
Figure 18: Killen Falls Drive and Friday Hut Road intersection should be assessed

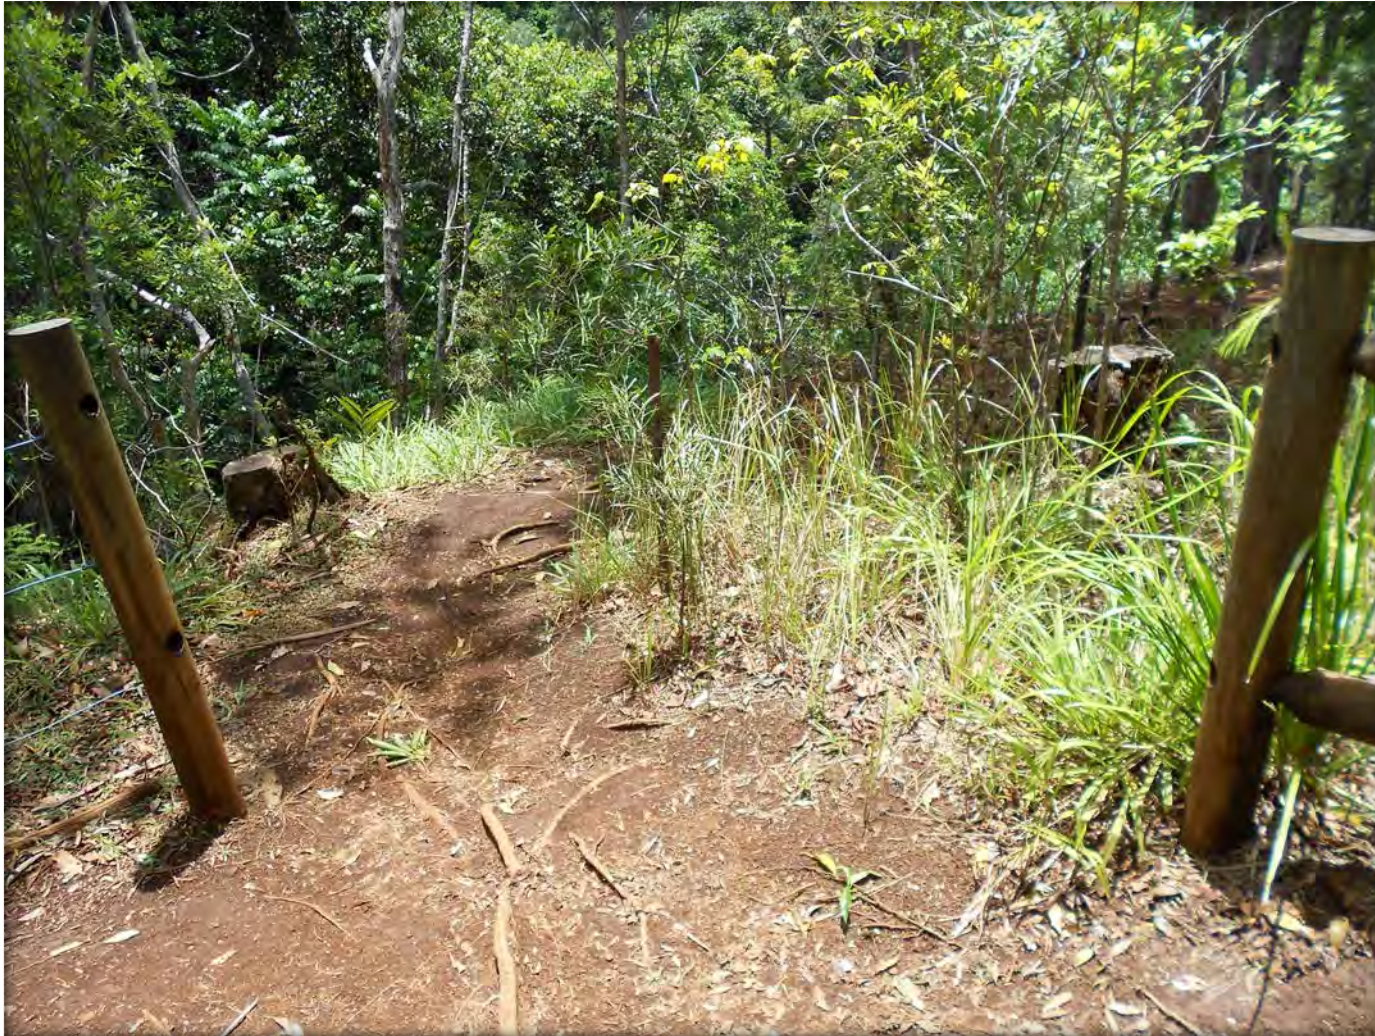
Figure 20: Fence that once blocked track to creek has been removed
