Coastal Zone Management Plan for Shaws Bay, Ballina

Volume 2: Supporting Information

PROJECT 14-019 – SHAWS BAY CZMP - VOLUME 2: SUPPORTING INFORMATION

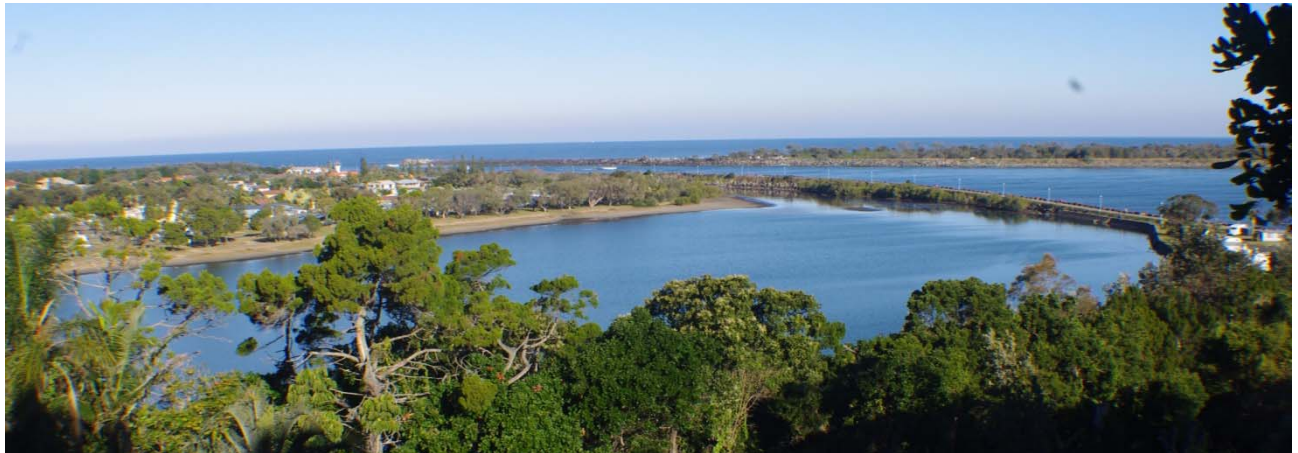
Figure 1: Shaws Bay and the Richmond River

The study area for the Shaws Bay CZMP is located near the mouth of the Richmond River in East Ballina on the NSW north coast (Figure 1). It lies within the Ballina Shire Council (BSC) local government area. The boundary of the study area follows the topographical catchment for Shaws Bay as shown in Figure 2.

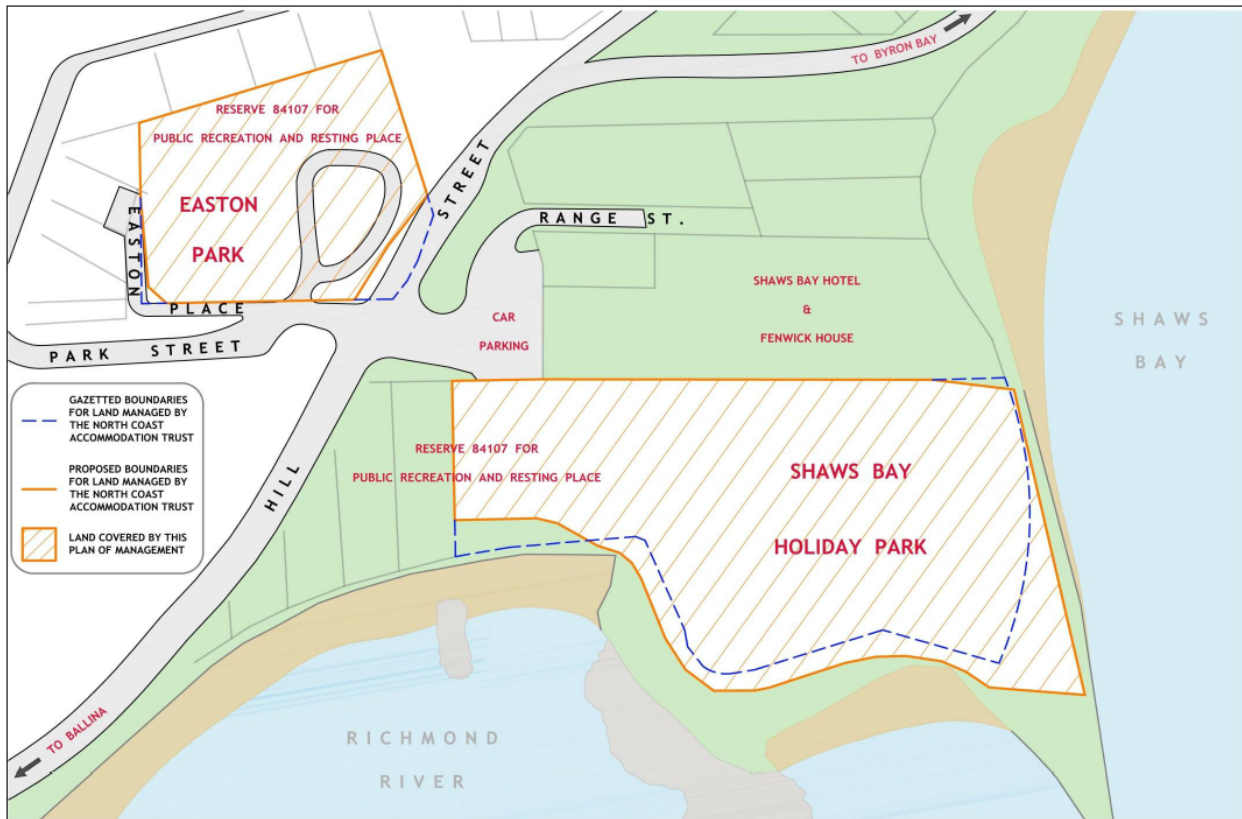
Figure 4: Land covered by the Draft Plan of Management for Shaws Bay Holiday Park and proposed boundary adjustment

appointment of the North Coast Accommodation Trust did not accurately represent the operational boundaries of the Holiday Park. The Plan includes proposed adjustment to the park boundary to reflect the operational areas as shown in Figure 4.

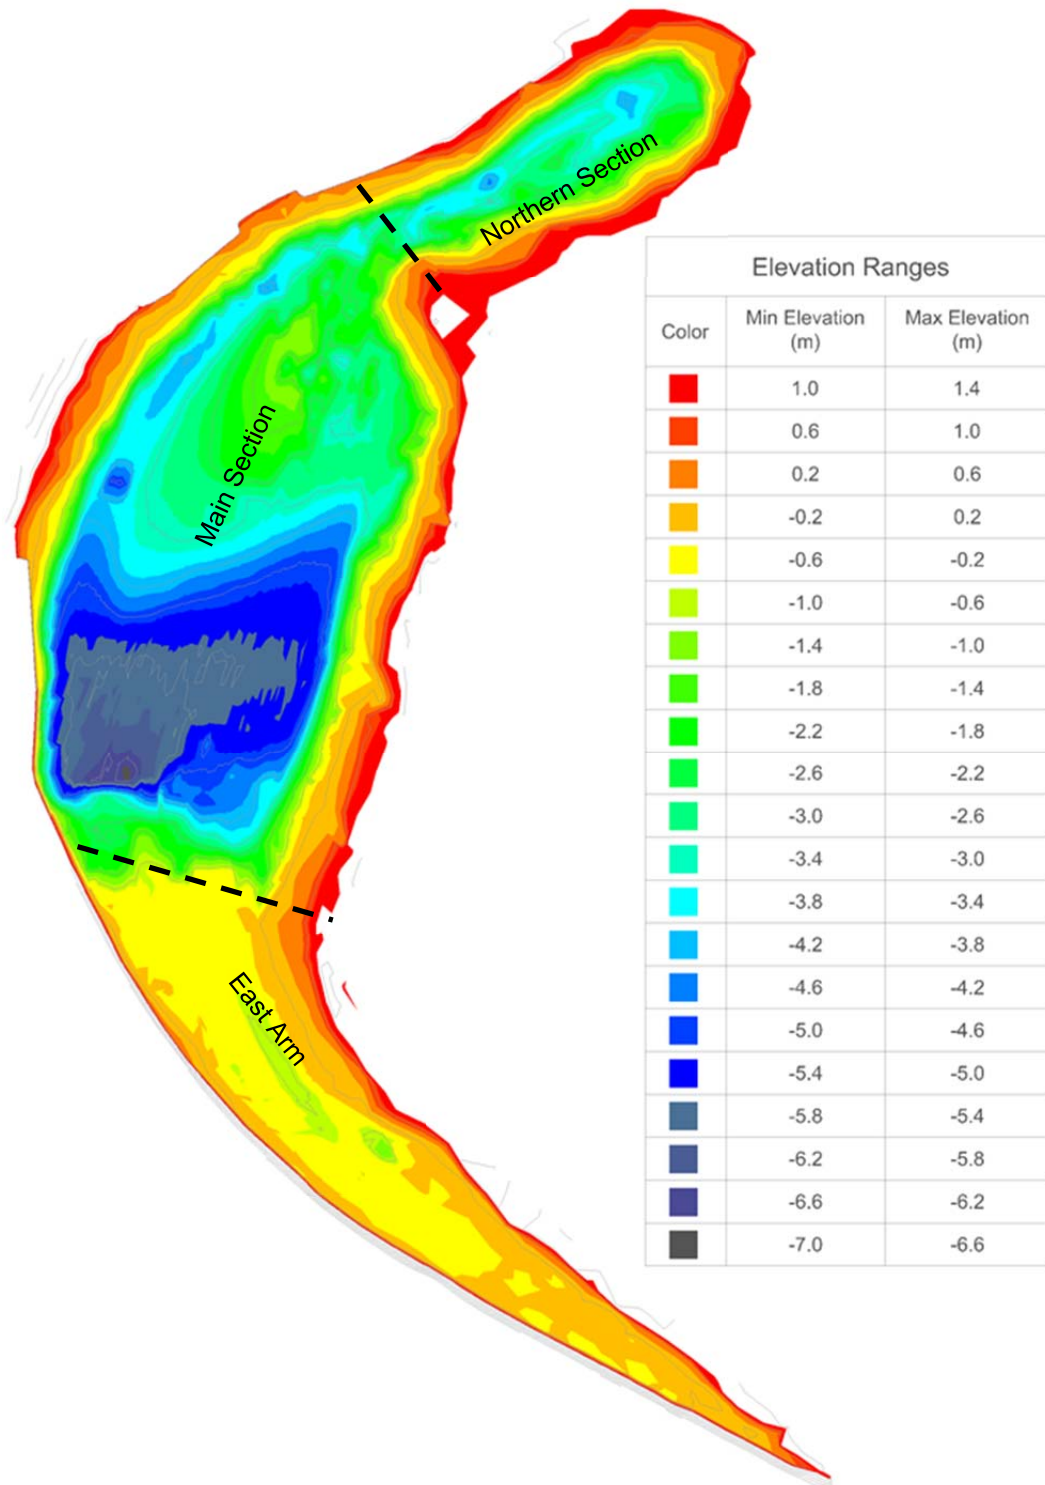
Figure 6: Shaws Bay bathymetry based on 2013 hydrographic survey

Although some anecdotal records exist of historical bathymetry, the only contemporary hydrographic surveys of Shaws Bay were undertaken in 1999 and again in 2013 (Figure 6). Changes in the bathymetry between these surveys and rates of infilling is discussed in Section 3.6.1.

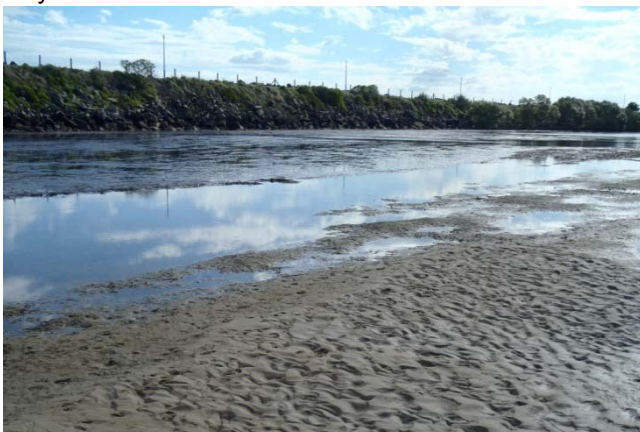
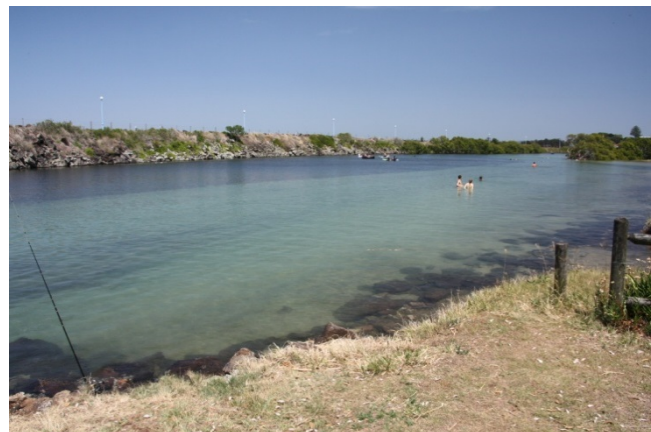
Figure 7: Shaws Bay bathymetry East Arm at low tide (left) and king tide (right, January 2014)

The large tidal exchange (see Section 3.5.2) and concentration of much of this flow in the East Arm, means that tidal flows are highly directional in this part of Shaws Bay, with velocities up to 0.3m/s in the sandy channel of the East Arm (PBP, 2000a). Within the Main Section of the Bay, tidal circulation is less observable but can be inferred from patterns in scour and sedimentation as well as the bathymetry of the Bay.

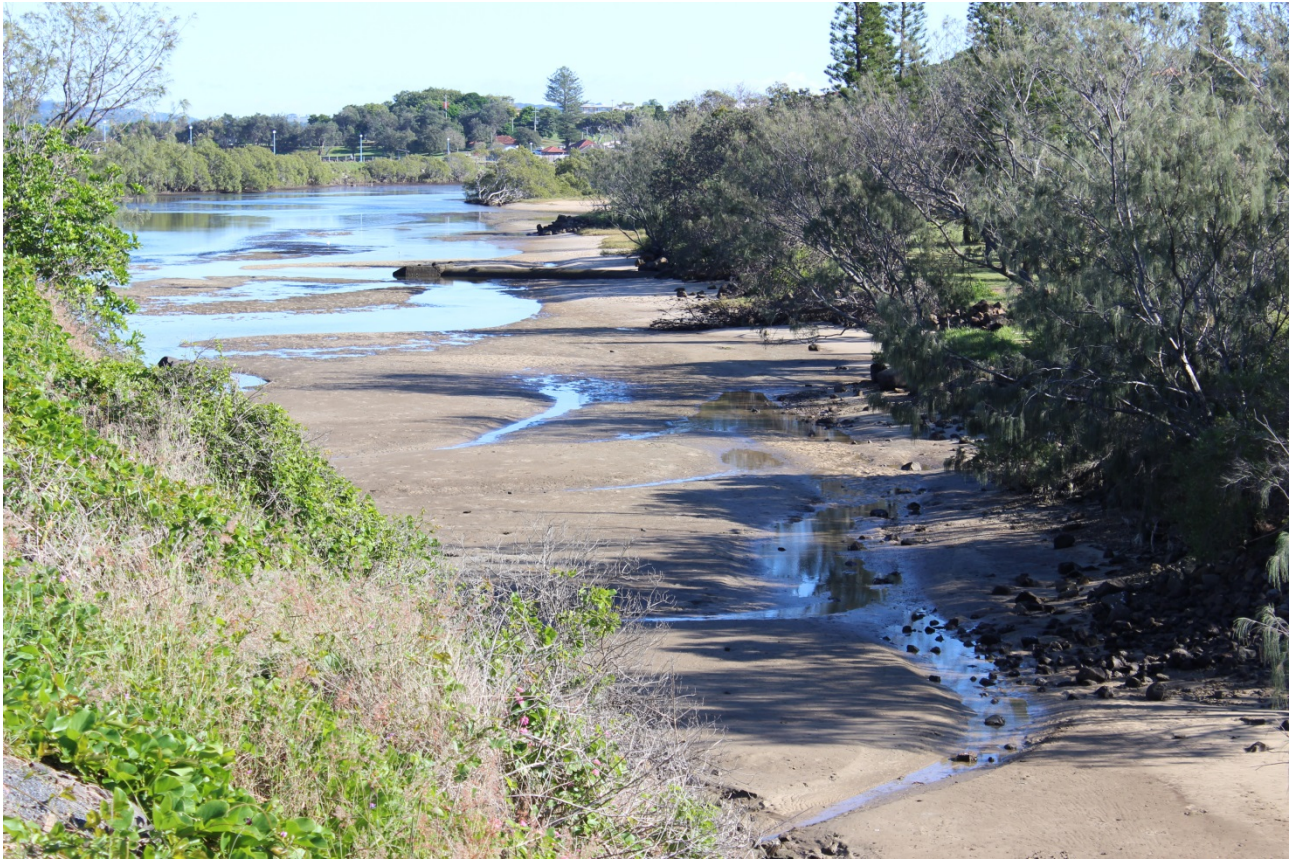
Figure 9: Low tide draining of the East Arm, Shaws Bay

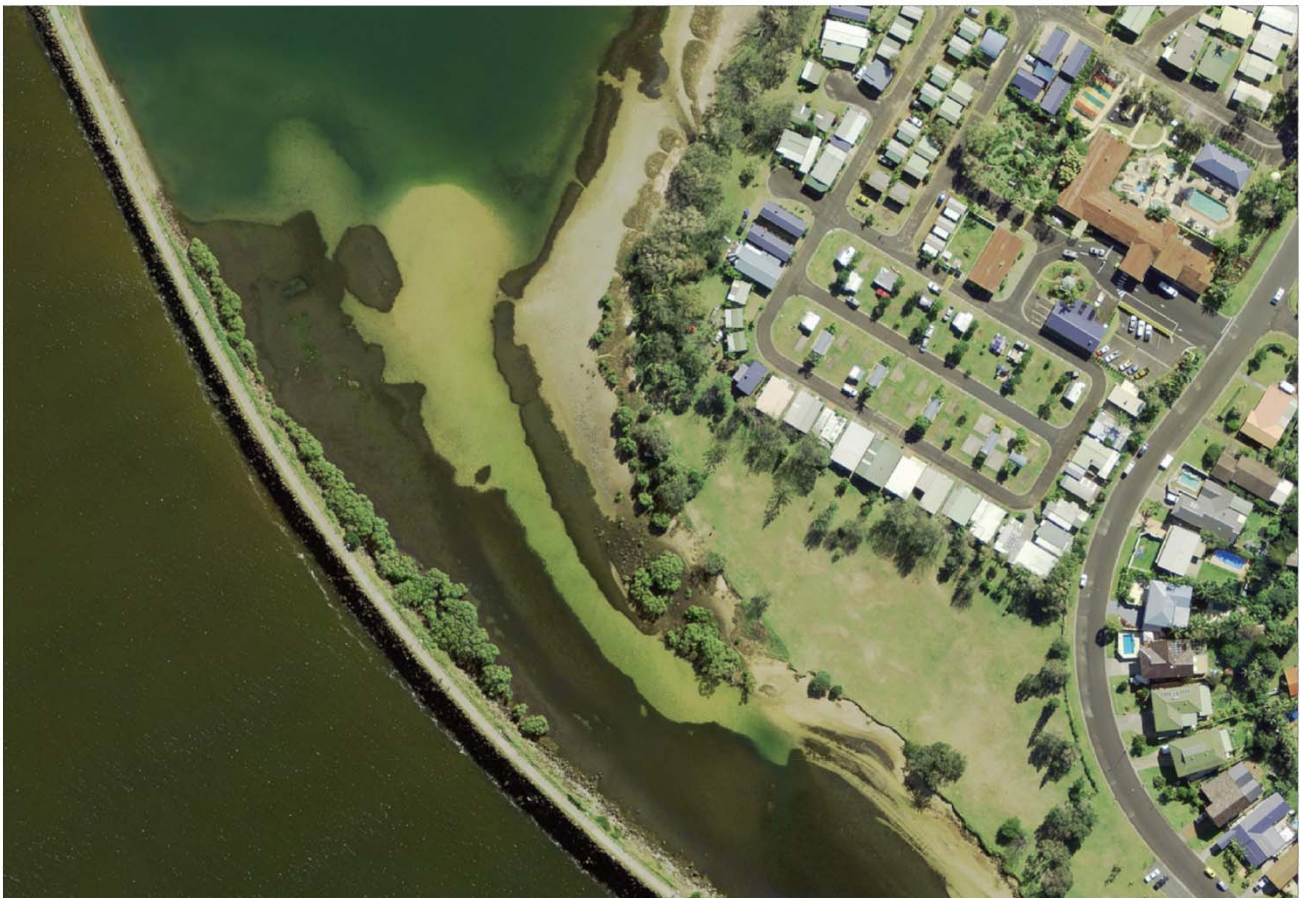
Figure 12: The sand delta formed at the confluence of East Arm and the Main Section of Shaws Bay and seagrass colonisation.

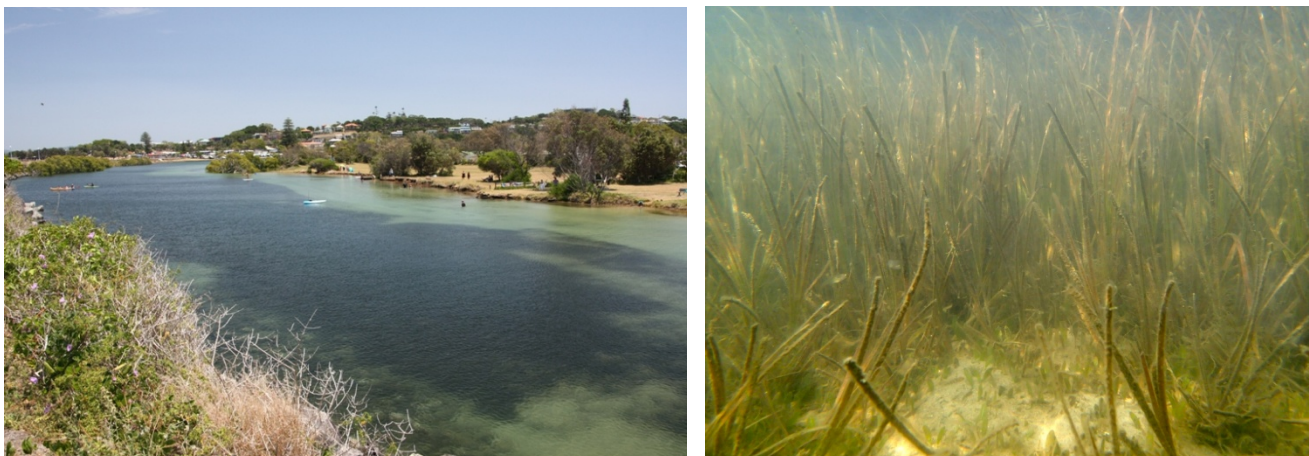
Figure 13: Seagrass and recreational activities along east arm (left) and seagrass and waterway access points (right)

- Shaws Bay is primarily a recreational asset with the most popular activity being swimming, followed by walking/exercise, picnicking and fishing;
- There is considerable community interest in maintaining the health and amenity of the Bay as well as enhancing the recreational experience of the area;
- The recreational experience at Shaws Bay creates strong links to the need to protect ecological values through water quality, vegetation management and protection of fish stocks;
- The overlap between recreational activities and ecological values creates some management conflict. For example, there was concern among many stakeholders regarding a perceived decline in amenity resulting from seagrasses and mangroves at waterway access points, whereas some respondents noted the value of the marine vegetation for habitat and water quality;

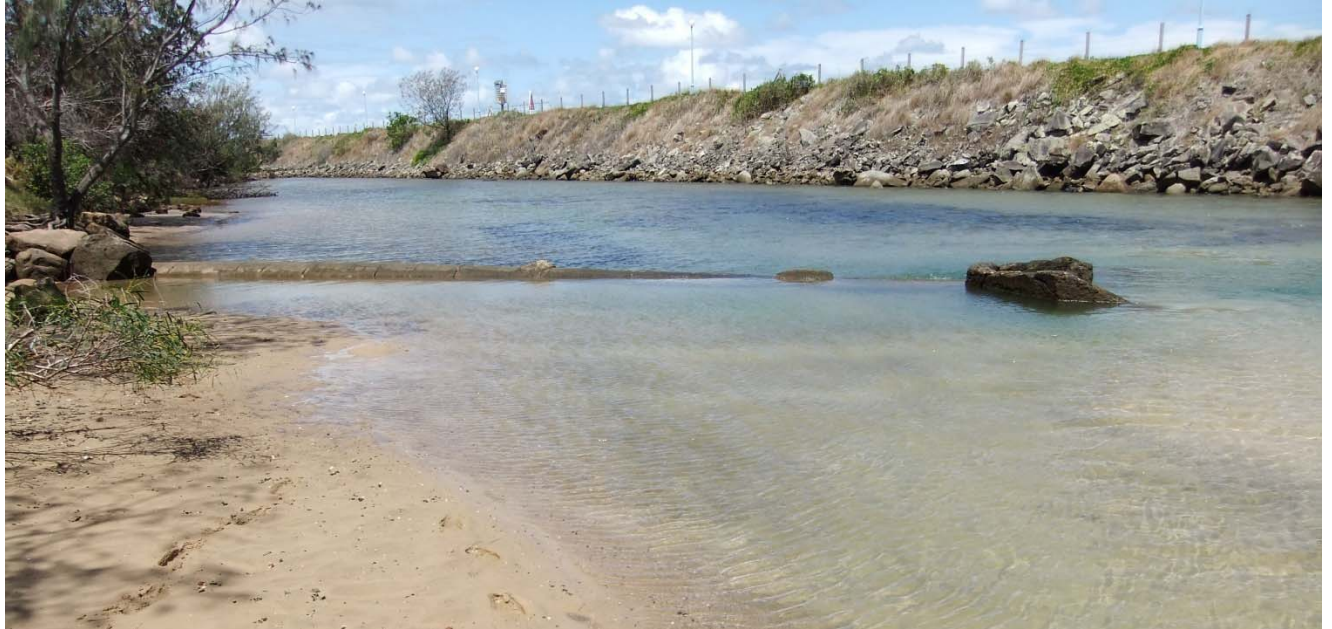
Figure 14: Shoreline recession indicated by location of stormwater outlet in the East Arm

Bank erosion is most pronounced on the northern shore of the East Arm and has been occurring for several decades. The best visual indicator of the distance of bank retreat is the location of the stormwater outlet in this section of the Bay, which would originally have been constructed to coincide with the position of the bank but now the bank is around 13m behind the outlet location.

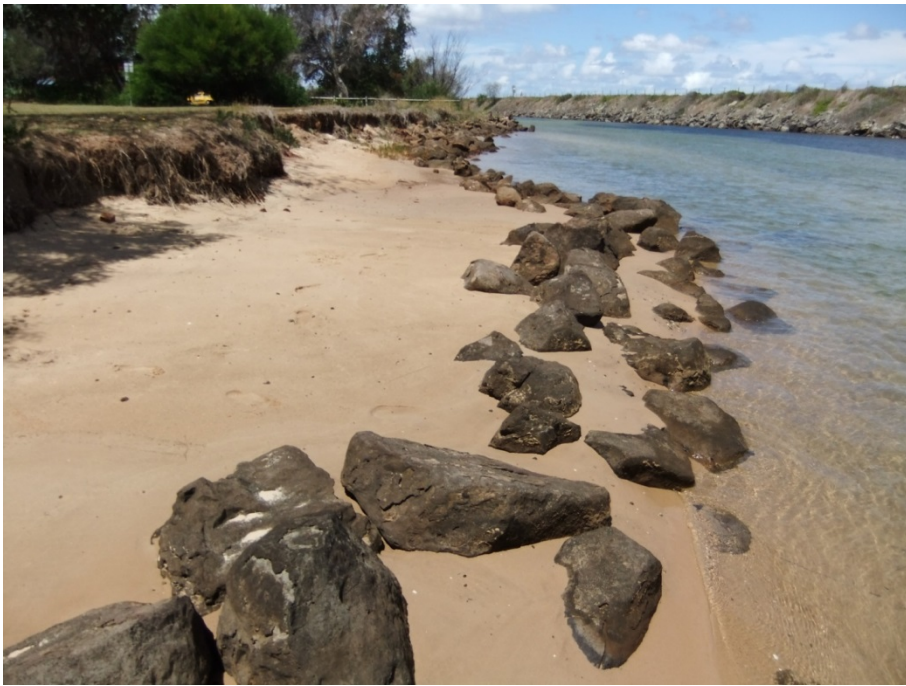
Figure 15: Bank erosion beyond the rock revetment in the East Arm

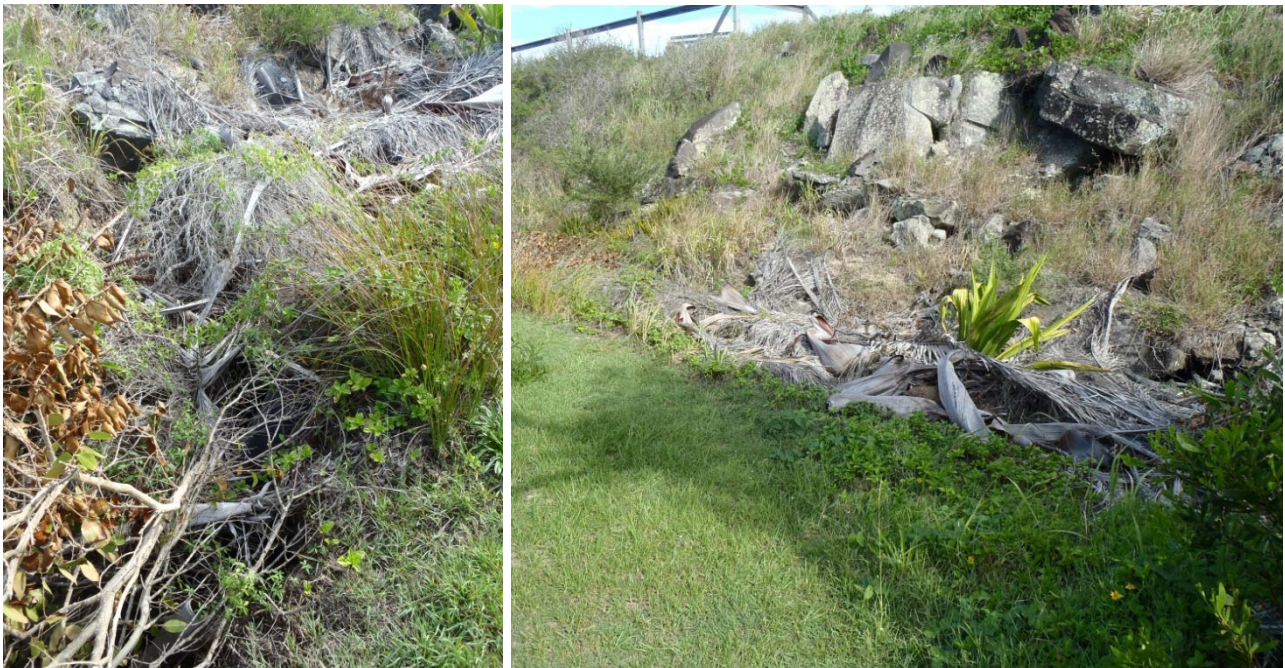
Figure 16: Sink holes along the training wall partially covered by garden clippings

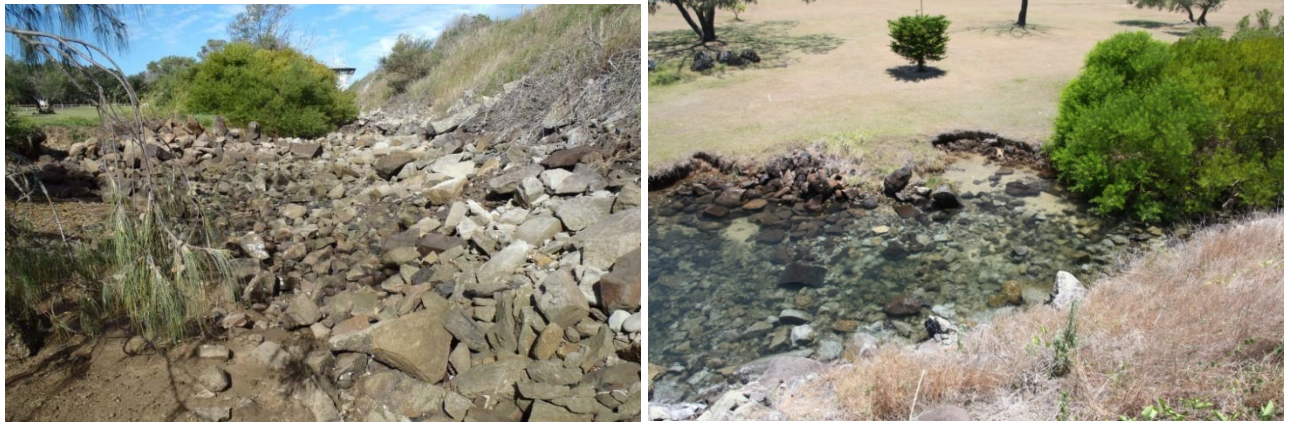
Figure 17: Continued erosion at the eastern extremity of the East Arm

This same process is leading to the eastward extension of the East Arm despite extensive rock placement (Figure 17).

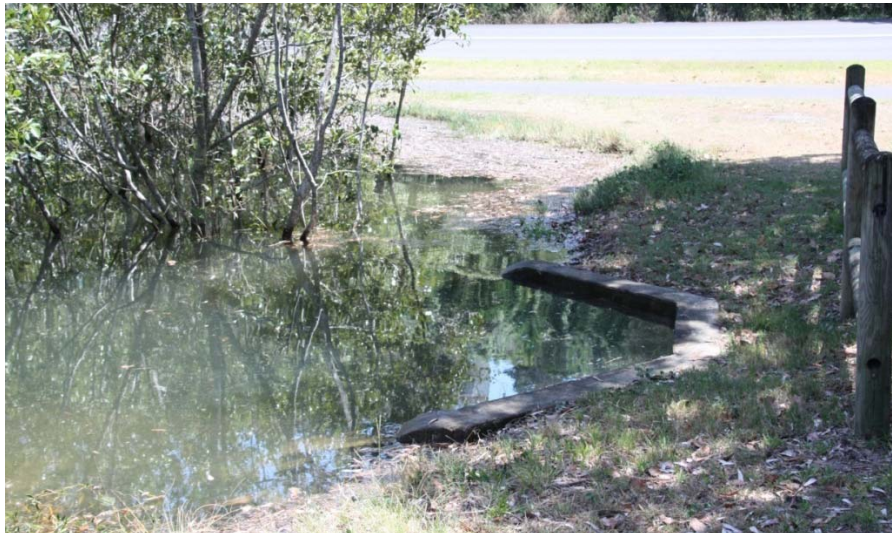
Figure 19: Tidal inundation of stormwater drain (January 2014)

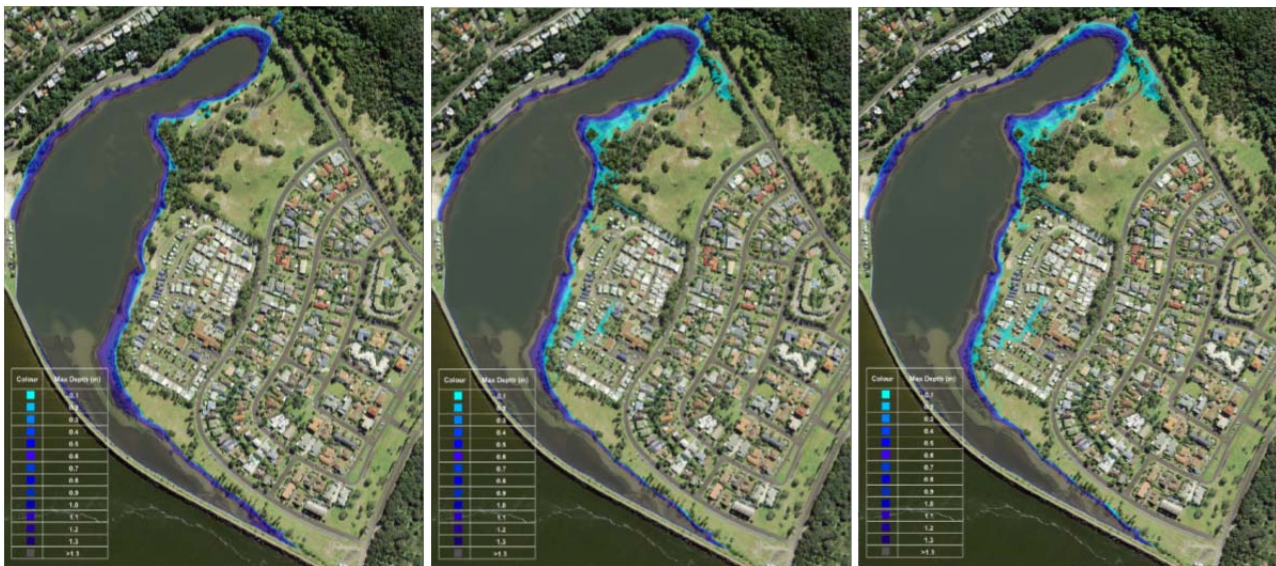
Figure 20: Predicted present day inundation due to 1, 50 and 100 year ARI ocean level events (not including wave setup)

A subset of the inundation scenarios is provided below in Figure 20 and Figure 22.

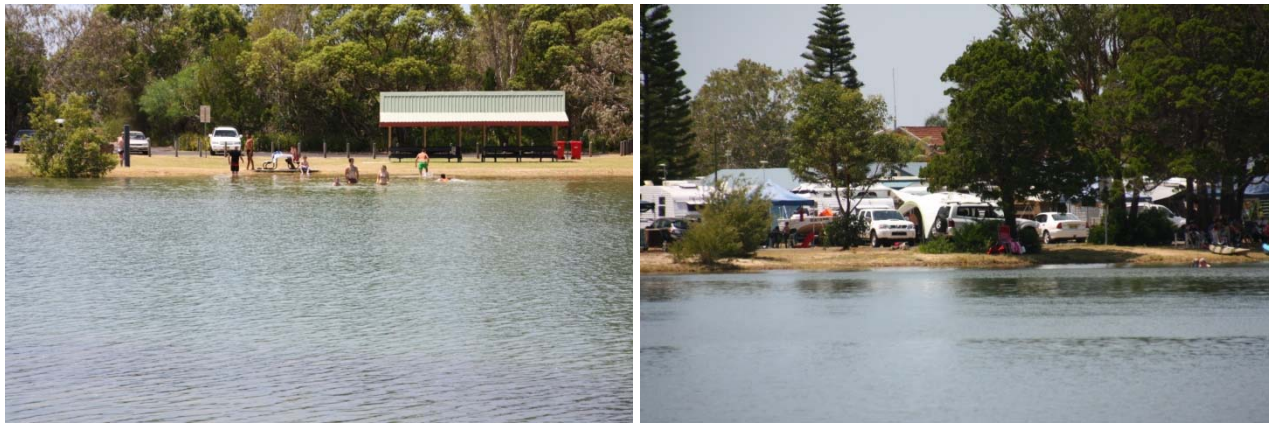
Figure 21: High tide level at Pop Denison Park (left) and Ballina Lakeside Holiday Park (right) January 2014

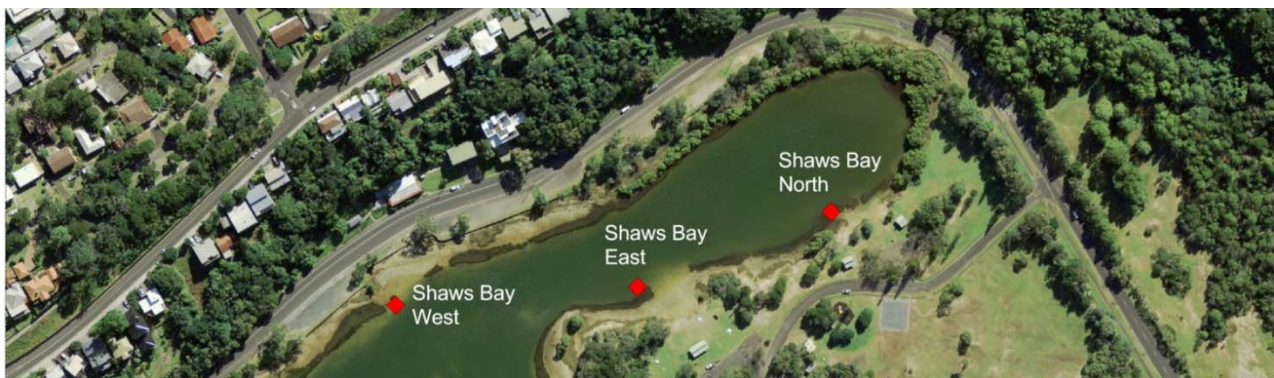
Figure 23: Beachwatch sampling site locations in Shaws Bay

There are three Beachwatch monitoring sites within Shaws Bay: Shaws Bay East, Shaws Bay North, and Shaws Bay West (Figure 23). Sites are generally sampled five times per month during the four busiest months of the swimming season (November, December, January and February) except when more frequent sampling is conducted during significant events such as major flooding of the Richmond River.

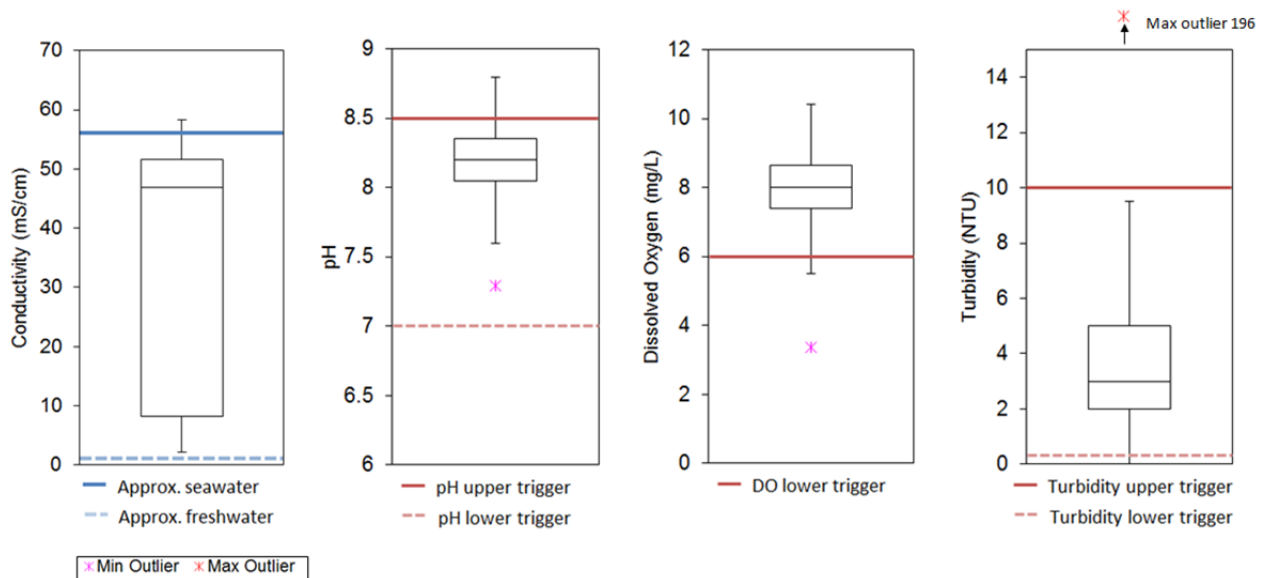
Figure 25: Shaws Bay water quality at east site: box and whisker plots for conductivity, pH, dissolved oxygen and turbidity for combined data collected in 2005/06, 2008/09 and 2010/11-2013/14 summer samples

Figure 25 shows box and whisker plots for the combined data set since 2005 showing the range of values measured over time. The central line in the box represents the median, the lower and upper box limits represent the 25th and 75th percentiles respectively. The *Richmond River Water Quality and River Flow Objectives* (OEH, 2014b) for estuaries are shown as horizontal lines. Comparison with water quality objectives has been undertaken by first comparing the median values of water quality data with the relevant guideline to assess whether trigger levels have been exceeded (as per ANZECC, 2000). The 25th and 75th percentiles have also been examined with reference to the guidelines (box and whisker plots) and finally the temporal trend of water quality relative to rainfall has also been examined for occasional exceedances to assist in interpretation of results.

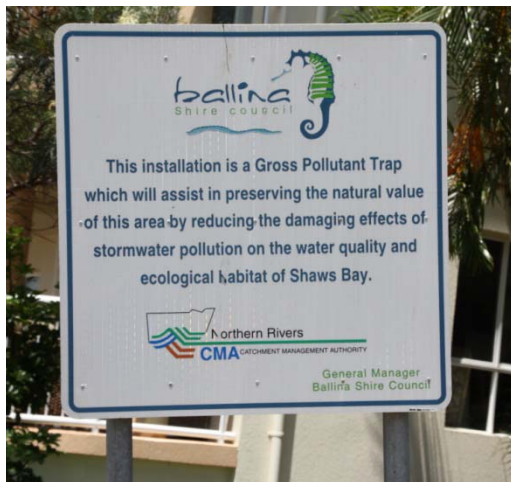
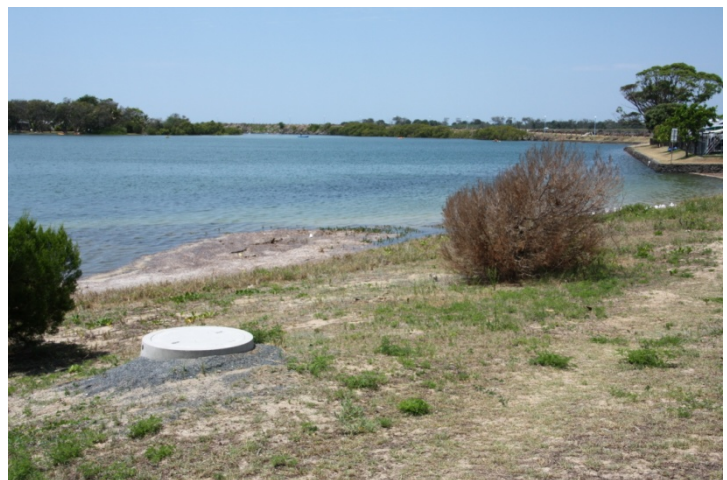
Figure 27: Stormwater GPT installed on western foreshore

Since the 2000 EMP, several improvements have been made in the Shaws Bay catchment that are expected to have a positive impact of stormwater quality including the installation and regular maintenance of filter bag pit inserts into all stormwater drains in the Shaws Bay residential area (Figure 28), installation of two Gross Pollutant Traps (GPTs) and the introduction of organic waste recycling which assists in diverting garden waste to council composting operations.

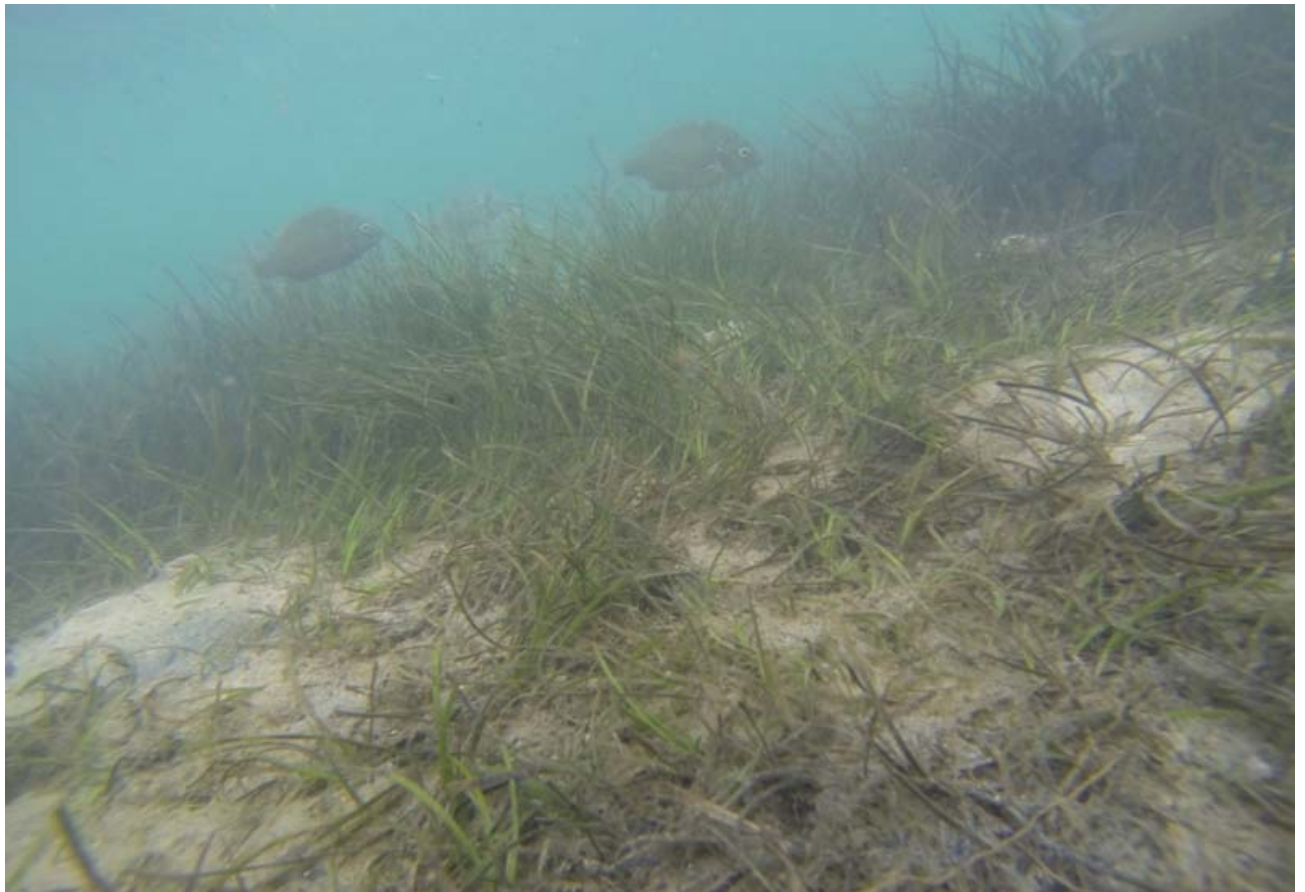
Figure 32: Typical Shaws Bay seagrass community dominated by *Zostera capricorni*

Seagrass communities within Shaws Bay consist of two species *Zostera capricorni* (Figure 32) and *Halophila ovalis*. The communities are overwhelmingly dominated by *Z. capricorni* which appears as long grass like strands of seagrass (up to 50 cm long). *H. ovalis* is a much smaller and delicate species which has small ovate leaves which grow very close to the bottom substrate, appearing generally around the margins of *Z. capricorni* meadows. Both species will collectively be referred to as seagrass.

Shaws Bay seagrass is in generally healthy condition with no *Ulva* spp. observed during the survey. A summary of seagrass health and condition is provided below based on the field assessment:

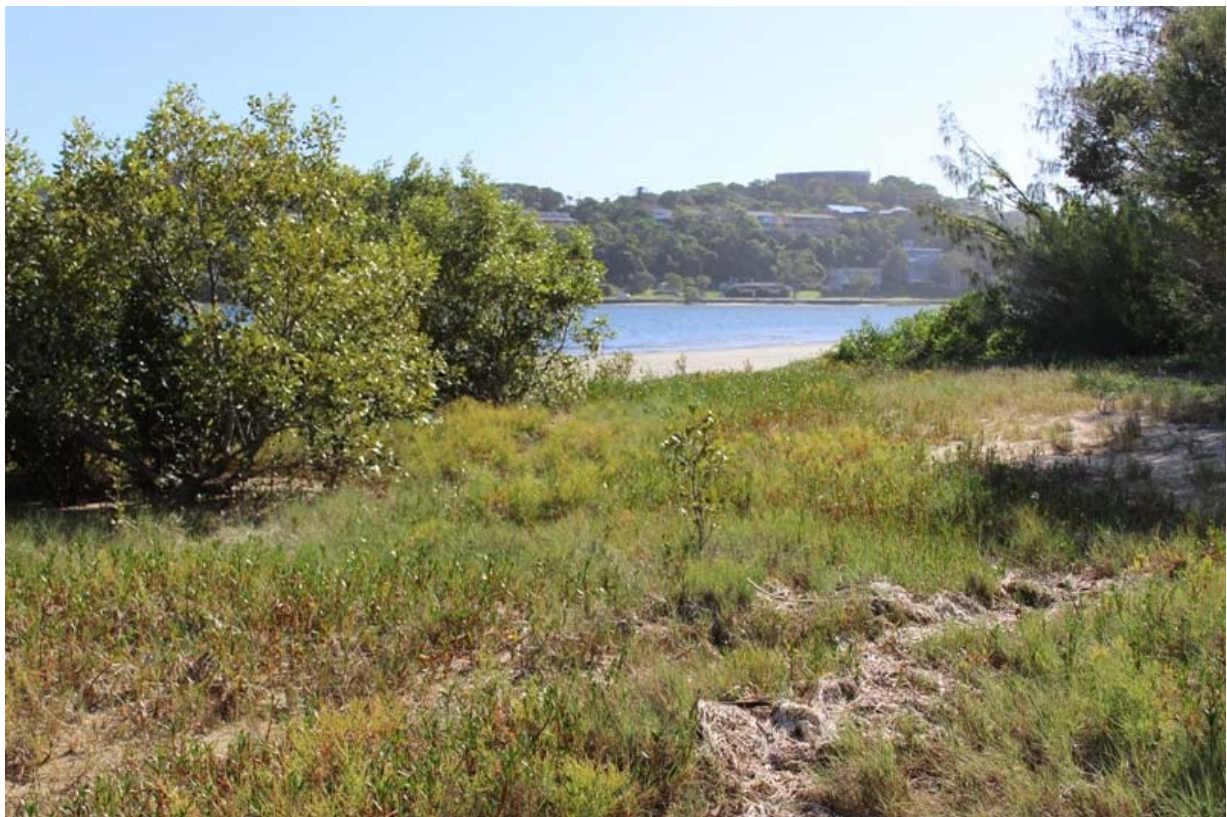
Figure 36: Shaws Bay saltmarsh community occurring behind mangroves. Dominant saltmarsh species are Saltwater couch (*Sporobolus virginicus*) and Shoreline purslane (*Sesuvium portulacastrum*)

The saltmarsh communities in Shaws Bay are dominated by Saltwater couch (*Sporobolus virginicus*) and the succulent Shoreline purslane (*Sesuvium portulacastrum*). Other commonly occurring succulent species were Samphire (*Sarcocornia quinqueflora*) and Astral Seabite (*Suaeda australis*). Small patches of sedge and rush species including Club Sedge (*Schoenoplectus* spp) and Sea Rush (*Juncus kraussii*) were observed sporadically around the perimeter, with one large sedge area just north of the beach area in front of the Shaws Bay Hotel. In general, saltmarsh communities were in good condition although weed invasion and encroachment by 'garden escapees' were degrading factors at some locations. Common weed species included Coastal morning glory (*Ipomoea cairica*), Siratro (*Macropodium atropurpureum*), Asparagus fern (*Asparagus aethiopicus*), and Bitou bush (*Chrysanthemoides monilifera*). It is also evident that Saltmarsh is restricted along its landward edge in many locations by hard structures (e.g. retaining walls, footpaths etc.), mown areas, or elevated topography. Over-time and in the presence of sea level rise it is likely that saltmarsh will be squeezed against these obstacles and landward-shifting mangroves and will eventually be replaced by them (refer to Section 6.2.4 further details).

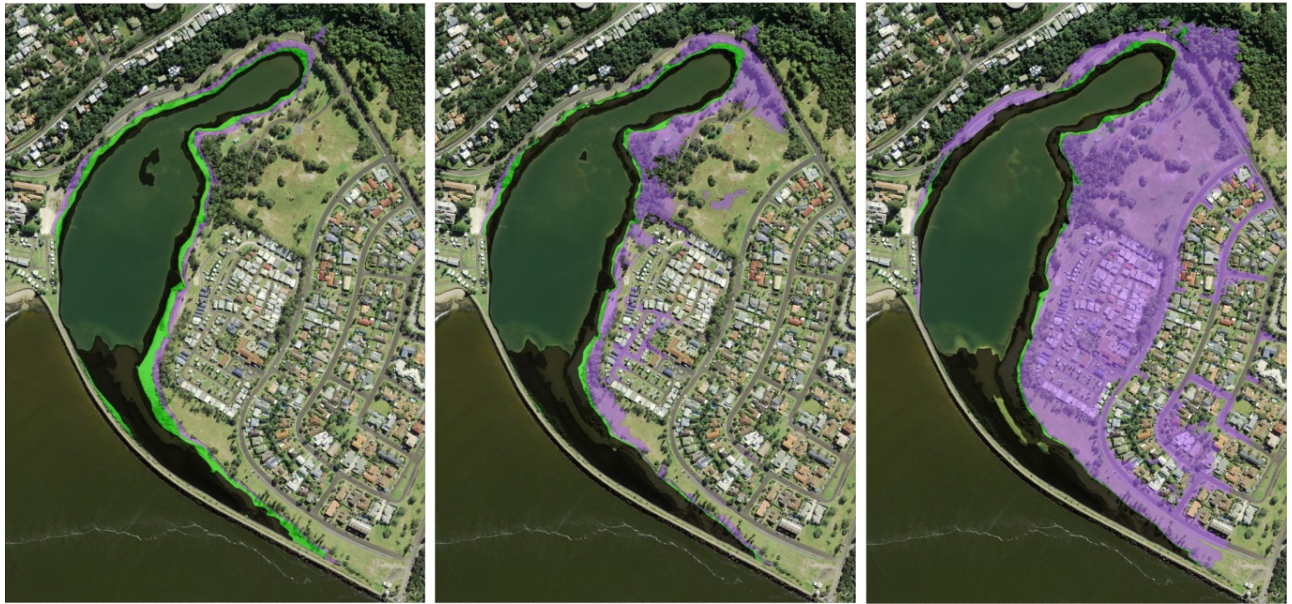
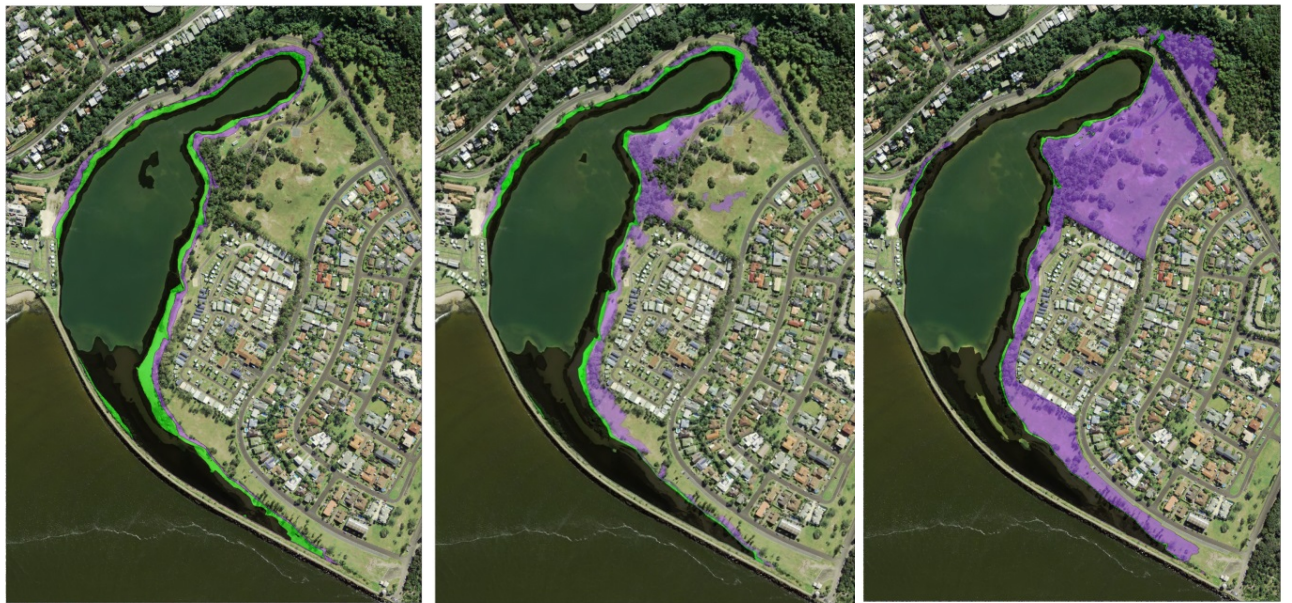
Figure 38: Potential areas for migration of estuarine vegetation types with sea level rise

Figure 38 shows the estimated potential areas for estuarine vegetation migration considering existing barriers and sea level rise scenarios for 2010 (current), 2050 and 2100 as well as these areas without the barriers (unconstrained). Seagrass (black); mangroves (green) and saltmarsh (purple) communities are depicted for each of the scenarios. Table 11 provides an estimate of the change in total area of seagrass, mangroves and saltmarsh for each of the scenarios and this is shown graphically in Figure 39.

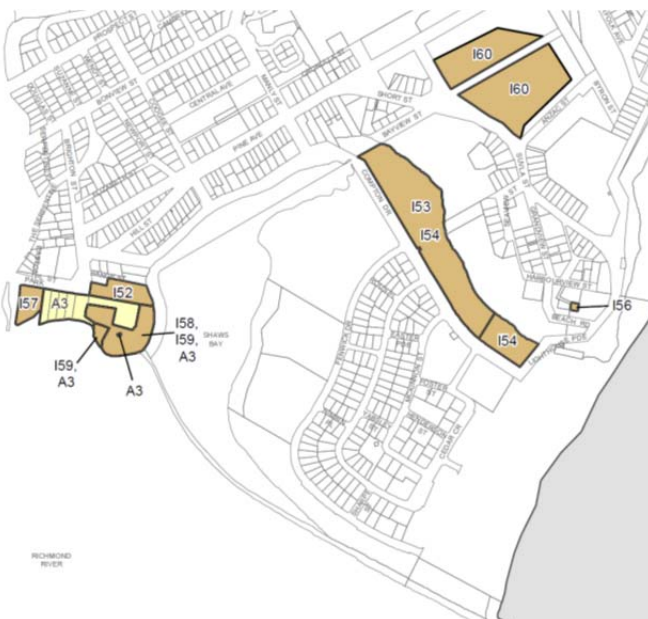
The Ballina Local Environmental Plan 2012 identifies the following heritage items in the study area (refer Figure 47):

The Ballina Local Environmental Plan 2012 also identifies the historic Shaws Bay precinct as an archaeological site (item A3 on Figure 47: Heritage items identified in Ballina LEP 2012 Figure 47).
