# **Coastal Zone Management Plan for Shaws Bay, Ballina**

## **Volume 2: Supporting Information**

**Final Draft**

**PROJECT 14-019 – SHAWS BAY CZMP - VOLUME 2: SUPPORTING INFORMATION**

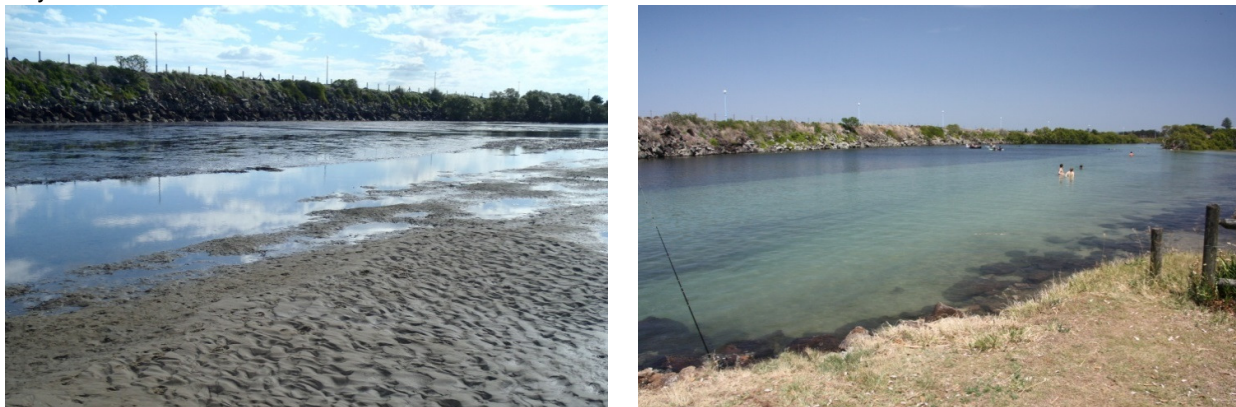
The large tidal exchange (see Section 3.5.2) and concentration of much of this flow in the East Arm, means that tidal flows are highly directional in this part of Shaws Bay, with velocities up to 0.3m/s in the sandy channel of the East Arm (PBP, 2000a). Within the Main Section of the Bay, tidal circulation is less observable but can be inferred from patterns in scour and sedimentation as well as the bathymetry of the Bay.

**Figure 7: Shaws Bay bathymetry East Arm at low tide (left) and king tide (right, January 2014)**

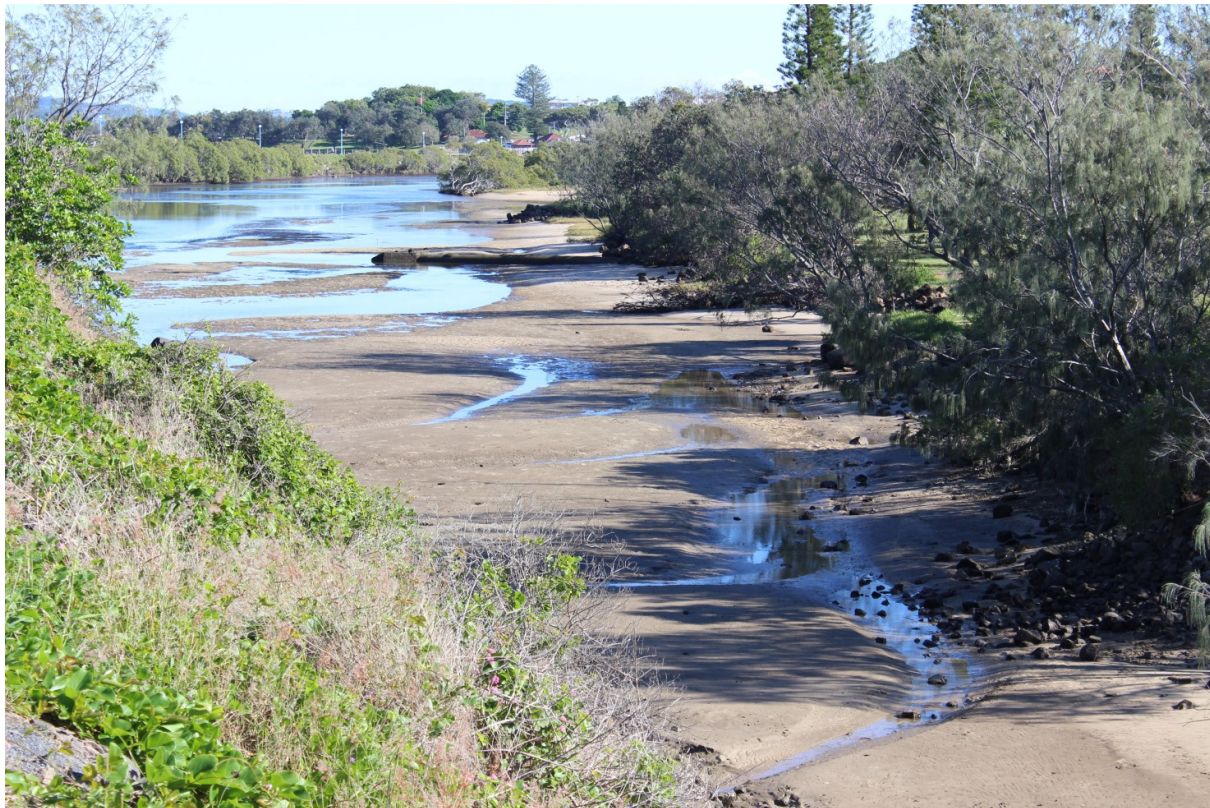
It is anticipated that continued sea level rise will lead to greater rates of tidal exchange in the future as the training wall currently appears to allow free exchange of higher water levels. This effect may be offset by increased sedimentation within and against the training wall and/or expansion of mangrove and seagrass growth along the wall within Shaws Bay which will further restrict exchange at low tide levels. Tidal exchange of the waters within the Bay may also change not only in response to rising average tide levels, but also due to sedimentation/dredging within the Bay which will alter the tidal prism and flushing characteristics.

**Figure 9: Low tide draining of the East Arm, Shaws Bay**

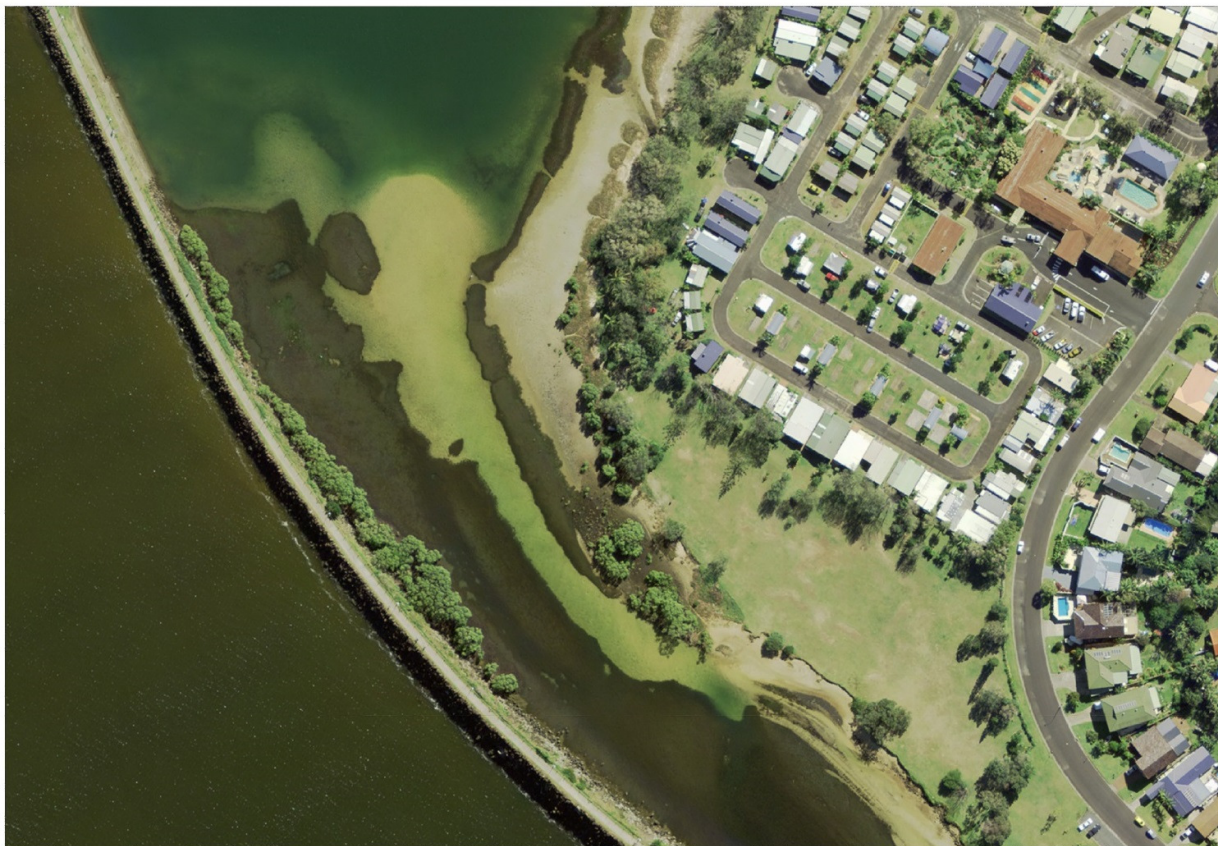
In conjunction with the broadening of the East Arm, comparison of the 1999 and 2013 bathymetric surveys also shows that this reach is becoming slightly shallower. It was observed during the seagrass surveys in 2014 (refer Section 6.2.1) that, apart from localised scour at points where the tide flowed through the training wall, the sediment composition along the southern side of the East Arm was generally finer. The deposition of this finer material encourages establishment of marine vegetation (seagrass and mangroves) which in turn reduces tidal scour and allows greater deposition. Unchecked, it is likely that this process will continue, with the sandy channel gradually meandering northward through erosion of the bank, with deposition of finer

**Figure 12: The sand delta formed at the confluence of East Arm and the Main Section of Shaws Bay and seagrass colonisation.**

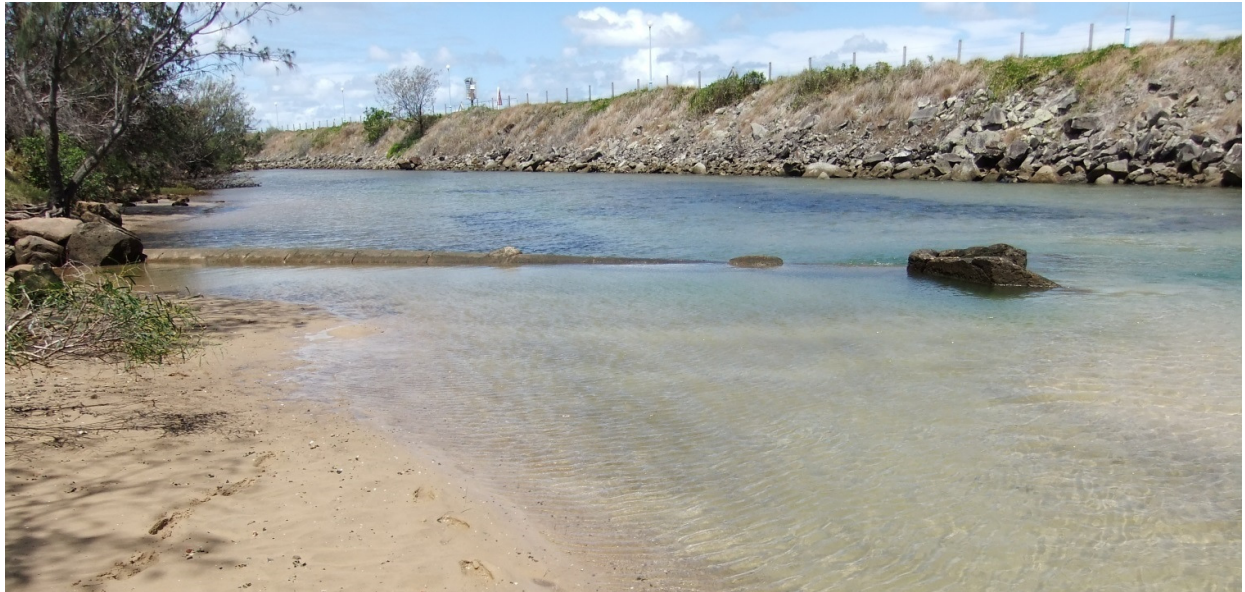
Bank erosion is most pronounced on the northern shore of the East Arm and has been occurring for several decades. The best visual indicator of the distance of bank retreat is the location of the stormwater outlet in this section of the Bay, which would originally have been constructed to coincide with the position of the bank but now the bank is around 13m behind the outlet location.

**Figure 14: Shoreline recession indicated by location of stormwater outlet in the East Arm**

Erosion in this reach is caused by the surging of water levels associated with long period waves propagating through the wall and into the East Arm. The oscillating water levels winnow out the fine sand from the base of the bank, leading to undercutting and eventual slumping of the bank face into the water. The loam material within the top 0.3m of the bank profile is fine grained and once this falls in the water, high tidal current velocities in this section have sufficient energy to transport this material away from the toe of the bank, thereby leading to ongoing erosion.

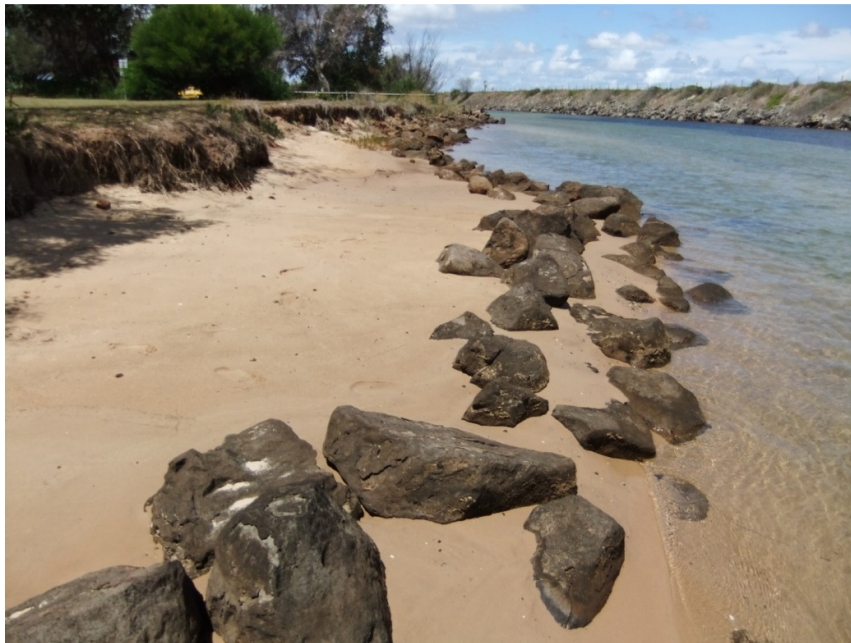
**Figure 15: Bank erosion beyond the rock revetment in the East Arm**

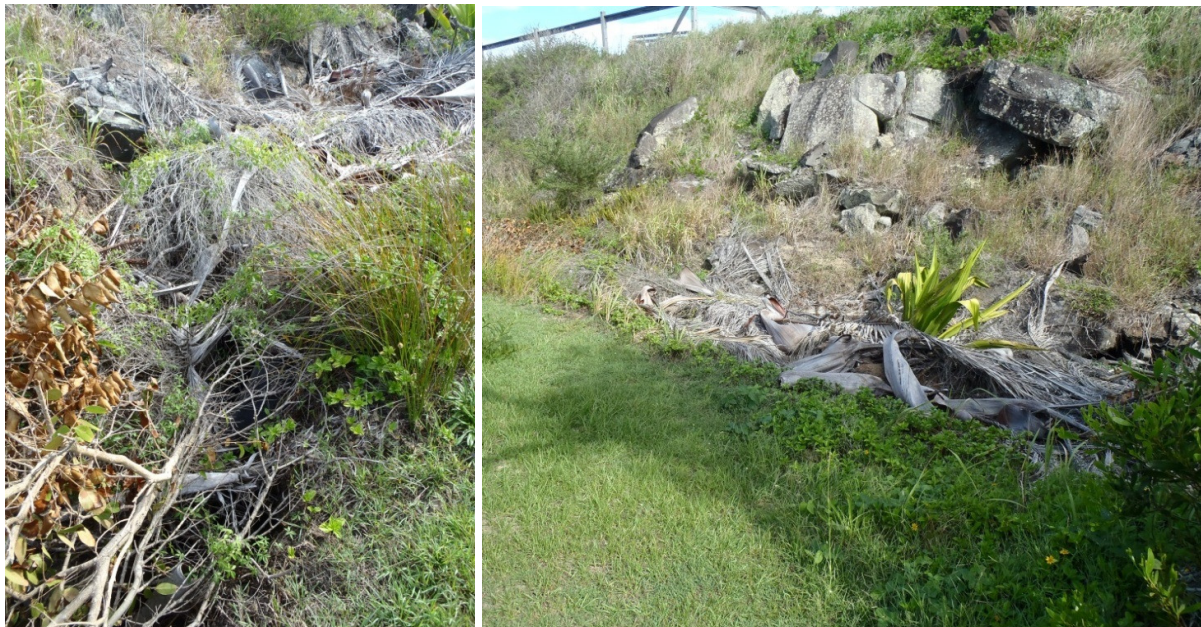
**Figure 16: Sink holes along the training wall partially covered by garden clippings**

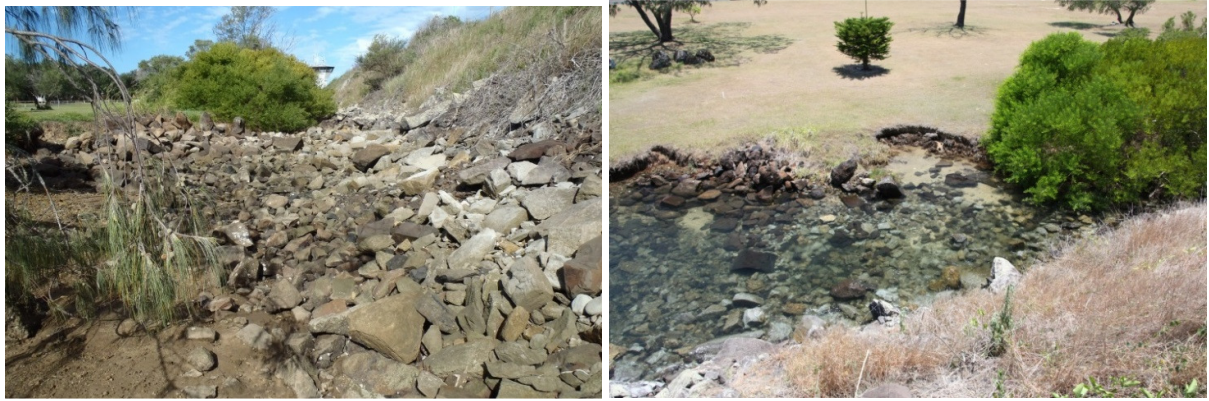
This same process is leading to the eastward extension of the East Arm despite extensive rock placement (Figure 17).

**Figure 17: Continued erosion at the eastern extremity of the East Arm**

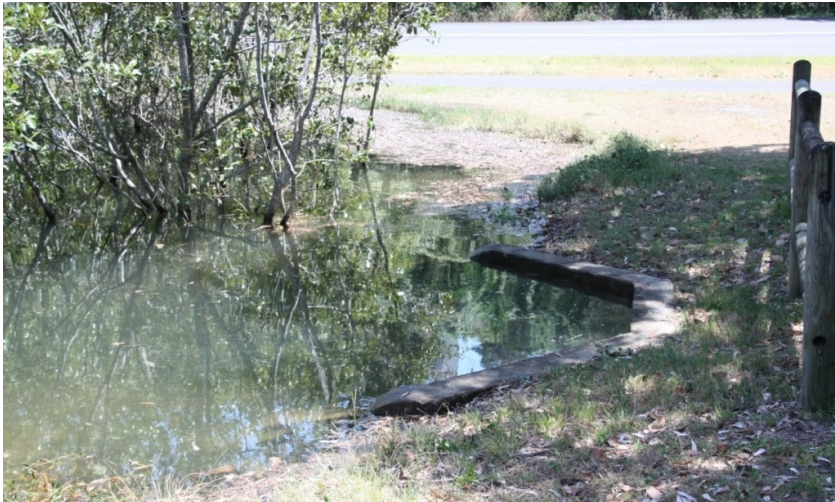
**Figure 19: Tidal inundation of stormwater drain (January 2014)**

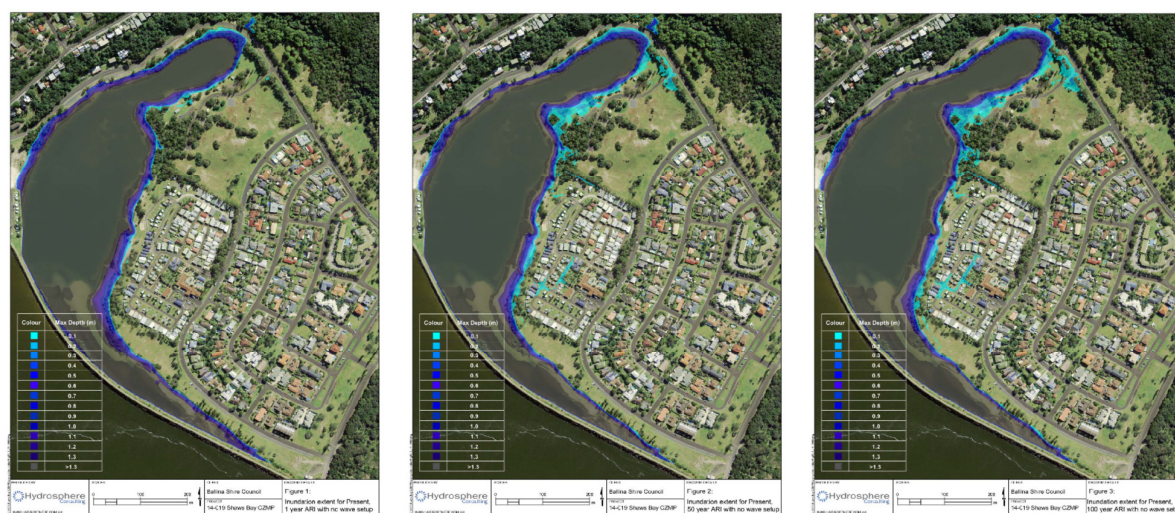
A subset of the inundation scenarios is provided below in Figure 20 and Figure 22.

**Figure 20: Predicted present day inundation due to 1, 50 and 100 year ARI ocean level events (not including wave setup)**

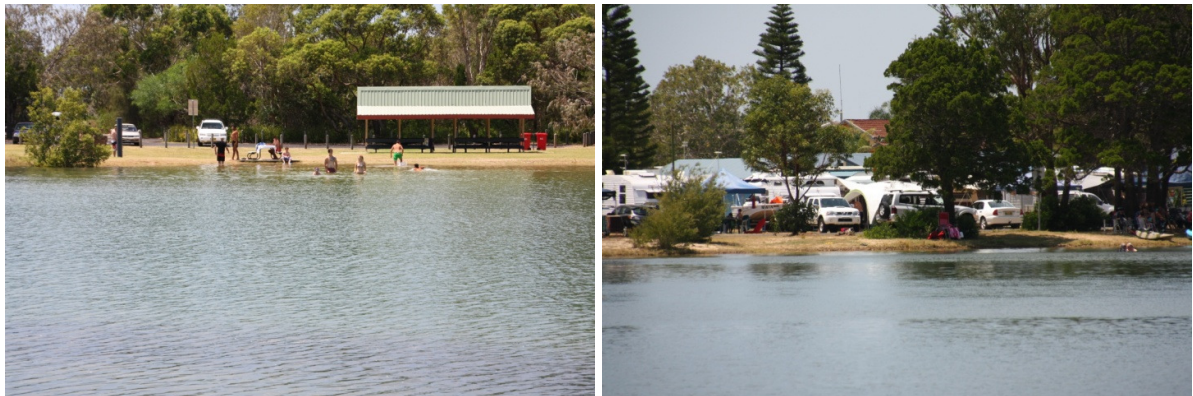
Ocean levels influence Shaws Bay by flowing through the training wall as discussed in Section 3.5 and can subsequently penetrate the low lying areas around Shaws Bay, particularly to the east, either by overland flow or intrusion through the stormwater network.

**Figure 21: High tide level at Pop Denison Park (left) and Ballina Lakeside Holiday Park (right) January 2014**

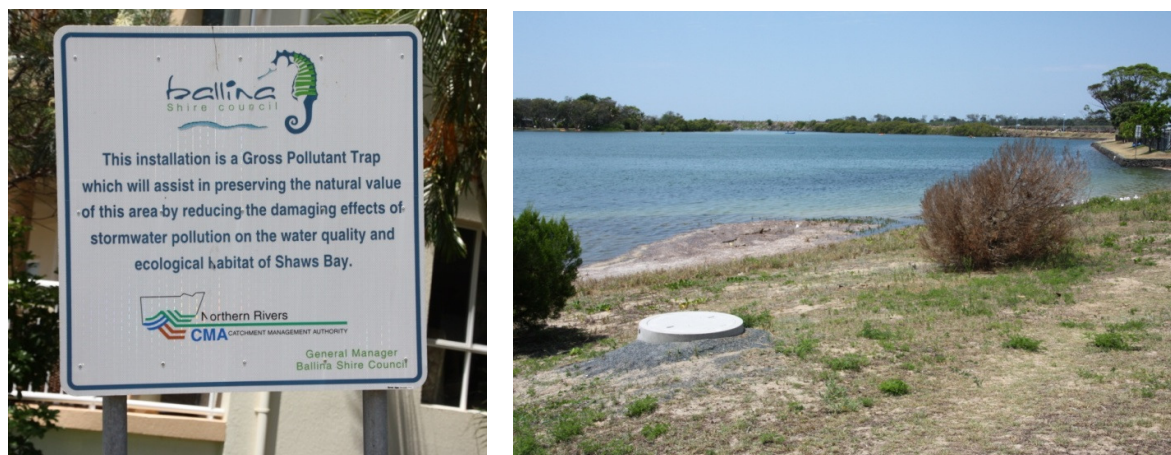
Since the 2000 EMP, several improvements have been made in the Shaws Bay catchment that are expected to have a positive impact of stormwater quality including the installation and regular maintenance of filter bag pit inserts into all stormwater drains in the Shaws Bay residential area (Figure 28), installation of two Gross Pollutant Traps (GPTs) and the introduction of organic waste recycling which assists in diverting garden waste to council composting operations.

Figure 27: Stormwater GPT installed on western foreshore

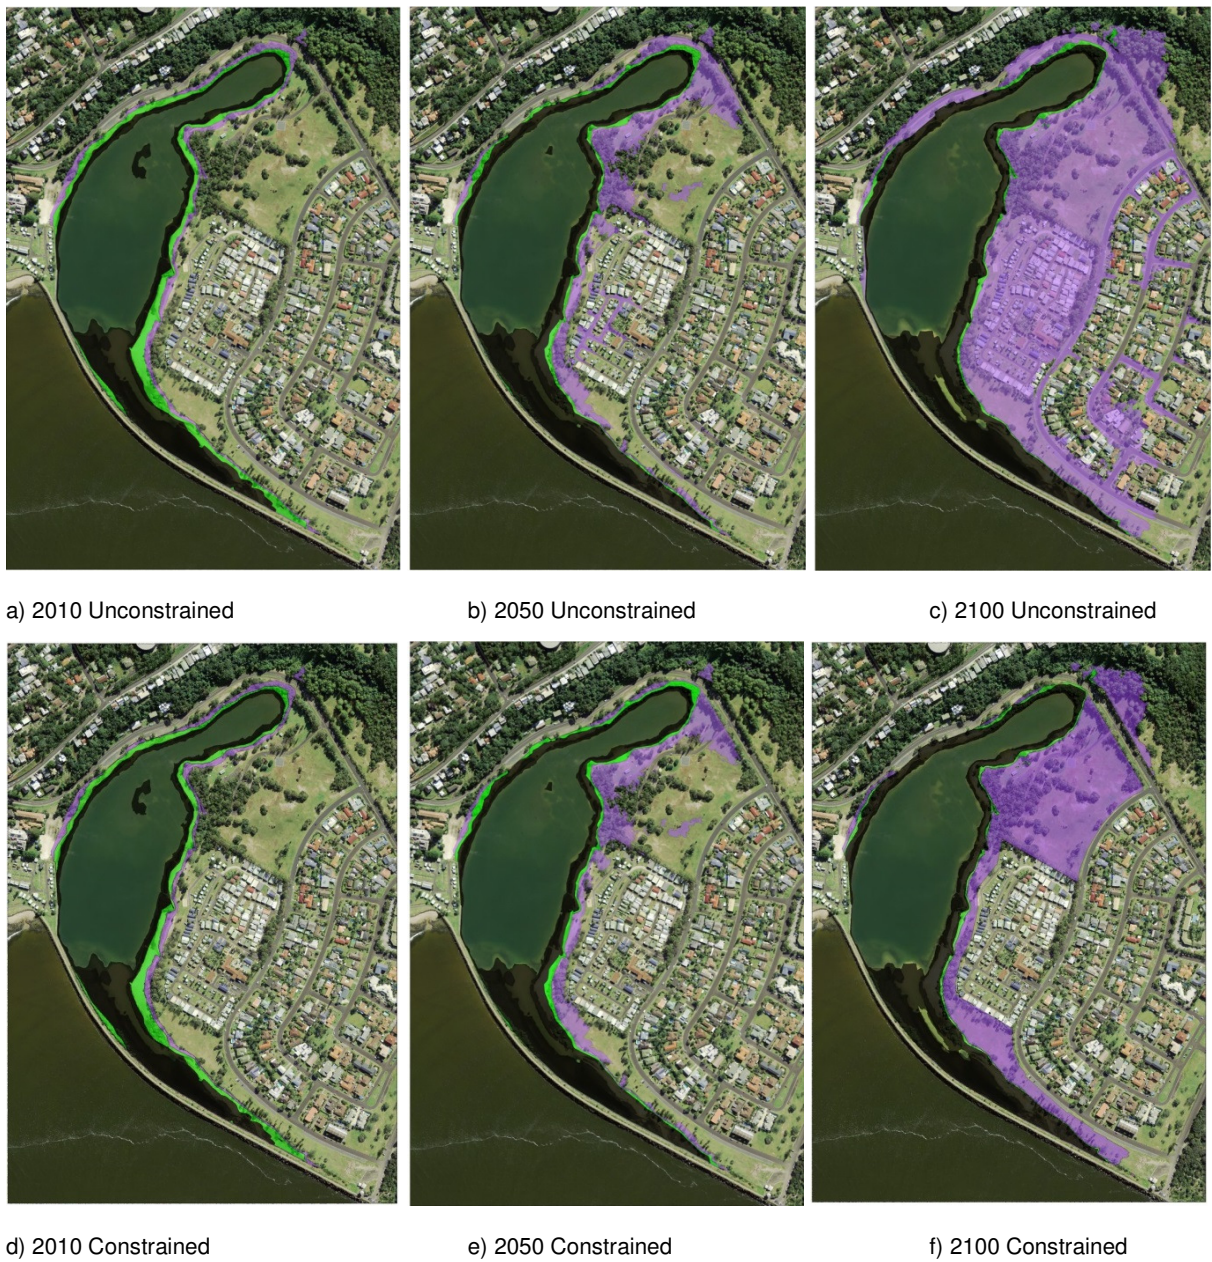
Figure 38 shows the estimated potential areas for estuarine vegetation migration considering existing barriers and sea level rise scenarios for 2010 (current), 2050 and 2100 as well as these areas without the barriers (unconstrained). Seagrass (black); mangroves (green) and saltmarsh (purple) communities are depicted for each of the scenarios. Table 11 provides an estimate of the change in total area of seagrass, mangroves and saltmarsh for each of the scenarios and this is shown graphically in Figure 39.

**Figure 38: Potential areas for migration of estuarine vegetation types with sea level rise**
