Lennox Head Seawall Upgrade Study

Reference: R.B20888.003.01.docx
Date: November 2016
Confidential

Leading on from this, BMT WBM has been commissioned by Ballina Shire Council to investigate the options for upgrading the shoreline defence at Lennox Head including a study to determine the competency of the existing historical seawall between Byron Street and the Lennox Head – Alstonville Surf Lifesaving Club. The Council's intent is to protect infrastructure under present day and future storm scenarios and identify any upgrading or seawall replacement required to provide a robust defence of the shoreline location. This is to be carried out with reference to the Coastal Zone Management Plan as well as maintaining a balance between amenity of the beach in front of the seawall and parkland between the seawall and Pacific Parade.

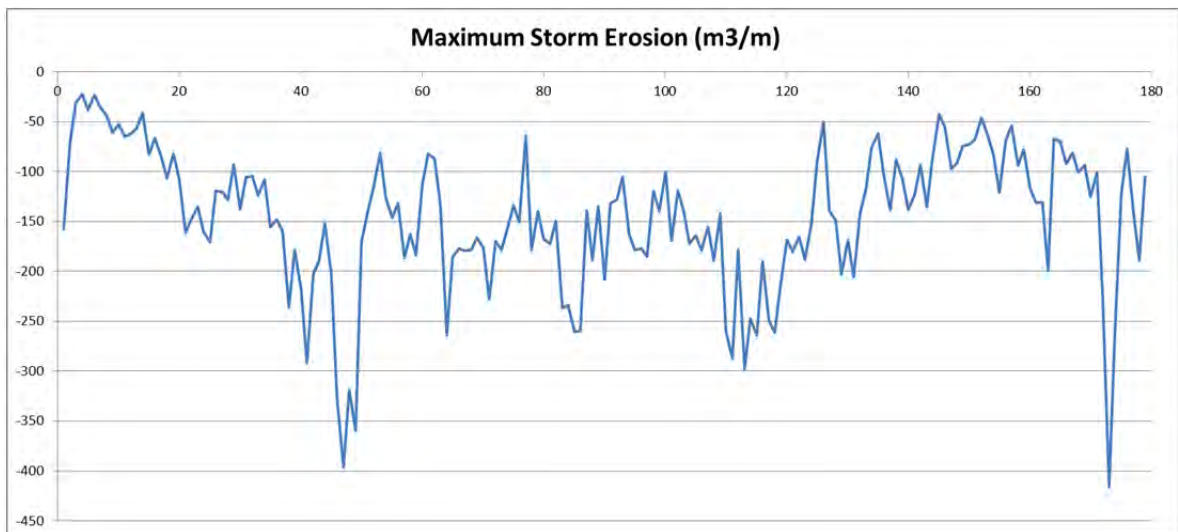
Figure 3-8 shows that the maximum volume loss along those shoreline sections where the presence of bedrock in the active beach profile is limited (Profile 35 and beyond) are typically in the range 150-300m³/m, consistent with experience at fully exposed ocean beaches elsewhere along the NSW coastline. However, south of Profile 35 the maximum volume losses are notably lower, particularly south of Byron Street (Profile 1 to 20) where the maximum historical volume loss is generally less than 50m³/m. The lower volume losses along the section south of Profile 35 can be attributed to the shallow bedrock that is present along this section of the coast.

Along the study area (Profile 20 to 38), the historical volume losses vary along the shoreline. Along the southern most 600m section (between Byron Street and Williams Street), the maximum volume losses are generally around 100-120 m³/m. North of Williams Street, as the nearshore reef become less profound, the maximum volume losses increase to approximately 200m³/m at Lake Ainsworth.

Figure 3-8 Historical Storm Bite Volumes along Seven Mile Beach

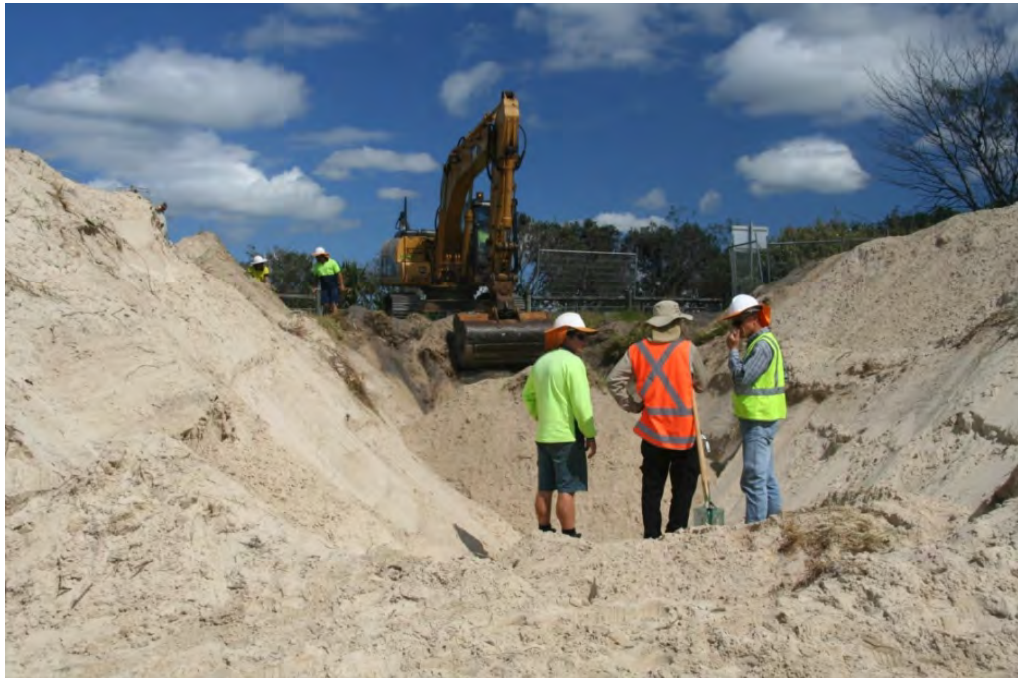
The arrangement of the wall at this location did not fit the general description of the seawall that had been built and later discussions revealed that the seawall probably didn't extend past the Lennox Head – Alstonville Surf Lifesaving Club.

Figure 4-5 Trenching back from the beach

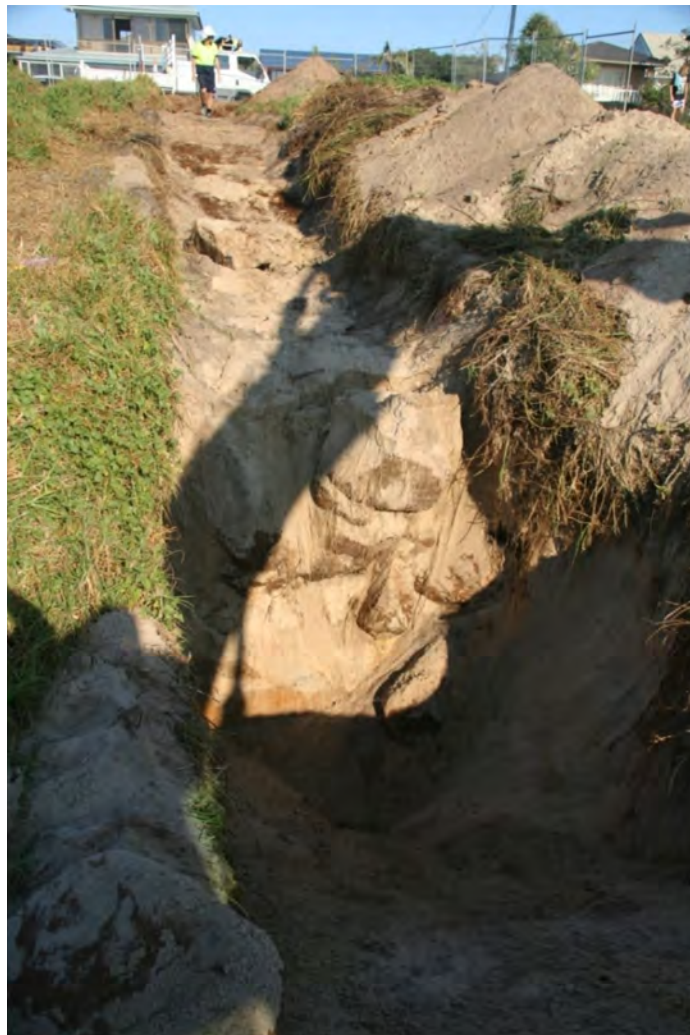
The toe section was replaced for safety and a second excavation was made about 2m landward of the toe. This site also contained half tonne rock in a 1m thick zone of red soil and smaller rock.

Figure 4-9 Toe of Rubble Slope

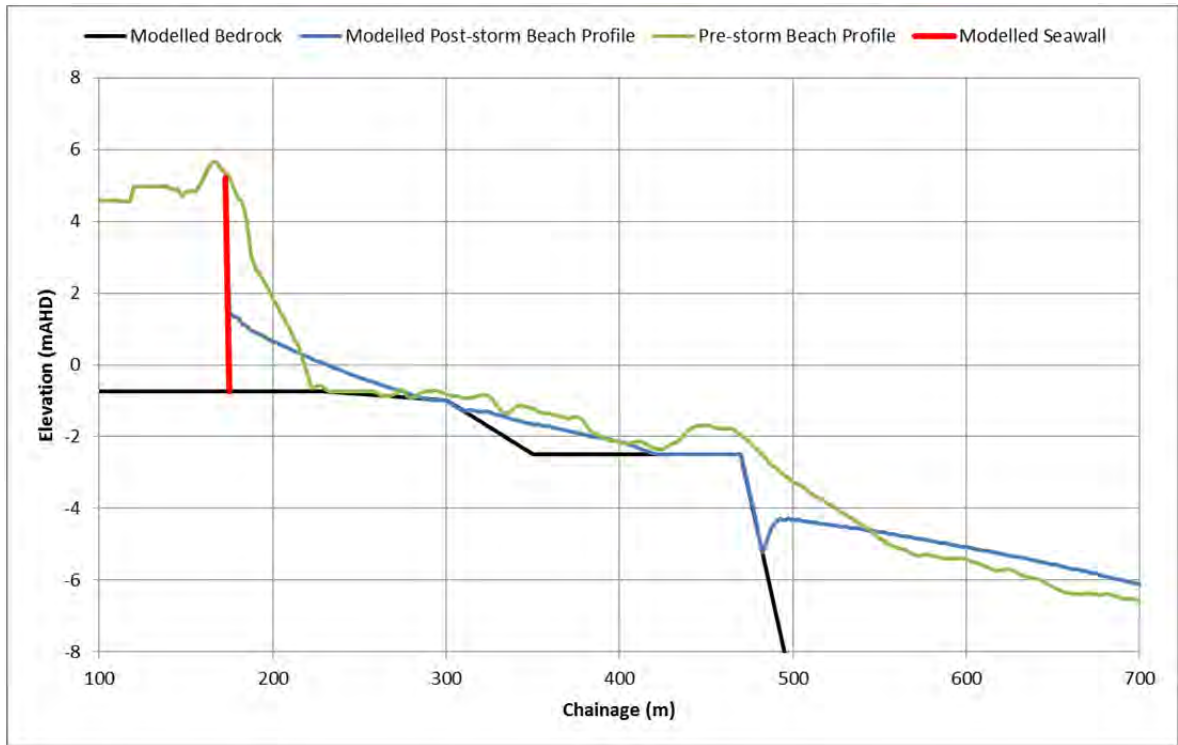
Under present-day conditions, assuming no further development between the seawall and Pacific Parade, the only infrastructure at risk due to storm erosion will be the car park at the end of Gibbon Street and any services located in this area. The road along Pacific Parade and the Surf Club building are presently not at risk of being affected by storm erosion for storm events up to the 100 year ARI event.

Figure 5-3 Modelled Post-Storm Beach Profile at Lennox Street for 100 year ARI event

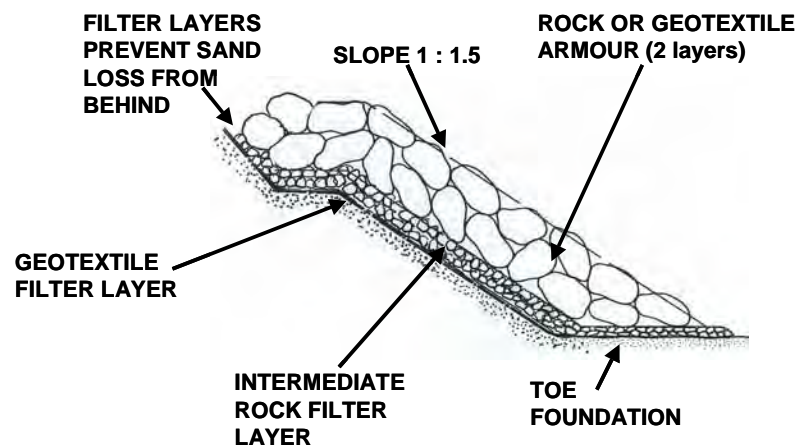
Figure 9-1 Design Section of a Typical Rock Seawall

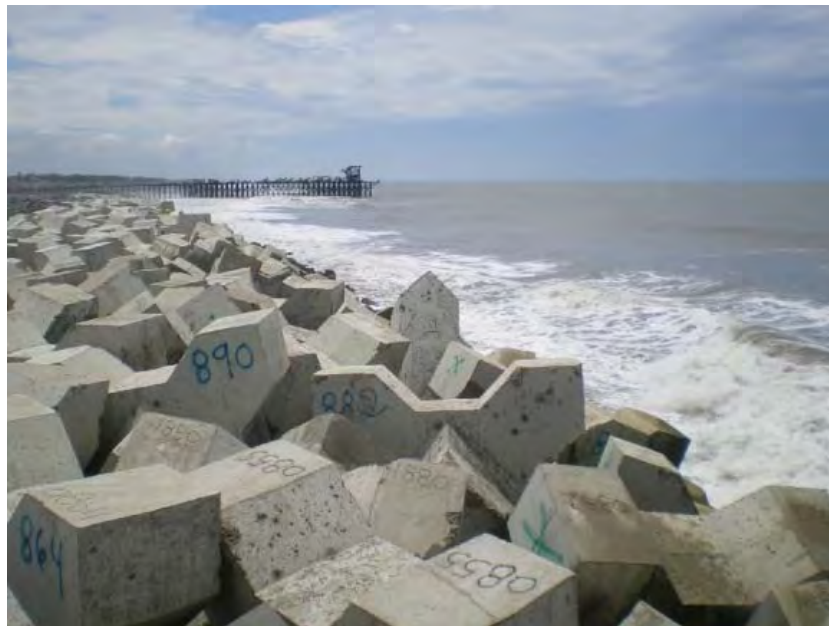
Figure 9-4 Randomly-Place Concrete Revetment (Photo courtesy Xbloc)

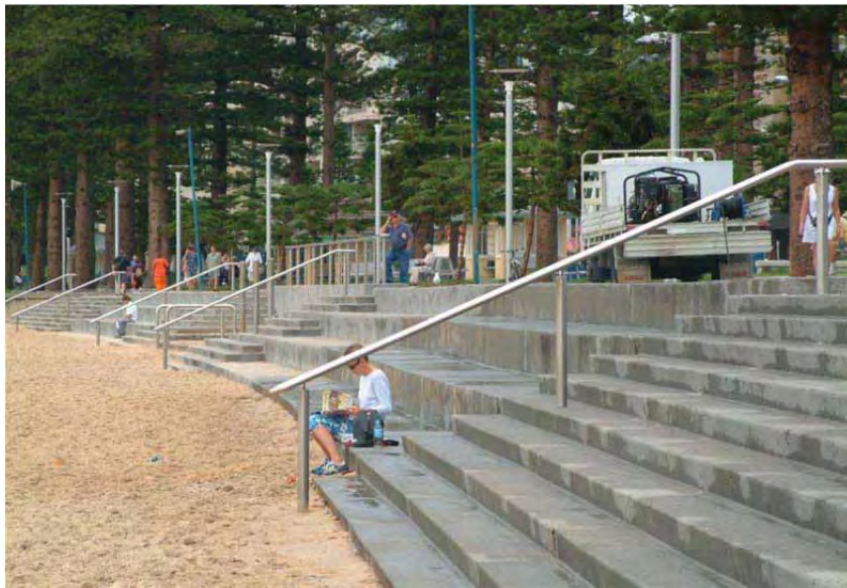
Figure 9-5 Stepped Seawall at Manly Beach, NSW (Photo from WRL, 2012)

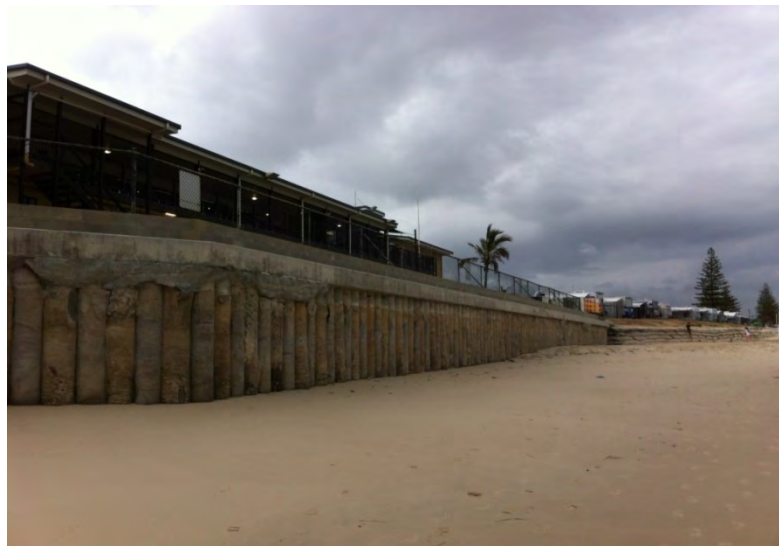
Figure 9-6 Secant Pile Seawall at Kingscliff Beach

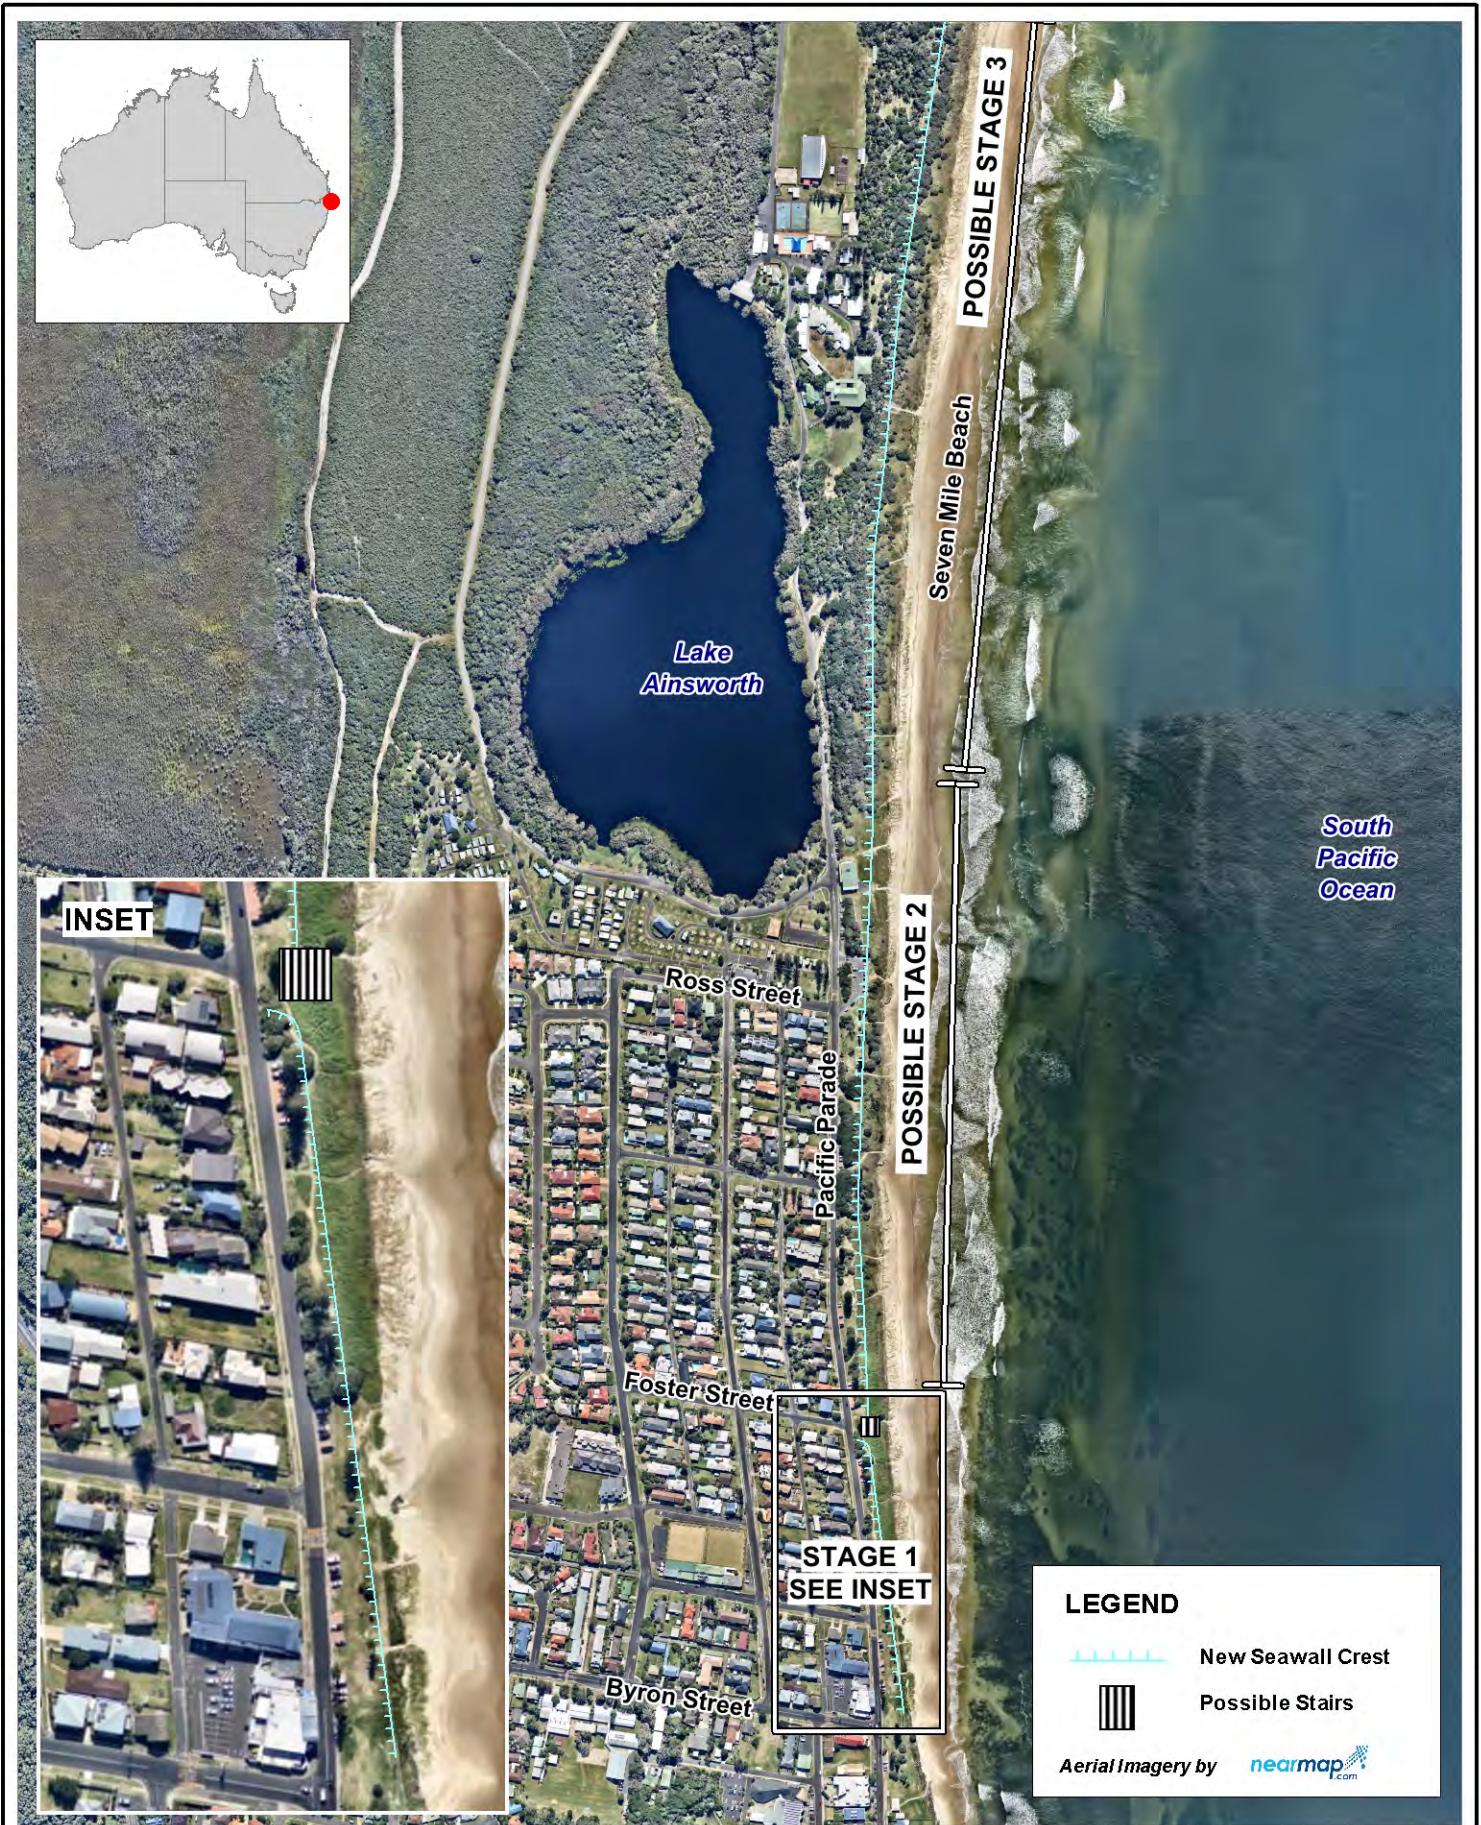
Figure:
11-1

The final stage will be the completion of the seawall to connect to the existing seawall protecting the Lake Ainsworth Sport and Recreation Centre including steps and associated carparks at the Lennox Head – Alstonville Surf Lifesaving Club and approximately 300m centres to the south. It is not possible at this time to predict when this might be needed, if staging is required or the cost.

Title:
Proposed New Seawall Construction Stages
