## PRELIMINARY CONTAMINATED SITE INVESTIGATION

Submission to Ballina Shire Council

BALLINA HEIGHTS ESTATE  
Lot 302 DP 1147087 & Lot 316 DP 1148856,  
Pacific Highway, Cumbalum

September 2010

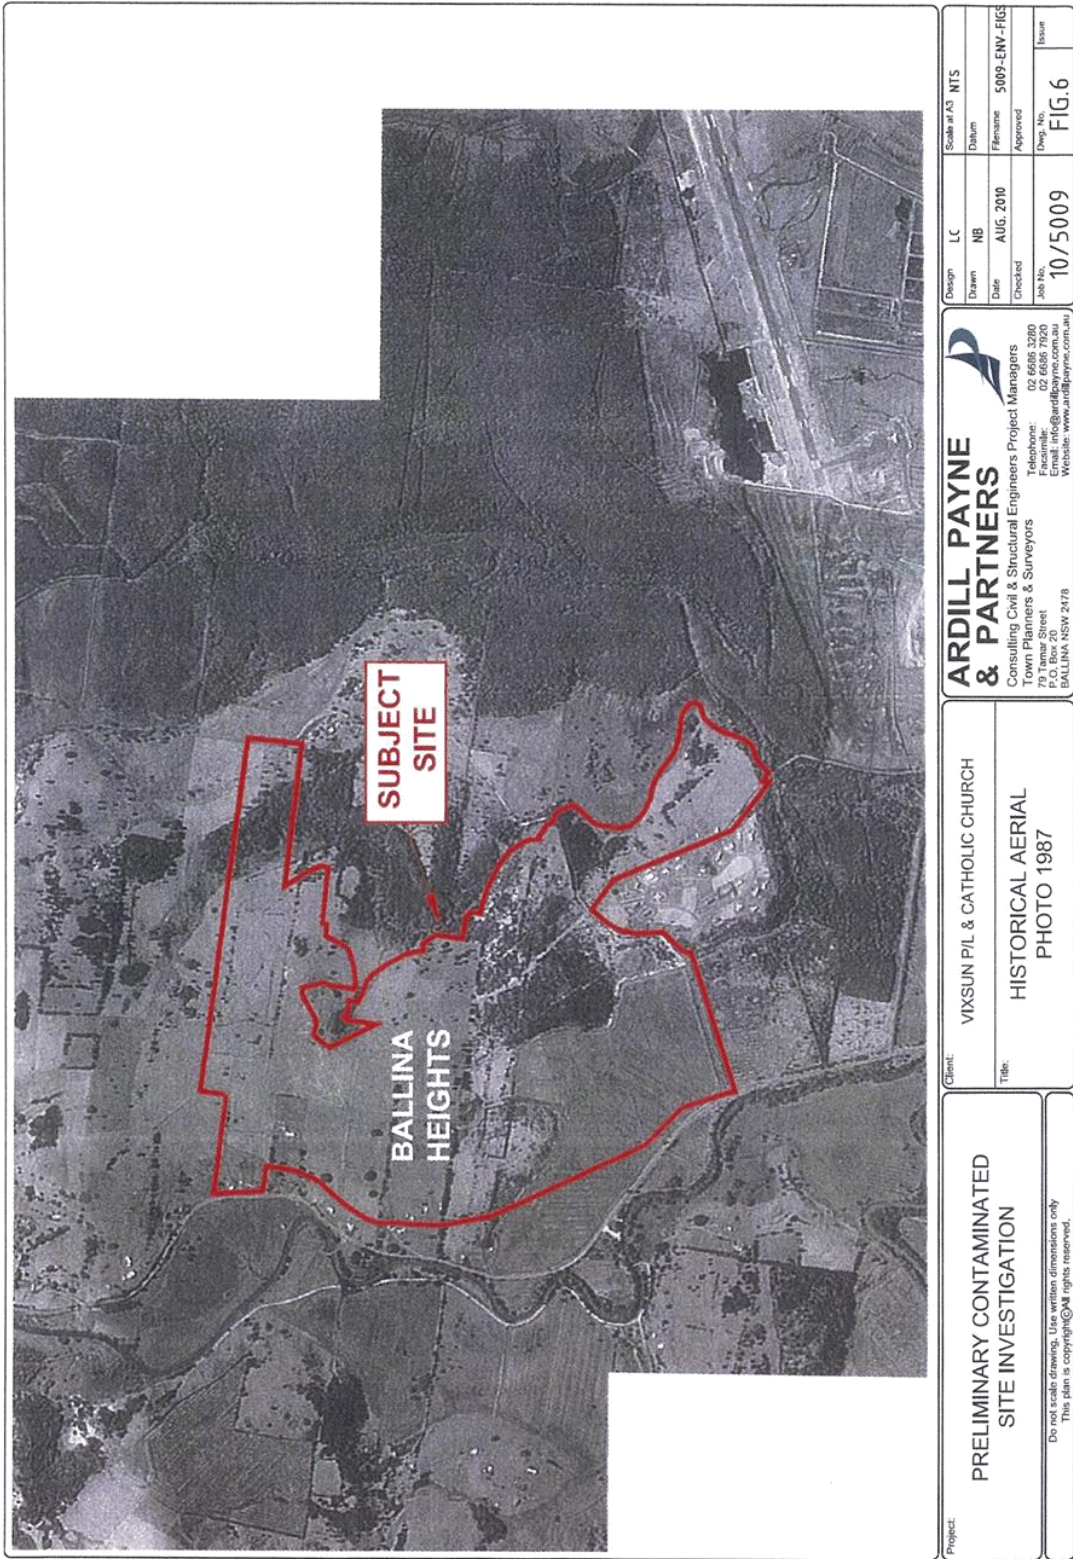
| Historical Aerial Photo Review | | Western Precinct | Eastern Precinct | Southern Precinct |
|---|--|---|--|---|
| 3/04/79<br>Refer to Figure 5<br>(Attachment 1) | Sugar cane is being grown on south-western portions. The north-south orientated shed identified in the previous image is no longer visible.<br>Possible agricultural areas in the mid section appear to be used for grazing. Refer to Figure 5 (Attachment 1). | No change evident to land use. Summerland Crescent to the south-east of the site is under construction. | No change evident to land use. | No change evident to land use. |
