PRELIMINARY CONTAMINATED SITE INVESTIGATION

Submission to Ballina Shire Council

Proposed subdivision of
Cumbalum Views

For:
Intrapac

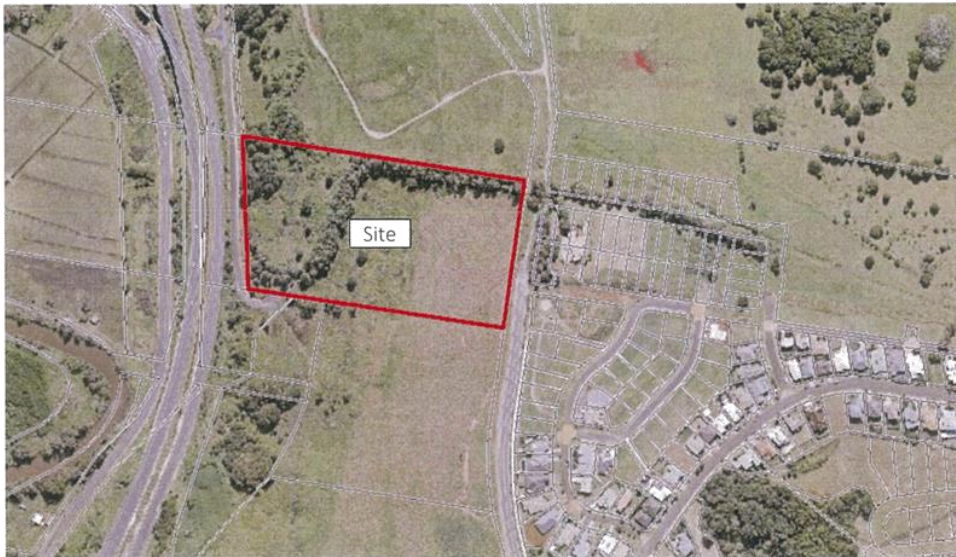
Figure 1: Site Locality

The site locality is shown in Figure 1.

The site is bound by Ballina Heights Drive to the east, future development to the south, Mitchell Close and Pacific Motorway to the west and vacant land to the north. The current acoustic environment at the site is primarily comprised of road traffic noise from the Pacific Motorway and the natural environment such as wind in vegetation and birds chirping.

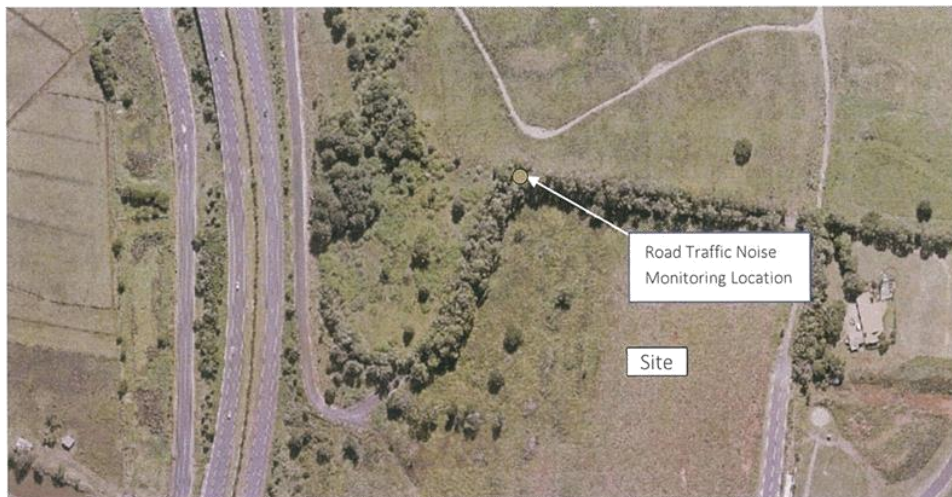
Figure 3: Noise Monitoring Location

Unattended noise monitoring was undertaken to measure the existing road traffic noise levels between Monday 22/07/2019 and Friday 2/08/2019. The noise monitoring location is shown in Figure 3. The noise monitor was placed along the northern property boundary approximately 170m from the nearest lane of the Pacific Motorway. The microphone was in a free-field position, approximately 1.4m above ground and had an unobstructed view of the motorway.

The noise monitor was set to measure statistical noise levels in 'A' weighting, 'Fast' response, over 15 minute intervals. Road traffic noise levels were measured in accordance with Australian Standard AS2702¹. Weather conditions for the days used for road traffic noise verification were fine and suitable for noise measurement.

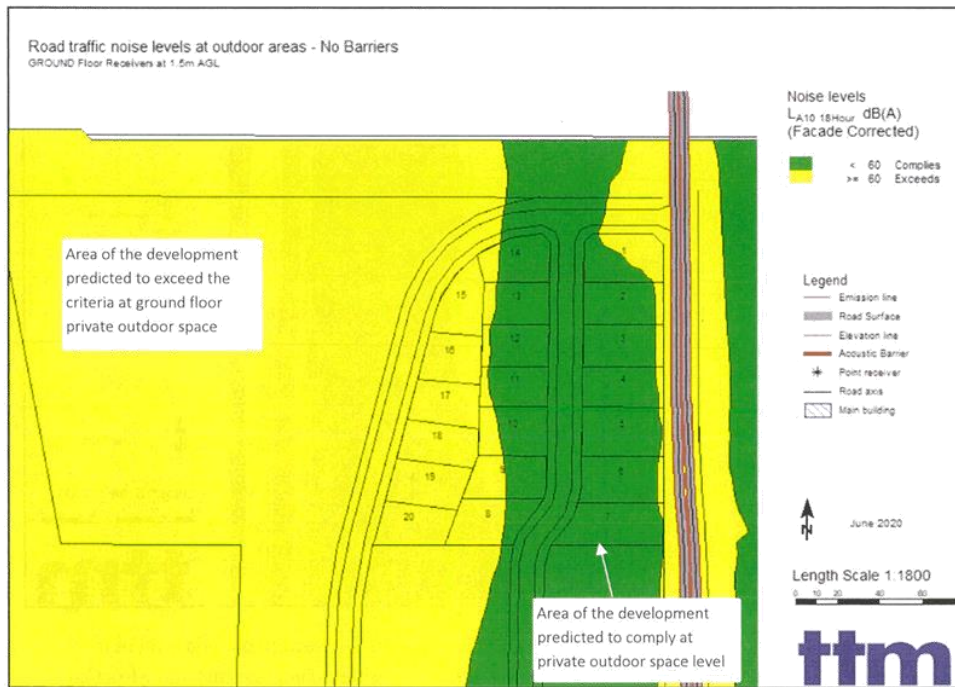
Figure 4: Predicted Ground Floor Private Outdoor Space Road Traffic Noise Levels – No Acoustic Barriers

Figure 4 presents the road traffic noise contours at ground floor private outdoor space level with no acoustic barriers.

Modelling shows that road traffic noise levels are predicted to exceed the external criteria at lots on the western side of the development. Given the orientation of future dwellings (garages and entry facing west) on Lots 15-20, outdoor recreation areas will be shielded by the building and are expected to comply. With the inclusion of a dwelling onsite, all lots are predicted to have an area of compliant outdoor space.

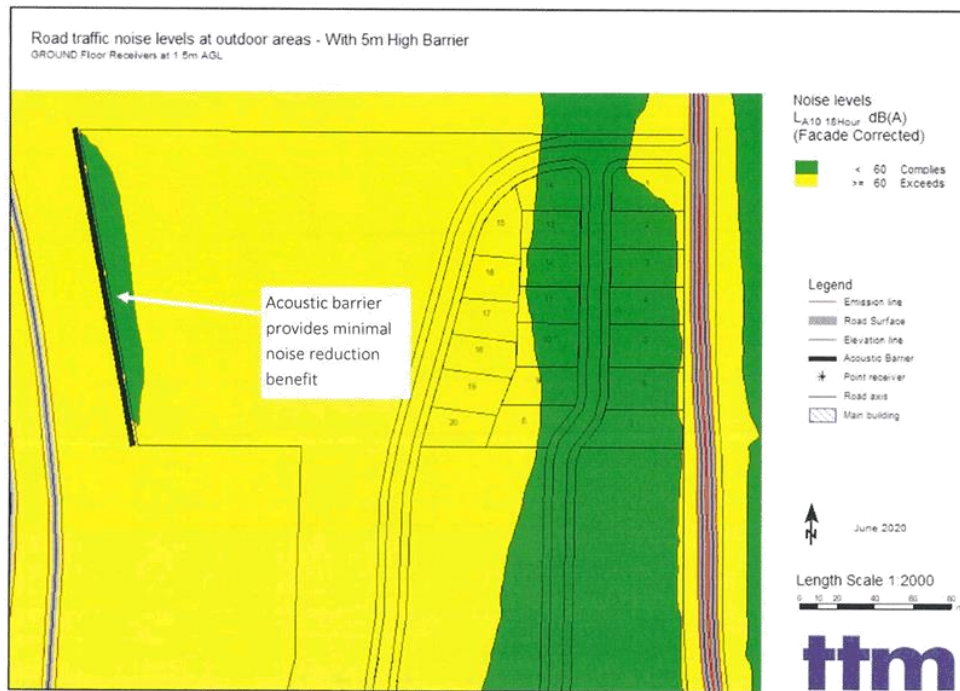
Figure 5: Predicted Ground Floor Private Outdoor Space Road Traffic Noise Levels – With Acoustic Barriers

Figure 5 shows the effect of a 5m high acoustic barrier located on the western boundary of the site.

The noise modelling shows that with an acoustic barrier (5m high) on the western boundary there is negligible noise reduction benefit across the site. Therefore, it is considered impractical to construct an acoustic barrier at this location based on the natural terrain levels and this assessment will consider the results excluding barriers. It is noted that once earthwork levelling is conducted for the site, the benefit achieved by acoustic barriers in selected locations may be improved and barriers may be reconsidered at this stage.

Due to the undulating nature of the site which rises significantly from the Pacific Motorway towards Ballina Heights Drive in the east, large height acoustic barriers located on the western boundary are predicted to provide negligible benefit to the site. Noise modelling inclusive of an acoustic barrier on the western boundary was conducted as a guide to show the effect of a barrier in relation of the undulating nature of the terrain. For the purposes of modelling a barrier height of 5m was chosen.
