BALLINA SHIRE COUNCIL AQUATIC FACILITIES STRATEGIC FINANCIAL PLAN DISCUSSION PAPER (2011)

Section 1 - Ballina Swimming Pool

Section 2 – The Alstonville Aquatic Centre

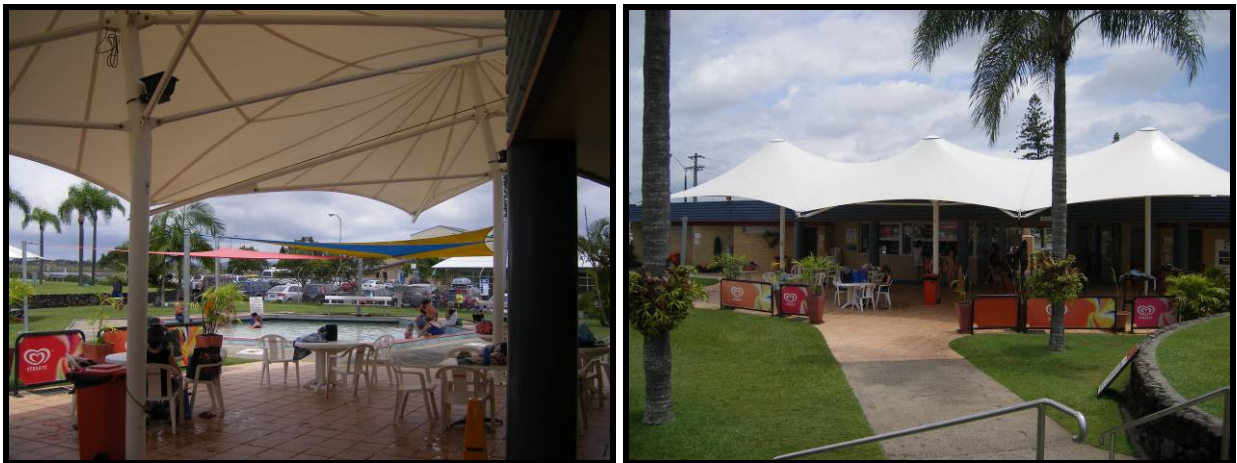
Kiosk Area Photos

The amenity and kiosk buildings are in relatively good condition and meet current access and user requirements. The kiosk area is suitable to the current operations. The floor coating in the male and female amenities has lifted in areas and will require re-surfacing the short term. The contracted pool managers have provided timber tables and seating around the toddlers pool / kiosk area to accommodate for parental supervision close to the kiosk area and within the shaded area.

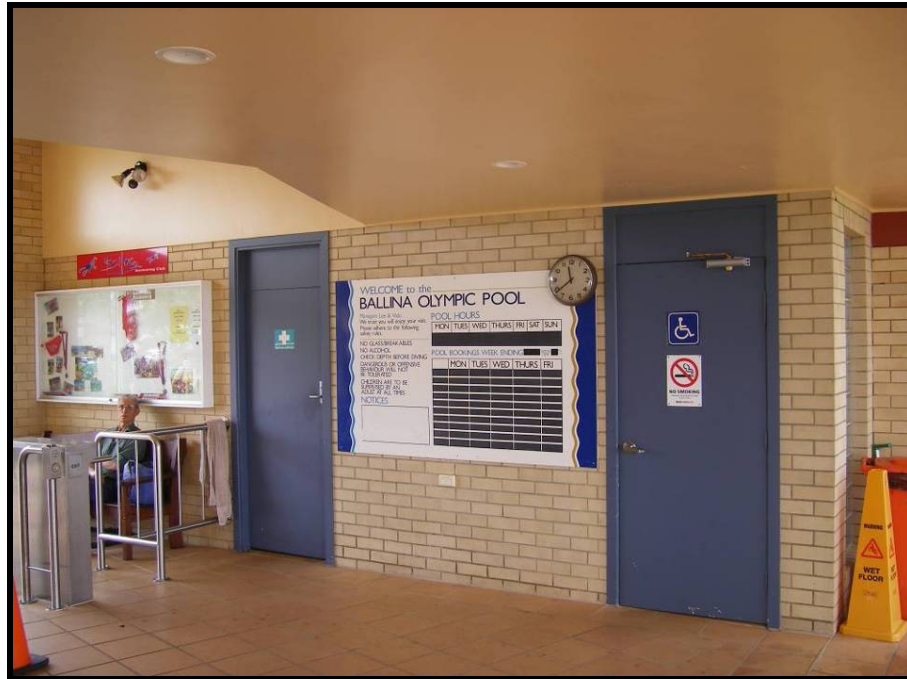
Wheelchair Accessible Amenities

Toilet and shower facilities are provided for both male and female patrons that have special access requirements. Access to the 50 metre and training pools for patrons with mobility restrictions is provided by a mobile chair lift. The mobile chair lift is operated by pool staff and requires a reasonable amount of careful manual handling. The training pool has steps and a hand rail for patrons that require extra security to increase stability when entering the water.

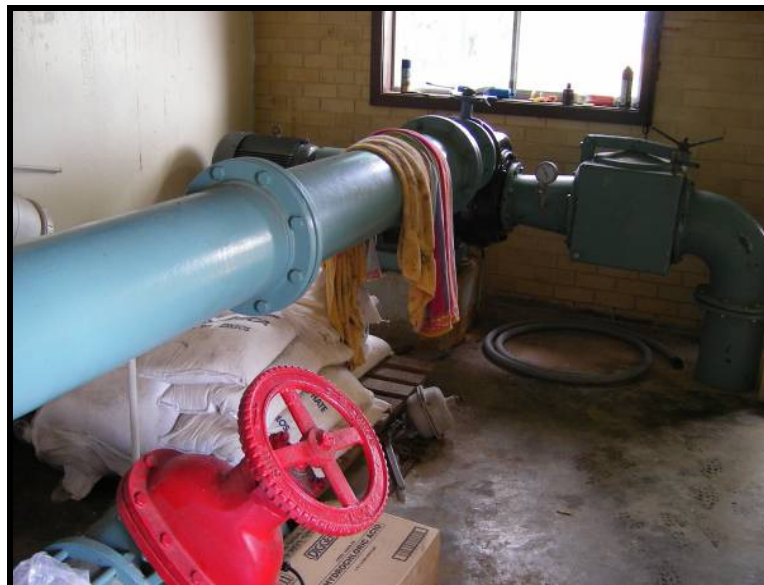
Pool Plant Room

The plant room is for the most part as constructed however it is deteriorating from age and the corrosive environment produced by the pool chemicals. There have been various modifications to the chemical dosing arrangements since the facilities construction. The swimming pool water is currently filtered by the original sand bed filters and then treated with chlorine, CO₂ and acid as necessary. The CO₂ injection system was installed in 2005 and mostly reduces the need for pool acid and other additives. The plant room brick work, pipes and fixtures are all exhibiting deterioration from 35 years of exposure to the harsh chemical environment. Currently the pool backwash water is slowly fed to sewer via a storage tank behind the plant room. Approximately 40,000 litres of backwash water is fed to sewer each week.

To provide for continued uninterrupted business the pool plant room will require modifications in the short to medium term. The existing plant is operational and effective however it is ageing and reaching the end of its useful life. The electrical switchboard and wiring systems also require replacement in order to be in line with current technology and standards to reduce the possibility of breakdown and other electrical related risks.

The long term scenario to maintain pool operations in the existing configuration would be to refurbish the plant room and replace the filter system with modern technology. If the facilities were to be redeveloped refurbishment of the existing plant room and filtering equipment would be an essential component. Coffs Harbour's 2010 refurbishment has shown that existing plant room building structures similar to this Council's can be utilised to create a modern plant room.

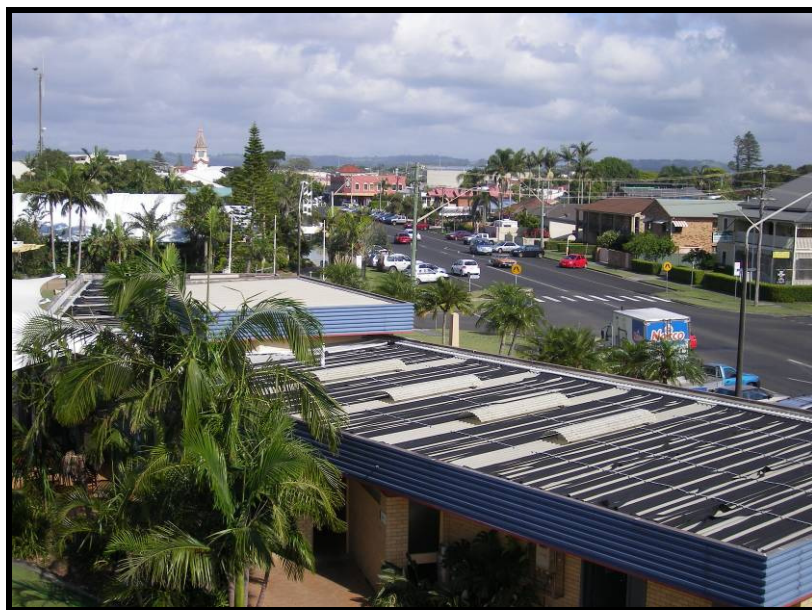
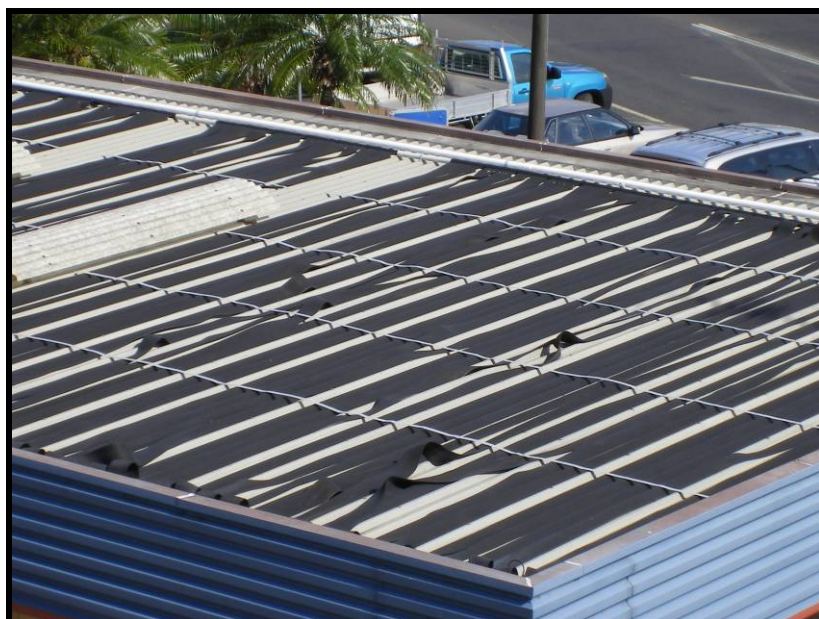
Pool Heating on Amenities Roofing

The Ballina pool facility has approximately 300 square metres of existing solar heating installed on the amenity building roof. The black tubing, joints and baffles that make up the solar water heating system are deteriorating from age. Heat retention blankets have also been provided to assist in retaining any heat provided by the solar system during operational hours. The sites exposure to wind dramatically reduces any heating affect from the existing solar heating system whilst the pool water is exposed during operating periods, particularly during the cooler shoulder periods at the beginning and end of the pool season.

The current solar water heating system does not adequately provide any meaningful increase to the pool water temperature during normal operations due to the size of the system and the effects of the wind. A number of alternative water heating options are available, however to provide stable water temperatures and to enable an extension of the pool season at the Ballina Site the most energy efficient water heating system available is a heat pump system. These systems can both operate as a stand alone heating system or can be utilised to work along side solar heating systems. The introduction of additional roof areas such as indoor pools or covered spectator seating could make further solar heating systems a viable supplement to a heat pump system.

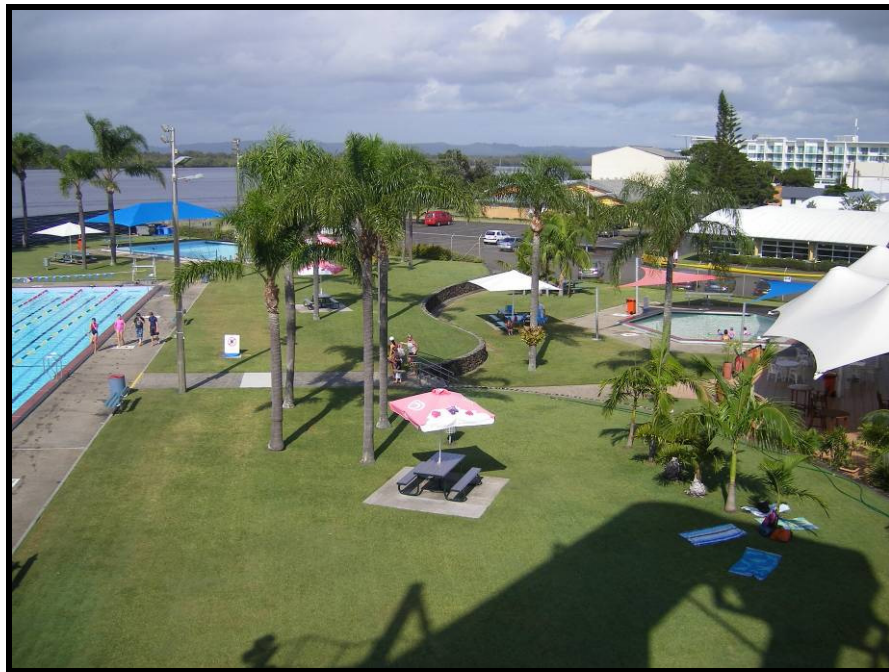
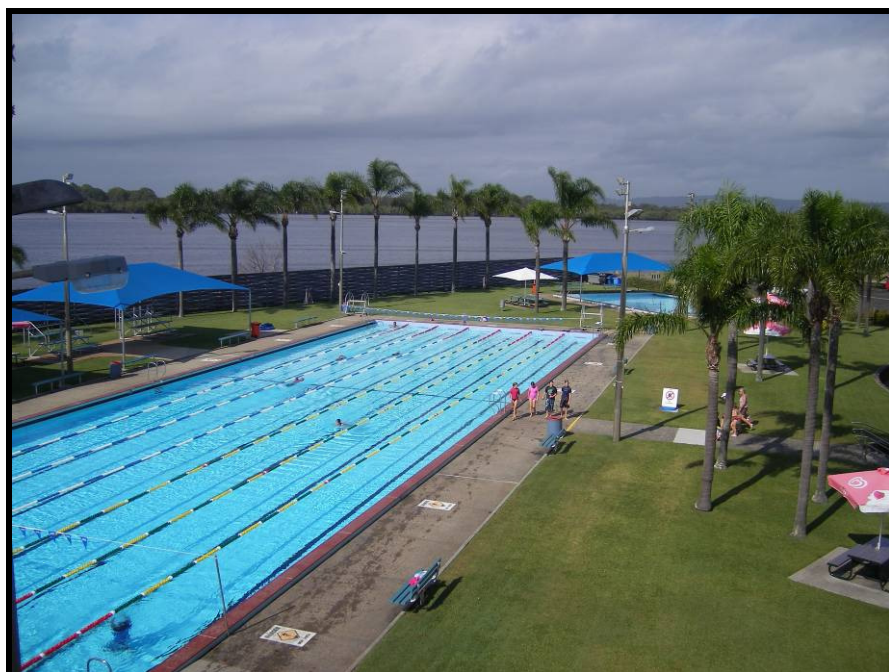
The grounds of the facility are very well presented much of the landscaping is as constructed with a few changes to pathways and general access. As per the Alstonville Pool facility there is a continuing Cocos Palm tree replacement program. No barbeque facilities are provided on the site however there are 14 picnic sets available for use by the patrons. There are four ageing spectator stands which are situated along the Southern side of the 50 metre pool. The stands were provided with shade in 2004.

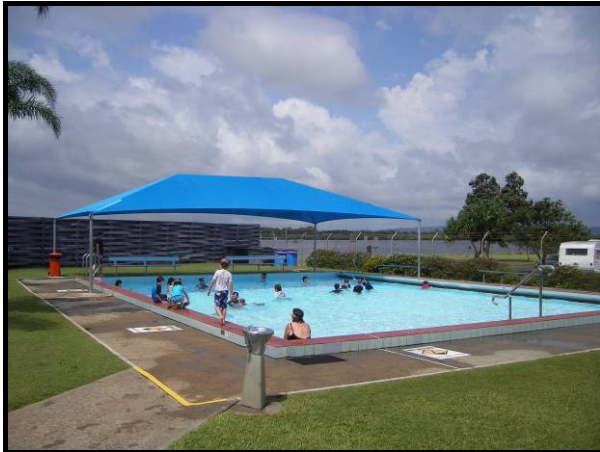
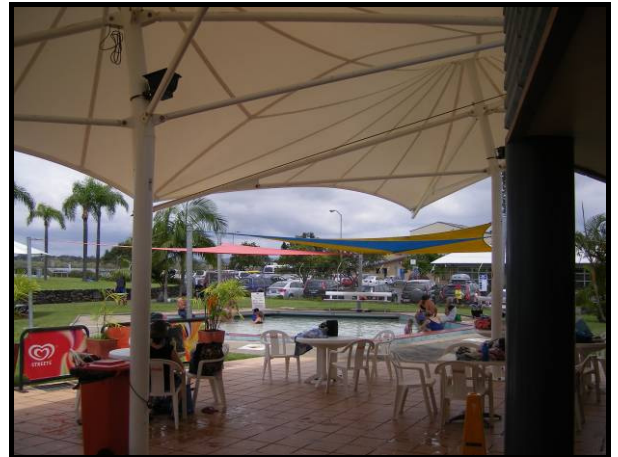
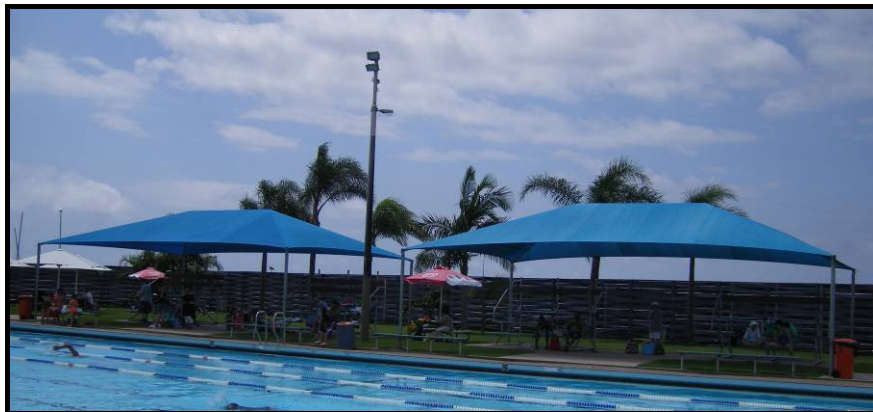
Shade structures were installed at the Ballina facility in 2004. The structures installed around the kiosk and toddlers pool area provide for adequate shading. Shade structures were also installed to cover the spectator stands adjacent the 50 metre pool and also the Southern end of the training pool for spectators and approximately 15 percent of the pool for swimmers. No shade is provided over any part of the 50 metre pool. The shading at the Ballina pool facility is enhanced by large umbrellas on a number of the picnic tables.

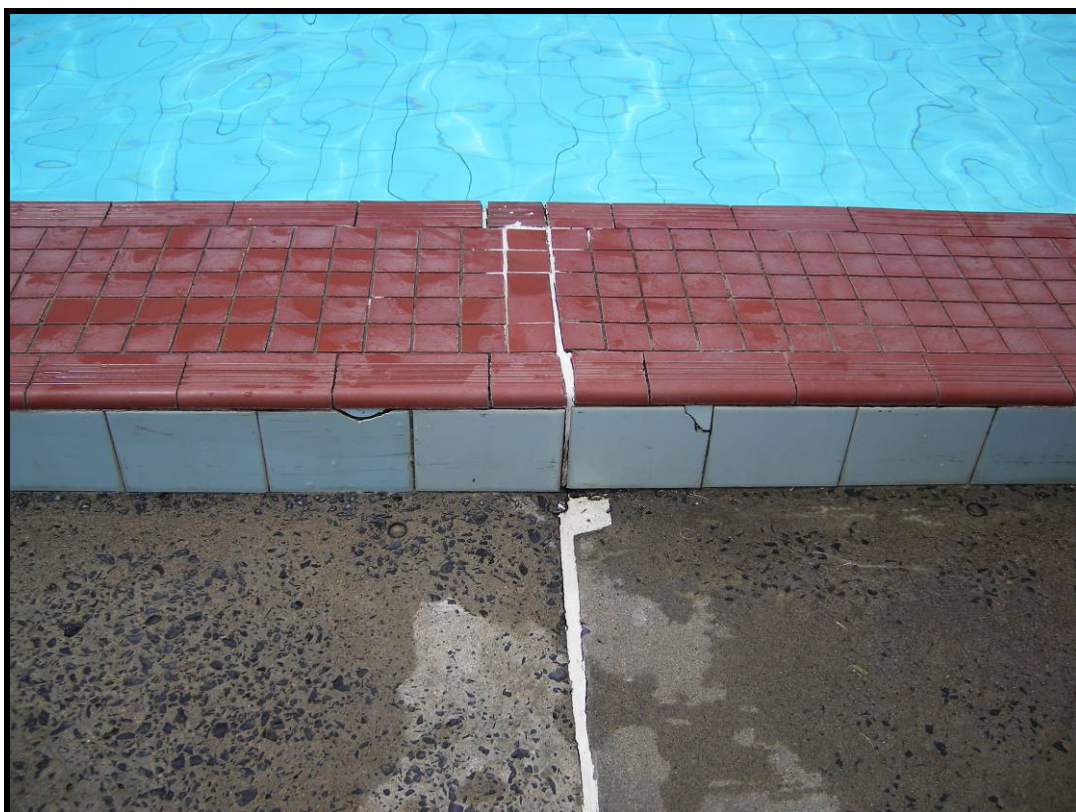
Pool Coping Tiling

The pool coping varies from 100 to 160mm above the pools surrounding concrete concourse/deck area. The coping's surface is finished with the original ceramic tiles installed in 1975 which are showing signs of 36 years of wear. The raised coping and the wear on the tile surfaces increases the risk of cuts, slipping and tripping and is not complimentary to a modern pool environment.

During the post 2009/10 pool season, inspection of the pool coping found many areas of the rendering which encompasses the tiling around the perimeter of the pool are beginning to loose adhesion (are drummy) similar to areas found at the Alstonville Pool and it is therefore expected that sections of the render will come away from the concrete pool structure at some time in the future. The problem exists primarily to the age of the pool structure and the long term exposure to the chemical environment.

The practical approach to remedy the coping problem is to remove the pool coping in its entirety and create a wet deck entrance into the pool thus also removing the hazard of a step and this risk of limb being stuck in the scum gutter. Examples of wet deck pool surrounds can be viewed in the images below.

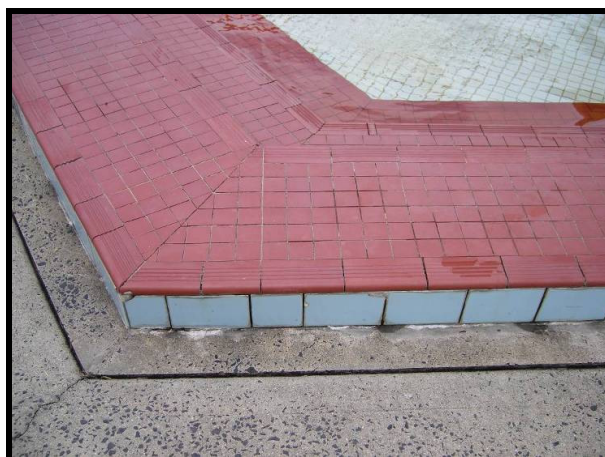
Toddlers Pool Coping

The tiles in the toddler's pool are original, stained and showing their age, some of the edges of the tiles are worn and cracking. Any proposed upgrade of the toddler's pool would most certainly look at more contemporary features meeting safety and user requirements for small children.

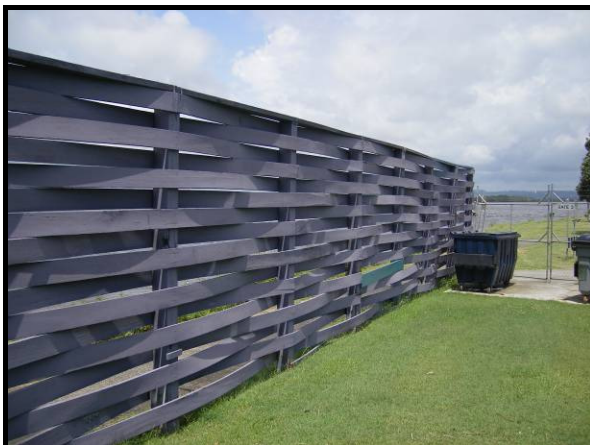
Photos of the Ballina Pool Timber Boundary Fence

The boundary fence around the pool facility consists of standard weldmesh security fence on the Northern and Western boundaries and a timber fence on the Southern and Eastern Boundaries. Both fences are in poor condition, the weld mesh fence will require replacement in the medium to long term. The timber fence requires regular maintenance due to its poor condition will require replacement in the short term, refer to the photos below.

The timber fence was originally designed as a break from the cooler Southern winds however it has proven to be ineffective as protection from the wind is mainly achieved on the grass area closer to the fence. The timber fence obstructs one of Ballina's best views across the Richmond River. One option for the replacement of the existing fences would be to install a black aluminium powder coated fence similar to those installed around NSW schools (*illustrated in the photo below*). This would not only enhance security and aesthetics of the site but also enable a view of the River across the facility.

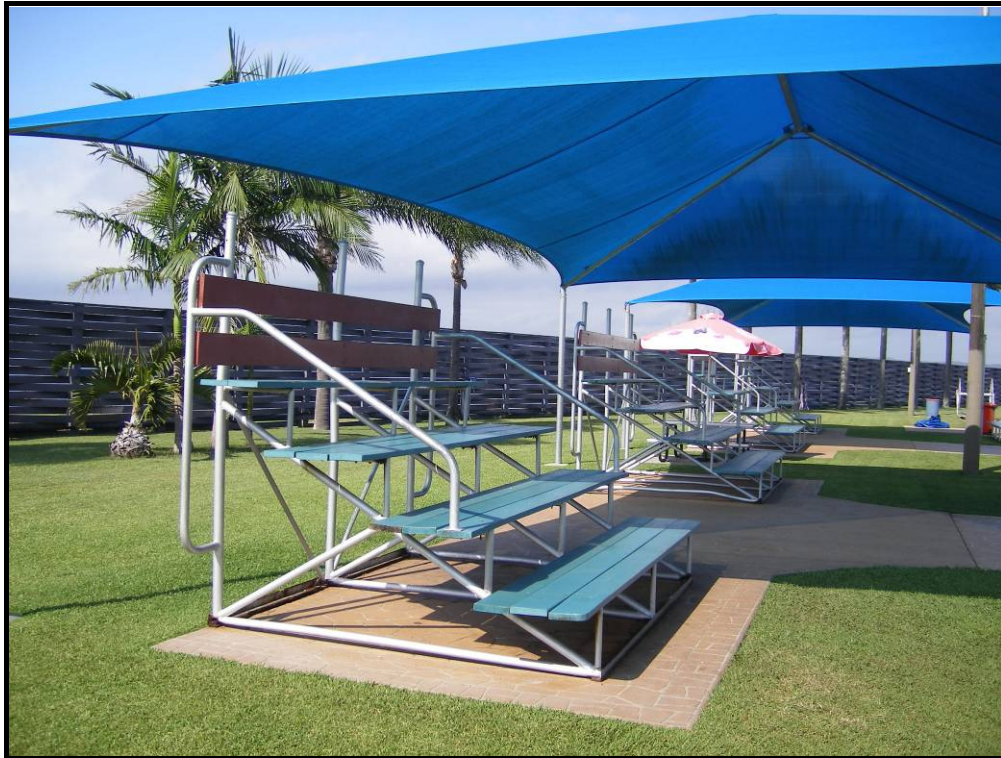
Existing Spectator Stands

There are four viewing stands along the Southern side of the 50 metre pool. These stands are aging and do not comfortably cater for the spectator numbers at larger sporting and school events. The existing stands are illustrated in the image below.

There are a variety of options for the replacement of the existing stands including aluminium stand alone units similar to the existing structures. These options are discussed below in the section “Desired Development”.

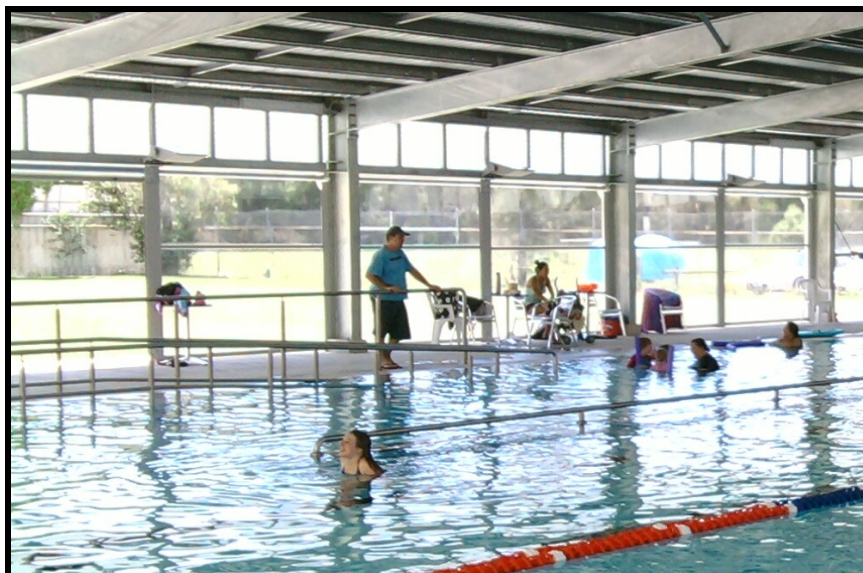
Access Ramp Coffs Harbour Indoor Pool

The current access to the pool for persons with mobility restrictions requires the use of a mobile hoist. Contemporary pool design allows for an access ramp and pool steps. This is usually achieved by the additional of the equivalent of half a pool lane. Any proposal to replace the pool coping and pool lining would be enhance by the addition of the steps and ramp. In terms of cost effectiveness this would also be the most appropriate time for these modifications.

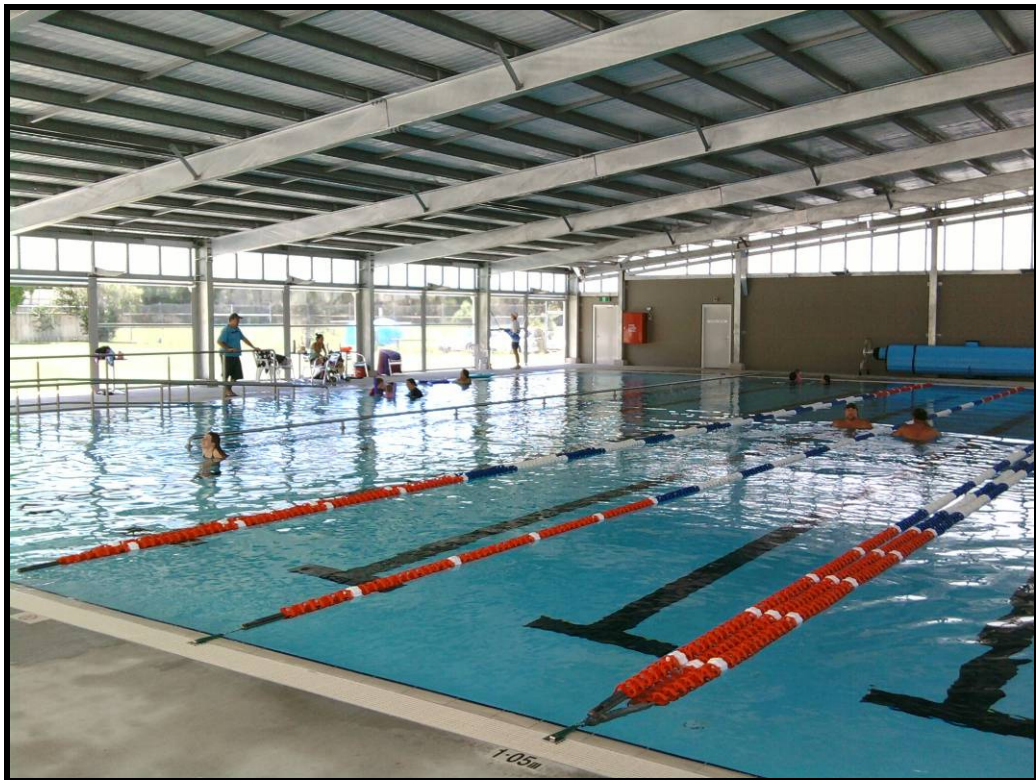
Coffs Harbour 25 metre Indoor Swimming Pool November 2010

The existing training pool has the potential to be expanded to a 25 metre x 25 metre pool and then enclosed by a weatherproof building structure. The redevelopment would incorporate the installation of the pool's own filtration and heating system allowing for operation as a stand alone facility throughout the year.

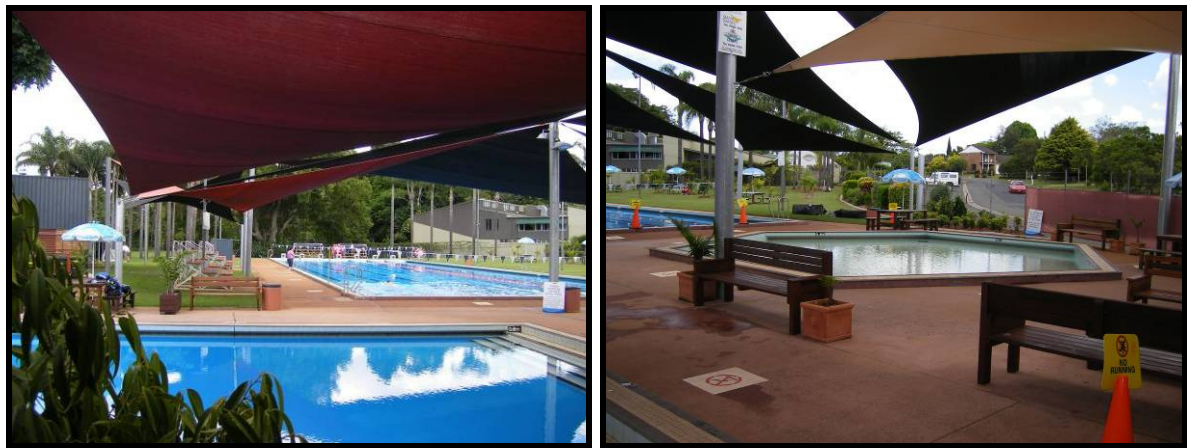
The Alstonville Swimming Pool Facility was opened in 1975. Changes or modification in the 35 years since the opening of the facility include a major upgrade of the amenities kiosk building in 1995, the installation of LPG pool heating in 1996 and the installation shade sails in 2005. Apart from these modifications, reactive repairs and programmed maintenance, there have been no major alterations or modifications to the buildings, plant room, water reticulation or surrounding grounds of the facilities to date. The swimming pools themselves consist of one 50 metre Olympic size pool, one 12 x 9 metre training pool and one hexagonal toddler's pool, which since construction have only undergone routine maintenance and remedial repairs specifically in regard the coping tiles and the painting of the internal lining of the Olympic and training pools.

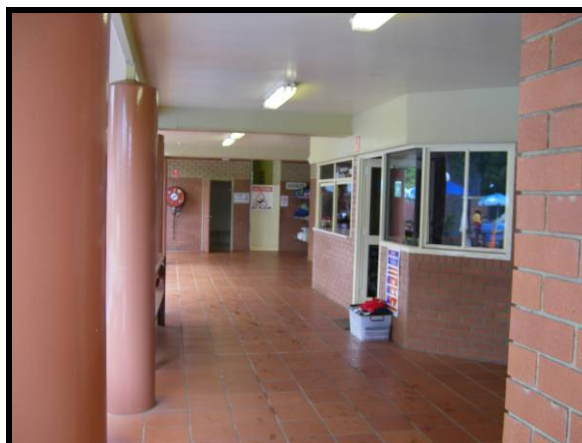
The amenity and kiosk buildings are in relatively good condition and meet current access and user requirements. The kiosk area is small however it is still functional. The contracted pool managers have provided timber tables and seating around the toddlers pool area to accommodate for parental supervision close to the kiosk area and within the shaded area.

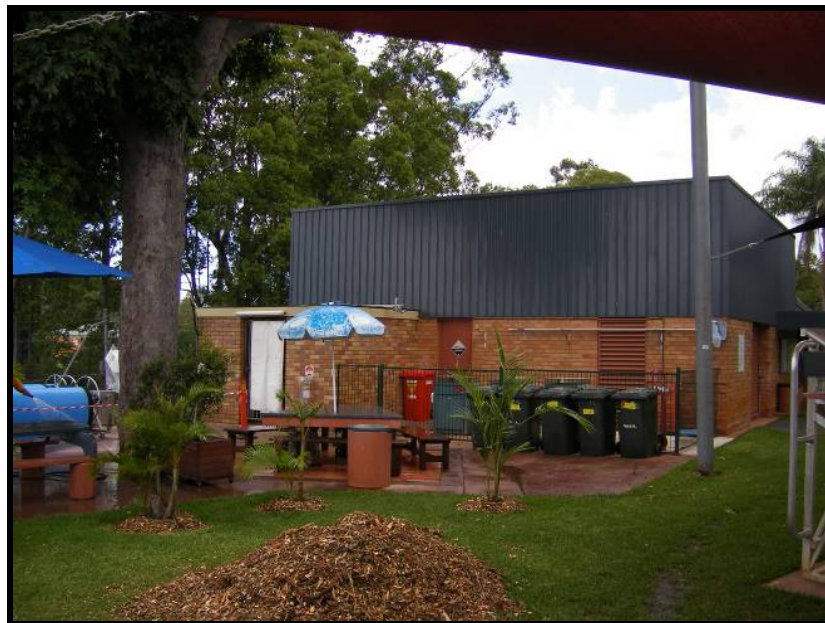
Alstonville Swimming Pool Plant Room

The plant room is mostly as constructed however it is deteriorating from age and the corrosive environment that is produced by the pool chemicals. There have been some alterations to the chemical dosing arrangements since the facilities construction. The swimming pool water is filtered by the original sand bed filters and then treated with chlorine, CO₂ and acid as necessary. The CO₂ injection system was installed in 2005 and mostly reduces the need for pool acid and other additives. The pool backwash water is drained across the Crawford Park soccer fields adjacent the pool facility. The amount of backwash water leaving the facility is approximately 45,000 litres per week. The plant room brick work, rendering, electrical equipment, pipes and fixtures are all exhibiting damage from 35 years of exposure to the harsh chemical environment.

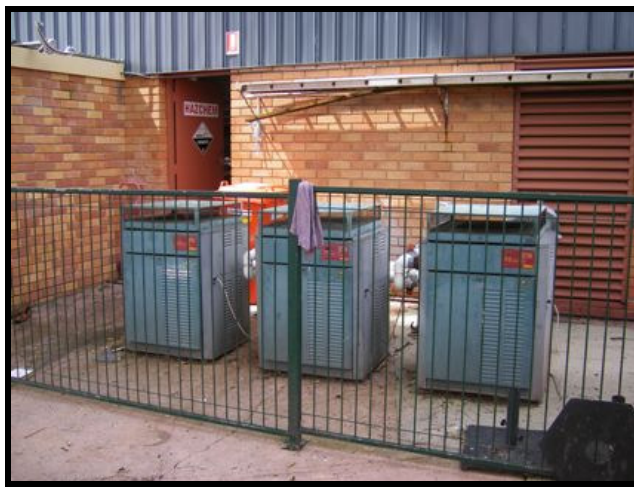
Alstonville Swimming Pool – Existing LPG Pool Water Heaters

The swimming pools are currently heated by three Liquid Petroleum Gas (LPG) heating units. These units were installed in 1996 and are now at the end of their useful lives. Maintenance of these units in terms of running costs and repairs is expensive because of the age of the units. At least one of the gas heating units will be required to be replaced during the 2010/2011 pool season to maintain the pool temperature during the shoulder (autumn) period of the season. Current technology offers alternative options for pool heating that can deliver improvements across the triple bottom line. However, entering into any of these options requires planning in line with the future direction of the pool facility.

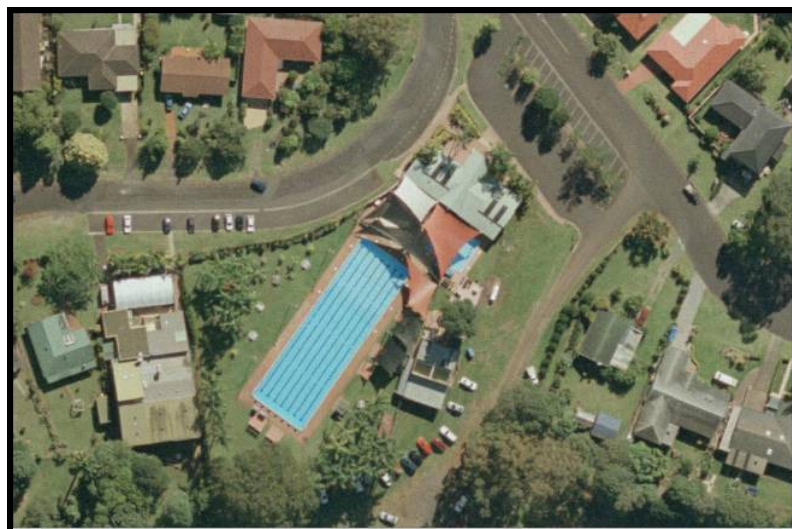
The grounds of the facility are very much as constructed with the main changes since construction being to the vegetation including a Cocos palm tree replacement program. There are 11 picnic sets available for use by the patrons however there are no barbeque facilities. Six ageing spectator stands are situated along the South-Eastern sides of the pool.

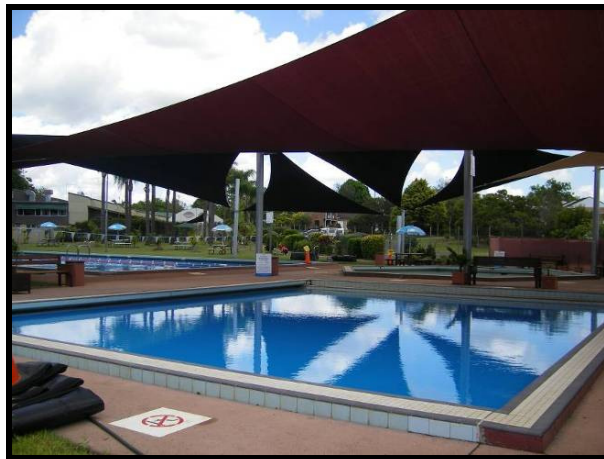
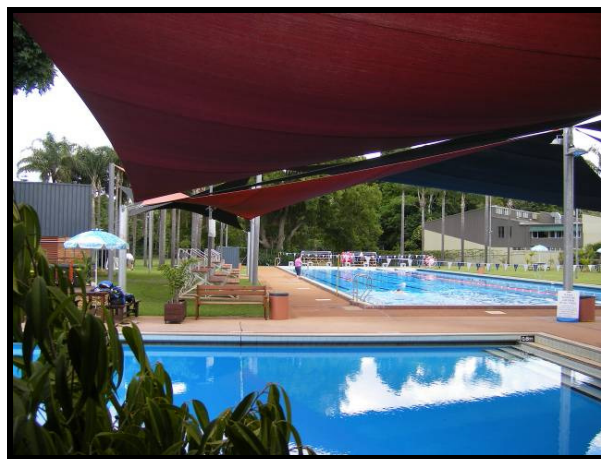
The shading at the Alstonville pool facility is adequate for swimmers in the main pool and more than adequate for the younger users of the pool facility around the toddlers and training pools. Shade sails were installed over the pools in 2004-2006 and are in good condition. The toddlers pool is approximately 70 percent covered, the training pool is approximately 50 percent covered and the 50 metre pool is approximately 10 percent covered. The only short-fall is shade for spectators around the 50 metre pool.

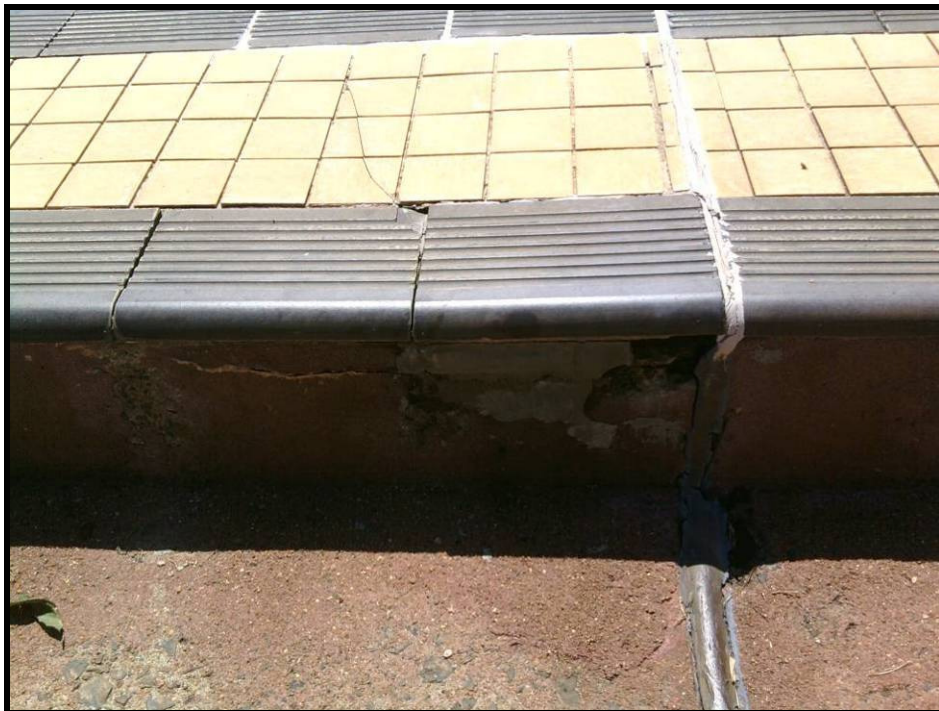
Sample of the Alstonville Pool Coping and Tiles

The pool coping varies from 100 to 160mm above the pools surrounding concrete concourse/deck area. The coping's surface is finished with the original ceramic tiles installed in 1975 which are showing signs of 36 years of wear. The raised coping and the wear on the tile surfaces increases the risk of cuts, slipping and tripping and is not complimentary to a modern pool environment.

The practical approach to remedy the coping problem is to remove the pool coping in its entirety and create a wet deck entrance into the pool thus also removing the hazard of a step and this risk of limb being stuck in the scum gutter. Examples of wet deck pool surrounds were provided in the earlier in sections of this report discussing the Ballina Pool.

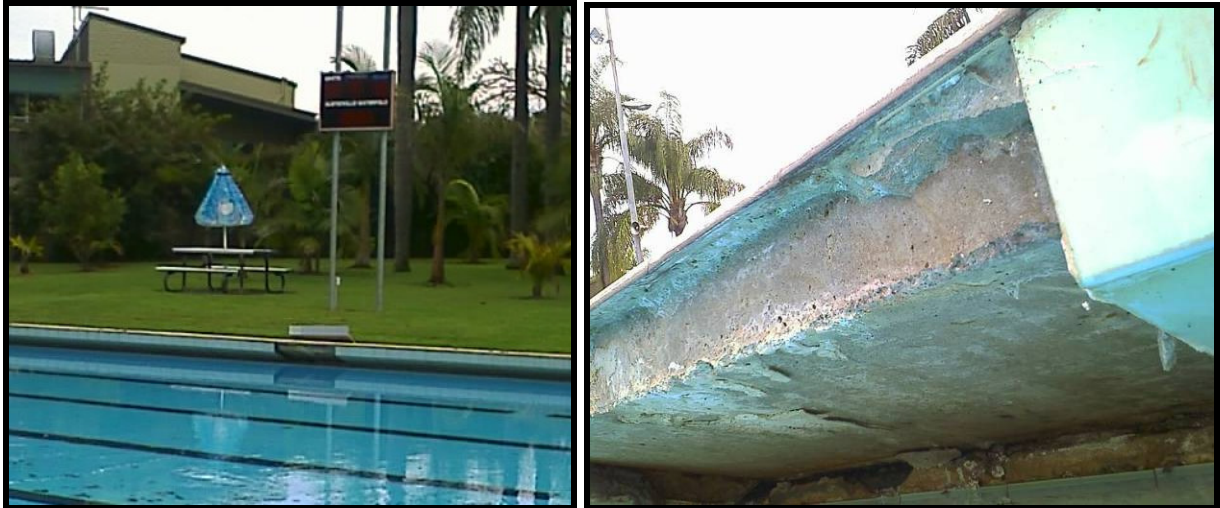
During the post 2009/10 pool off season, a large section of the pool coping rendering and the tiling attached collapsed into the 50 metre pool (*refer to the photo next page*). Remedial repairs were carried out just prior to the opening of the 2010 / 2011 season. Inspection of the coping found that many areas of the rendering which encompasses the tiling around the perimeter of the pool have lost adhesion (are drummy) and it is therefore expected that further sections of the render will come away from the concrete pool structure. If further sections of the pool coping come away during the current or later pool seasons the pool facility may need to be closed down so that the pool can be drained for temporary repairs.

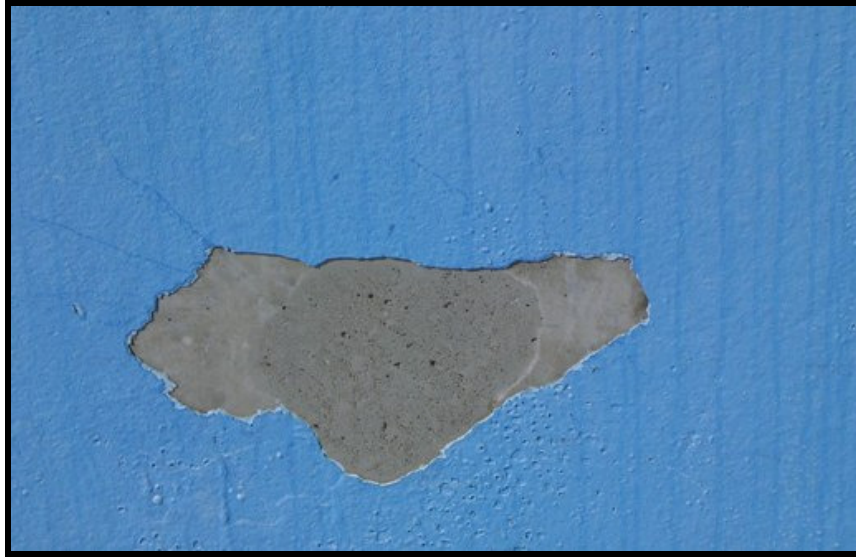
Current Painted Surface – 50 metre and Training Pool

The three pools at the Alstonville Facility are of concrete construction. The 50 metre and training pools have a vulcanised rubber paint lining and the toddler's pool is tiled lined. There is a large amount of unexplained water loss throughout the pool season at Alstonville pool facility this can only be attributed to leaks in the pool structures or the reticulation lines circulating to and from the pools.

The painted pools have a build up of paint layers from the many re-coats they have received over the years and air pockets have begun forming around the basin. This causes areas to break away leaving sharp edges and exposed concrete. The most practical and cost effective remedy given the age of the pools would be to have the painted surface removed and to then reline the pools with an alternative membrane such as a vinyl lining. The relining of the pools and replacement of the pool coping would be run as congruent projects to maximise on economies of scale. Forming part of any relining works on the pools would be the replacement of reticulation lines and certification of the water integrity of the pools and pipe work.

Rectification of the water leaks will be an invasive process requiring replacement of the reticulation lines and re-lining of the swimming pools. This work would be automatically included in any upgrade of the facilities and should be looked upon as a major influencing agent to progress Council's swimming pool facility planning process.

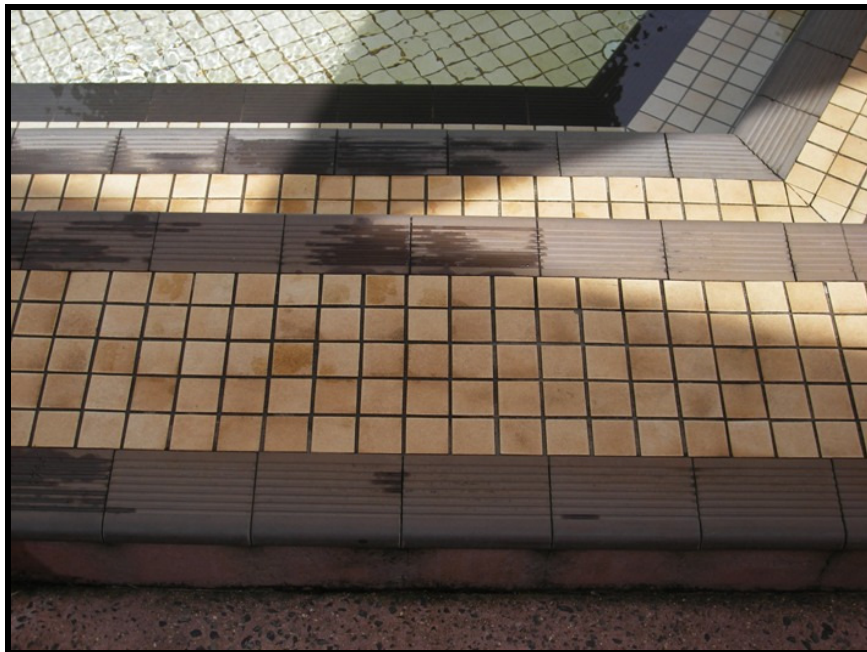
Toddler's Pool Coping

The tiles in the toddler's pool are original, stained and showing their age, some of the edges of the tiles are worn and cracking. Any proposed upgrade of the toddler's pool would include resurfacing as a minimum.

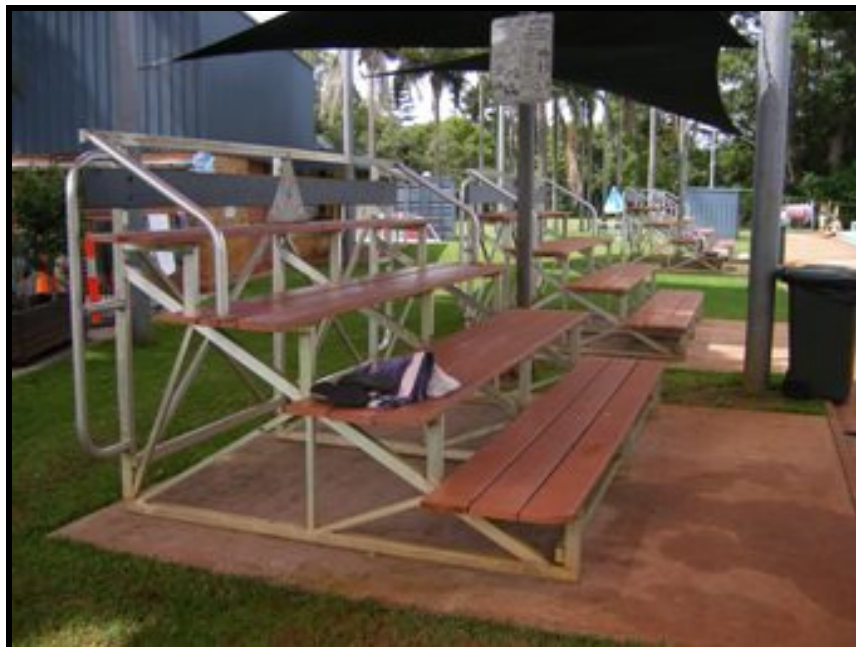
Existing Spectator Stands

There are six viewing stands along the Eastern side of the 50 metre pool. These stands are aging and do not comfortably cater for the spectator numbers at larger sporting and school events. The existing stands can be seen in the photo below. The options for spectator seating and shading are the same as discussed in the earlier Ballina Pool section of this report.

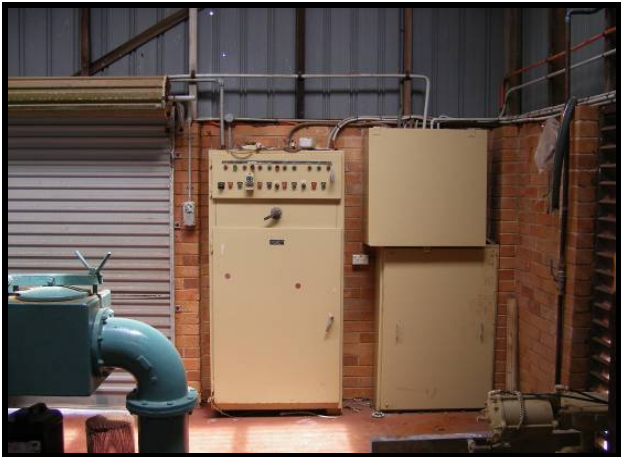
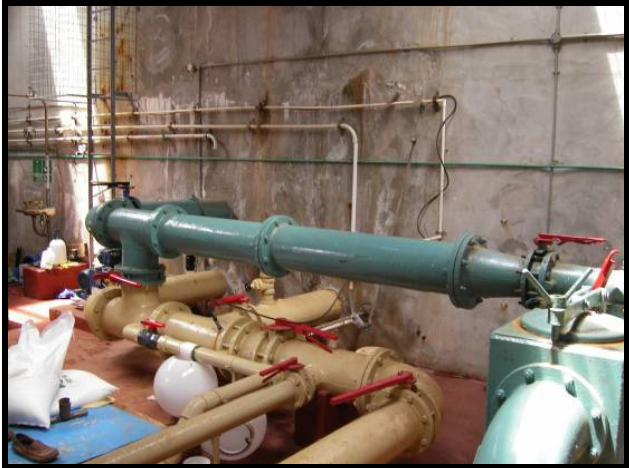
Alstonville Swimming Pool Plant Room

The cement lined cast iron piping within the pool plant room has begun to decay and has resulted in urgent repairs already during the 2010 / 2011 season. The electrical switchboard and wiring systems are also suffering from the corrosive effects of the chemical environment and require replacement in order to reduce the possibility of breakdown and other electrical related risks and further to be in line with current energy efficient technology and electrical standards.

To provide for continued uninterrupted business the plant room piping will need to be replaced in the short to medium term. The long term scenario would be to refurbish the plant room and replace the filter system with modern technology. As discussed and illustrated earlier in the Ballina section of this report, this Council's existing plant room structure can be utilised to create a modern plant room.
