Significance Assessment

Pilot Vessel (PV) *Richmond* Ballina Naval & Maritime Museum, Ballina NSW

Client Manager: Sarah Ward
Report Number: PR112463-1
Version Date: RevB, November 2012

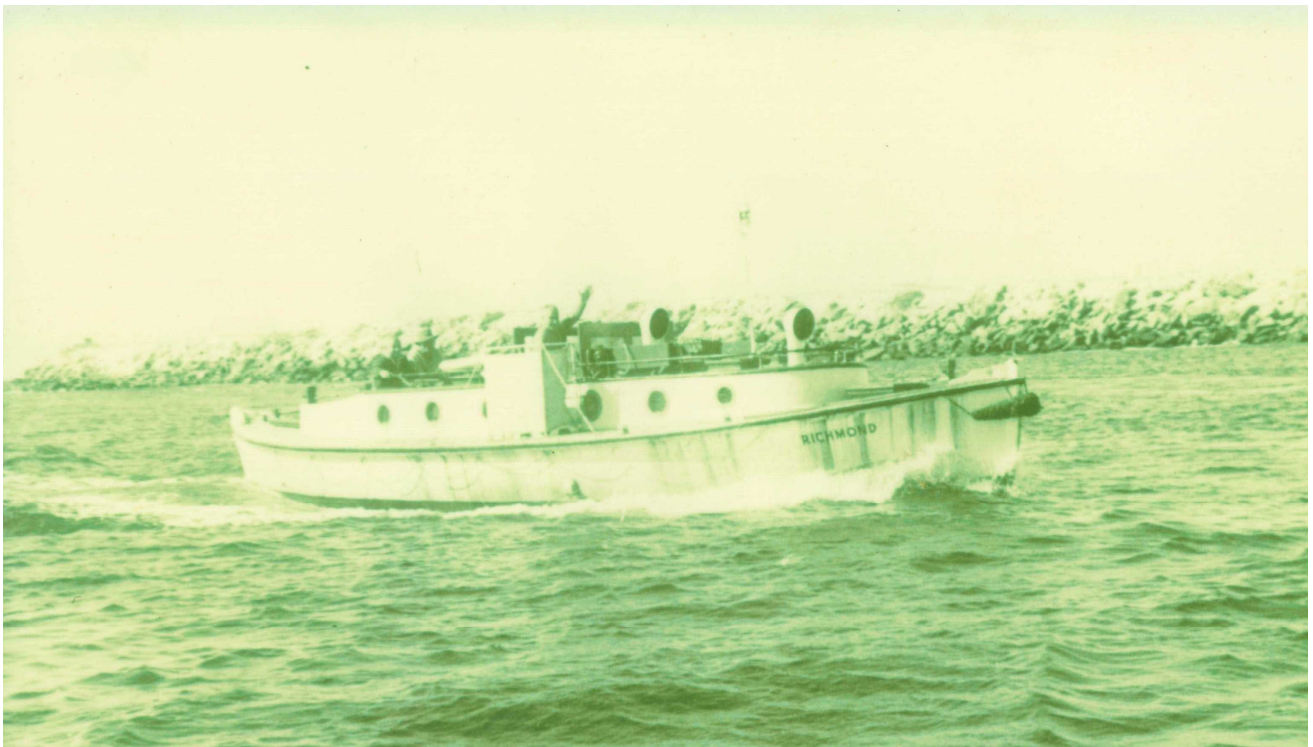
Plate 2: PV *Richmond* coming into 'Port'. Date unknown. Image courtesy Ballina Naval & Maritime Museum.

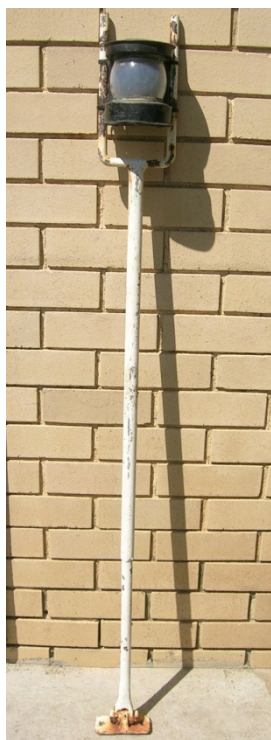
Plate 3: Disassociated Mast (Light Staff) of the PV *Richmond*. Note staff is *in situ* in Plate 4. Image courtesy Ballina Naval and Maritime Museum.

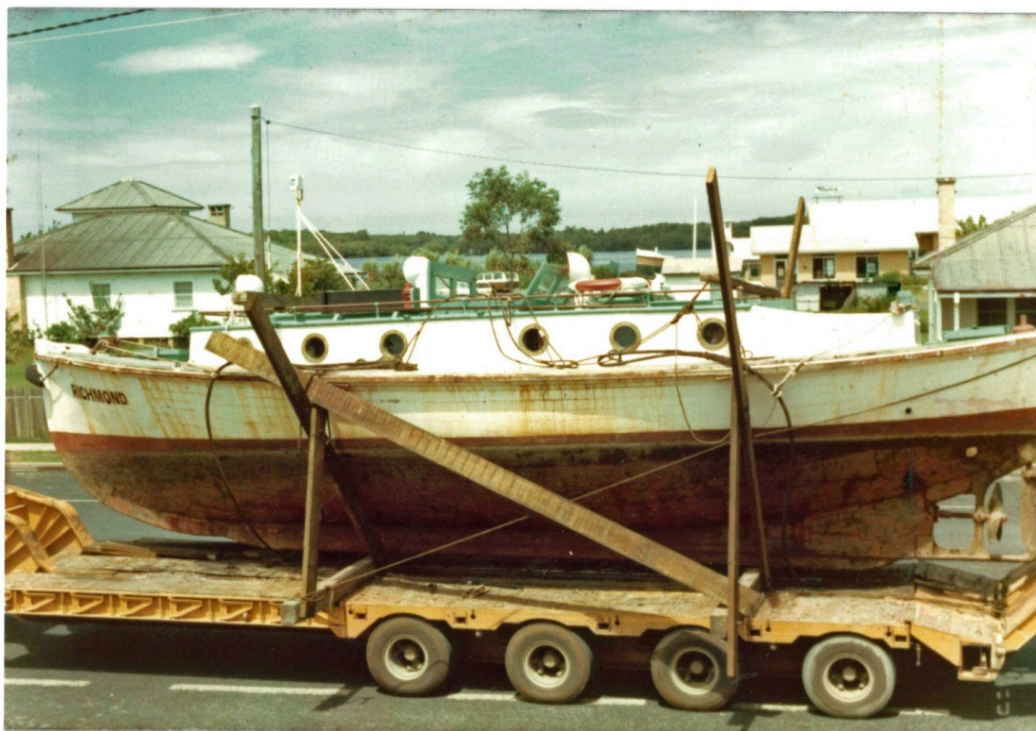
Plate 4: PV *Richmond* being transported to Ballina Town Centre after the transfer from MSB. Image circa 1982. Courtesy Ballina Naval and Maritime Museum.

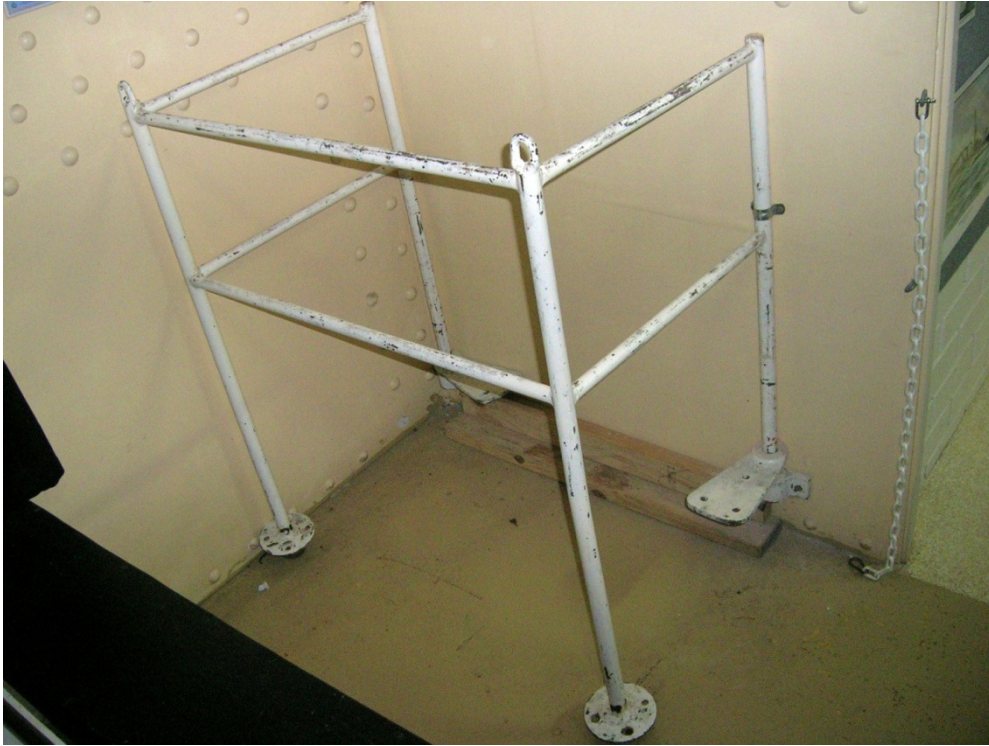
Plate 5: PV *Richmond* Pilot Cage (without Canvas) on display in the Ballina Naval and Maritime Museum. Note cage *in situ* in Plate 2. Image courtesy Ballina Naval and Maritime Museum.

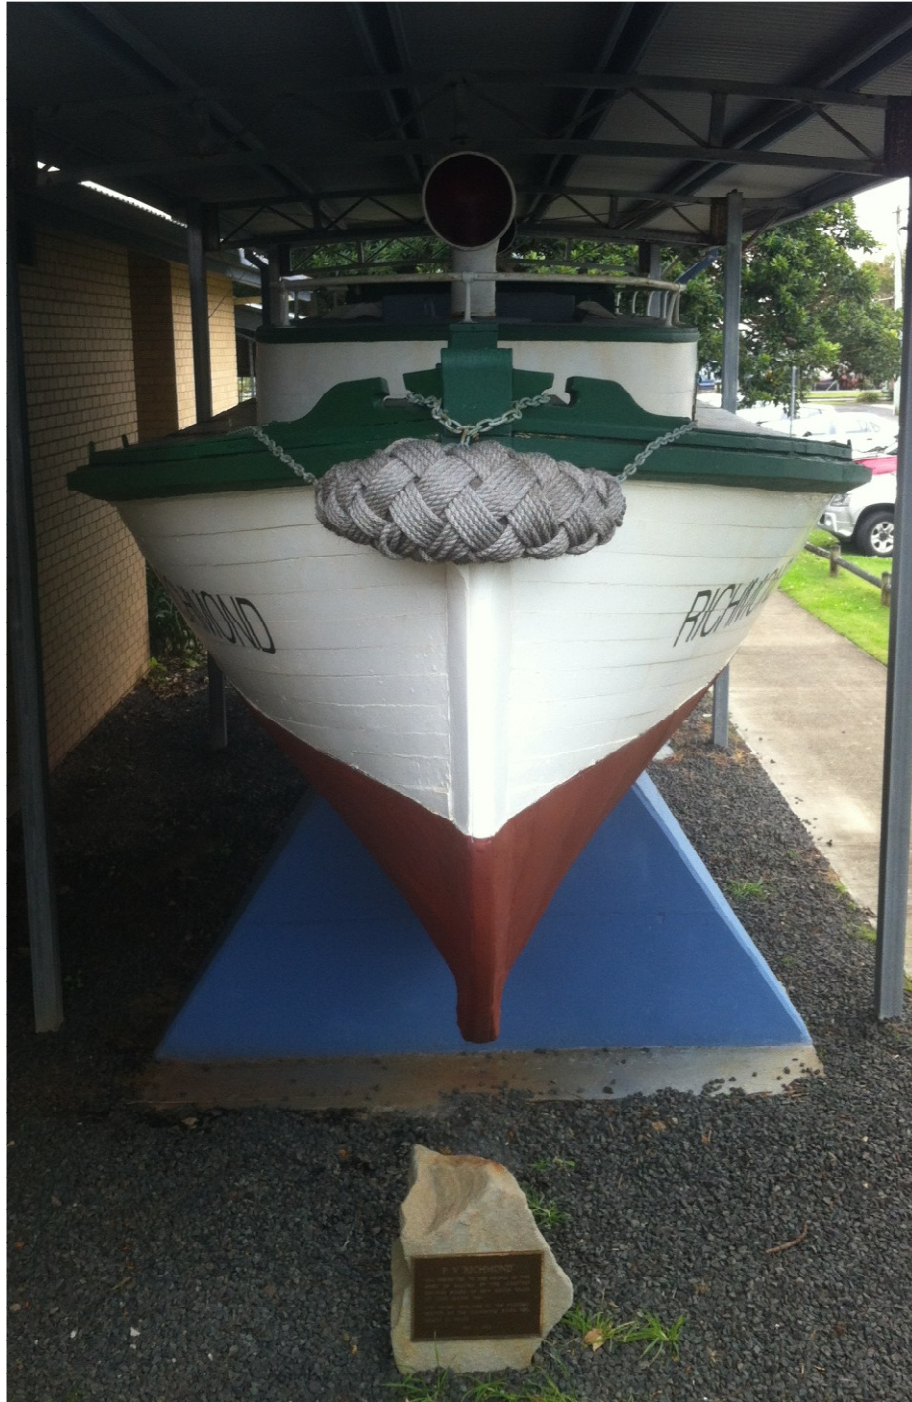
Plate 7: PV *Richmond* on display at the Ballina Naval and Maritime Museum Looking towards the bow (March 2012)

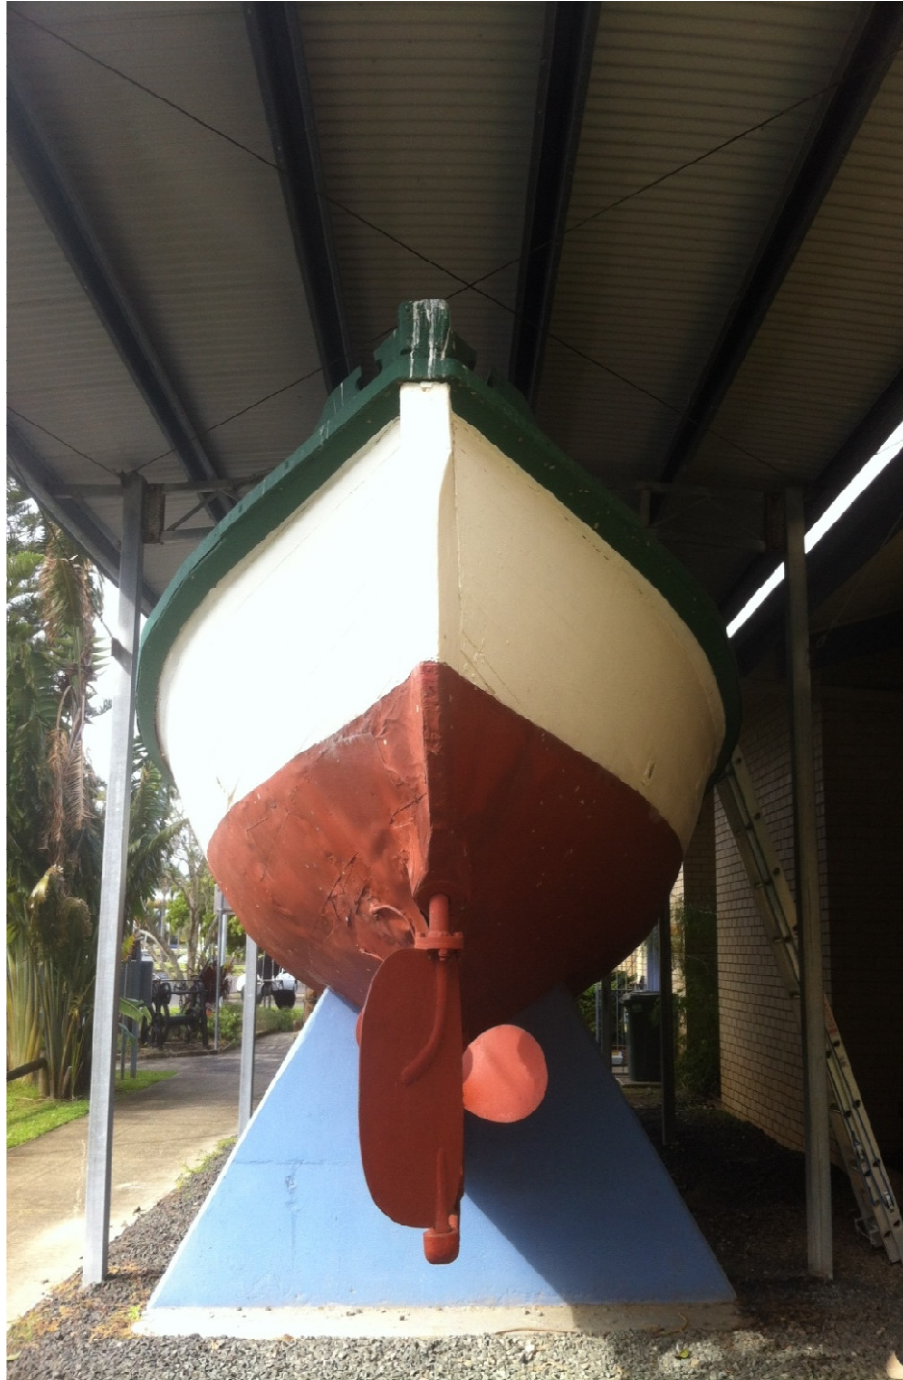
Plate 8: PV *Richmond* on display at the Ballina Naval and Maritime Museum Looking towards the Stern (March 2012)

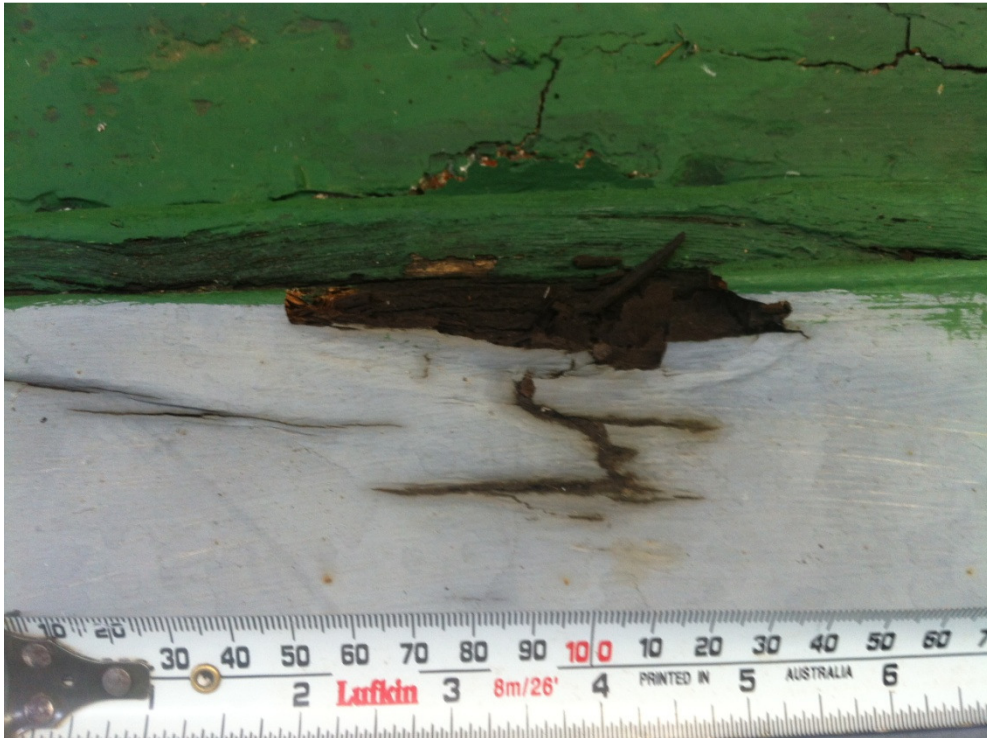
A second visual inspection was undertaken on 14 June 2012. Through observation it was evident that superficial deterioration had dramatically increased. The plywood deck sheathing, for example, was saturated with water and appeared to be 'rotting', the sag in the keel had increased to the point where it had come away from the keelson, several tin alloy patches on the hull below the waterline were hanging away from the hull and the fibreglass strip covering the shear strake/buffer had come away from the vessel on the starboard side. It is recommended that the vessel be brought inside as a matter of urgency. This will help to arrest further deterioration by bringing it out of the wind and weather. It is also recommended that a further conservation assessment/needs analysis be undertaken by a professional Conservator to determine exactly what conservation is required and the order in which it should be undertaken. This will allow scientific testing of the vessel to determine any urgent scientific treatment, as well as to make further recommendations on any climate control requirements that will need to be introduced once the vessel is indoors. Section 5.0 will help to inform this process. Funding should be obtained to facilitate the Conservation Assessment, Conservation Treatment and resulting Conservation Management Plan. It is also recommended that sufficient training be

Plate 9: Damage to the plywood deck sheathing of PV *Richmond*. Note ply appeared to be saturated and was in the process of delaminating.

Funnels	Moderate to High	Suggest paint needs to be removed, metal treated to stabilise and rails repainted with a more sympathetic product for display purposes.
Deck	Deck sheathing	Low	Plywood alterations are highly degraded. Suggest removal and deck timbers underneath assessed and stabilised as required. Consider replacement with a more sympathetic option post conservation of deck timbers.
	Timber decking	Low to moderate	Deck timbers appear sound however plywood should be removed to and deck timbers conserved.
Fixtures	Hatches	Low	Treatment to stabilise and existing hatch covers for interpretative/display purposes.
	Port holes/scuttles	Moderate	Port holes/scuttles need to be treated as evidence of green corrosion produce exists. Glass can be stabilised without repair as cracks are indicative of use history. Green paint needs to be removed from surrounds prior to treatment.
	Propeller	Moderate	Propeller needs to be treated as evidence of green corrosion produce exists. Glass can be stabilised without repair as cracks are indicative of use history. Red paint needs to be removed from surrounds prior to treatment.

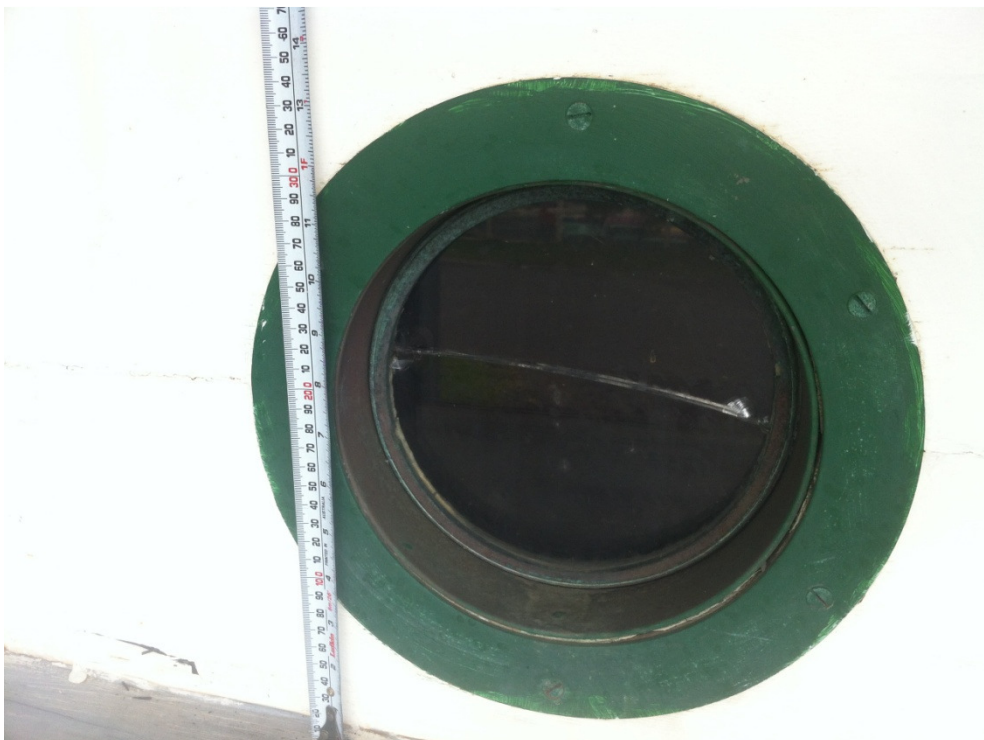
Plate 10: PV *Richmond* Port Holes; note one port hole/scuttle was missing entirely. The glass in the remaining port holes was all split horizontally. Note corrosion evident under the intrusive paintwork on the brass surrounds.

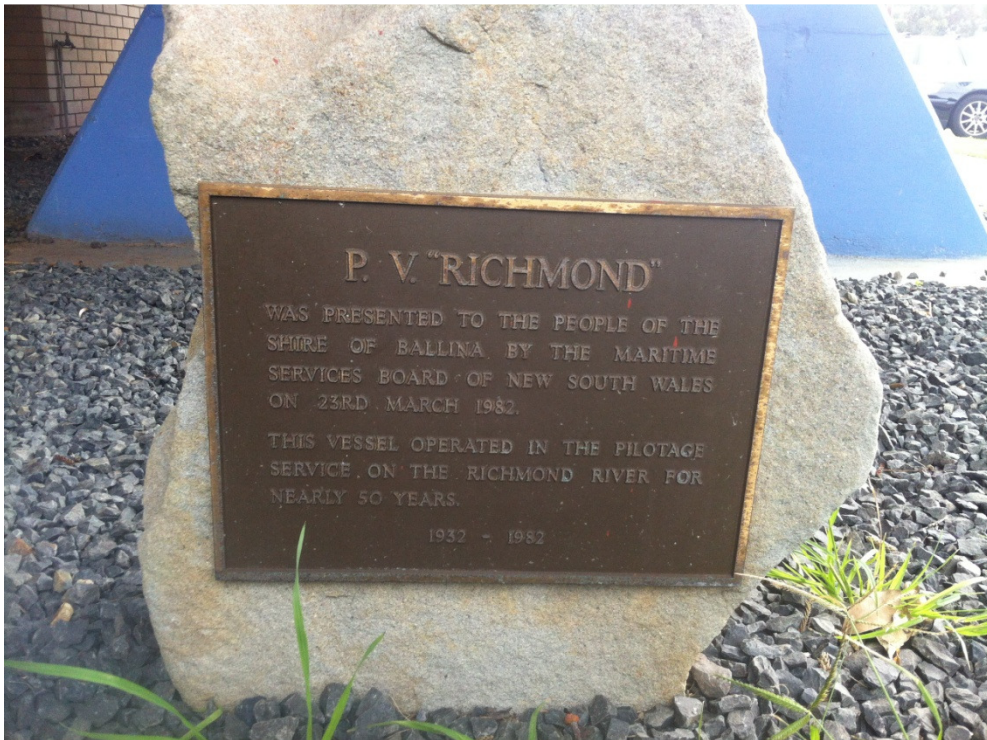
Plate 11: PV *Richmond* plaque mounted on ship's ballast (March 2012).

Soon after the vessel's retirement, MSB made the decision to donate the vessel to the people of Ballina Shire and a presentation was made to the people of Ballina Shire on Tuesday 23 March 1982 (MSB 1982: 5). A commemorative plaque (Plate 11) had been set in stone adjacent to the vessel and unveiled as part of the handover ceremony. The stone was believed to be of historic significance itself as it had been transported from Sydney as ballast in a timber boat in the early days of sailing ships (MSB 2012: 7). The same year, the Pilot's Cottage (Plate 1) was donated to the people of Ballina Shire and was opened as a maritime museum (Anon. 1983: 7) in 1983. However, with the demolition of the Pilot's cottage in 1992, the PV *Richmond* remains an important tangible link to the significant history of Pilot services in Ballina.

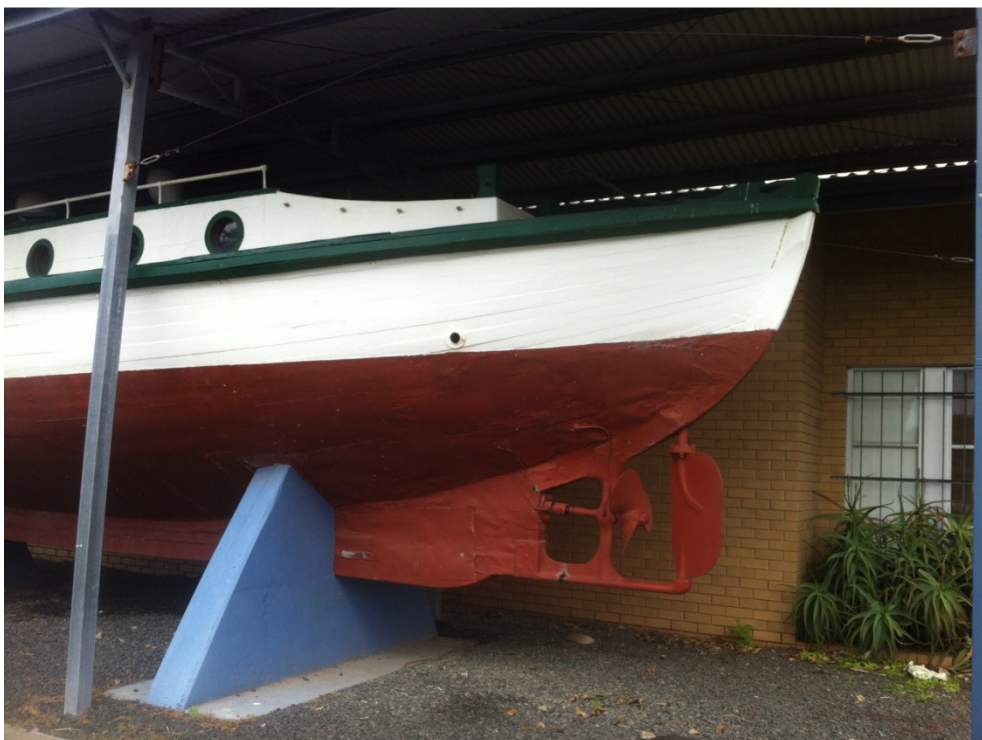
Plate 12: PV *Richmond* looking toward the stern. Note hull intrusive tin-alloy sheathing repairs are coming away from the hull. Not also that gap beginning to form between the keel and keelson (March 2012).

Keel	Moderate to High	Highly degraded element with little intrinsic heritage value, but which contribute to the overall significance of the item as is the 'backbone' of the hull structure. This needs conservation treatment urgently to prevent further damage to ships structure.
	Timber Keelson	Moderate	Degraded element requiring urgent conservation treatment. Decay of the keel is likely to further damage keelson if left untreated.
Hull	Shear strake/buffer (timberhead)	Low	Urgent conservation and repair is required. Intrusive fibreglass moulding and polyurethane foam filler should be removed and replaced with a sympathetic alternative.

The removal and replacement of the fibreglass cabin coating, the ply deck timber, and the patched hull sheathing, for example, would enhance structural integrity as well as mitigate risk of further damage and would not be considered to have a negative heritage impact. This is because the components being replaced are themselves intrusive replacements of earlier original fabric. Employing conservation techniques to arrest further deterioration of original fabric, such as the hull timbers, would enhance heritage significance.

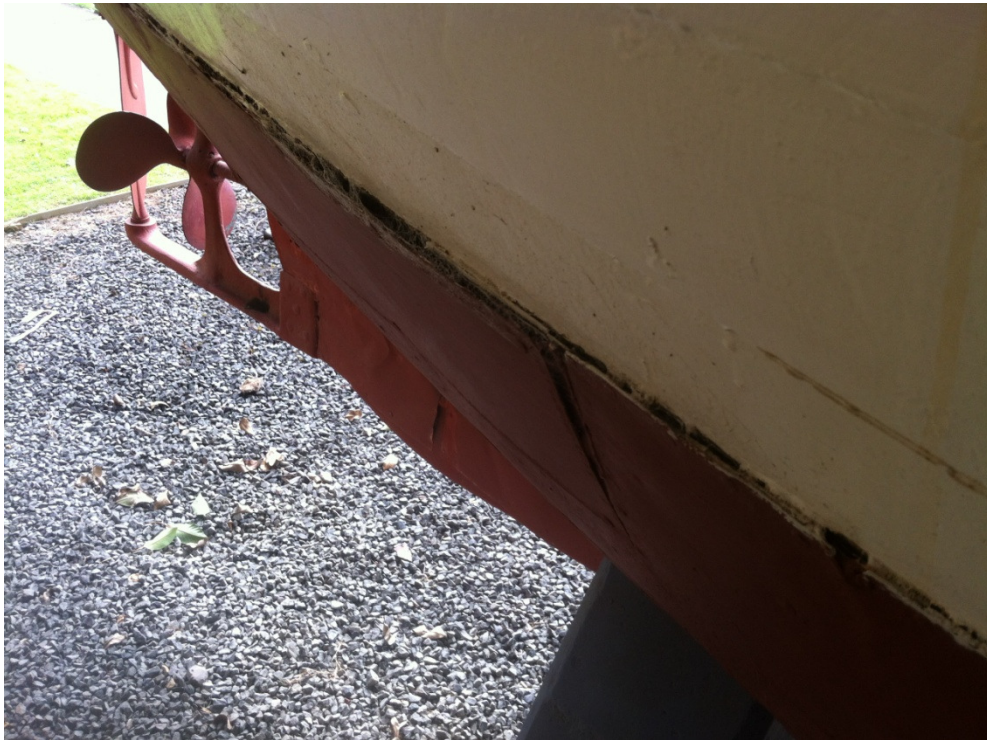
Plate 13: PV *Richmond* looking toward the stern. Note hull intrusive tin-alloy sheathing repairs are coming away from the hull. (March 2012).

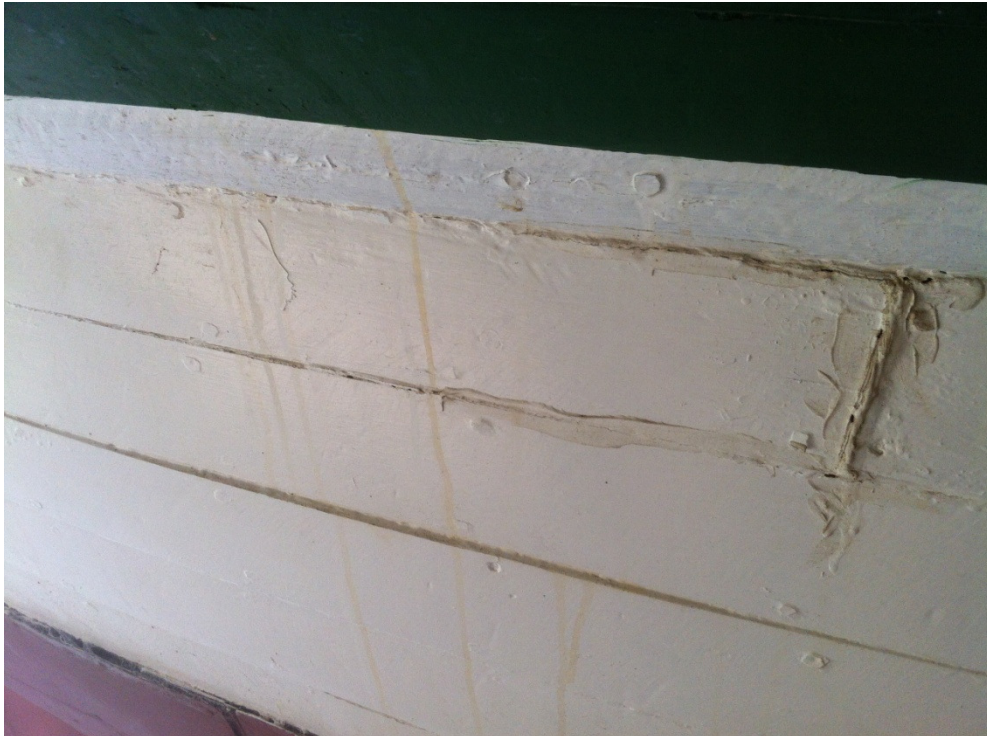
Plate 14: PV *Richmond* starboard planking. Note repairs to caulking (March 2012).

Caulking	Low to Moderate	Conservation treatment to stabilise caulking to maintain integrity of hull. Suggest leaving exposed caulking around port hole that is missing, for interpretative purposes.

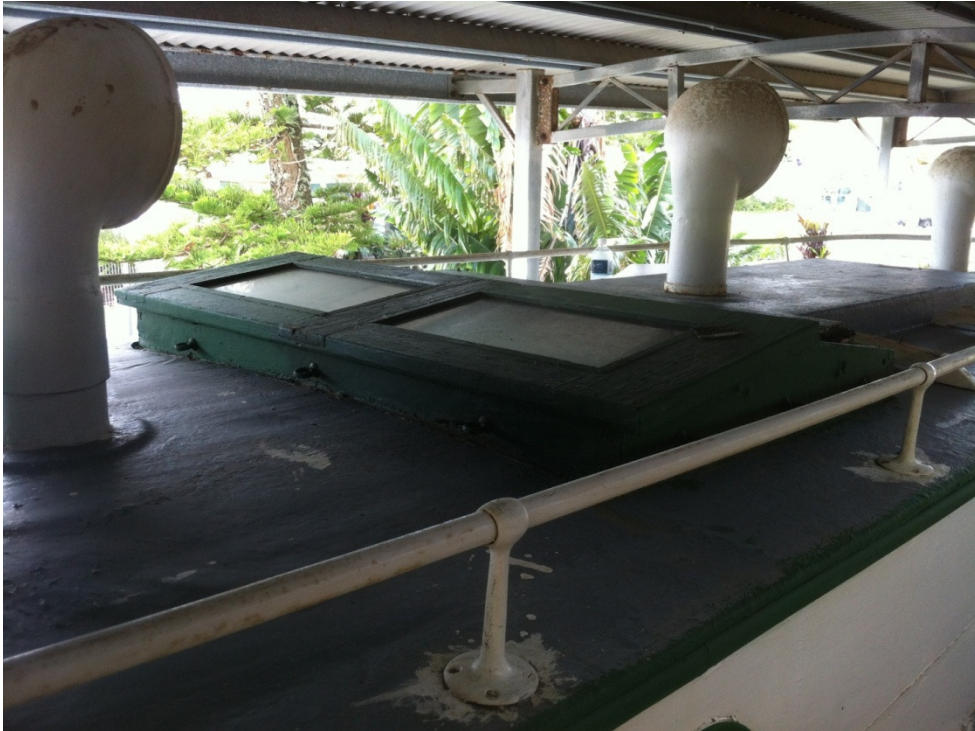
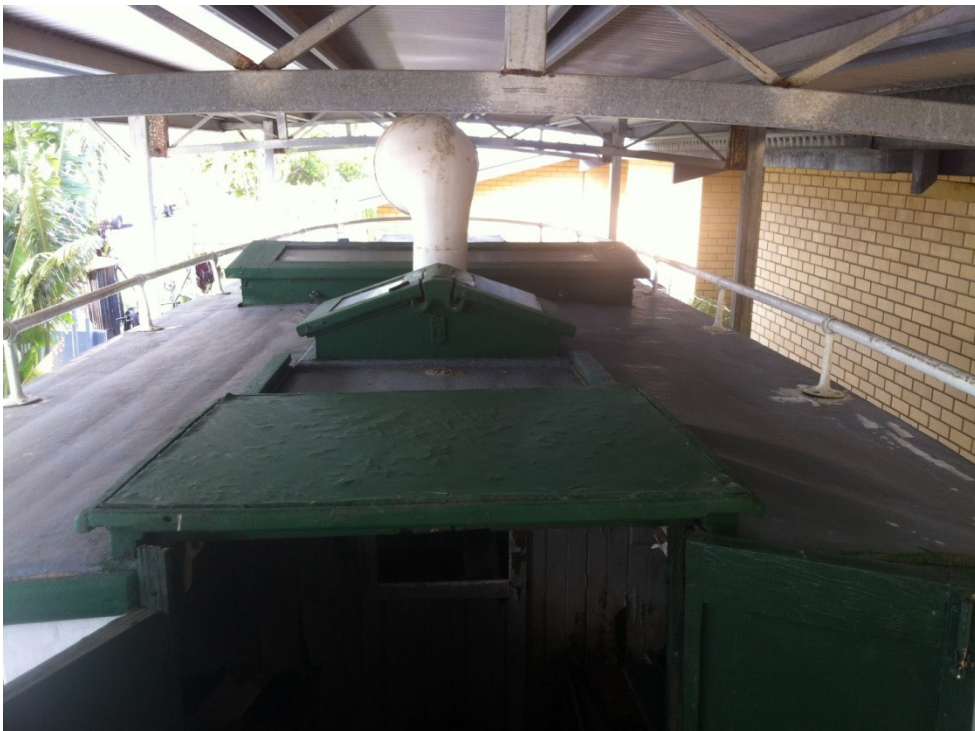
Cabin	Roof coating	Intrusive	Fibreglass coating has functional purpose however is intrusive and damaging to the item's heritage significance.
	Furniture	Low	Timber cabin furniture appears original, although degraded and no longer intact. Lacks integrity and intrinsic value. Damage detracts from contributive significance.
	Metal Rails	Moderate to High	High degree of original fabric. High degree of integrity and intactness of fabric. Demonstrates a key element of the item's significance. Originally rail supports were painted in green trim and rails red to match colour below waterline. Repainting does not detract from significance.
	Funnels	Moderate to High	High degree of original fabric. High degree of integrity and intactness of fabric. Demonstrates a key element of the item's significance. Repairs/repainting does not detract from significance.
Deck	Deck sheathing	Low	Plywood alterations detract from significance and appear intrusive. Sheathing is a poor quality three-ply, not 5-ply marine grade so unlikely to be original, perhaps a late addition. Difficult to interpret.

Plate 15: PV *Richmond* looking across cabin roof. Note intrusive grey fibreglass coating and damage to cabin roof timbers/hatch covers (March 2012).

Plate 16: PV *Richmond* looking across cabin roof. Note intrusive grey fibreglass coating and damage to cabin roof timbers/hatch covers (March 2012).

Cabin	Superstructure	Moderate	Degraded elements requiring conservation treatment to stabilise cabin superstructure.
	Deck timbers	Low	Cabin decking timbers lacks intactness. Conservation to stabilise, repair and reinstate decking timbers to their original location is required.
	Roof coating	Intrusive	Fibreglass coating has functional purpose however is intrusive and damaging to the item's heritage significance. It appears to be stable, however should be removed for interpretative/display purposes.
	Furniture	Low	Timber cabin furniture appears original, although degraded and no longer intact. Conservation treatment required to stabilise and repair timbers. Suggest these be reinstated/restored to former position to interpretative/display purposes.
	Metal Rails	Moderate to High	Suggest paint needs to be removed, metal treated to stabilise and rails repainted with a more sympathetic product for display purposes.

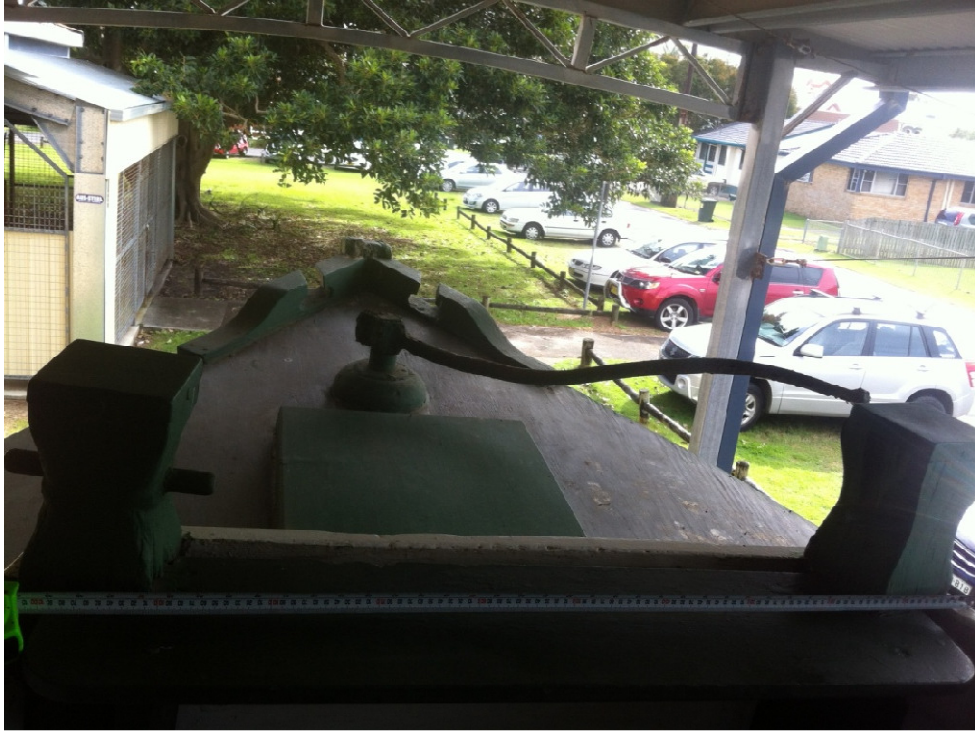
Plate 17: PV *Richmond* looking across stern. Note tiller in foreground and poor state of deck sheathing (March 2012).

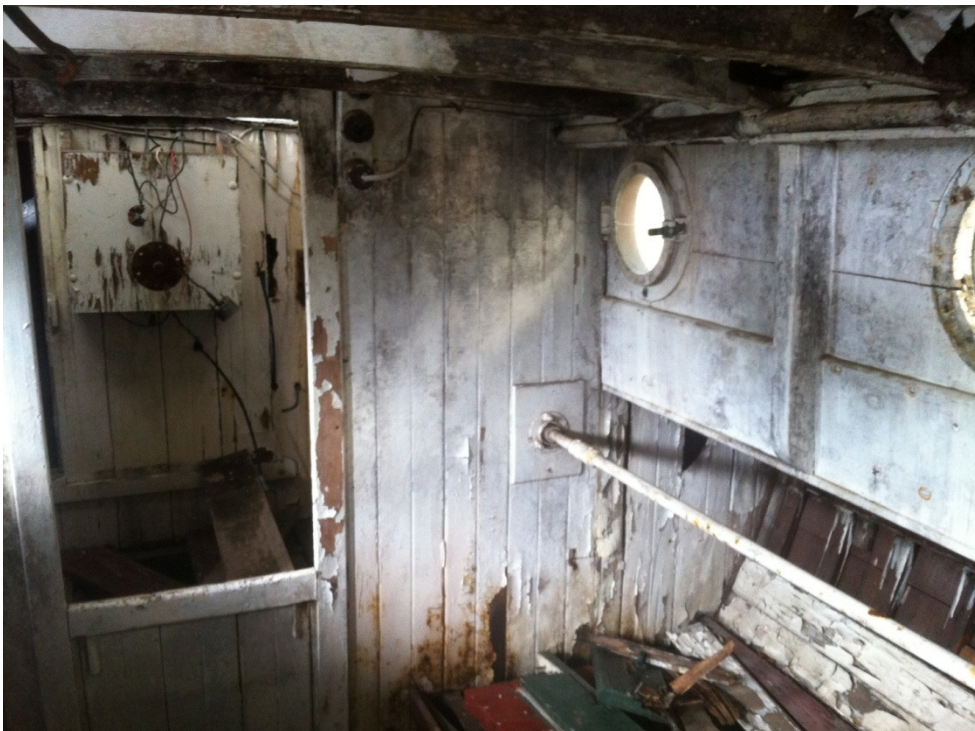
Plate 18: Looking inside starboard cabin/coach-house. Note deteriorated state of paintwork, timber cabin structure and cabin furniture. Exposed frames and hull planking can be seen to the right of the photo. (March 2012).
