512017

**LIMITED ENVIRONMENTAL SITE ASSESSMENT, LOT 491,
DP729381 AND LOT 284, DP755684, TAMARIND DRIVE,
BALLINA, NSW**

**ENVIRONMENTAL EARTH SCIENCES NNSW
REPORT TO GEOLINK
28 FEBRUARY 2013
VERSION 0**

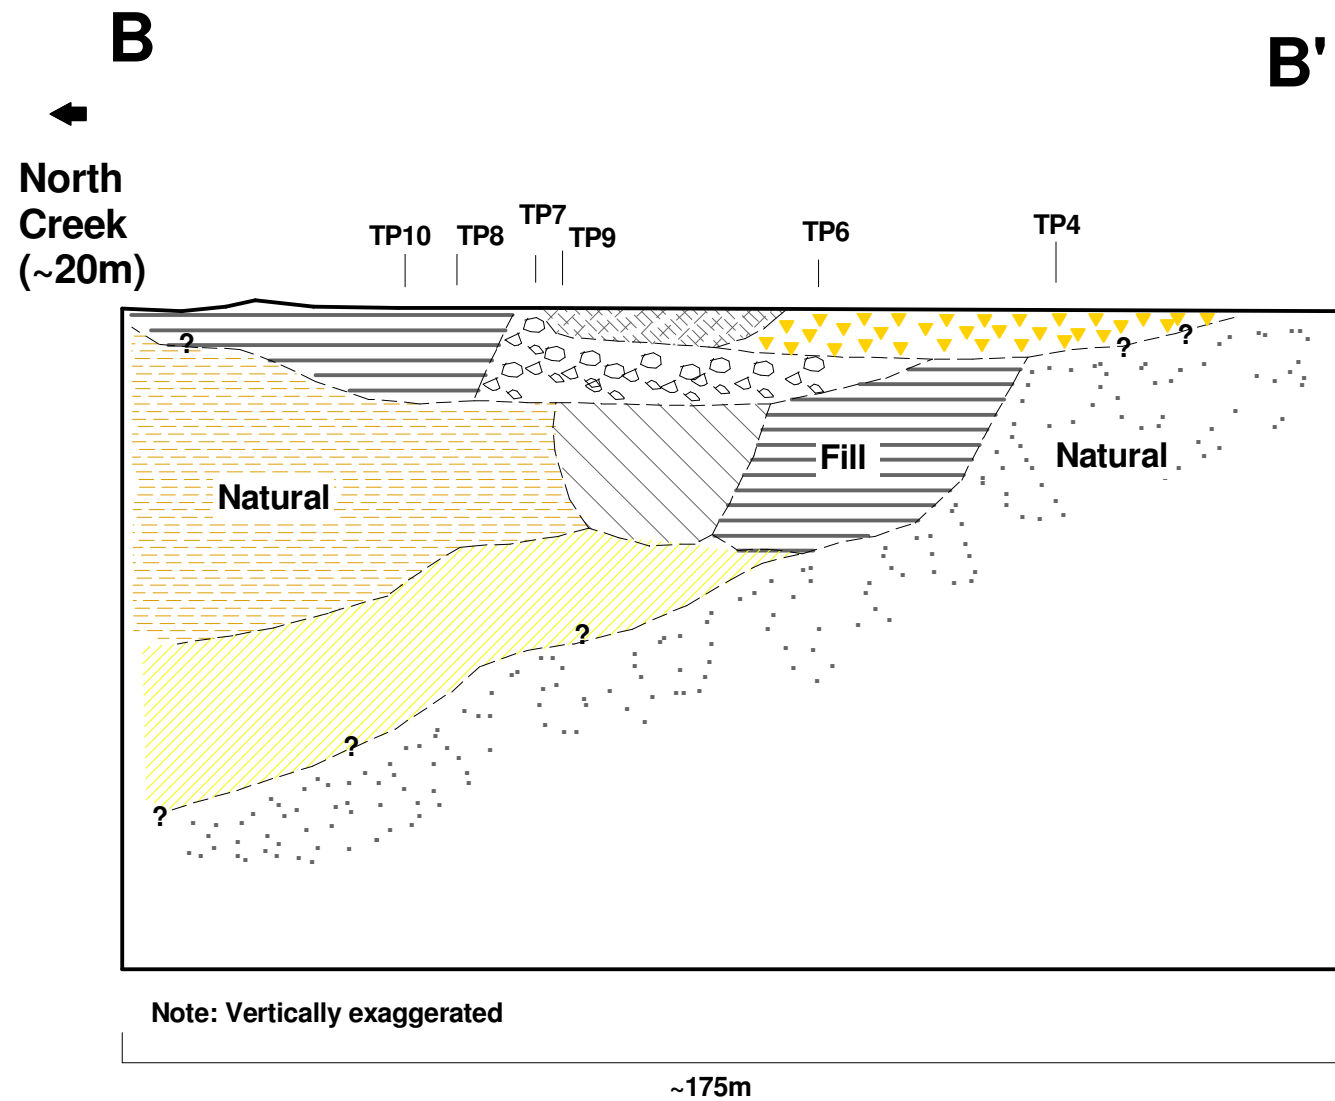
Inferred Stratigraphy - Cross-Section B-B'

- Waste (mixed clays with rubbish-broken glass bottles, tiles, bricks, wood, plastic, metal, wire, minor putrescibles)
 - Fill (firm or loose, dark grey/brown, silt or silty clay or sand)
 - Fill (Dark brown silty clay, black clay with yellow sand, gravel or bitumen)
 - Fill (Mixed clays with minor gravels)
 - Fill (Broken rock fragments with some clay)
 - Fill (Dark brown silty clay or clay with minor rubbish - broken glass bottles, tiles and wood chips)
 - FILL (Yellow sand and clay)
 - NATURAL (Dark brown silty clay and clay with dark red and orange mottles)
 - NATURAL (Dark grey/brown clay or sandy clay)
 - NATURAL (Dark grey/brown sand and sandy clay)
 - NATURAL (Yellow/grey sand)
- Standing water level
