Potential Habitat Modification of Mangrove Basins

Jon Knight & Pat Dale (Griffith University)
Pat Dwyer (Fisheries NSW)

Proposed Management of the Mangrove Wetland at Bosun Blvd

April 2013

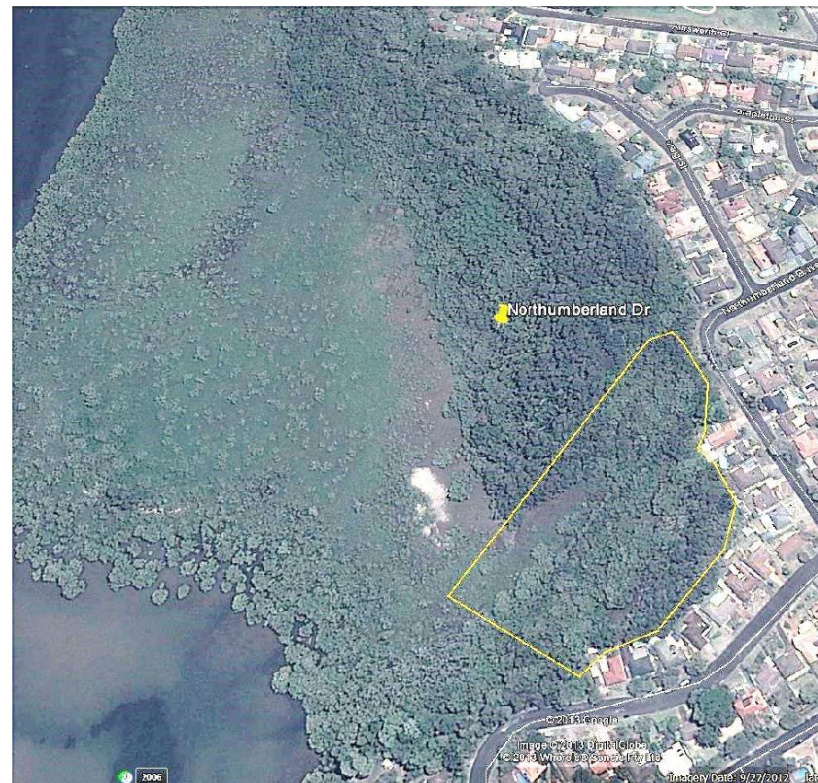
Northumberland Drive

Area highlighted contains

- a number of complicated hydrologic features
- variety of vegetation types
- appears to possess mosquito habitat
- may be due to past modification such as constructed drainage that has now grown over

It may be possible to reduce the *Aedes* mosquito hazard by changing hydrology

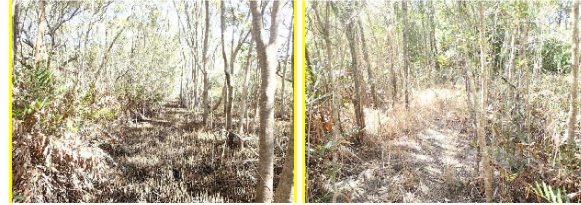
Saltmarsh with good flushing and limited mosquito hazard

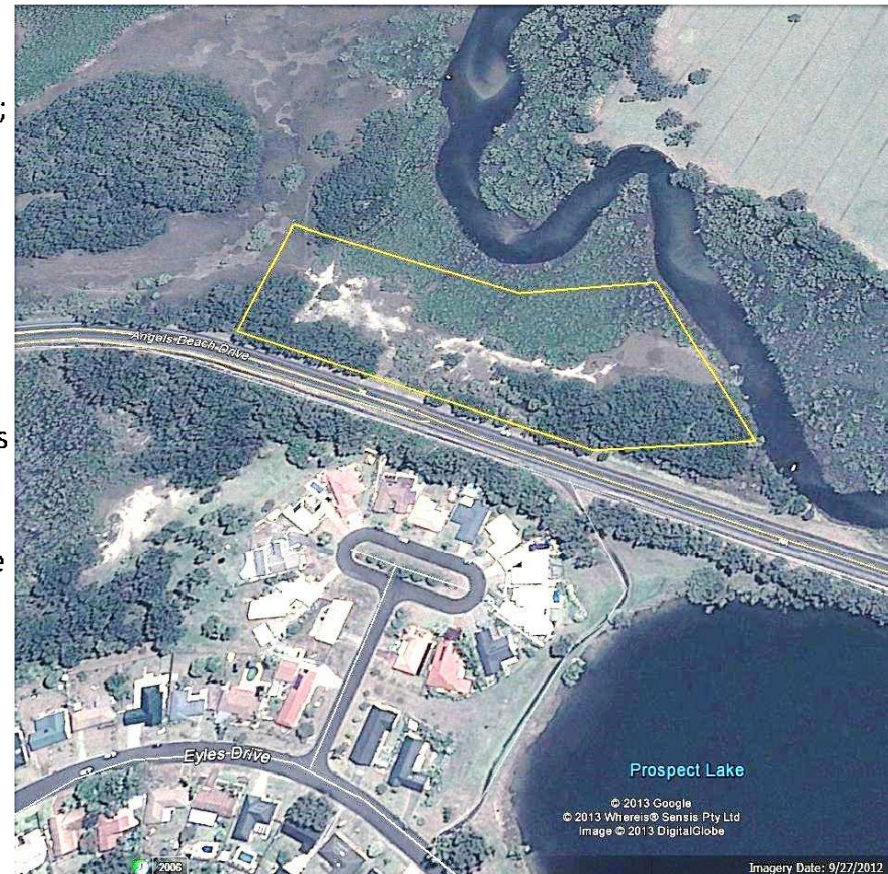
Angels Beach Drive

Area highlighted contains:

- Accessible hydrologic features;
- Mostly saltmarsh with sedge and mangroves;
- Appears to possess mosquito habitat indicated by suitable depressions with limited flushing;
- Some impact of past vehicle tracks that may now contributes to mosquito problem.

It may be possible to reduce the mosquito hazard by flushing depressions – as in runnelling type approach or filling some areas to limit inundation.

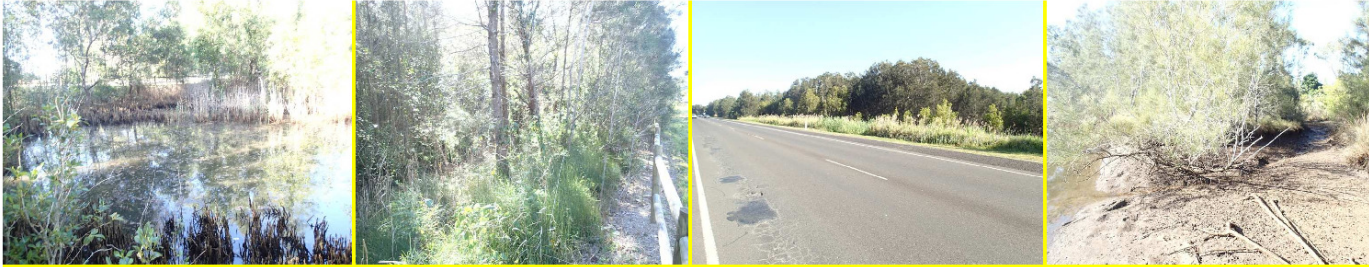
This pool is isolated from all but the highest tides which inundate the pool by moving along the roadside table drain. The limited flushing of the site exacerbates mosquito hazard.

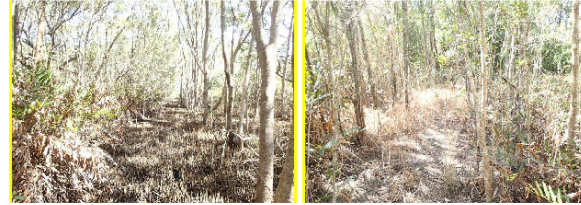
Saltmarsh with good flushing and limited mosquito hazard

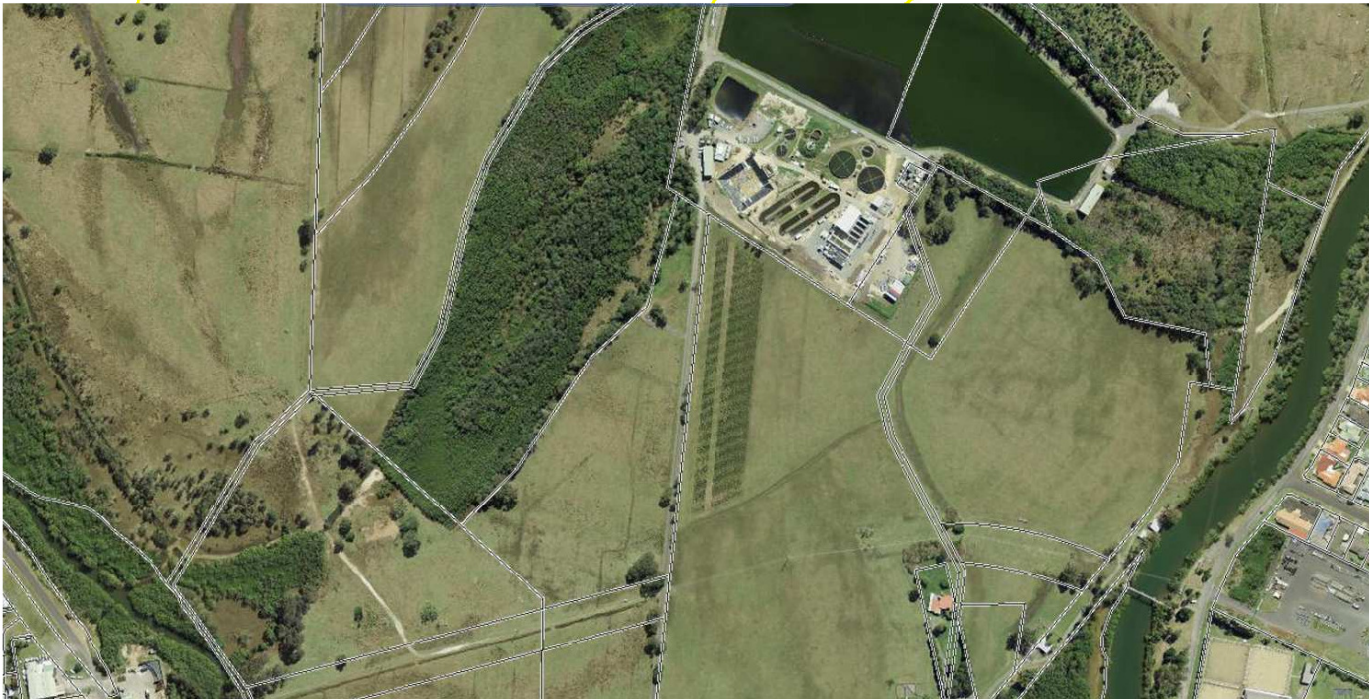
Within the highlighted area hydrology is complicated by remanent drains and ongoing stormwater inputs which appear to have changed vegetation types and increase mosquito hazard.

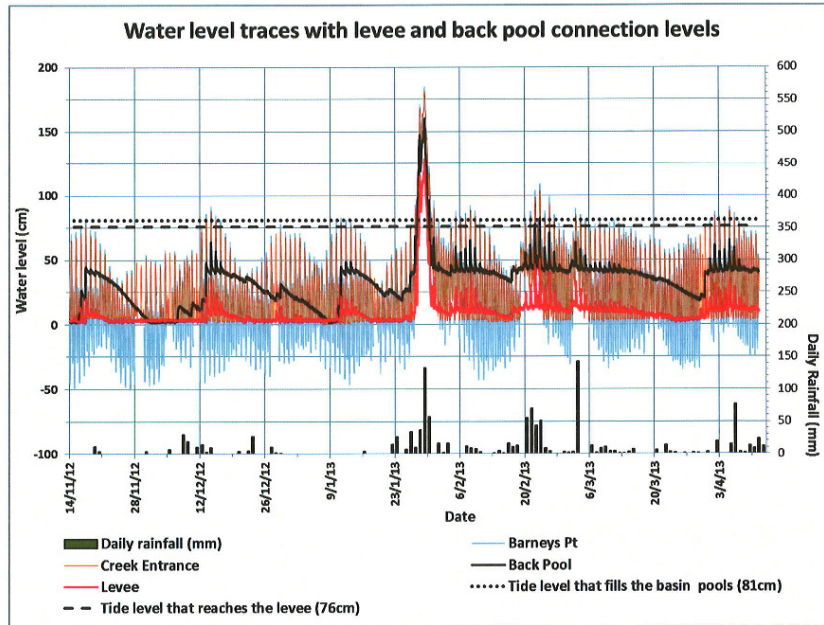
Fig 1: Water depth traces from the Bosun Blvd site (Nov 14 2012 and April 11 2013) superimposed over the tide trace from Barneys Pt MHL station. Tidal connection levels (basin pools and levee) are shown relative to Barneys Pt tide levels where the Barneys Pt water level data has been transformed to the Australian height Datum. The three site data sets are as recorded. The loggers were placed on the substrate. Rainfall data is from Tweed Heads Golf course BOM site (www.BOM.gov.au).

The impact of rainfall/runoff is best illustrated for the period 7-12 Dec 2012 on Fig 1 where water levels in the basin pool (thick black trace line) show a small increase of ~120mm corresponding with 20mm and 30mm of rainfall on consecutive days. Responding to rainfall when the basin pools are empty is the main justification for developing option 4 over option 3 as above.

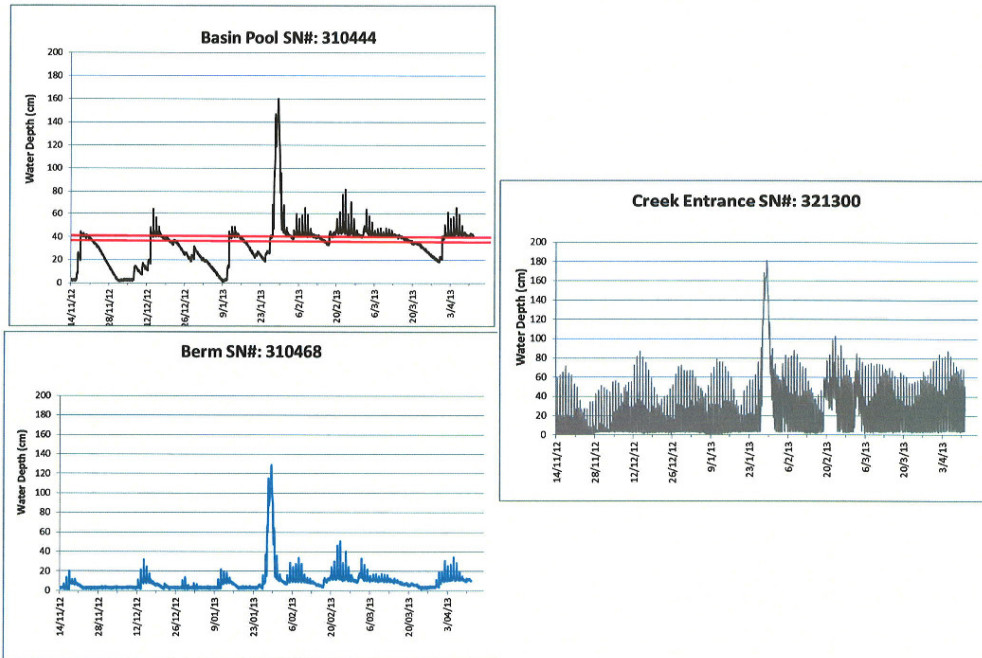
Fig 2: Individual water level traces. The red lines in the basin pool plot are the fully connected level (upper) and partially connected level (lower).

- a) **Basin pool** depth logger located in the base of the deepest depression. The level of water retained in the basin pool after tidal ebb across the levee was 40cm.
- b) **Levee** depth logger located in low part of the levee north of the rocks. The level of water across the levee is generally controlled by tide height, however about 5-10cm of water remains after the tidal ebb for 3-4 days and decreases at about 3 cm/day. This may be

because there is a slight depression where the logger was deployed or the logger was not deployed exactly on the levee.

- c) Creek entrance depth logger located in the opening of the creek. The creek entrance is a mirror of the system (as expected). The CE connects about 30 minute before Barneys Pt and as a comparable tidal pattern but is truncated at lower tides. The gauge, by chance, was positioned at an elevation of approximately 0m AHD.

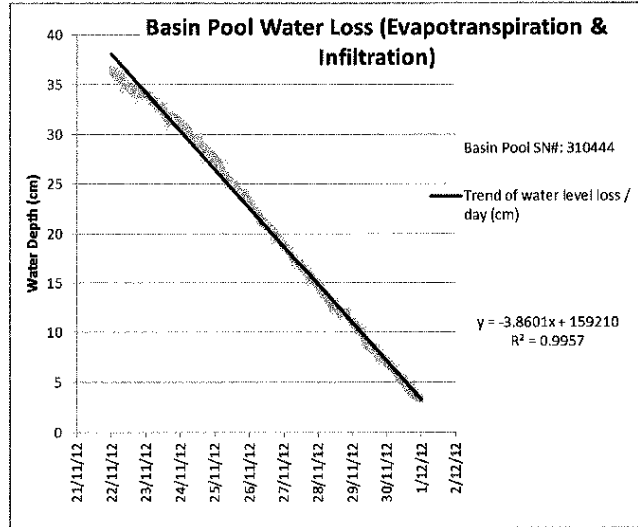
Fig 3: Water loss rates due to evapotranspiration and infiltration from the basin pool.

Water level decreases as a result of evapotranspiration and infiltration from the basin pool. In the absence of recharge the water level decreases at ~3.8cm/day. The period displayed (23rd Nov – 1st Dec 2012) was comparable to other similar sections of the basin pool trace.

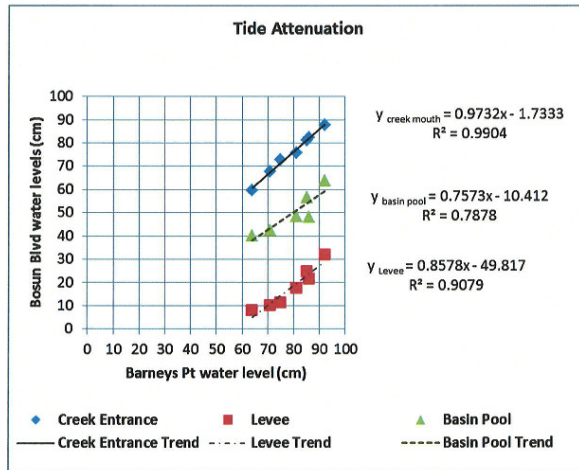
Fig 4: Attenuation calculation plots derived from traces for 12-18 Dec 2013.

Attenuation of the tide trace compared with Barney’s Pt. All three sites show a loss of energy when compared with the Barney’s Pt observation data. The data were derived from high-tide levels on each of 12-18th Dec 2013. The slope of the trend lines shown in Fig 4 (or x-co-efficient from each equation shown in Fig 4) indicates the attenuation rate as a loss in water level compared with Barneys Pt levels and included:

- a) Creek Entrance 97.3%. A loss of 2.7% could be within the error of the data.
- b) Levee 85.8% or a loss of 14.2%.
- c) Basin Pool 75.7% or a loss of 24.3%

Note that the tide levels shown are for the part of the high-tide that connects with the sites at Bosum Blvd.

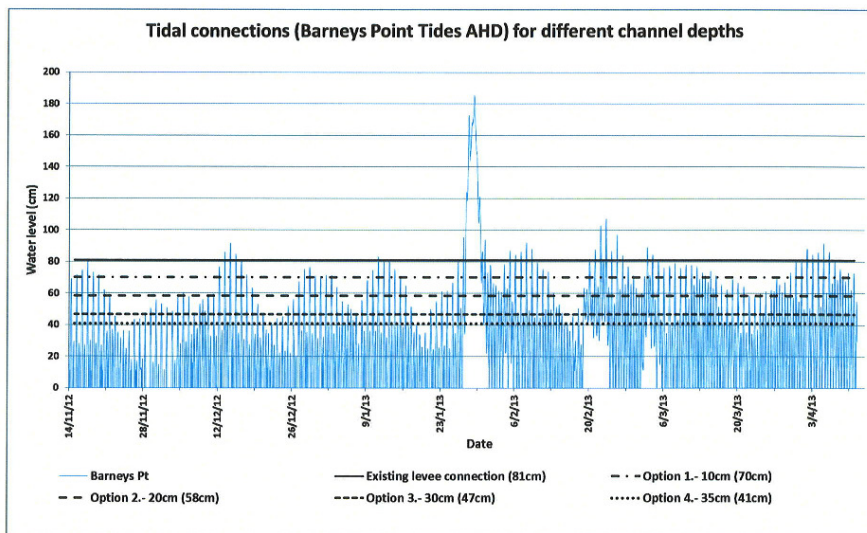
Fig 5: Intersection of channel depth options overlaid on Barneys Pt tide trace (MHL data) where the tide data were converted to the Australian Height Datum. Low-tide data below zero m AHD are not displayed for clarity reasons.

Fig 5 illustrates the intersection of Barneys Pt tides and the proposed channel depth options. The deeper the channel the more frequently tides connect into the mangrove basin, increasing flushing within the basin area. Also, the length of the gap when no tides connect to the basin decreases with greater channel depth.

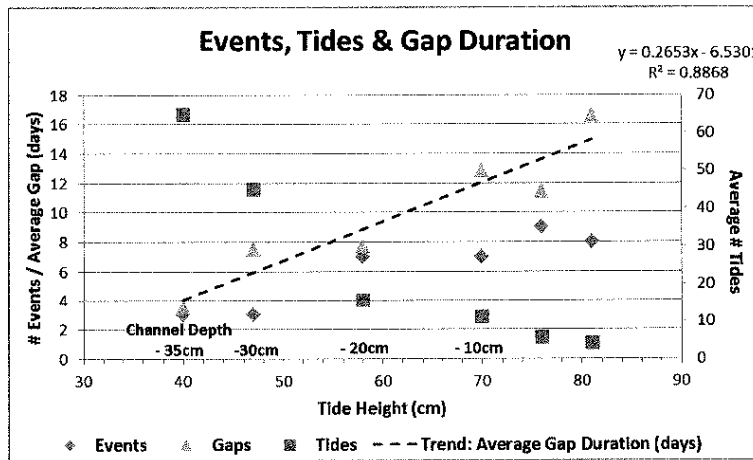
Fig 6 : Comparison of tidal connection factors (events, tides and gaps) for each of the four channel depth options (-10, -20, -30 & -35cm as labelled) and levee and basin pool levels (tide height at 76 and 81 cm respectively). Events: contiguous tides where gaps between consecutive tides were < 3 days). Tides: average number of tides in each event. Gaps: average duration of the gap between tidal events.

Patterns in number of events, number of tides and gap duration (with trend line) for different high-tide heights (as in Table 1 & 2) are illustrated in Fig 6. A trend line has been fitted to the gap duration data to enable deriving gap duration from tide height.
