PHASE 1 SITE CONTAMINATION ASSESSMENT

Rezoning of Lot 1 DP517111, Lennox Head
NSW

GEOTALST03192AC-AB
30 May 2013

**RE: Phase 1 Site Contamination Assessment for Rezoning of Lot 1 DP517111,
Lennox Head NSW**

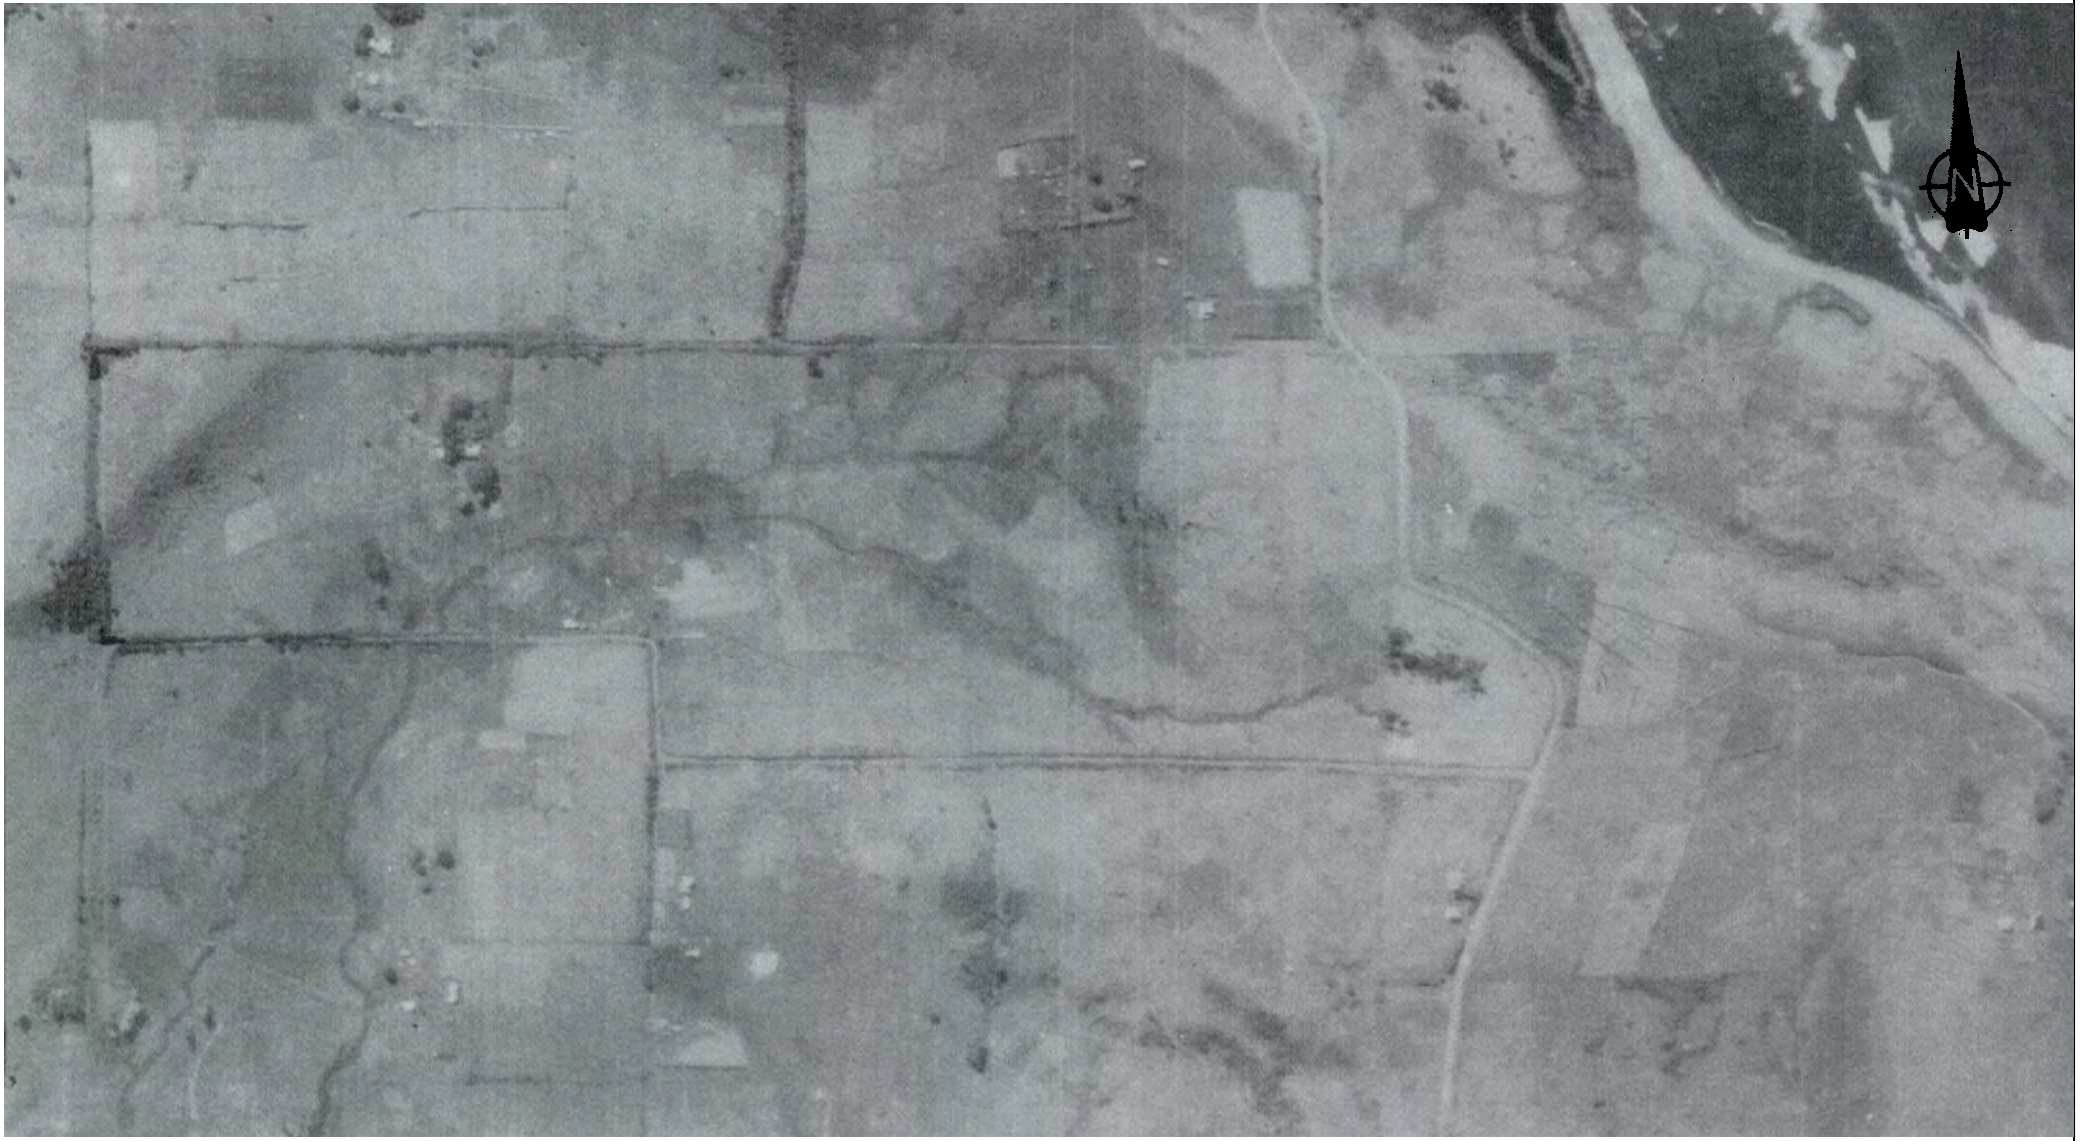
client:	Indigo (Lennox Head) Developer Pty Ltd	
project:	Phase 1 Site Contamination Assessment for Proposed Rezoning, Lennox Head NSW	
title:	Extract Aerial Photograph - 1947	
project no:	GEOTALST03192AA-AC	figure no: A1

Run: 2
Photo: SVY122
Date: 27/5/47
Location: Byron Bay

A review of historical aerial photographs indicated that the large portion of the site on Lot 1 DP 517111 has been vacant cleared rural land from 1947 to present day.

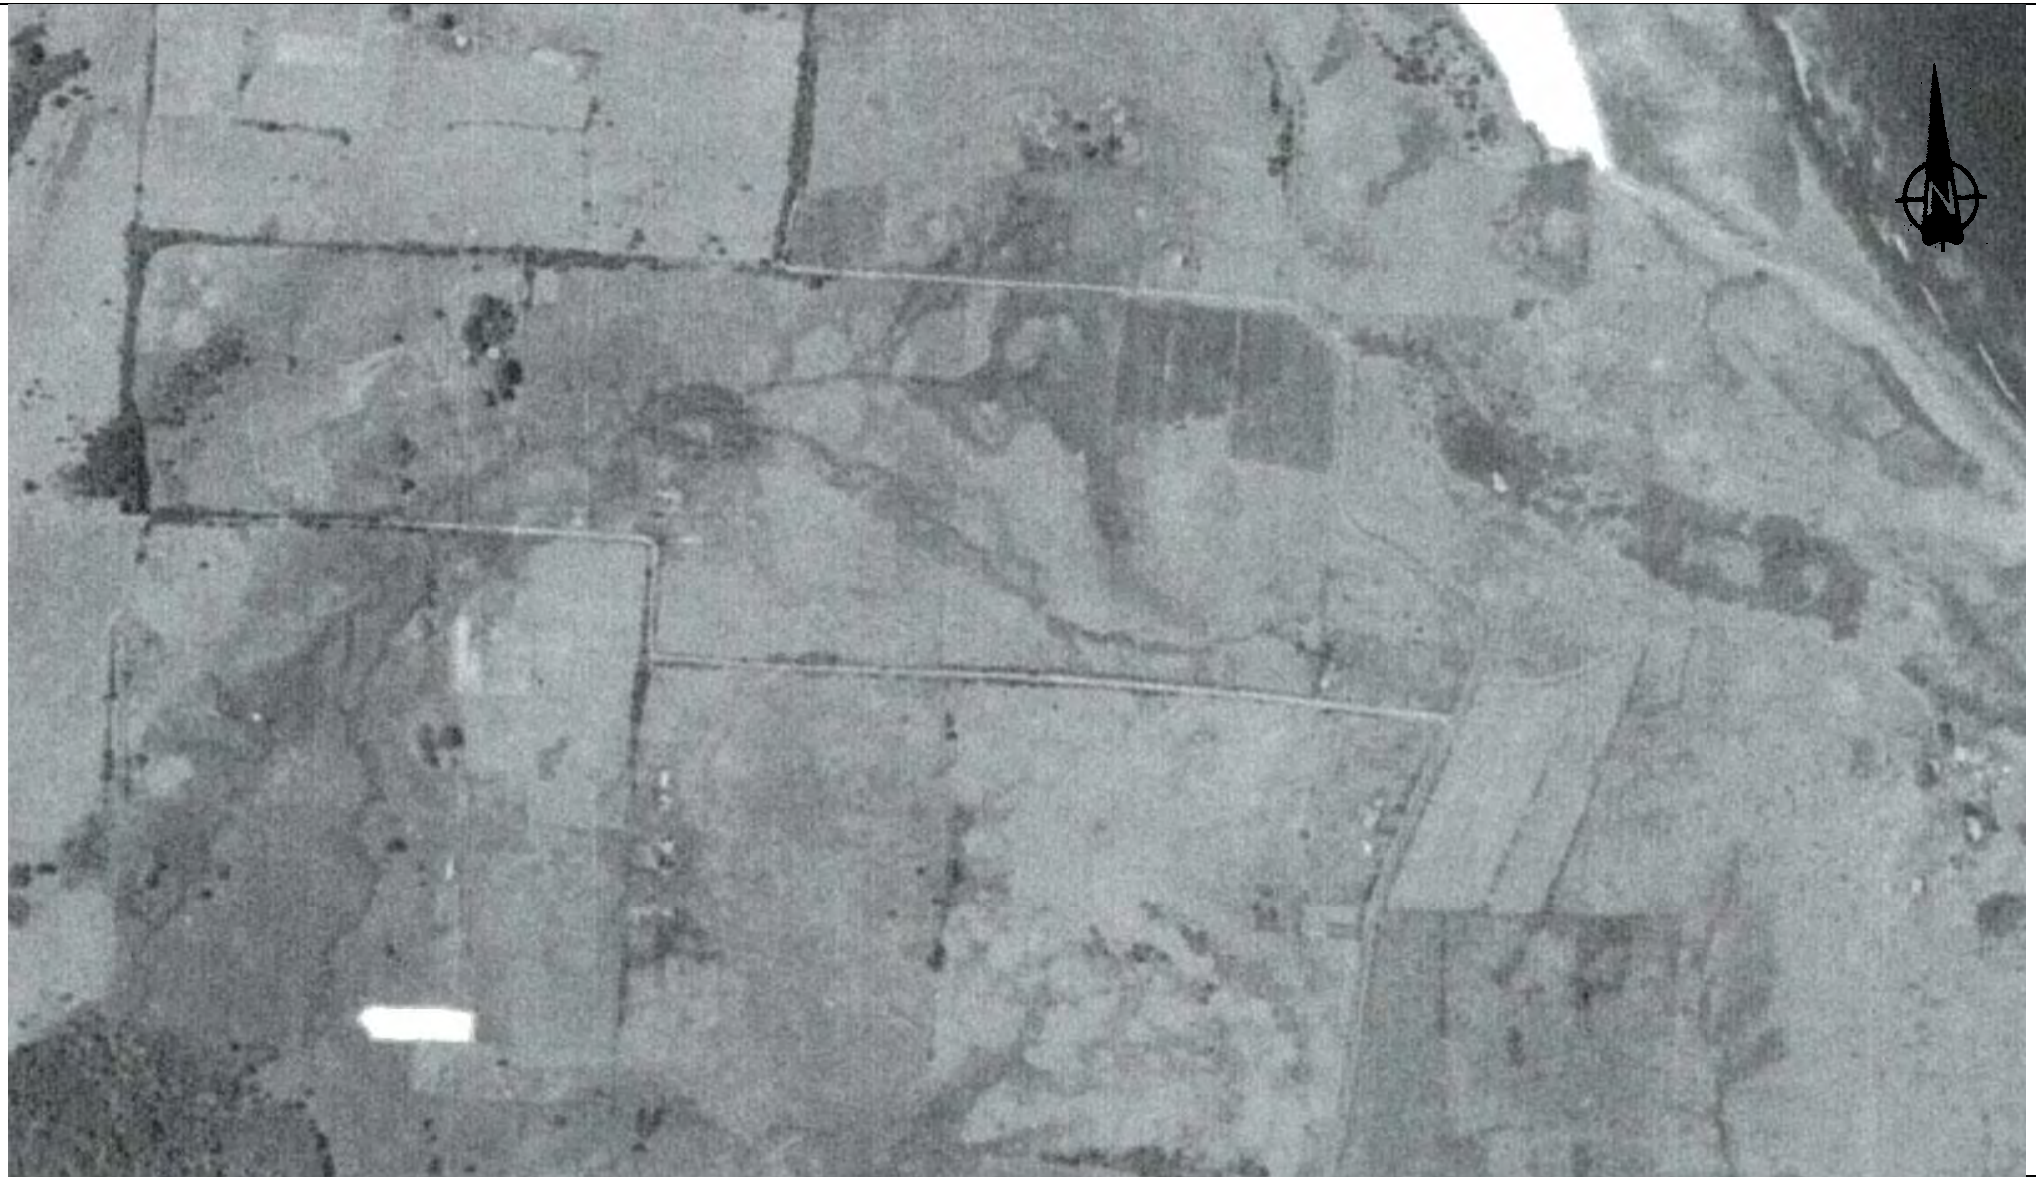
client:	Indigo (Lennox Head) Developer Pty Ltd	
project:	Phase 1 Site Contamination Assessment for Proposed Rezoning, Lennox Head NSW	
title:	Extract Aerial Photograph - 1958	
project no:	GEOTALST03192AA-AC	figure no: A2

Run: 5
 Photo: 326 5067
 Date: 12/10/58

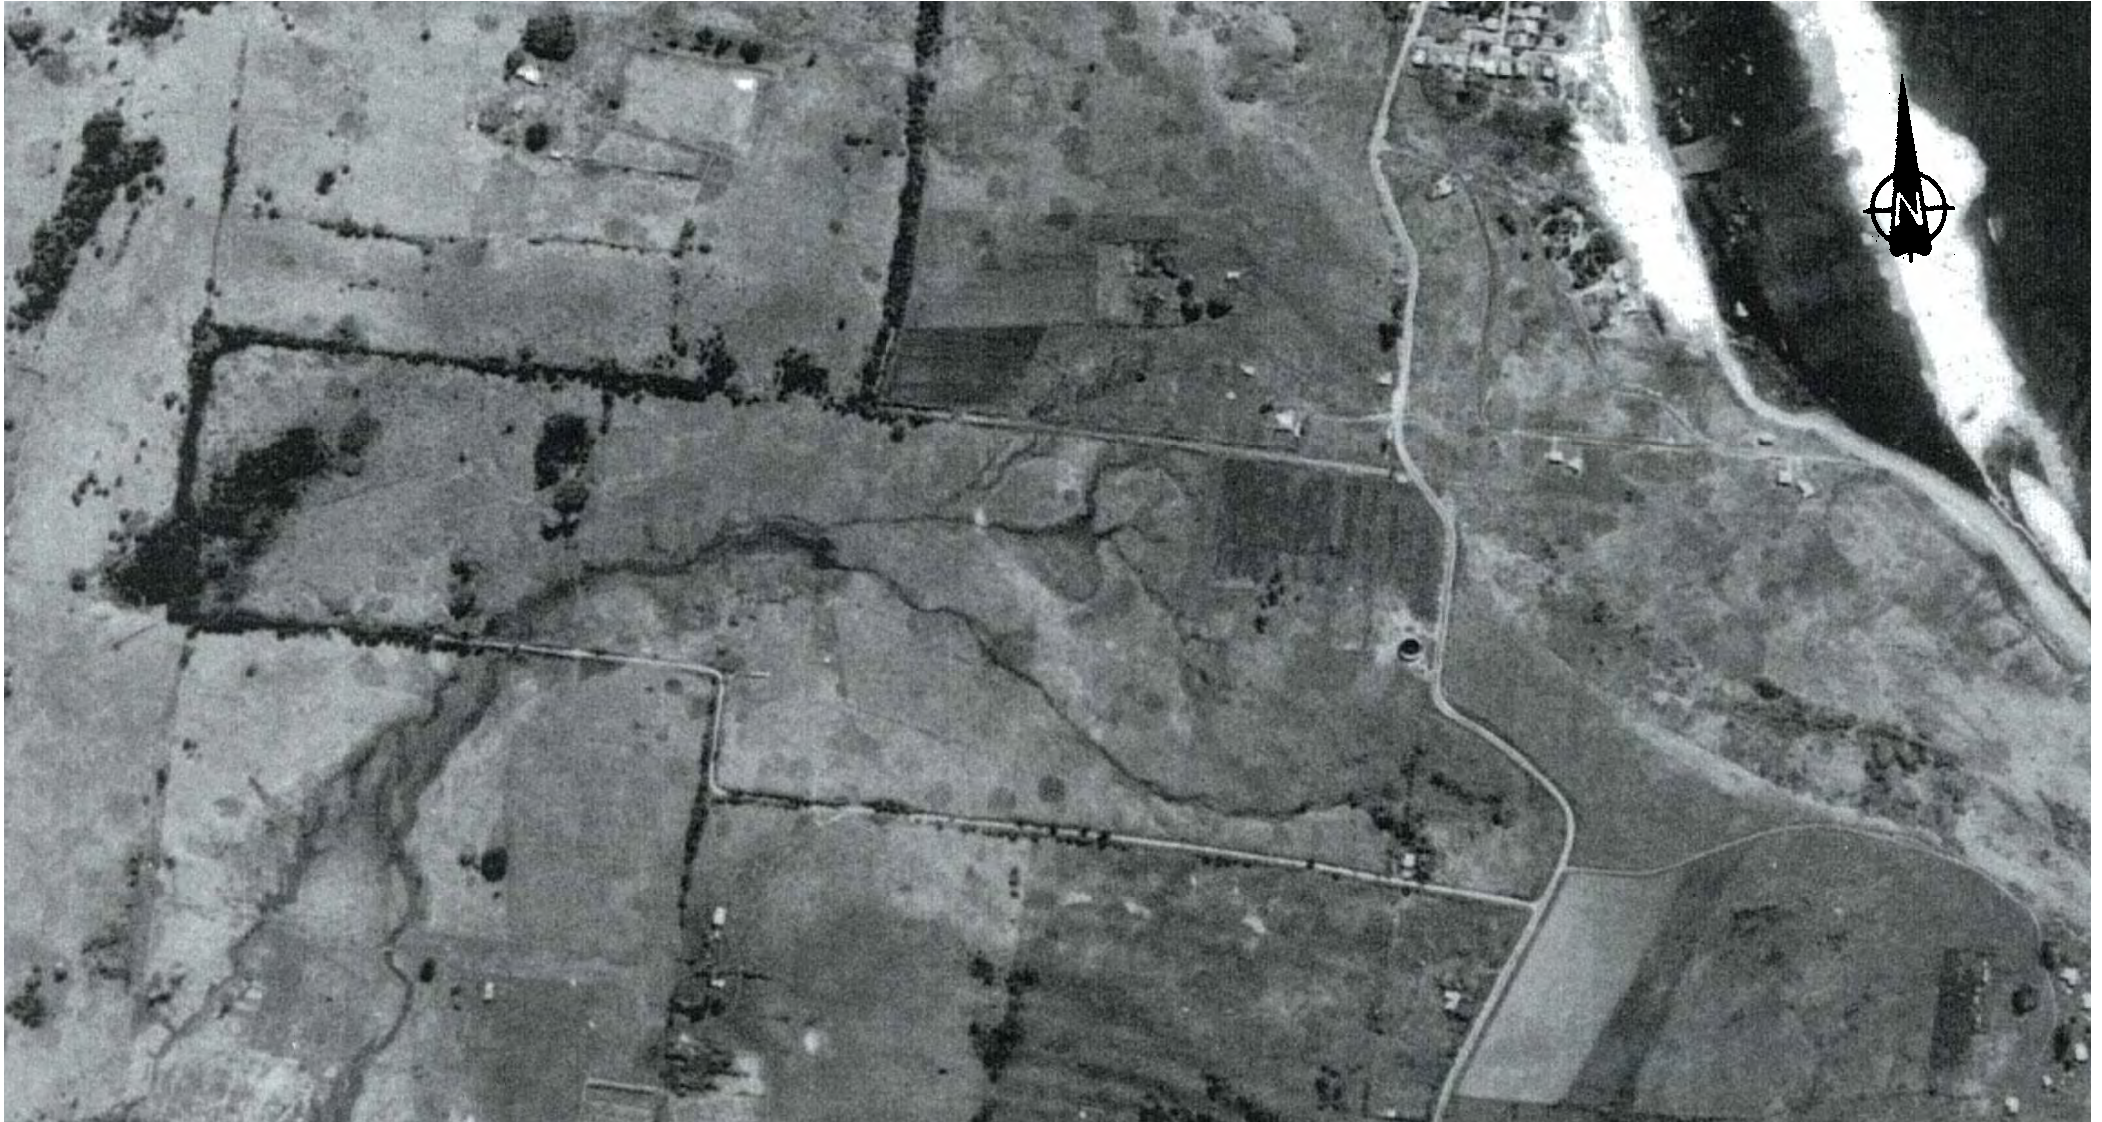
client:	Indigo (Lennox Head) Developer Pty Ltd	
project:	Phase 1 Site Contamination Assessment for Proposed Rezoning, Lennox Head NSW	
title:	Extract Aerial Photograph - 1967	
project no:	GEOTALST03192AA-AC	figure no: A3

Run: 7
 Photo: 1520 5121
 Date: 29/5/67

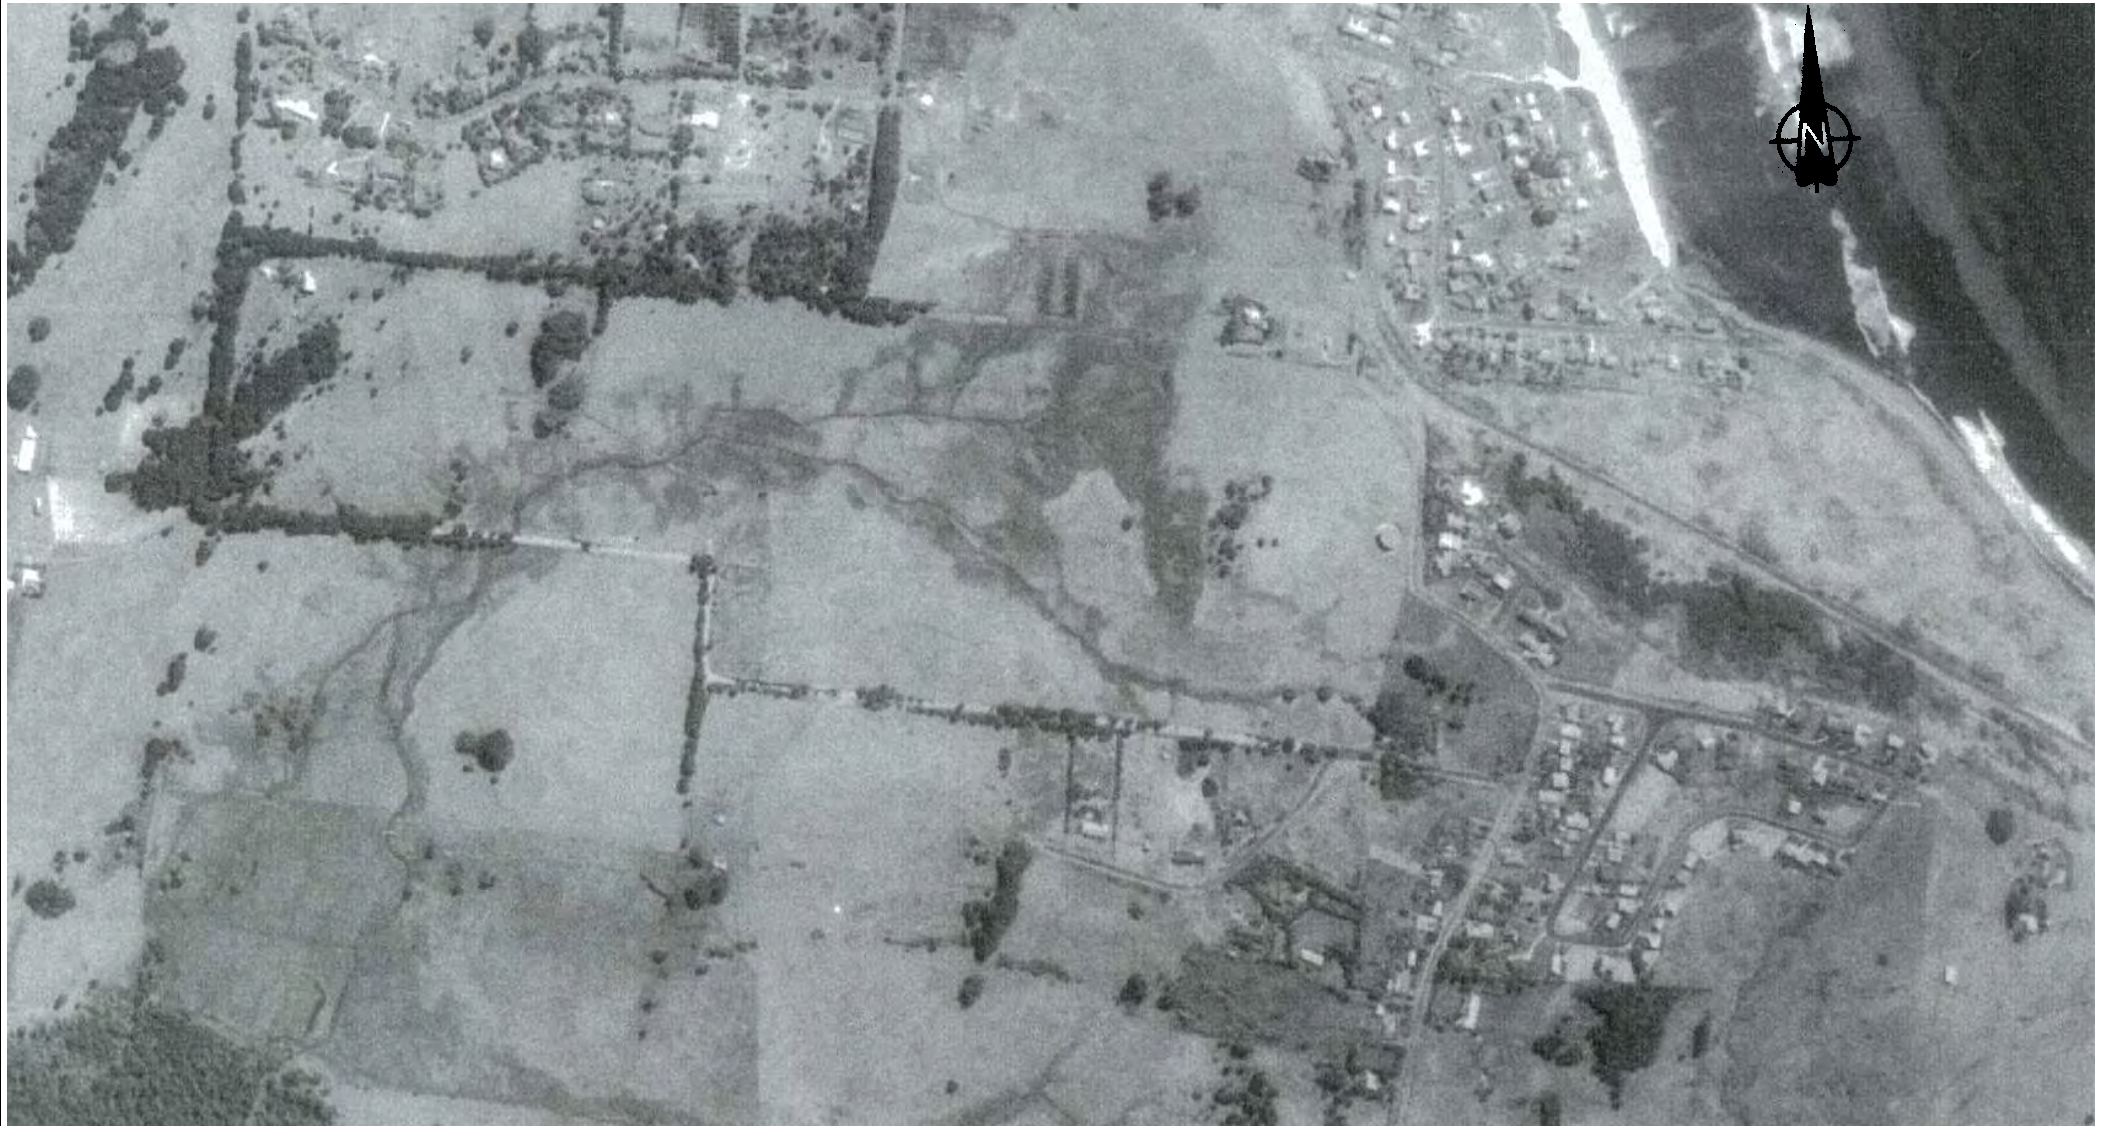
client:	Indigo (Lennox Head) Developer Pty Ltd	
project:	Phase 1 Site Contamination Assessment for Proposed Rezoning, Lennox Head NSW	
title:	Extract Aerial Photograph - 1987	
project no:	GEOTALST03192AA-AC	figure no: A5

Run: 5
Photo: 3584 223

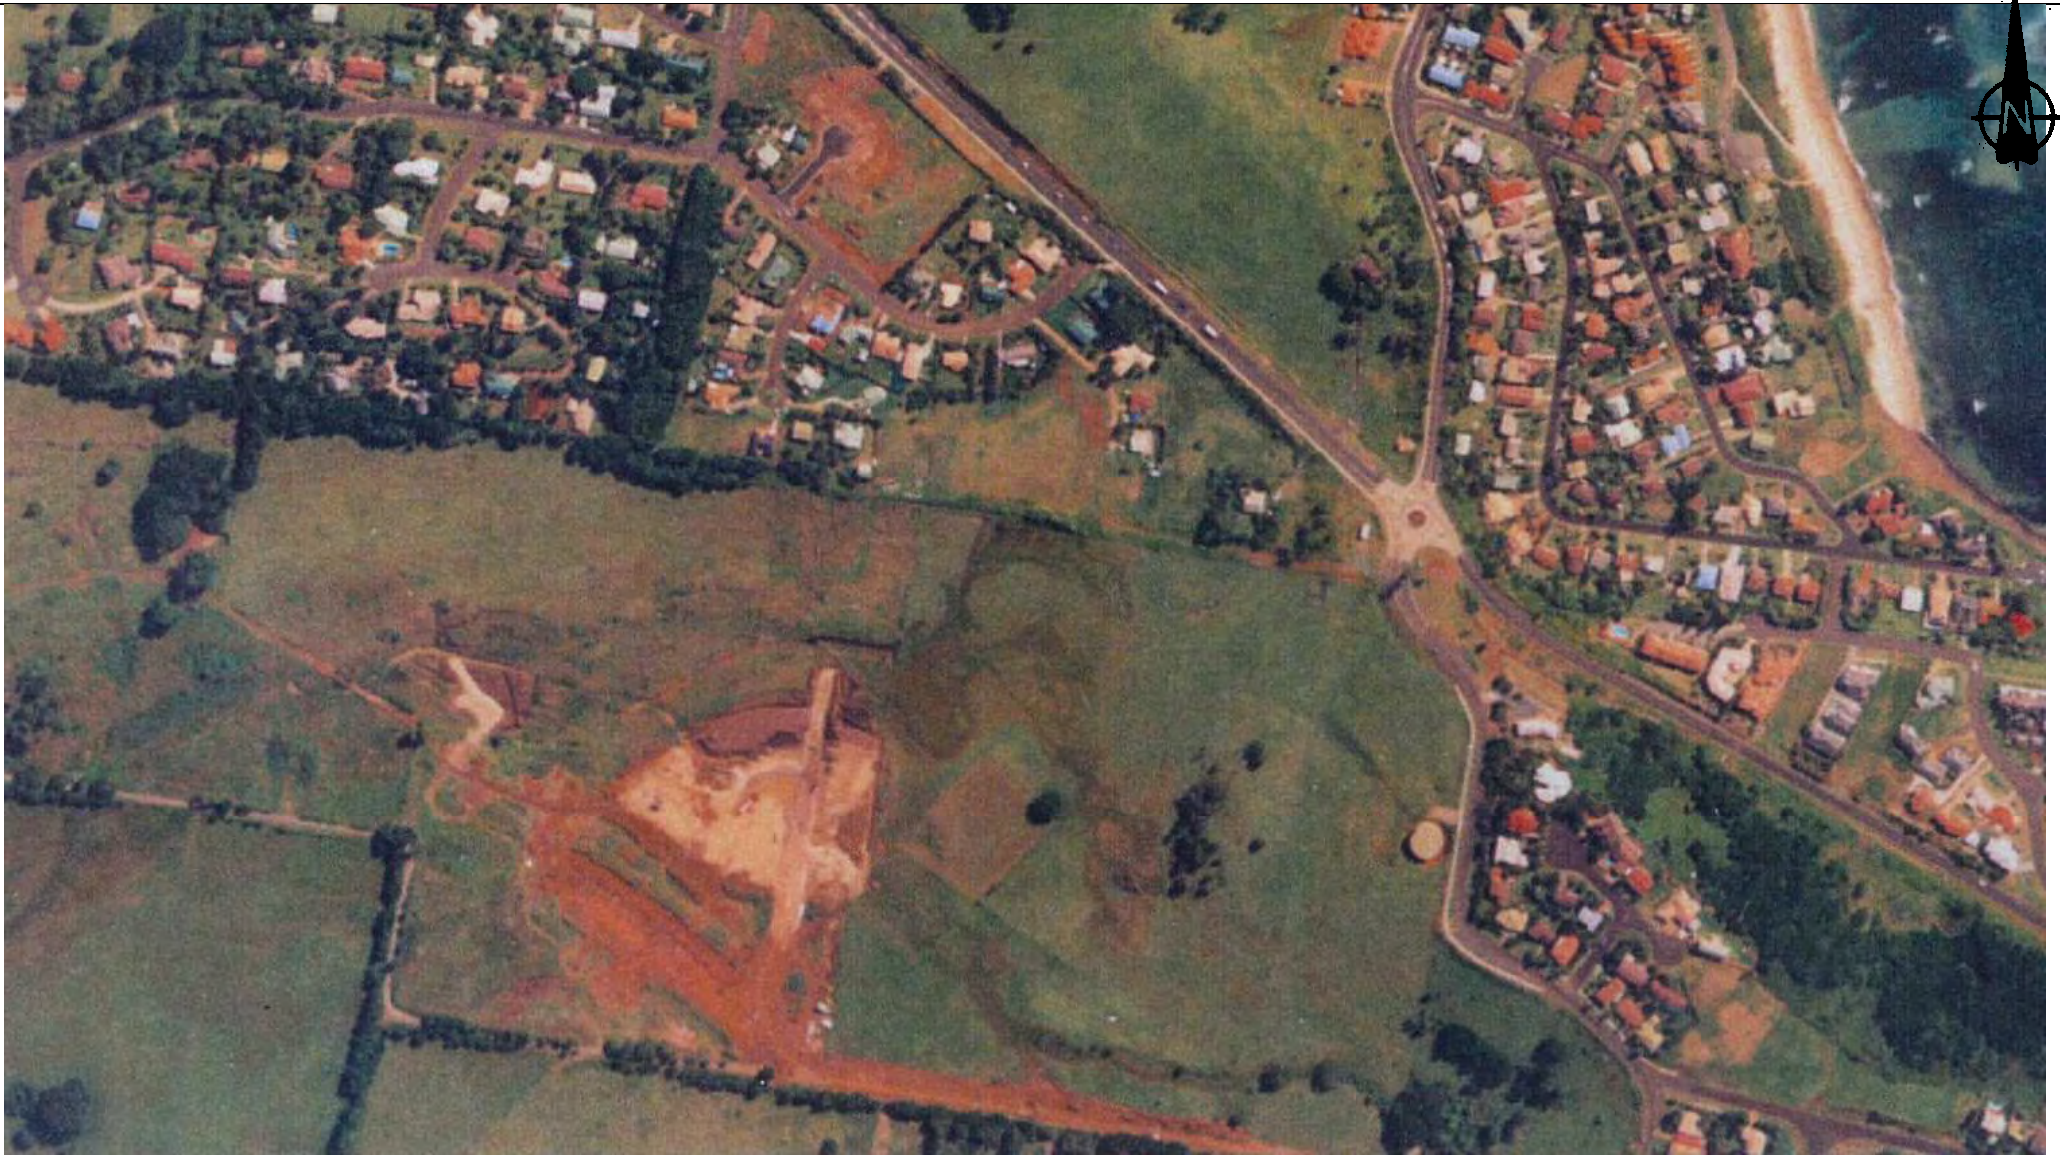
client:	Indigo (Lennox Head) Developer Pty Ltd	
project:	Phase 1 Site Contamination Assessment for Proposed Rezoning, Lennox Head NSW	
title:	Extract Aerial Photograph - 1997	
project no:	GEOTALST03192AA-AC	figure no: A6

Run: 8
 Photo: 4359 108
 Date: 22/4/97
