Tosha Falls Management Plan

Part A

Prepared for Ballina Shire Council

Adopted by Ballina Shire Council on 25 January 2018

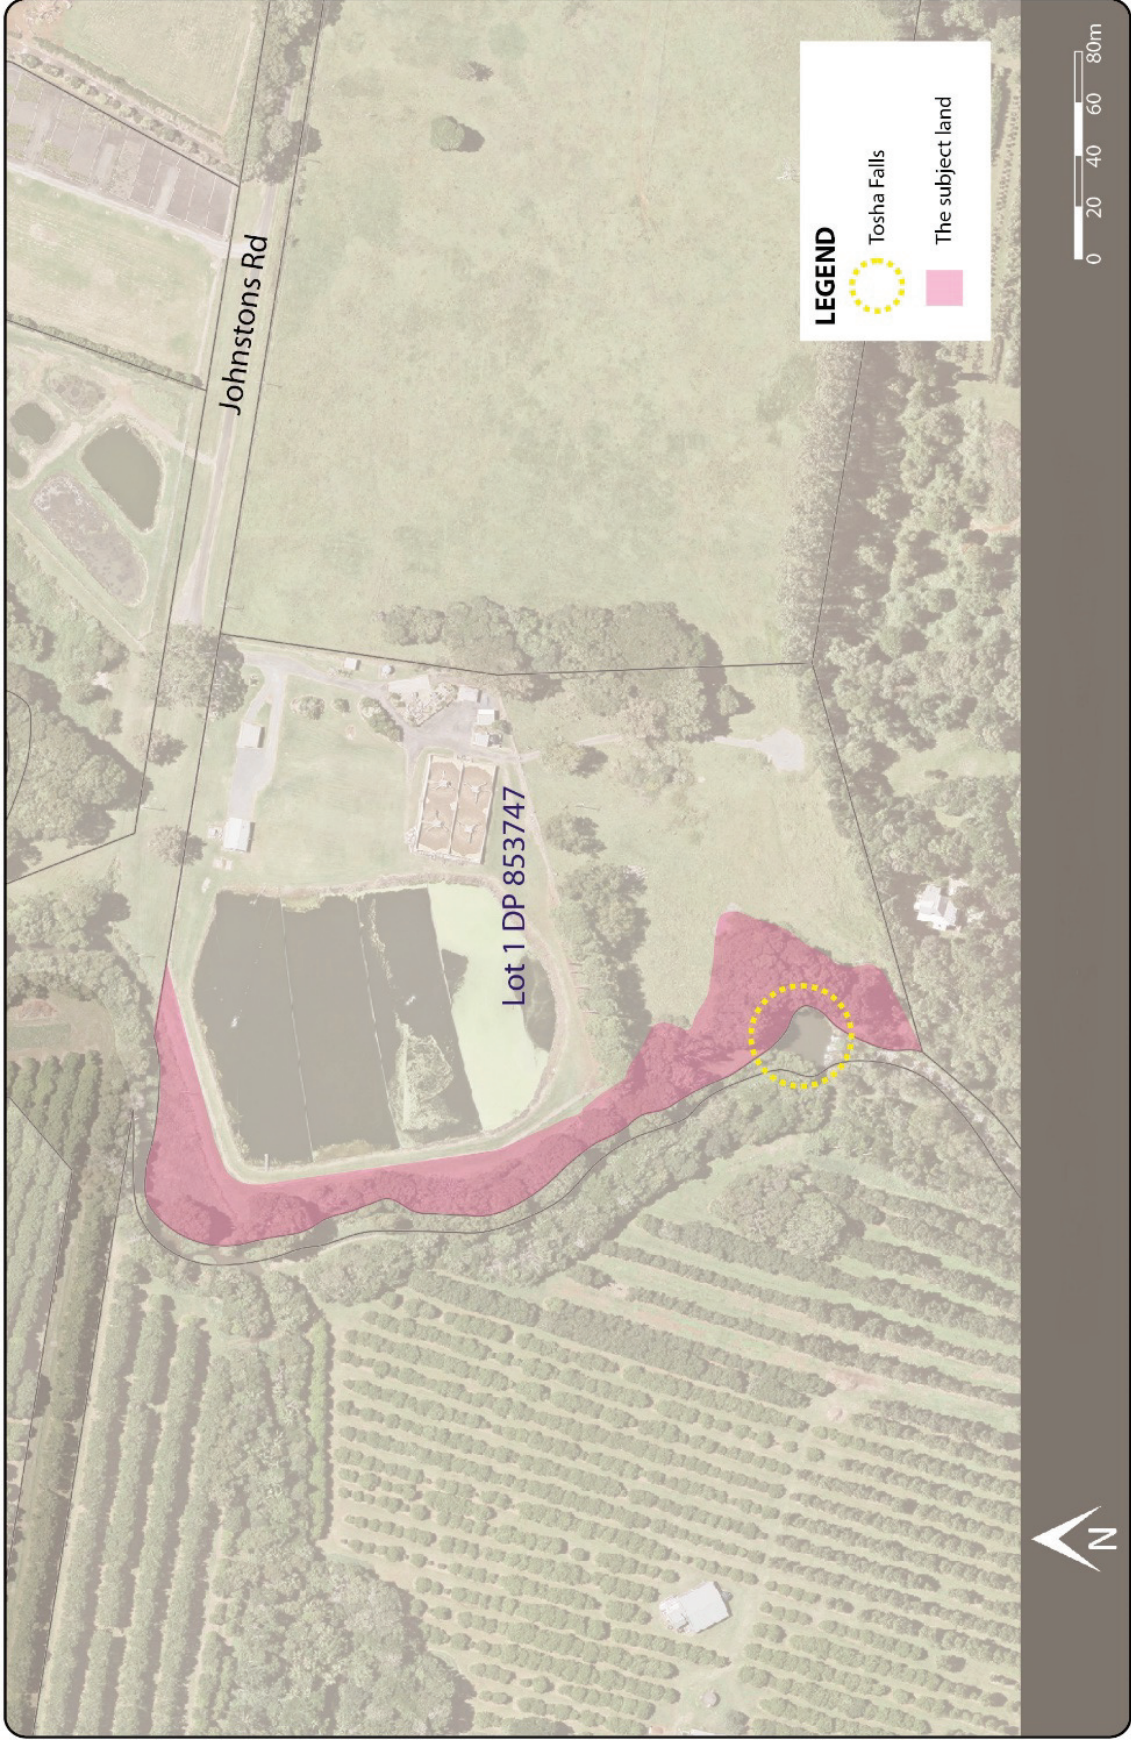
Figure 1: Part Lot 1 DP 853747, Alstonville (the subject land)

The land subject to this management plan is part of Lot 1 DP 853747 (the subject land). Part Lot 1 is approximately 0.92 hectares and is primarily a riparian strip located at the western edge of Lot 1 (Figure 1).

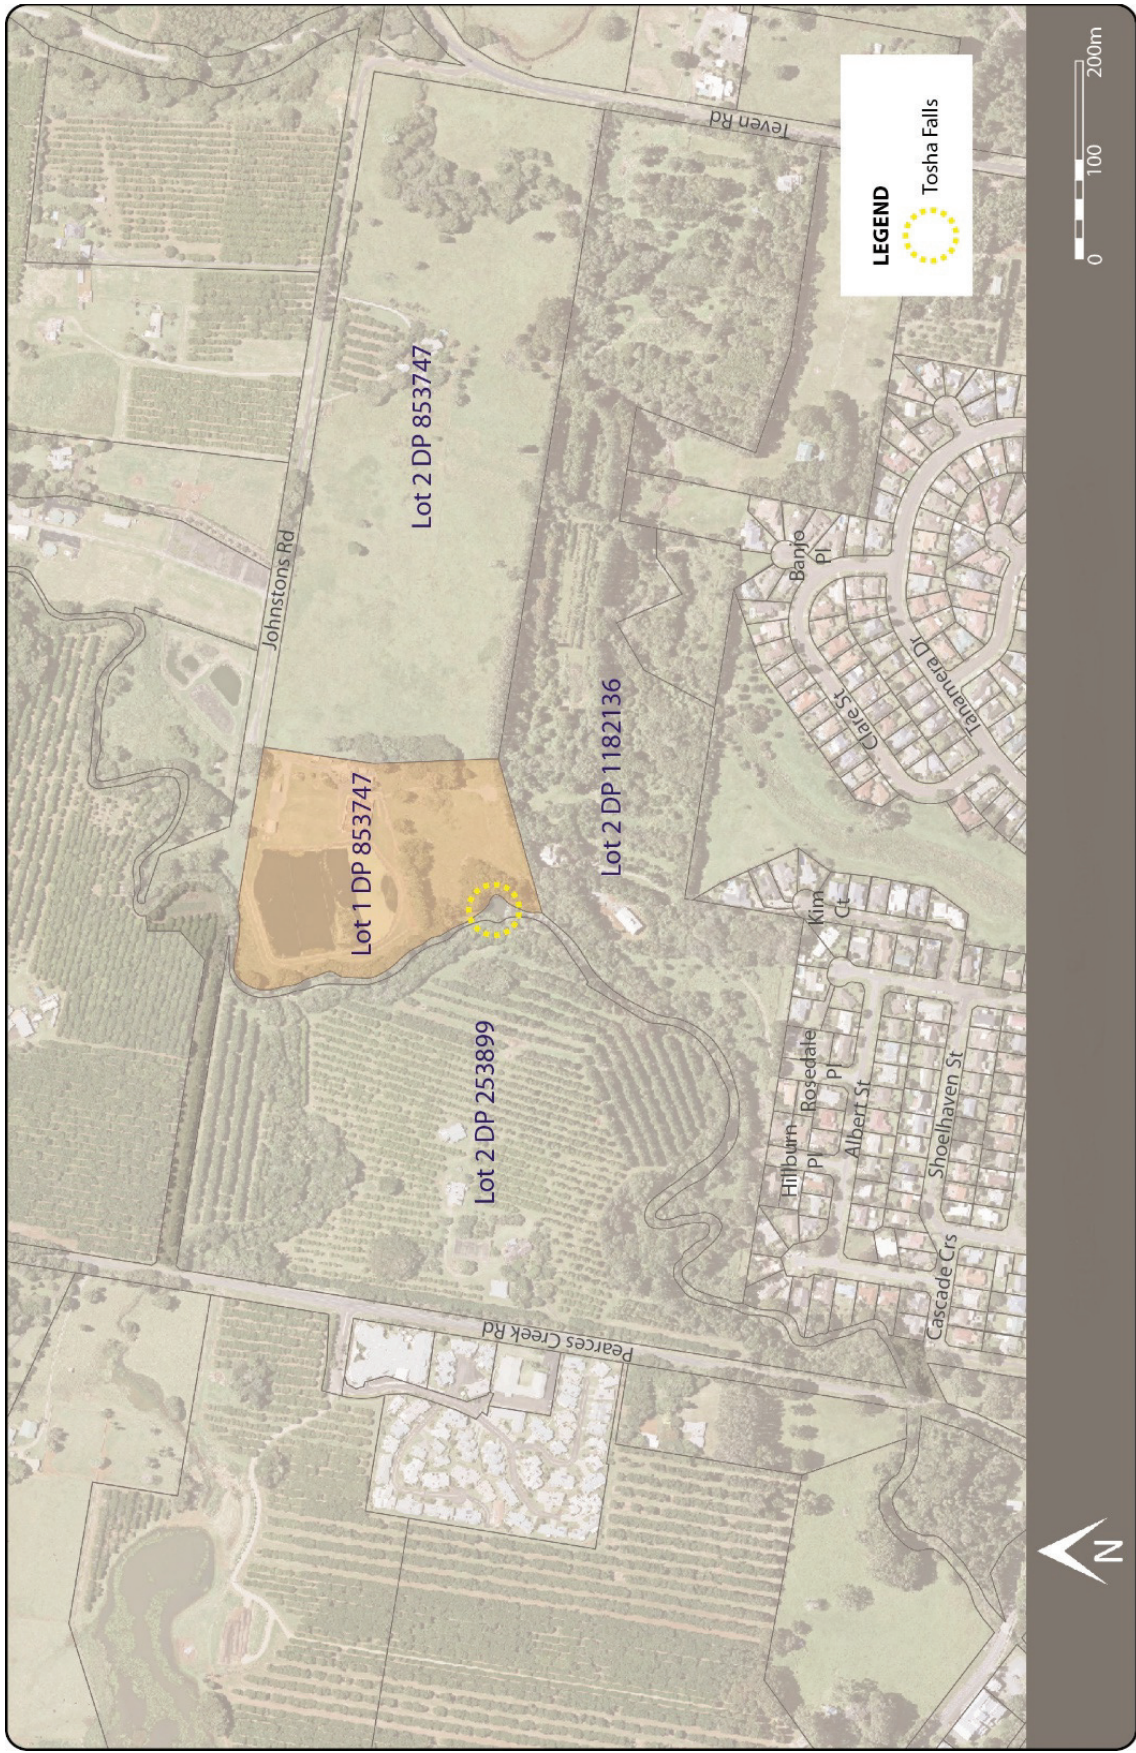
Figure 2: Lot 1 DP 853747, Alstonville (and surrounding land)

The entire area of Lot 1 is approximately 5.2 hectares, and a large part of this is occupied by the Alstonville Sewage Treatment Plant (Figure 2). The lot is located at the termination of Johnstons Road on the southern side. Council also owns land on a separate lot on the northern side of Johnstons Road. Tosha Falls is located on Maguires Creek, which is the boundary between Lot 5 DP 253899 (to the west) and Lot 1 DP 853747 to the east. Approximately 30 metres to the south of Tosha Falls is Lot 2 DP 1182136.

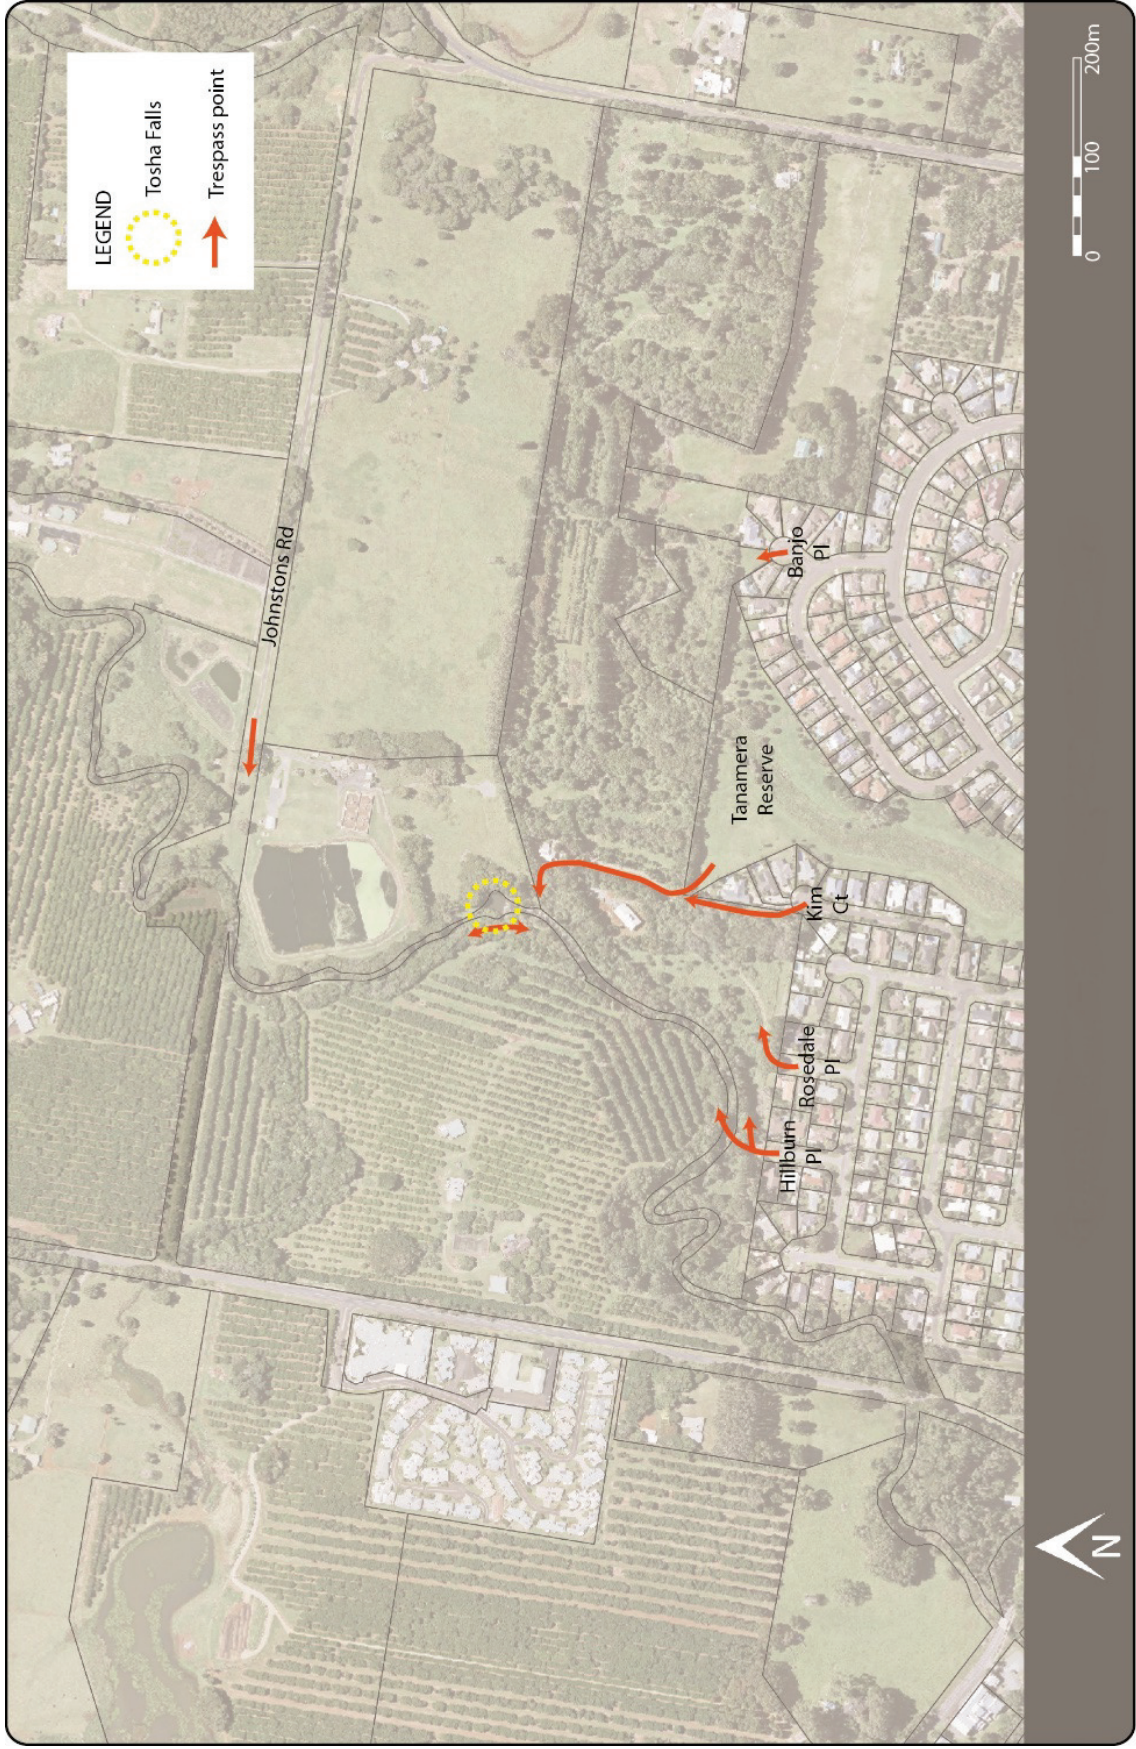
Figure 6: Trespass and privacy issues related to accessing Tosha Falls

The trespass access points are all from public land or road reserves that are poorly fenced and signposted. Past attempts to do both have been subject to vandalism. The trespass has been reported by neighbours to local Police, but this has not resulted in any obvious reduction in trespass.

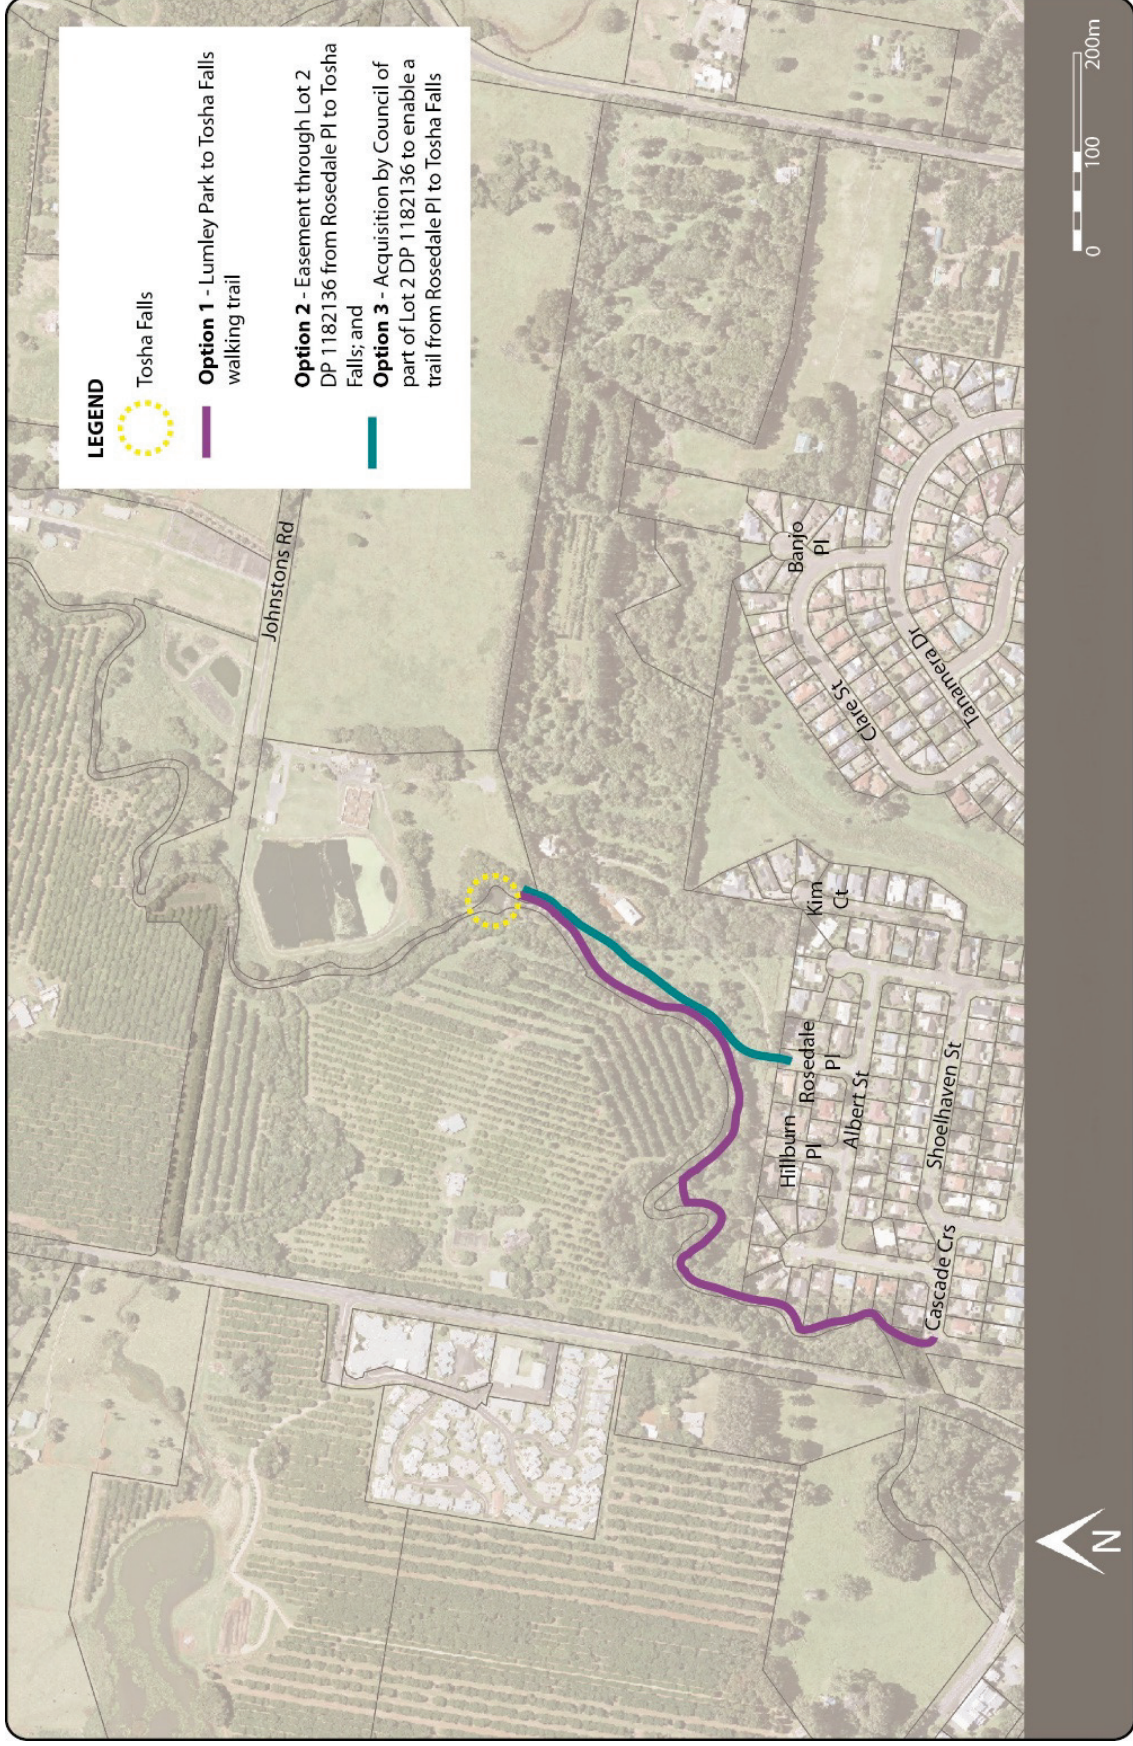
Figure 8: Accessing Tosha Falls other than from Johnstons Road
