Richmond Ecohealth Project 2014

Assessment of River and Estuarine Condition

Final Technical Report

February 2015

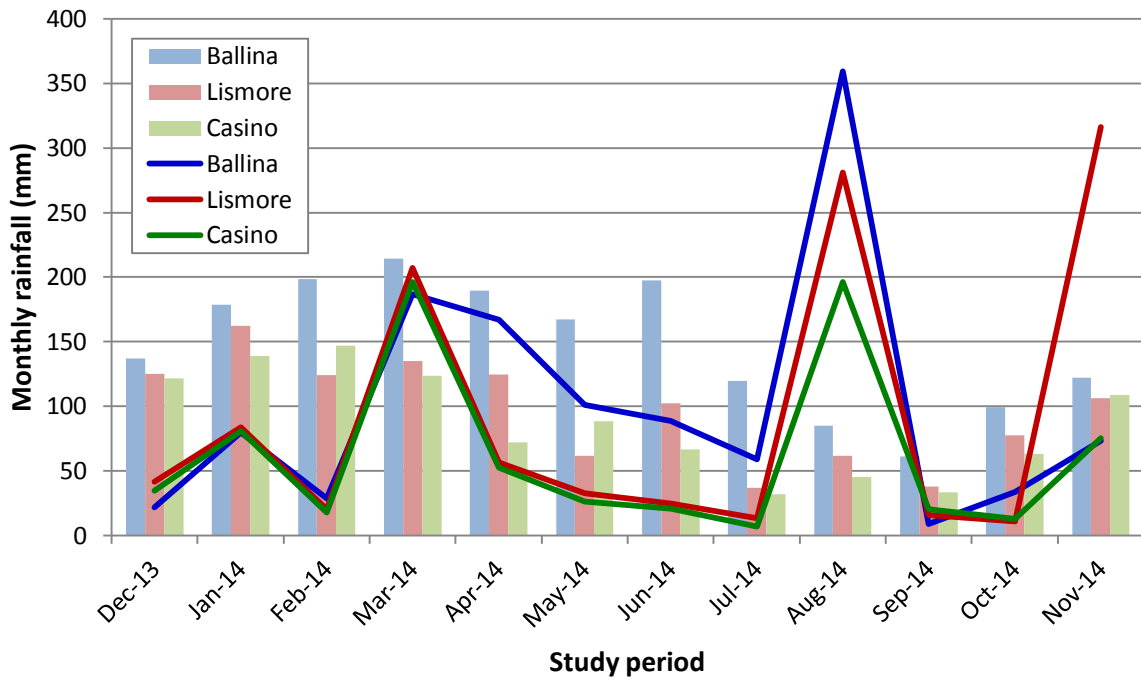
Figure 2.6 The long-term mean monthly total rainfall (columns, mm) and the monthly total rainfall during the sampling period (lines, mm) at Ballina (gauge 058198), Lismore (gauge 058214), and Casino (gauge 058208).

Rainfall in the region during the 2013-2014 sampling period was well below the long term mean, with an annual total rainfall of 1208.4mm at Ballina, 1104.4mm at Lismore, and 743.4mm at Casino (Figure 2.6). Monthly total rainfall ranged from 2.8mm in September to 359.2mm in August at Ballina, 11.2mm in October to 316mm in November at Lismore, and 7mm in July to 196.4mm in both March and August at Casino.

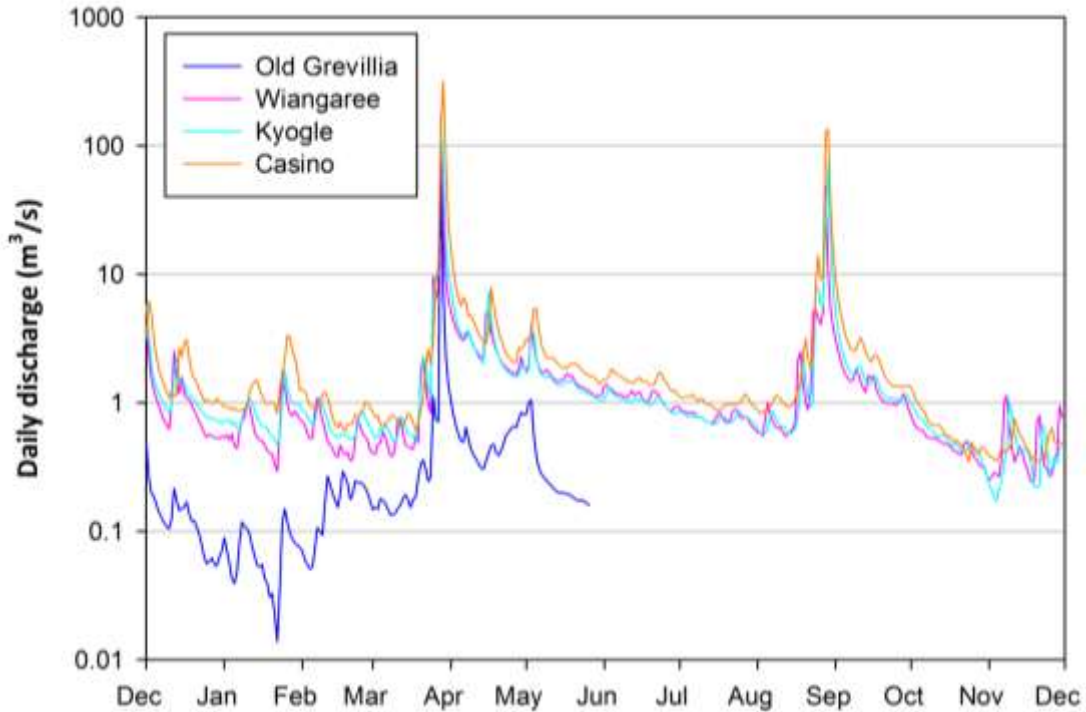
Figure 2.7 Daily discharge (m^3/s) in the Richmond River longitudinally downstream from Old Grevillia (gauge 203056), Wiangaree (gauge 203005), Kyogle (gauge 203900) to Casino (gauge 203004) from 1 December 2013 to 30 November 2014 (data from NSW Office of Water).

Daily discharge at Old Grevillia, Wiangaree, Kyogle, and Casino reflected the variable rainfall for the Richmond Catchment (Figure 2.7). The highest mean monthly discharge of 1676.7ML/d ($19.4 \text{ m}^3/\text{s}$) was recorded at Casino in March; this was only half the long term average for March (Figure 2.8). The lowest mean monthly discharge of 39.7ML/d ($0.46 \text{ m}^3/\text{s}$) for Casino was recorded in November. Discharge data for the upper Richmond at Old Grevillia is not available for dates after the 26th of May 2014. However, the highest mean monthly discharge for the first 6 months of sampling was 240.5ML/d ($2.78 \text{ m}^3/\text{s}$) recorded in March, with the lowest discharge of 6ML/d ($0.069 \text{ m}^3/\text{s}$) in January. The highest mean monthly discharges for The Richmond River at Wiangaree and Kyogle were 696.8ML/d ($8.06 \text{ m}^3/\text{s}$) and 834.1ML/d ($9.65 \text{ m}^3/\text{s}$) respectively, both recorded in March. The lowest mean monthly discharge for Wiangaree and Kyogle was 39.2ML/d ($0.454 \text{ m}^3/\text{s}$) and 34.2ML/d ($0.396 \text{ m}^3/\text{s}$) respectively, both recorded in November. These rainfall and discharge data demonstrate the below-average rainfall and resulting reduction in discharge throughout the sampling period. There were two significant peaks in both rainfall and discharge in March and August 2014 (Figure 2.9).

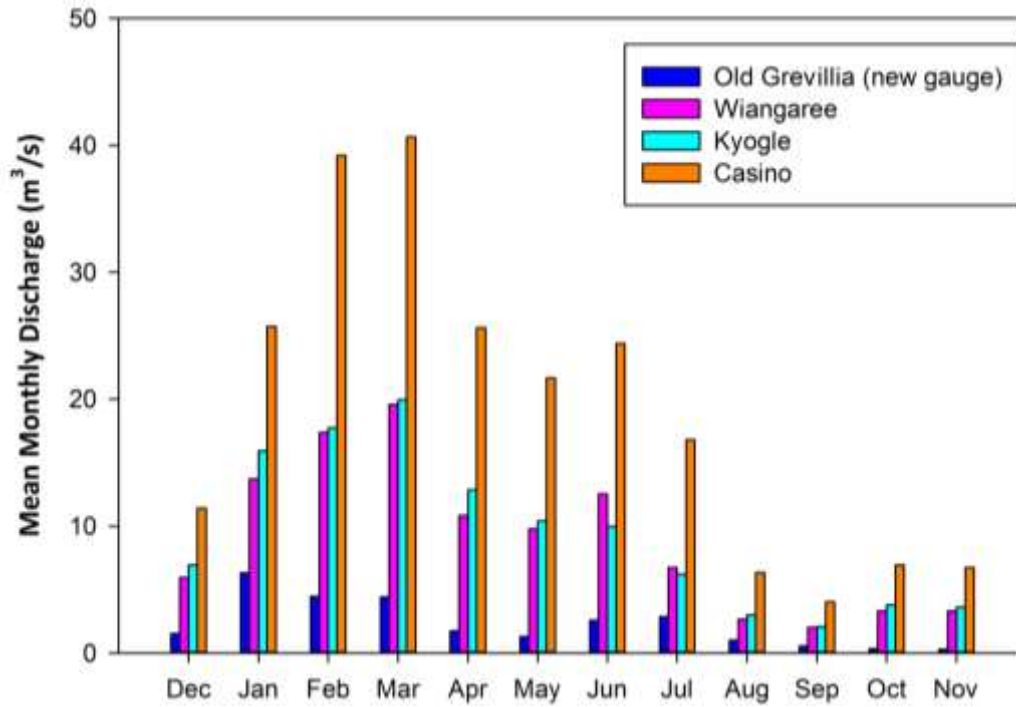
Figure 2.8 Long term mean monthly discharge (m³/s) in the Richmond River longitudinally downstream from Old Grevillia (gauge 203056), Wiangaree (gauge 203005), Kyogle (gauge 203900) to Casino (gauge 203004, NSW Office of Water).

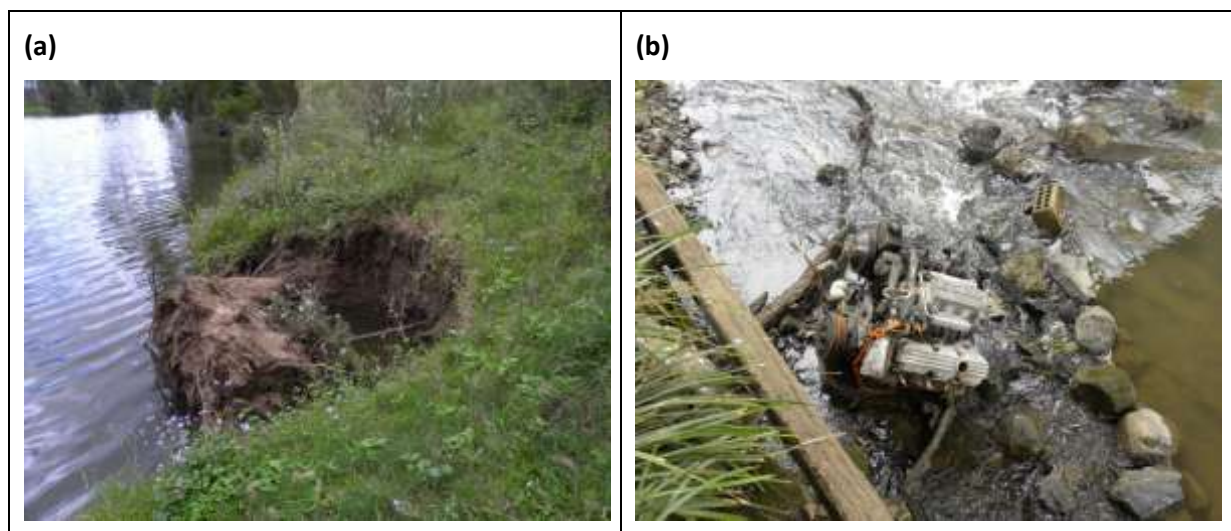
Figure 3.5 Sites on the Richmond Main Stem showing (a) localized mass failure of river banks (RR9), (b) fine-grained sediments smothering a cobble riffle (RR11).

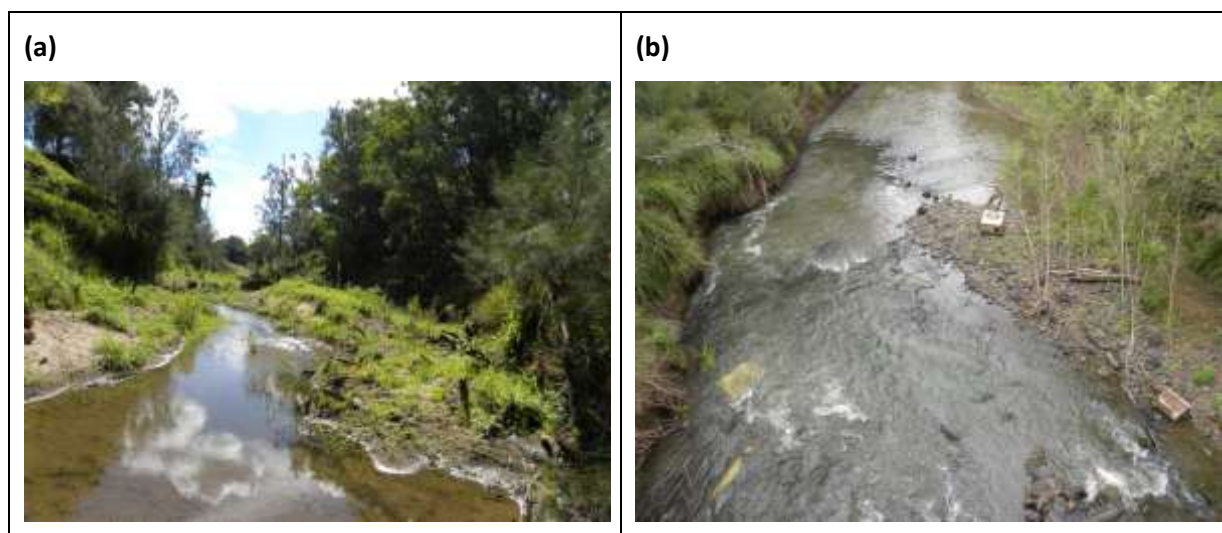
**Figure 3.10** Sites in Iron Pot Creek and Shannon Brook showing (a) poor geomorphic condition due to stock access (IPC1), and (b) rubbish dumped in the channel (SB1).
