Ballina Shire Council

Shaws Bay Dredging

Baseline Surveys and Data Analysis

March 2018

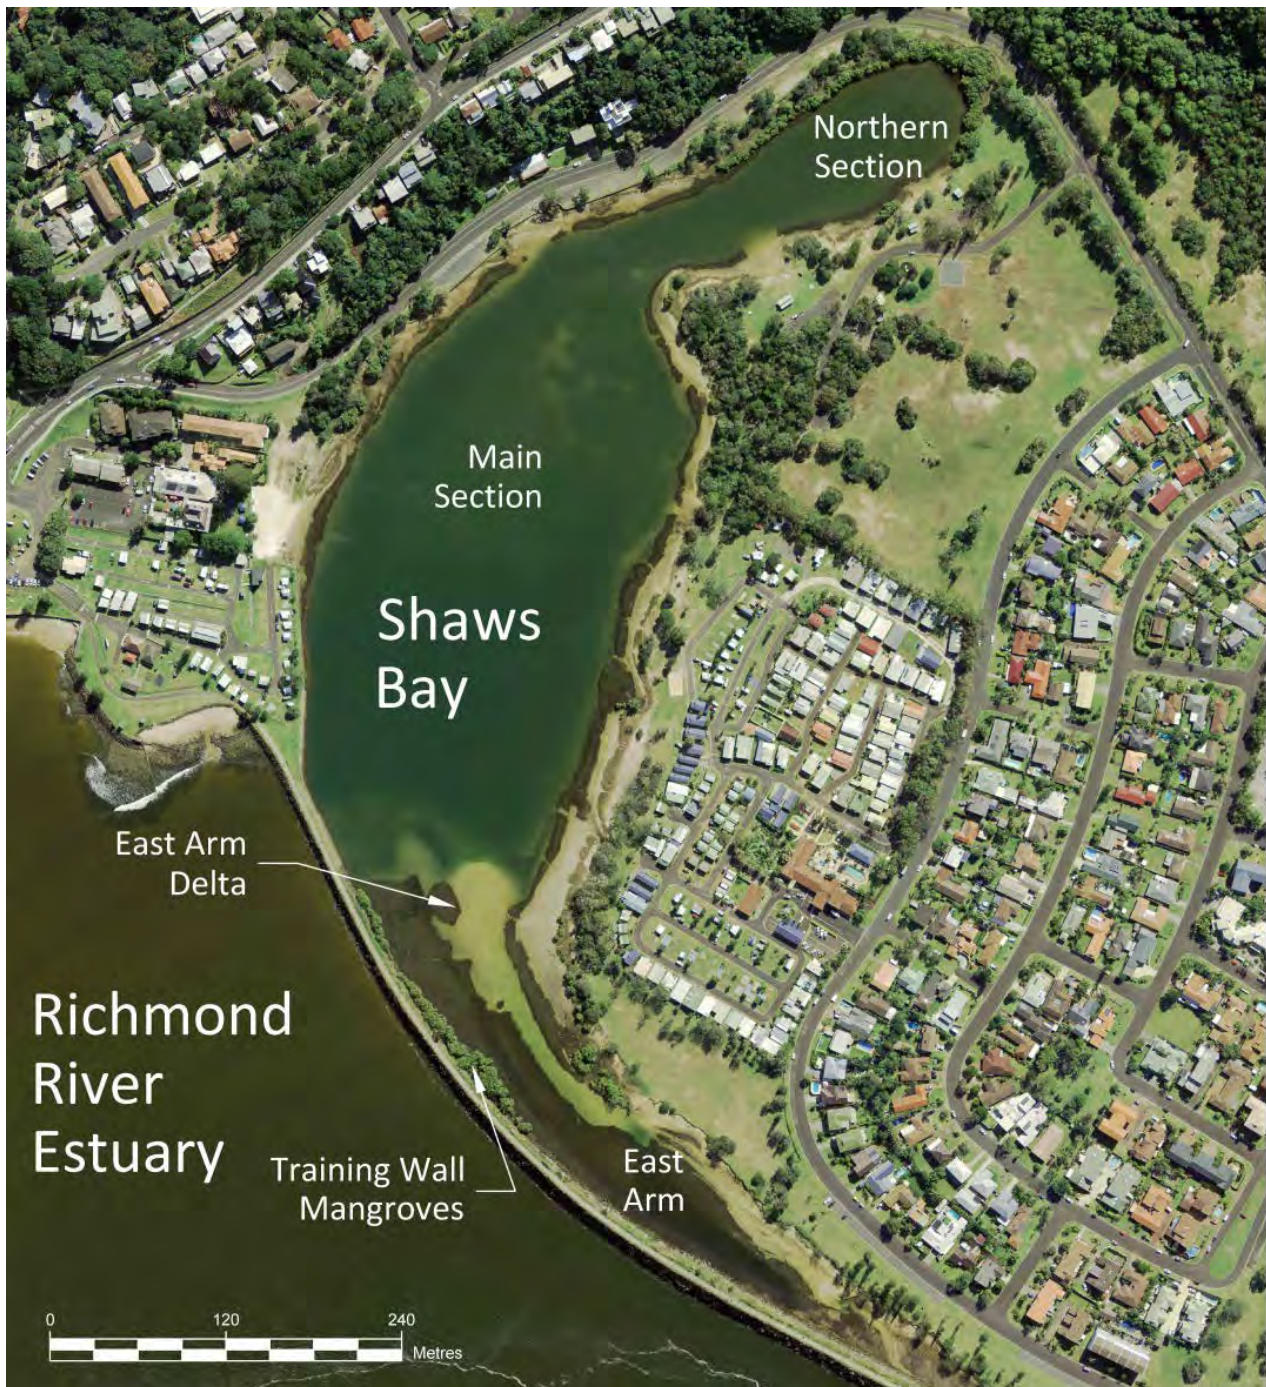
Figure 1. Shaws Bay

Shaws Bay is a modified tidal embayment that was once part of the Richmond River channel. It consists of 3 main sections referred to in this report as the East Arm, the Main Section as well as the Northern Section (Figure 1). It was created by construction of the northern river training wall and reclamation of land for urban development. The Bay is hydrologically connected to the Richmond River and tidal flows enter and exit through the rockwork of the training wall. Whilst the upper sections of the training wall are highly porous and allow the high tide to pass through relatively unobstructed, the lower portions are less so and this produces a weir-like effect resulting in water being ponded above the level of the adjoining estuary on the receding tide. The resulting tidal regime in the Bay has approximately equivalent high tides to the main estuary, but low tides are truncated to a minimum of around -0.2m AHD in the main part of the Bay and -0.3m AHD within the East Arm.

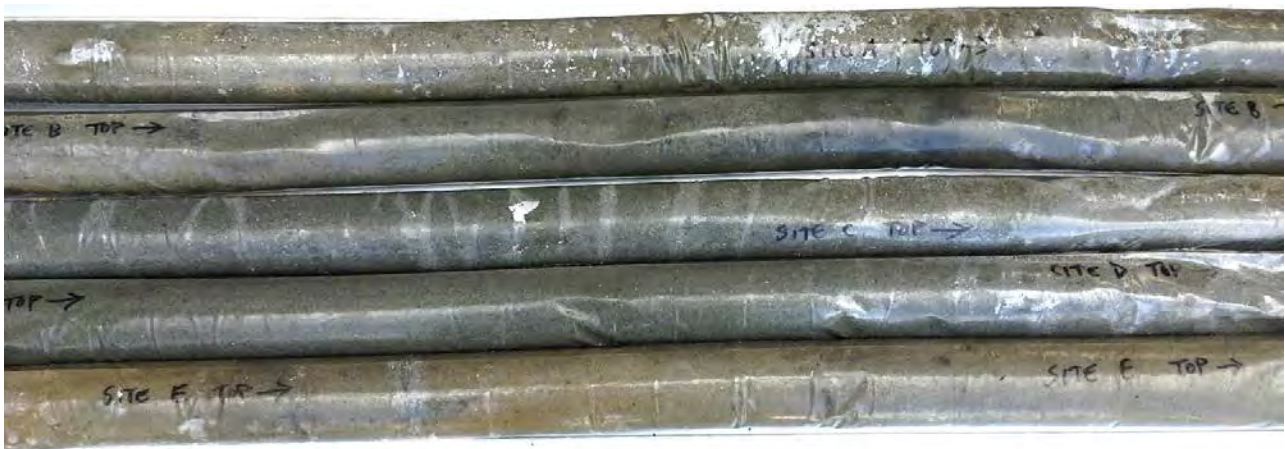
Coring was undertaken utilising a 60mm vibracoring system deployed from Hydrosphere's work vessel 'Mudskipper'. With this method, an aluminium tube is vibrated mechanically and driven vertically downwards, typically 1.5 to 2.5m, into the sediment. A food-grade plastic liner and core catcher/cone assembly is utilised to retain the sediment within the tube. The tube is extracted from the sediment using an on-board crane, and once aboard, the plastic lining and sediment core are extracted and the core is then available for further processing (Figure 2). Although the vibration of the tube leads to some minor disturbance of the core periphery, this method generally yields an excellent representation of the sub-surface strata allowing photography, logging and sub-sampling of specific depths/strata from the sediment core.

Figure 2: Extracted cores within plastic liners prior to splitting and core logging

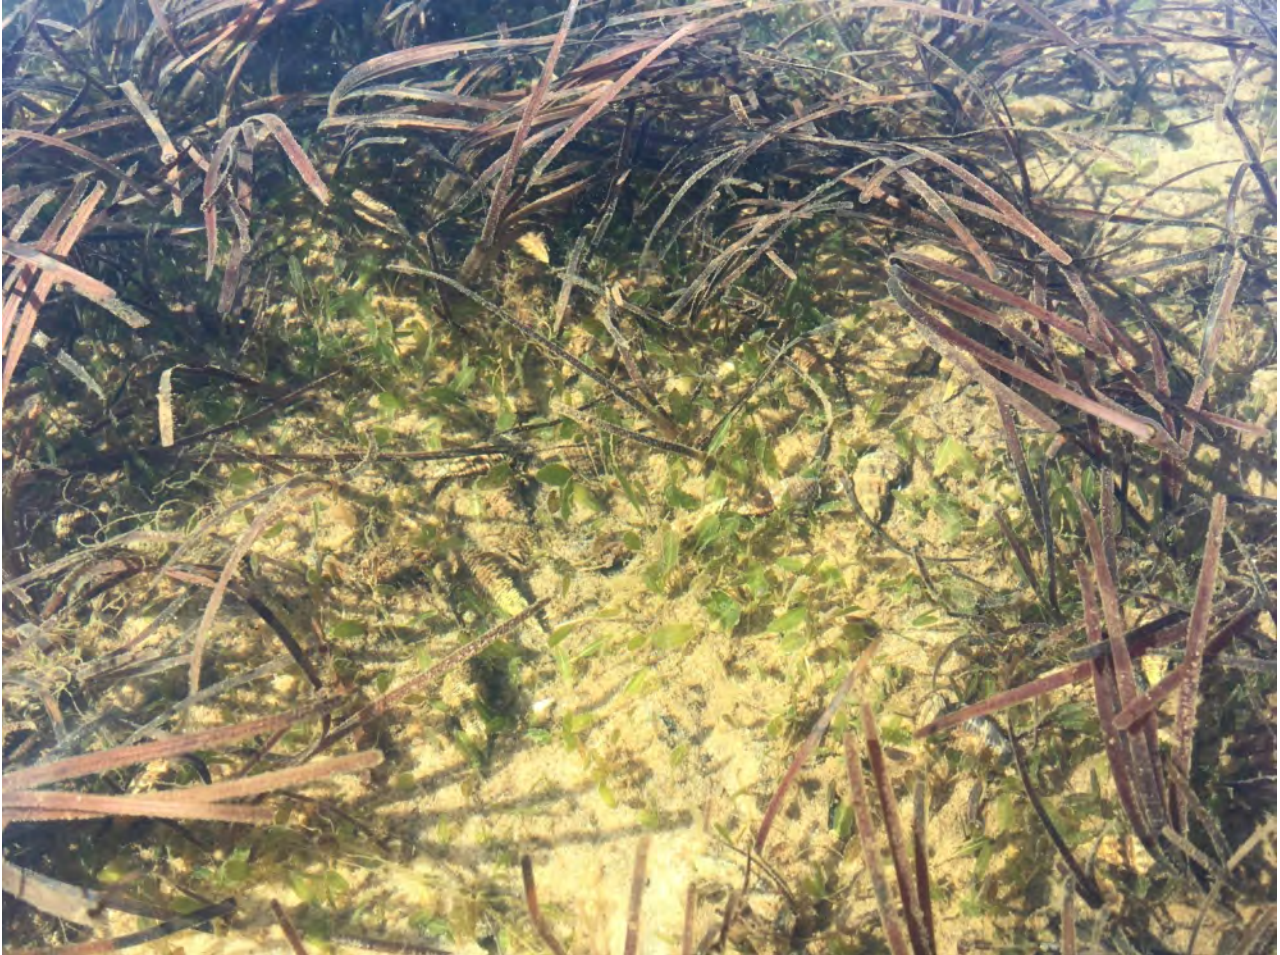
- Areas of *Halophila ovalis*. This smaller species occurs in protected areas of good light exposure/water clarity. It has previously been observed to occur both inshore and offshore of fringing *Zostera*. This seagrass tends to form a low 'carpet' on the sediment, which can range from sparse to dense coverage. The variable coverage, short growth form (typically 1-3cm) and low-contrast light green colouration means that it is not able to be discerned with any accuracy from aerial photography.

Figure 4. *Halophila* growth in close proximity to *Zostera* seagrass

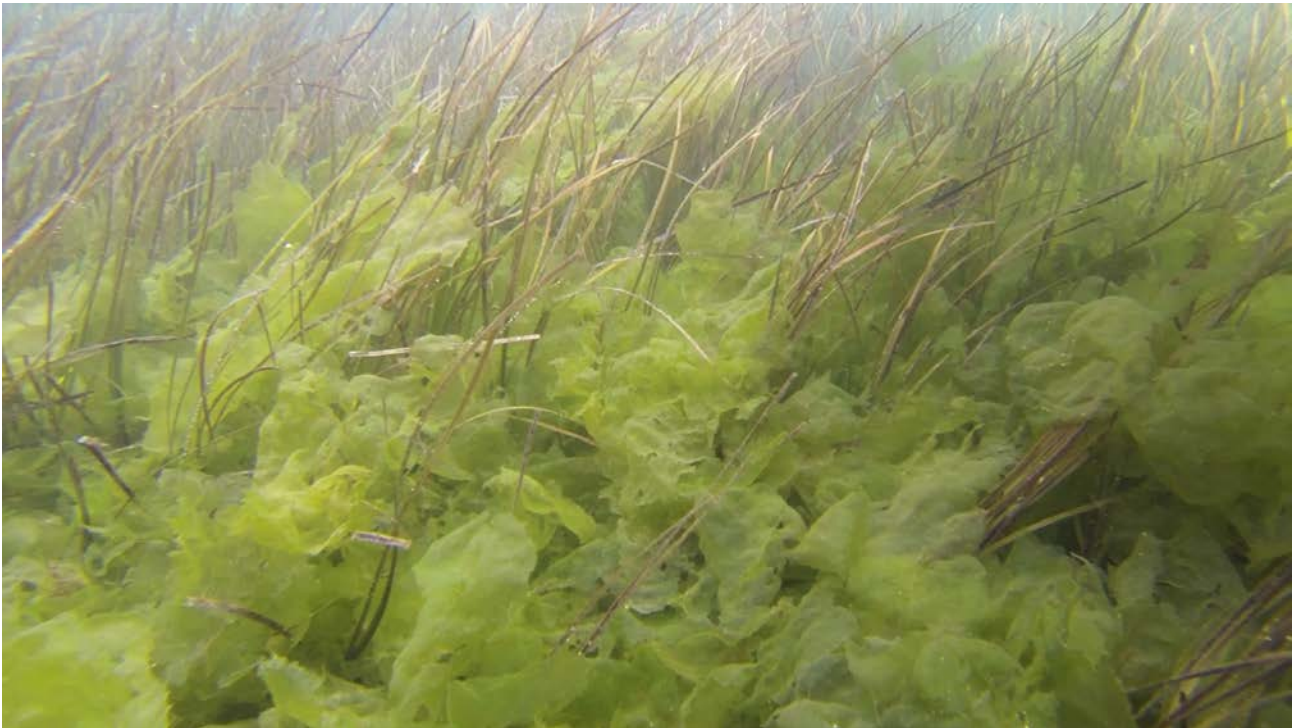
A key finding of the surveys was that much of the bed of Shaws Bay is blanketed in dense growth of the green macroalga *Microdictyon umbilicatum*. The species is superficially similar to the sea lettuce *Ulva*, but grows significantly larger. It forms large thin lobate plates up to 45cm in diameter, which although seeming unattached, generally grow on the bed in protected areas and within seagrass beds (Figure 5). This alga tends to smother seagrass, and forms thick blankets of live and dead *Microdictyon* on the bed of the estuary. Blanket thickness of up to 80cm was observed during the seagrass surveys and it is considered likely that deeper deposits of this material, along with terrestrial vegetative matter as well as seagrass, brown algae debris and some organic material from mangroves is likely to have accumulated to greater levels in the deepest part of the Bay, which was not surveyed.

Figure 5. Typical growth of *Microdictyon* within *Zostera* seagrass

Although native, the presence of *Microdictyon* in bloom proportions is considered to be detrimental to the ecological health of Shaws Bay. There is direct visual evidence of this species smothering *Zostera*, and as well as degrading the value of large areas of sub-tidal sandflat for popular recreationally important fish species such as whiting and flathead. Although not assessed, the breakdown of dead algae would release nutrients into the water column and is likely to be contributing to the sludgy surface sediments encountered during sediment coring.

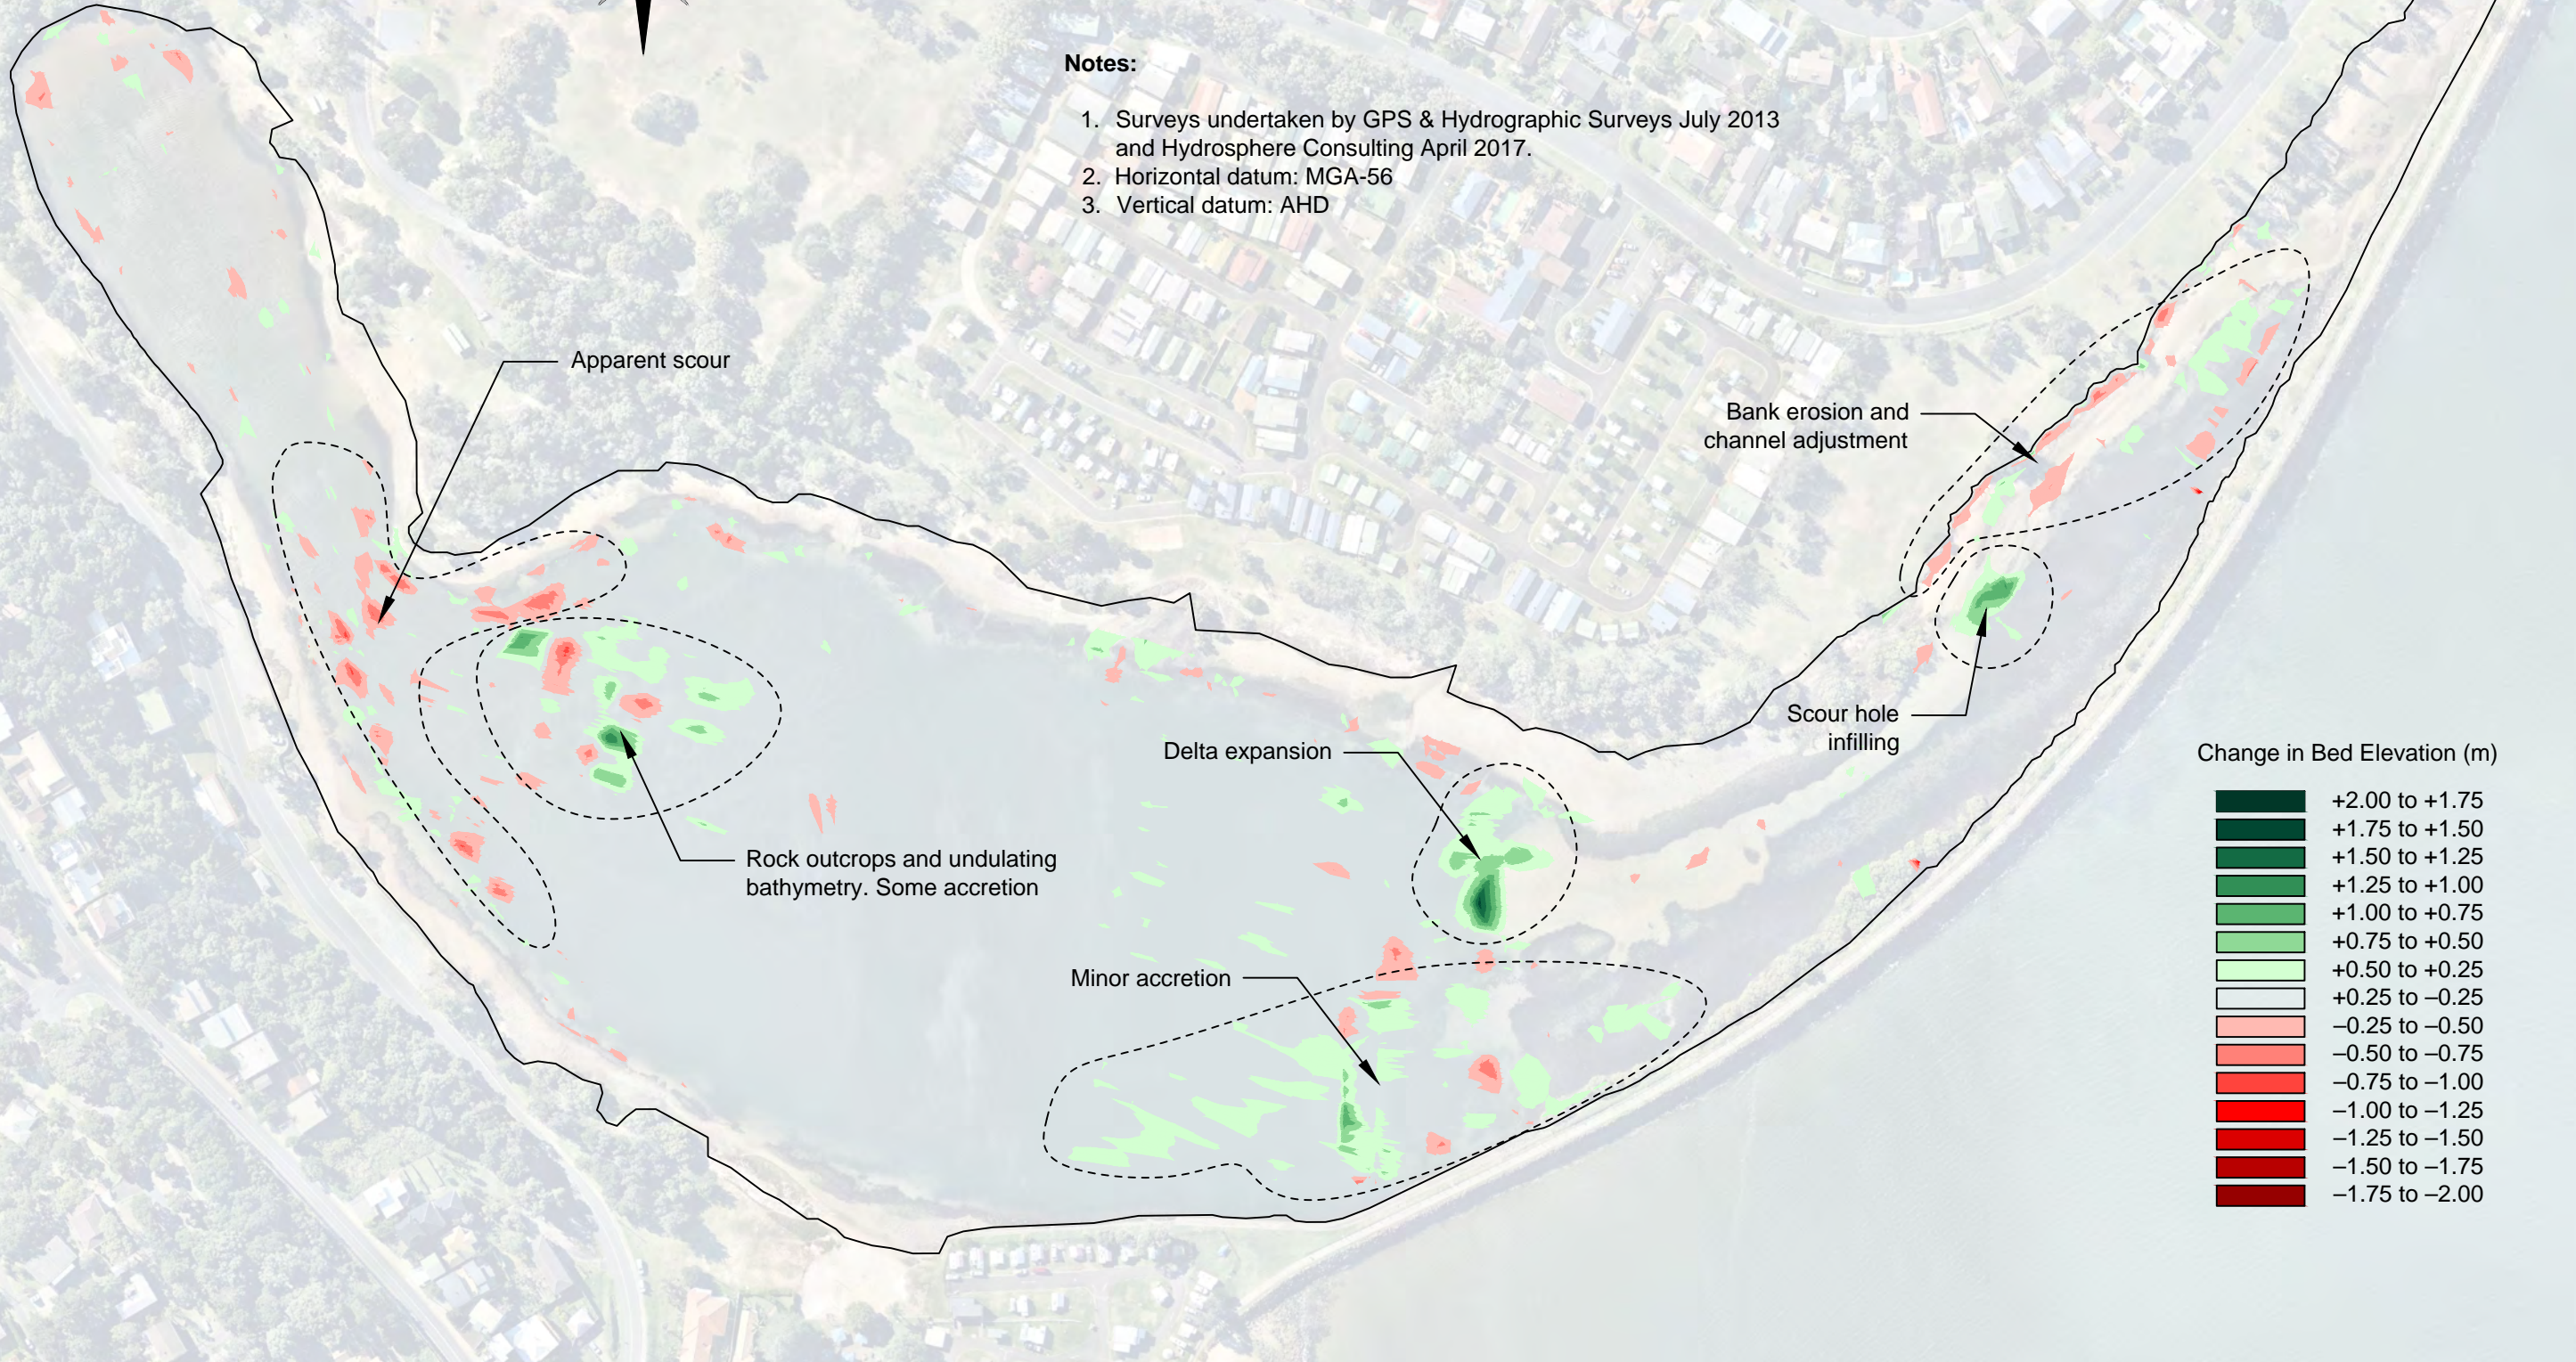
DRAWING NUMBER
DRAWING 4

1. Surveys undertaken by GPS & Hydrographic Surveys July 2013 and Hydrosphere Consulting April 2017.
2. Horizontal datum: MGA-56
3. Vertical datum: AHD

Change in Bed Elevation (m)

The 2017 hydrosurvey corresponded very well with the 2013 survey and there was very little broad-scale change in bathymetry of the waterway (Appendix 1, Drawing 4). Minor random variations between the derived 2013 and 2017

The notable areas of difference between the 2013 and 2017 surveys were as follows (refer Appendix 1, Drawing 4):

1. Localised changes in the channel form and depth within the East. For instance a significant scour hole that was present in 2013 has infilled in 2017 and there appears to have been some increase in channel depth along the east arm, which is assumed to have contributed to the additional sediment deposited at the East Arm delta. The effect of continued erosion of the northern bank of the East Arm is also apparent. Apart from broad changes it should be noted that the spatial resolution of bathymetric data in the East is significantly reduced due to deletion of false sonar returns over dense seagrass in this area.

6. Overall, excluding the areas highlighted above, there was little detectable change in bed level, with the nett volume change due to minor variations ($\pm 0.25\text{m}$) being negligible. Apparent significant variations between the 2013 and 2017 surveys near the survey margins (e.g. along the training wall) are not shown in Appendix 1, Drawing 4 and are considered (as was also noted in the 1999 to 2013 comparison) to be artefacts of minor survey differences.
