Chickiba Lakes Acid Sulfate Soils and Wetland Management Plan

EWS06-07

Prepared for Ballina Shire Council and funded by the
Northern Rivers Catchment Management Authority

June 2006

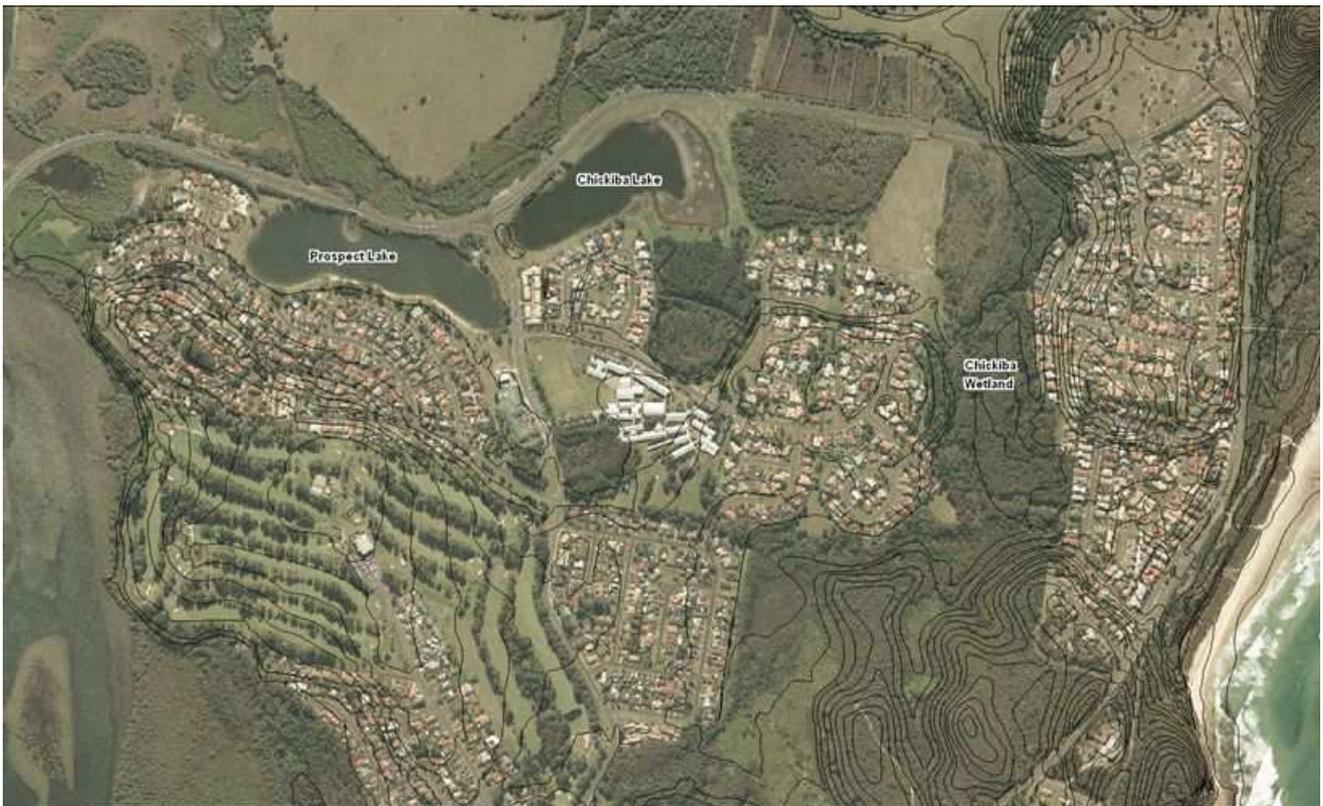
Figure 6: Aerial photograph of the study area.

A drain has been constructed along the western edge of the Eastern Chickiba Wetland. In other areas stormwater pipes discharge directly into the melaleuca wetlands and lakes. Stormwater flows leave the study area by three routes: through a stormwater pipe at the Chickiba Eastern Wetland, located under Angels Beach Drive, and under two bridges for Chickiba Lake and Prospect Lake. The stormwater flows into the wetlands and lakes are shown as arrows in Figure 2. Figure 6 shows an aerial photo of the study area.

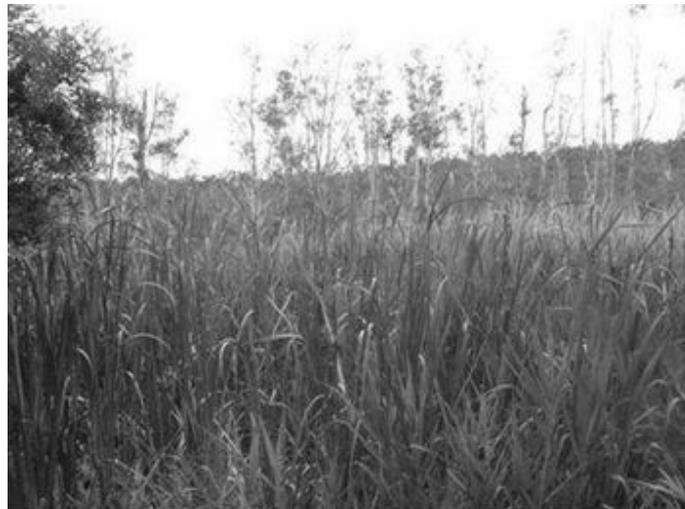
Plate 1: *Typha* and *Phragmites* dominating the Eastern Chickiba Wetland. Sparse melaleuca canopies in the background.

The assessment found that the northern part of the wetland was in very poor condition due to changes in the hydrological regime (see Plates 1 and 2). Substantial volumes of untreated stormwater runoff were flowing into the wetland, and outflows were restricted.

Phragmites and *Typha* are native species, but in this context are an indicator of damage because these reeds would not normally grow so densely in this wetland under the melaleuca canopy. Anecdotal evidence and observation of the similar landscape nearby suggest the wetland was dominated by melaleucas. Fallen trees and instances of windthrow were common, indicating waterlogging of the melaleuca forest.

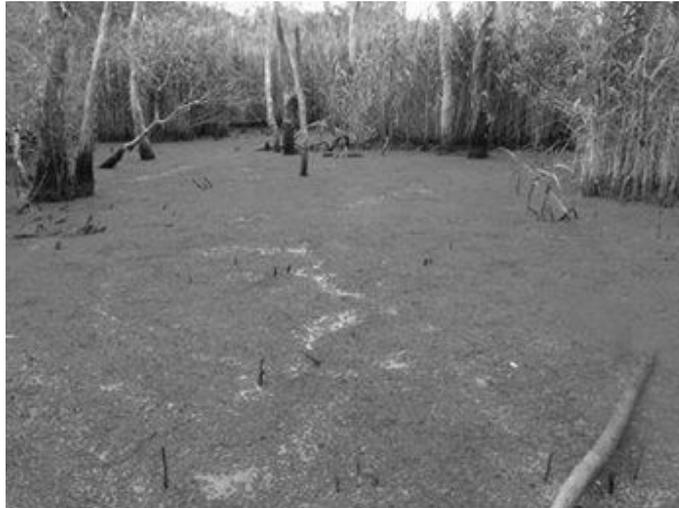
Plate 2: Open water zone with Azolla cover in Chickiba East Wetland.

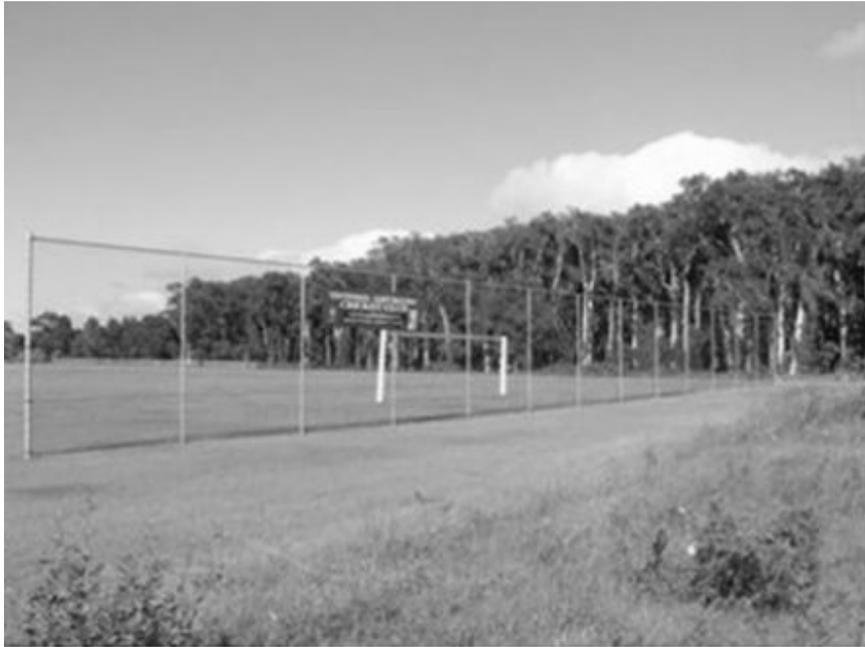
Plate 4: Chickiba West Wetland from the sports field, looking southwest.

The Chickiba West Wetland has been reduced, confined, and fragmented from the other wetlands in the complex by the construction of the Chickiba Sporting Field, by fill placed between the wetland and Chickiba Lake, the Angels Beach Drive to the north, and urban development above the wetland. This has created a rectangular wetland with one discrete inlet and one discrete outlet. Due to the urbanisation above the wetland, increases in peak discharges from storm events are common due to increases in impervious areas and therefore increased runoff and reduced infiltration to groundwater.

The western wetland (Plate 4 and Figure 12) drains a catchment of about 20 hectares extending from the south. The Angels Beach Drive separates the wetland on the south side of the road from the cleared wetlands and salt marsh complex on the north side.

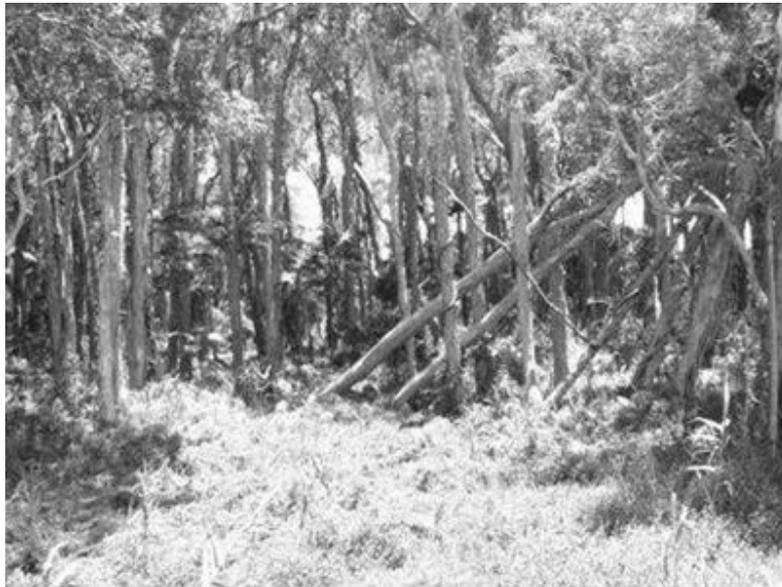
One impact of increased stormwater runoff into and possibly restricted drainage out of the wetland is shown in Plate 5. A number of melaleuca trees have fallen over which is most likely due to more frequent wetter periods and shorter drying cycles.

Plate 5: Windthrow in the Chickiba West Wetland.

Given the situation in the Chickiba West Wetland, with uncontrolled stormwater inputs and the possibly restricted outlet, similar impacts of varying degrees to those in the Chickiba East Wetland may be expected over time as the wetland degrades from excessive inundation and other factors such as nutrient loads.

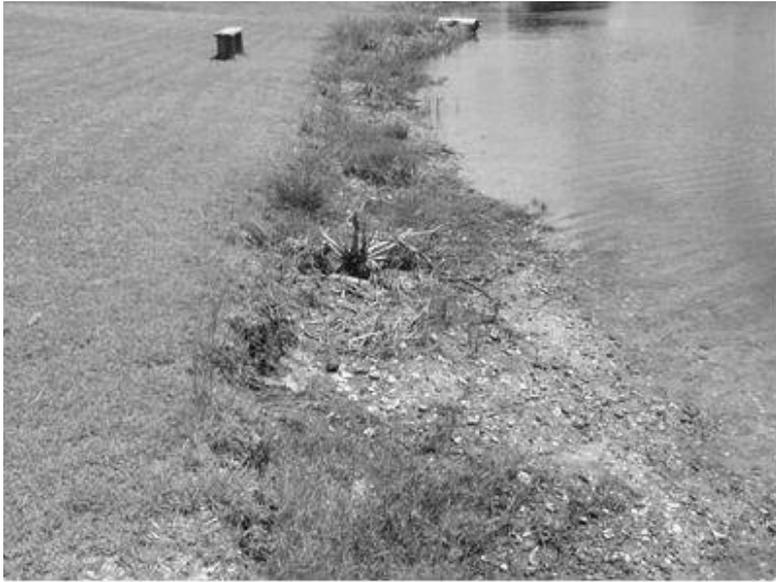
Plate 6: Erosion area along the foreshore bank at Chickiba Lake.

1. Reshaping the foreshore bank to a suggested low batter followed by replanting bank with salt couch, *Phragmites* spp., and/or *Juncus kraussii*. This will stabilize the bank as shown in Plate 8. It is recommended that the slope for the erosion areas replicate the area of salt couch shown in Plate 8. A topographic survey is also recommended.
2. Hardening the bank with concrete training walls, large logs, gravel baffles, or alternative erosion reduction measures.

Option 1 is recommended.

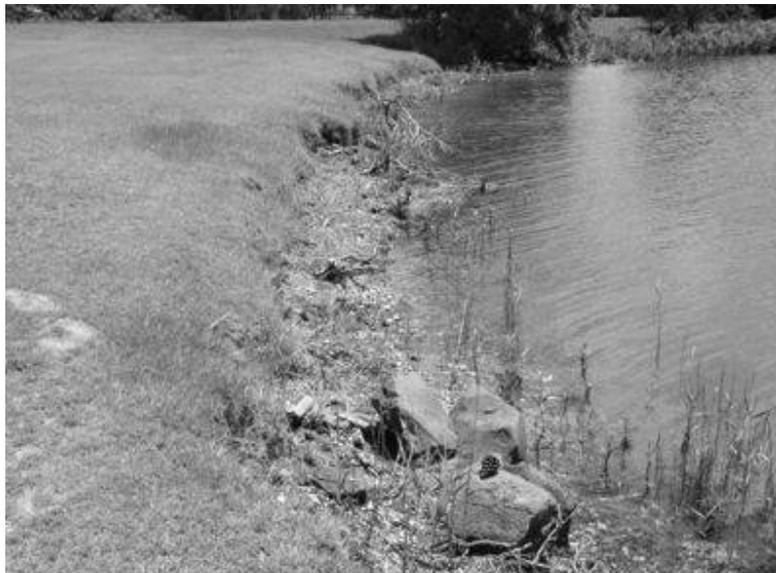
Plate 7: Second erosion area along the foreshore bank at Chickiba Lake.

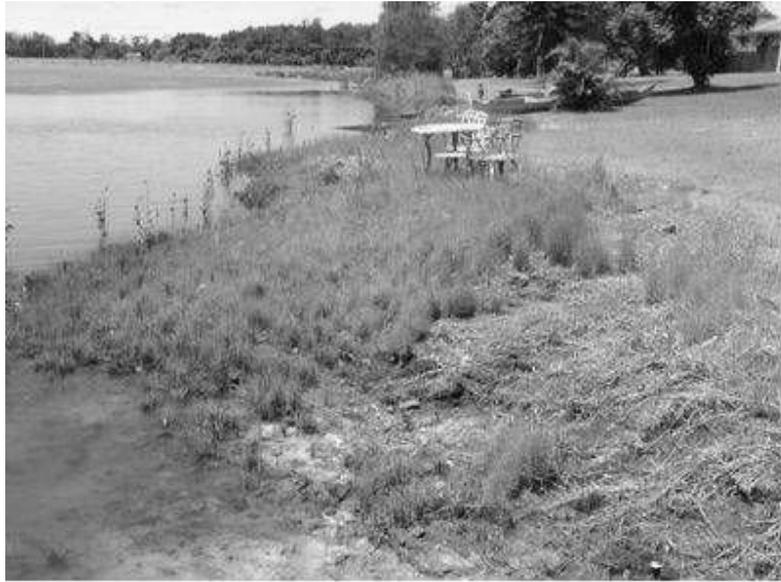
Plate 8: Area of salt couch stabilising the bank

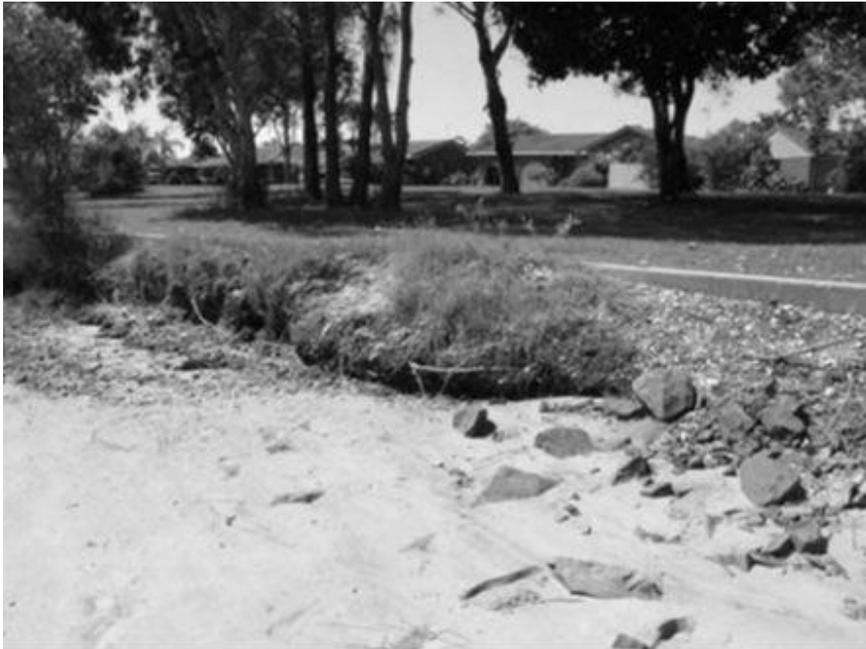
Plate 9: Area of erosion at Prospect Lake.

1. Reshaping the foreshore bank to a designed V:H ratio replicating adjacent areas of no erosion and healthy vegetation. This should be followed by replanting bank with appropriate species such as salt couch, *Phragmites*, or *Juncus kraussii*. This will stabilize the bank as shown in Plate 8.
2. Hardening the bank with concrete training walls, large logs, gravel baffles, or alternative erosion reduction measures.

Potential costs for these options approximate to \$6-\$10/m² for reshaping and planting, and \$100/m for concrete walls.

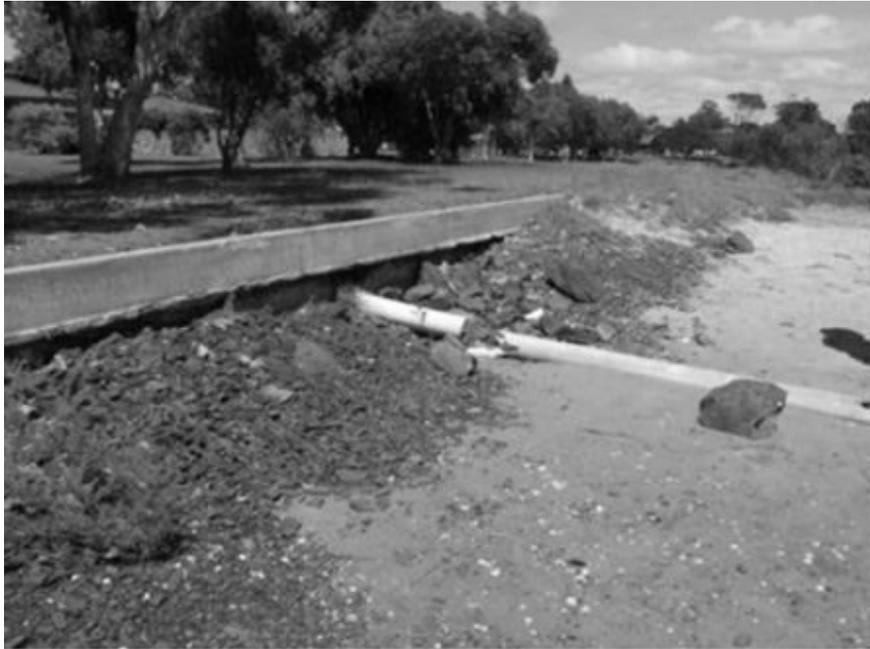
Stormwater discharge into the lake is likely to be causing longer term damage to the lake ecology through nutrients and regular introduction of unnaturally high flows (Plate 10). The flushing efficiency of the lake inlet/outlet would require detailed assessment to gain a deep understanding of processes and impacts, but a best practice approach is to reduce discharges whenever possible. The sustainable approach is to carry out most WSUD assessment - rainwater tanks, preservation of natural systems, and ecotechnology such as constructed wetlands where possible.

Plate 10: Stormwater pipes discharging into Prospect Lake

Opportunities exist at the site for retrofitting rainwater tanks on nearby houses, swale technology during infrastructure upgrade, and constructed wetlands. See Section 6 for more details on stormwater management using Water Sensitive Urban Design.

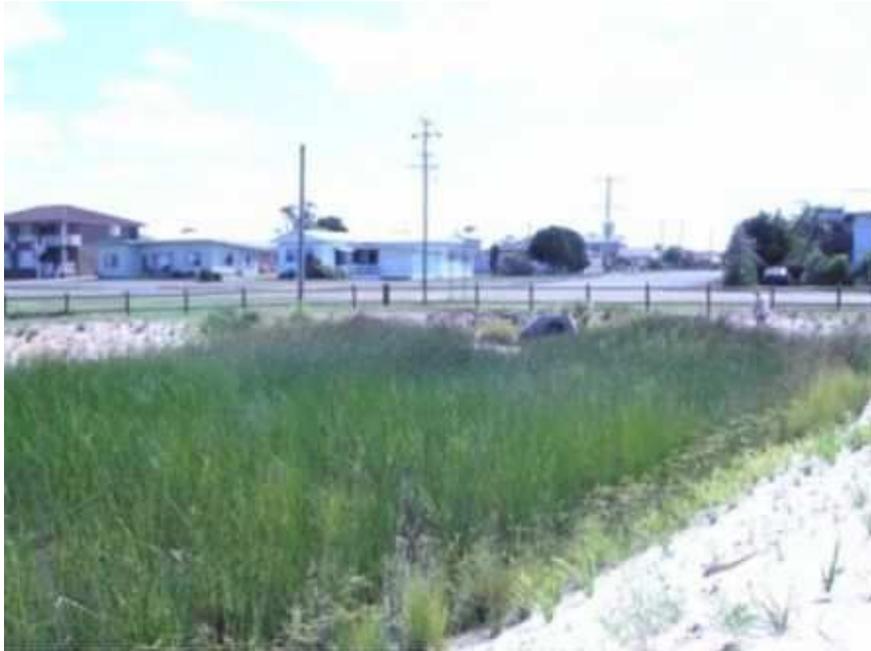
Constructed wetland systems are shallow, extensively vegetated water bodies that use enhanced sedimentation, fine filtration, and pollutant uptake processes to remove pollutants from stormwater. Water levels rise during rainfall events and outlets are configured to slowly release flows, typically over three days, back to dry weather water levels (Melbourne Water, 2005; DLWC, 1998). An example of such stormwater wetlands is the Airforce Beach wetlands at Evans Head, NSW (Plate 11).

Plate 11: Example of a constructed stormwater wetland in a residential situation (location: Evans Head, NSW)

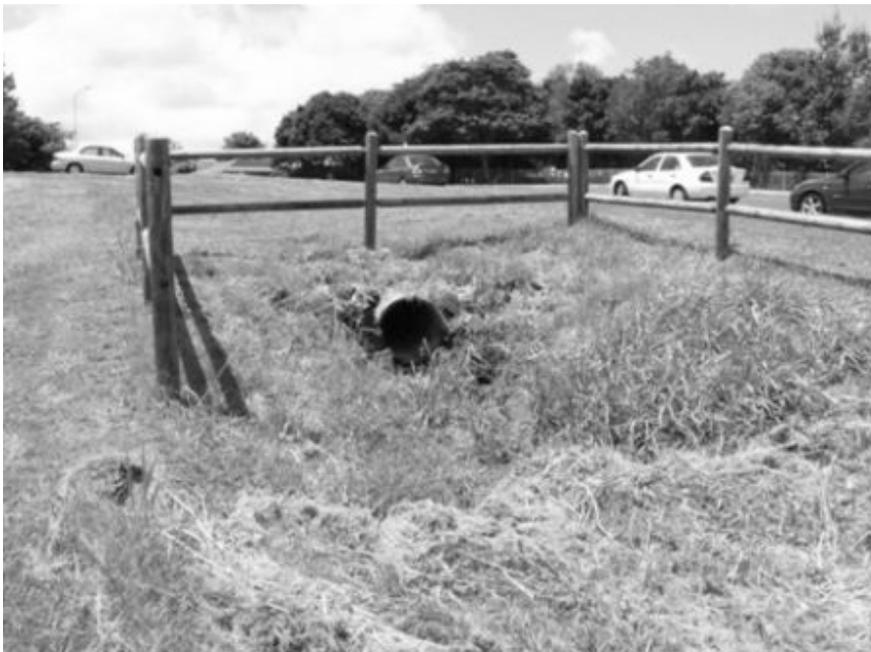
Plate 12: Stormwater pipe in elevated position near Southern Cross School - suitable for a constructed wetland treatment system

Throughout the study area suitable sites for constructed wetlands are limited, given the tendency for stormwater pipes to be located low in the environment, discharging either into the lakes or the natural wetlands. However, some outlets such as the stormwater pipe located near Southern Cross School (Plate 12) provides an opportunity for a constructed wetland to help reduce nutrients, sediments and excessive peak flows of water from entering the receiving environment.
