Keith Hall Drainage Options Study

WRL TR 2021/06, December 2021

UNSW
Water Research
Laboratory

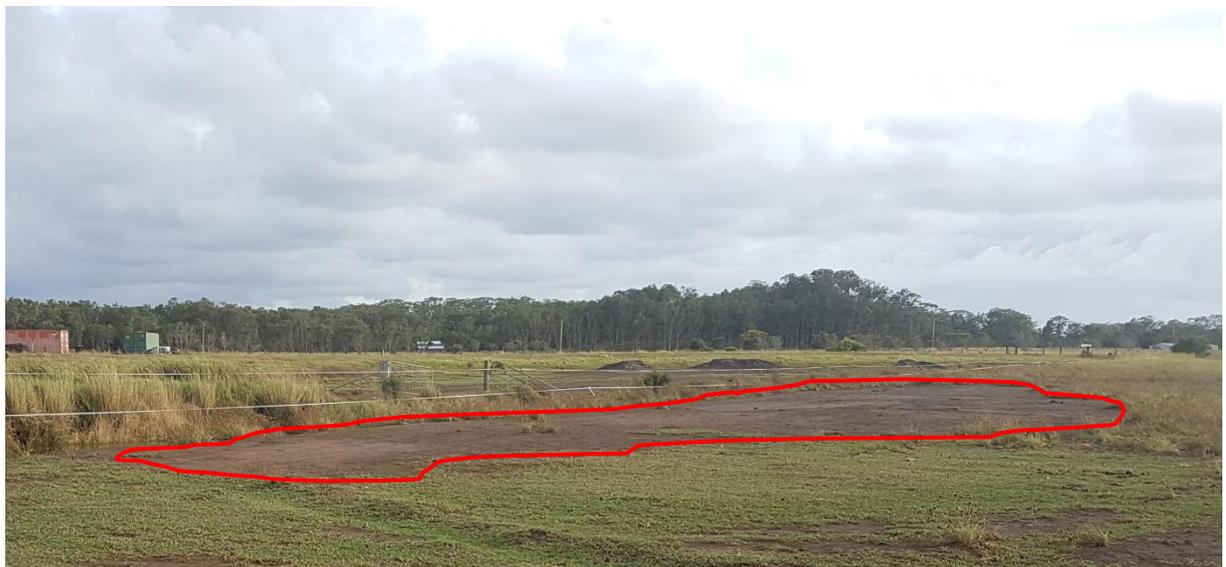
Figure 2.6: Acid scalding adjacent to Keith Hall No. 1 Drain (February 2019)

Acid surface scalding has also been observed at Keith Hall by WRL (2019) who measured surface soils to have a pH of 3.5 on low-lying areas of the floodplain adjacent to Keith Hall No. 1 Canal near its connection with Mosquito Creek (Figure 2.6). Acid scalds occur where acid sulfate soils are located at the ground surface and events such as over grazing or prolonged inundation cause the loss of vegetation and the surface soil layer (Rosicky et al., 2004). Following runoff events, acid on the surface of scalds is easily transported into the drainage network. Currently, the acid scalds at Keith Hall are irregular across the floodplain adjacent to Keith Hall No. 1 Canal, however, unless treated correctly the area of the acid scalds may grow. Note, acid scalds can be rehabilitated by excluding stock and mulching as per the methods outlined by Rosicky et al. (2002) and Rosicky (2006).

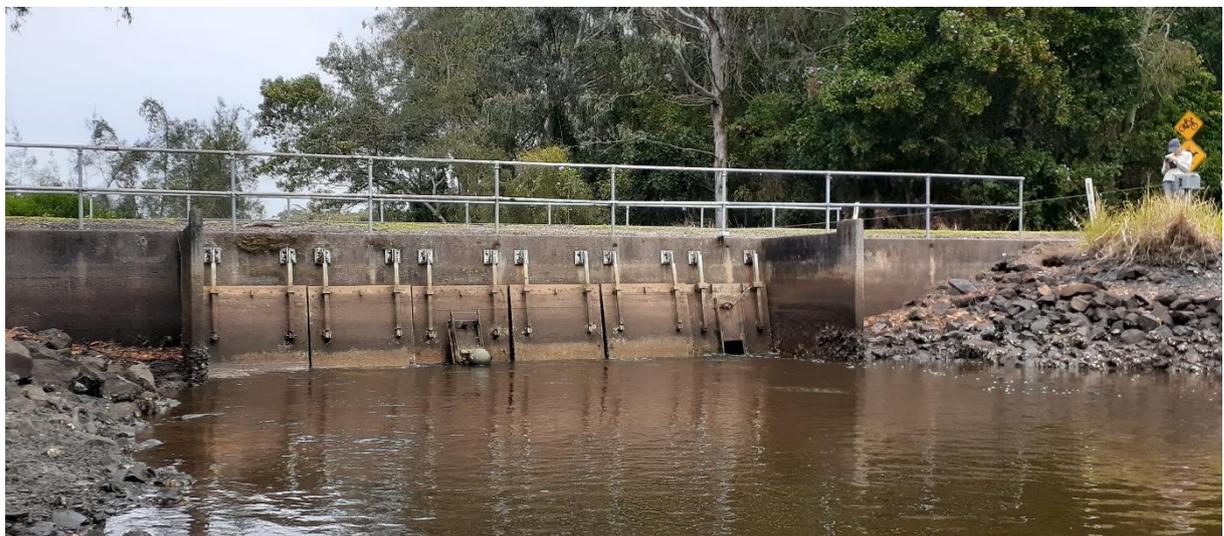
Figure 2.10: Keith Hall floodgates (October 2020)

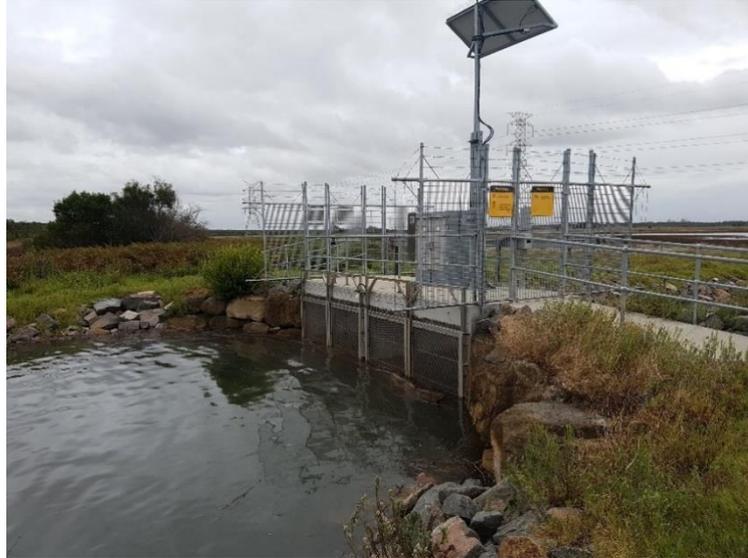
Figure 3.1: Example of automatic gates controlled by water level gauges (Kooragang Island, Hunter River)

For this option the floodgates on either Keith Hall No. 1 Canal or Union Drain have been modified to automatically open and close based upon the tidal water levels in the river. Technical details on how this has been applied for each floodgate are outlined in Appendix B. Modifying the floodgates in this way means that increased flow volumes can be encouraged to pass through the Keith Hall drainage network without causing inundation of the floodplain. When water levels in the drainage network are low, the floodgates allow tidal water from the estuary to flow into the drainage network. When river water levels reach a certain trigger height, the floodgates can then be programmed to close preventing further water entering the drainage network and floodplain inundation. An example of a floodgate structure that has been implemented elsewhere using this technology is shown in Figure 3.1. Numerical modelling has been completed to determine the optimal trigger level for closing the floodgates.

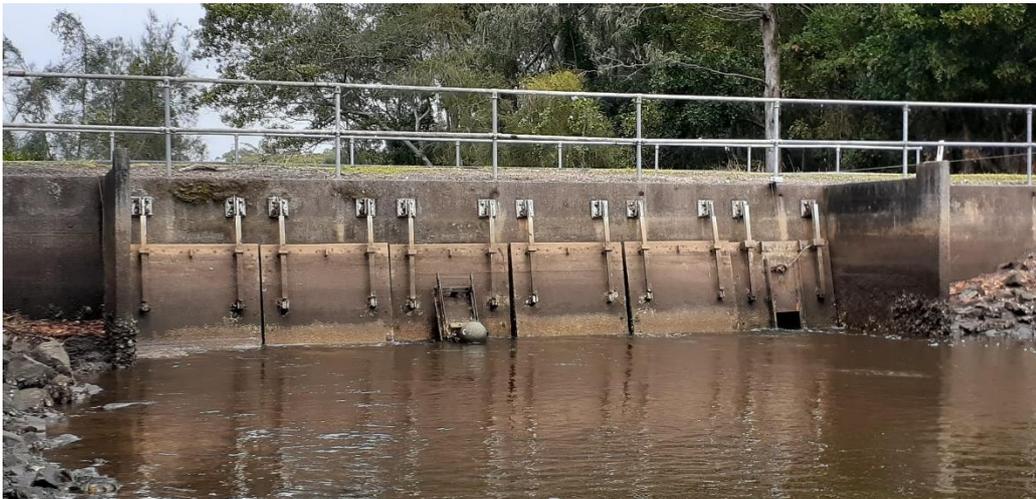
Figure 3.2: Sluice gate (right) and buoyancy driven tidal gate (left) on the Keith Hall floodgates

Presently, there are a number of modifications that permit tidal flushing into the Keith Hall drainage network. On the Keith Hall No. 1 Canal floodgates there is a sluice gate and a buoyancy gate which are operated as per the “Keith Hall Drainage System Active Floodgate Management Plan” (RCC, 2020) (Figure 3.2). There is a buoyancy gate located on The Escape floodgates which allows controlled tidal flows upstream. There is also a buoyancy gate which has been decommissioned and does not open on the Union Drain floodgates. The Mosquito Creek floodgates currently have a single buoyancy gate that allows limited tidal exchange, however local landowners occasionally open the floodgates to allow larger volumes of tidal water to flow upstream to improve water quality and control freshwater weeds. Field observations found that tidal connectivity allows the growth of mangroves upstream of the Mosquito Creek floodgates.

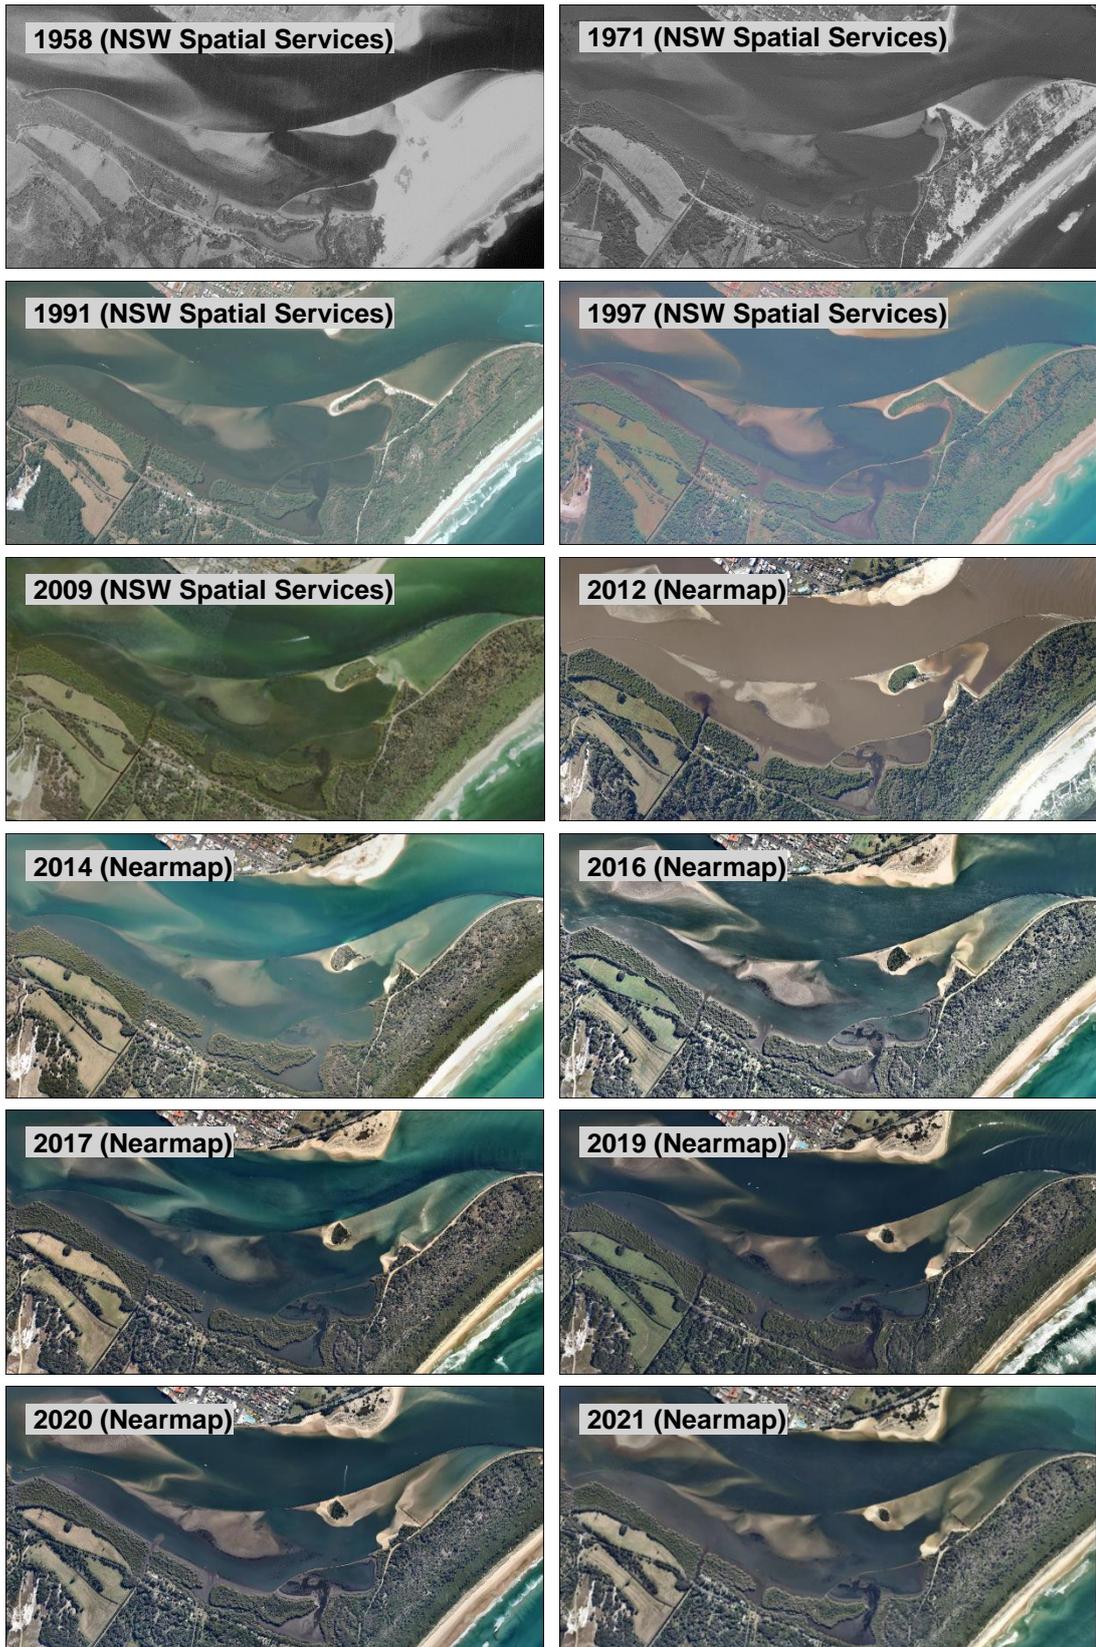
Some smaller gaps exist including one opposite Keith Hall No. 1 Canal. The construction of Keith Hall No. 1 and No. 2 Canals can be seen to occur between 1958 and 1971, however, the gap in the training wall appears to pre-date the imagery. Since the construction of Keith Hall No. 1 Canal there does appear to be some erosion or clearing of a channel through the sediment on the southern side of the training wall at this location. Besides this change, the sediment to the south of the western training wall remains relatively unchanged across all the images.

Figure 4.1: Comparison of aerial imagery of Mobbs Bay from 1958 to 2021

Aerial imagery is available for Mobbs Bay from 1958 to 2009 (via NSW Spatial Services) and from 2012 to 2021 (via Nearmap). Figure 4.1 shows the changes that the sediment of Mobbs Bay has undergone since 1958.

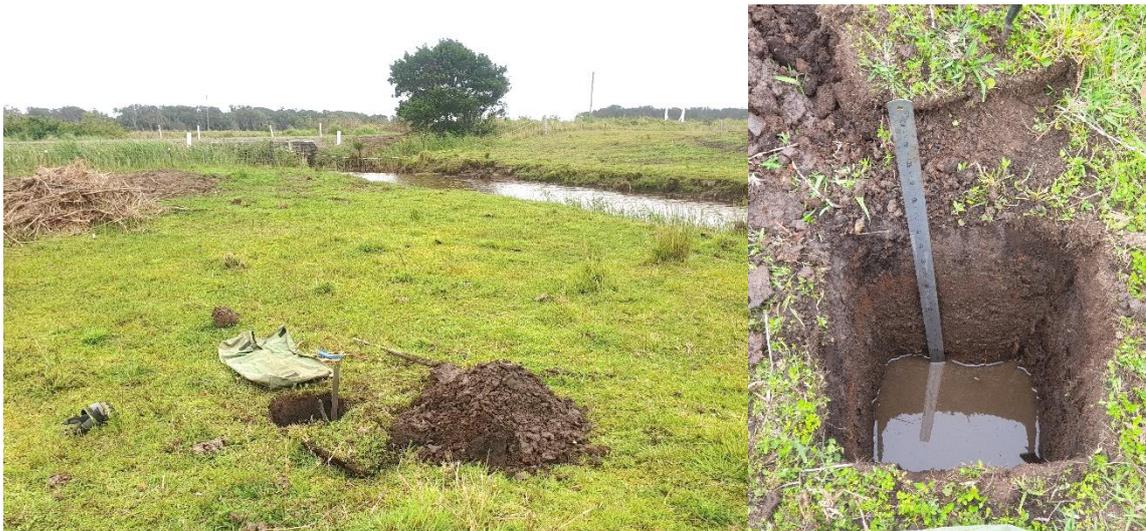
Figure A.22: Pit used to measure hydraulic conductivity adjacent to KH_P2

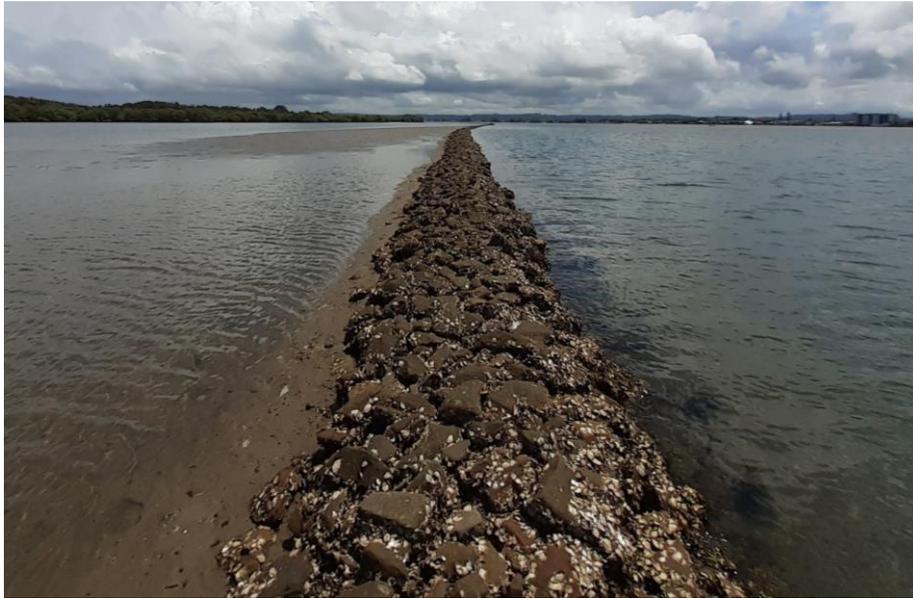
Figure A.25: Mobbs Bay training wall looking west

Measurements of the crest elevation of Mobbs Bay training wall were taken on 28 October 2020 to help develop a conceptual understanding of Mobbs Bay. In total, 641 elevation measurements were observed. As shown in Figure A.25, the crest elevation of Mobbs Bay training wall varies depending on the placement of individual armour units. Subsequently, to ascertain the crest elevation, numerous measurements were taken of the crest along the training wall. Using this method an indicative elevation for different sections of the training wall could be inferred. Elevation measurements across the training wall are shown in Figure A.26. Note, the survey to the west of Mobbs Bay island was far more detailed when compared to the survey to the east. This was due to limited accessibility to the training wall on the eastern side where it was significantly impacted by waves.

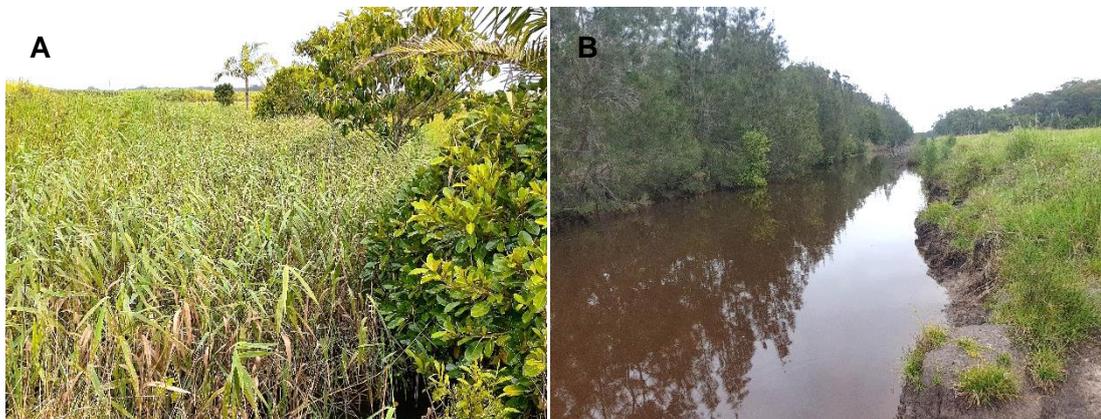
Figure B.5: Dense vegetation in the channel on Mosquito Creek represented by a Manning's n of 0.10 (A) and a clear channel on Keith Hall No. 1 Canal represented by a Manning's n of 0.04 (B)
