**COASTAL ROCK POOL SURVEY**

**OPTIONS AND RECOMMENDATIONS**

**JANUARY 2010**

Report Yamba Rock Pool January 2010 compiled by Greig McDowall Coordinator Open spaces East

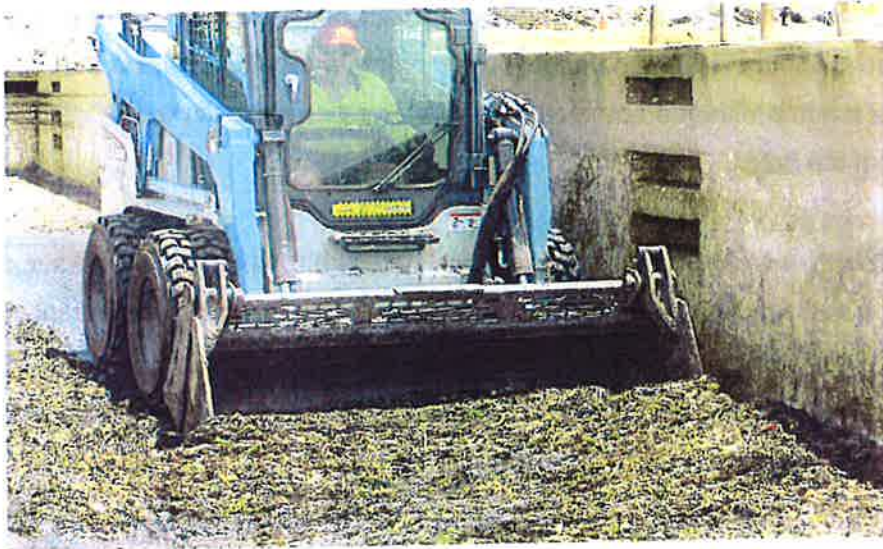
### Cleaning of Yamba Rock Pool January 2010

1. Positioning of the pool on the rock shelf. If the pool is placed on a rock shelf away from the Beach (in deep water) the quality of the water is less likely to be affected by sand and other sediment found in the inter-tidal zone. Yamba Rock Pool is situated in the southern corner of Main beach in the inter-tidal zone and has had major problems of sediment (sand and seaweed) since construction.

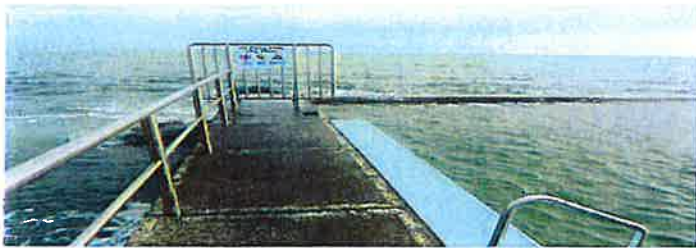
<b>HIGH TIDE OVERTOPS POOL</b>

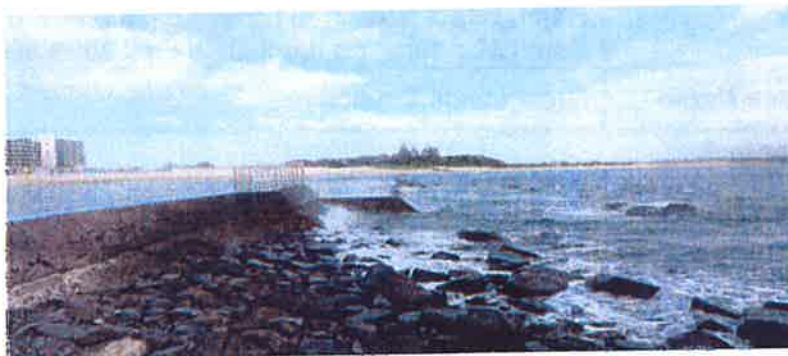
**ROCKSHELF**

**NOTE;** Through out the year the rock shelf is regularly covered by a build up of sand covering the pump intake and filling the pool with sand

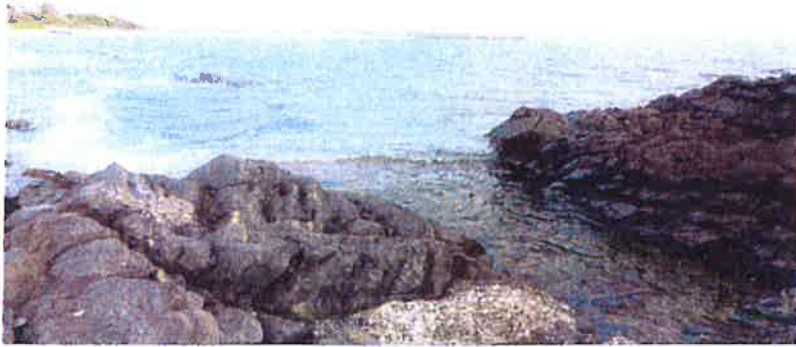
The pump intake has a grill to try and reduce the amount of rocks being drawn into the pump

**PUMPINTAKE**

**NOTE;** Through out the year the rock shelf is regularly covered by a build up of sand covering the pump intake and filling the pool with sand

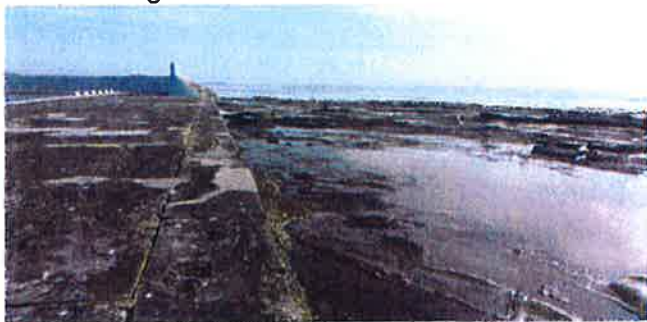
<b>EASTERN WALL</b>

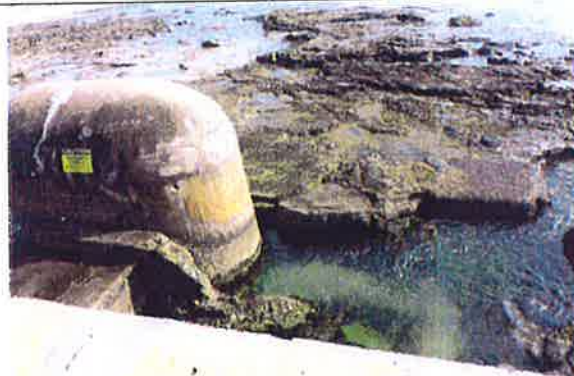
**PUMPHOUSE & INLET**

1. Pump Make No information
2. Size No information
3. Year of installation No information
4. Operational life of pump No information
5. Maintenance issues  
To much sand in pool intake (can fill up at times)impellers need regular maintenance
6. Annual cost
7. Other;  
There is restricted access for crane when pump is required to be remove for repair

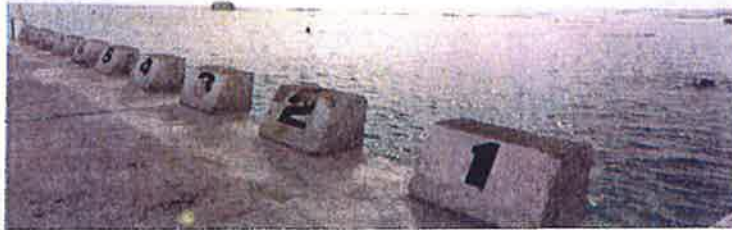
Nil other protection Baths are exposed medium and larger seas have direct impact

**MEDIUM & LARGER SEAS HAVE DIRECT IMPACT**

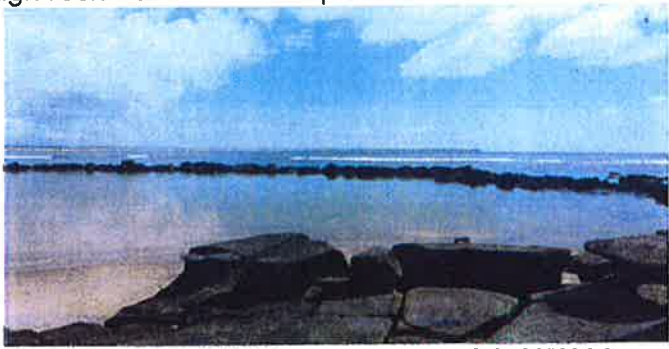
<b>WATER FLOWS THROUGH ROCK WALL</b>

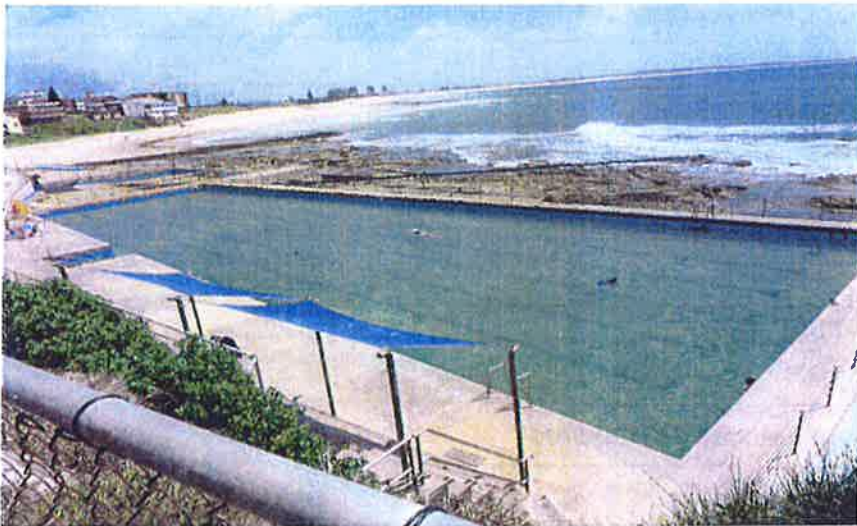
**ROCK POOL PRESENT DAY (AFTER UPGRADE)**

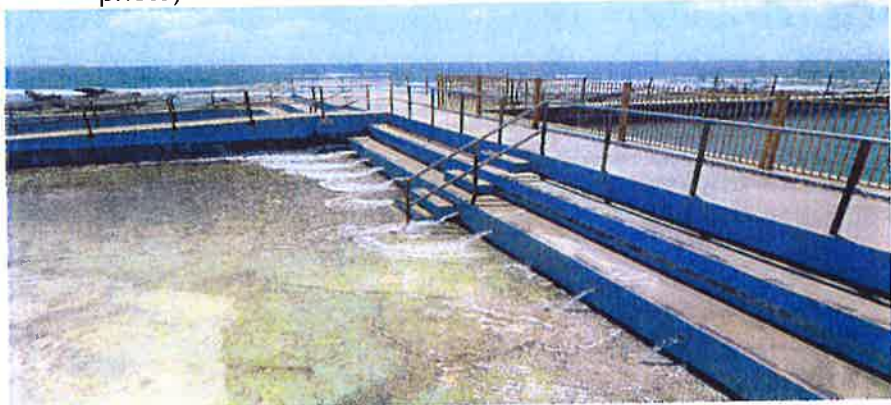
<b>EXTENSIVE STAINLESS STEEL HAND RAILING AND FENCING</b>

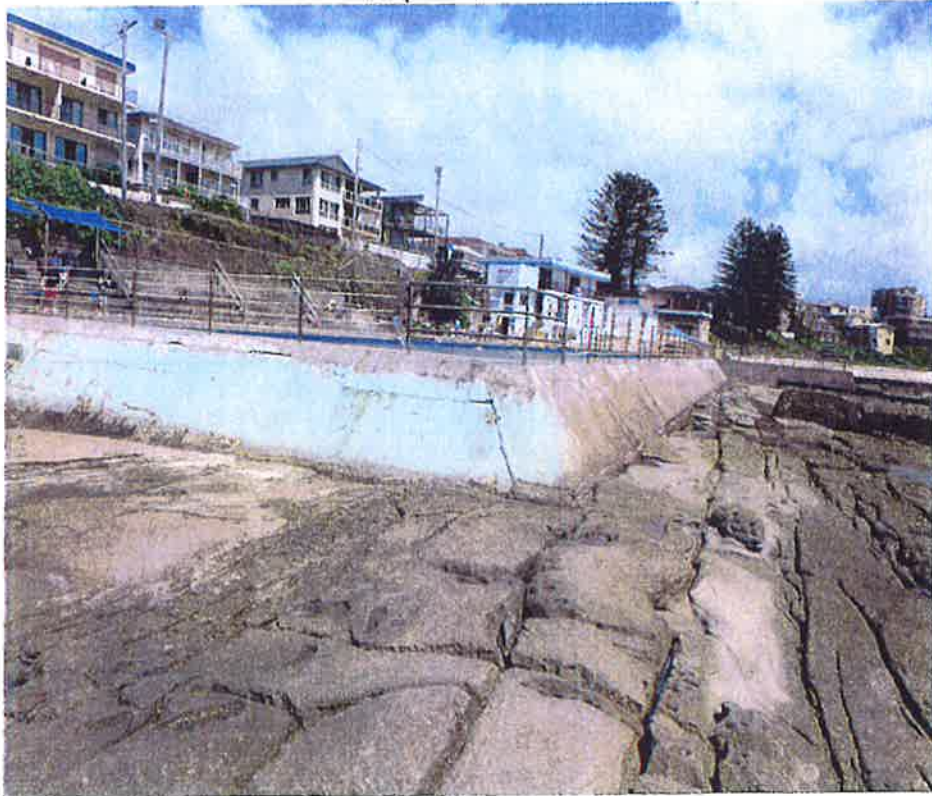
**The pool before the recent upgrade had major problems with sand and seaweed sediment ,similar to what is currently experienced in the Yamba Rock Pool**

**FURTHER INVESTIGATION OF THIS POOLS UPGRADE IS  
STRONGLY RECOMMENDED**

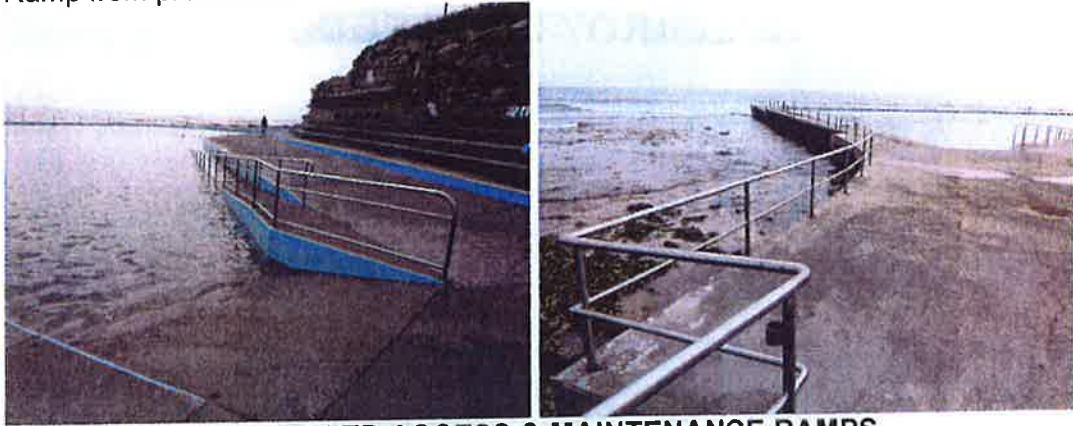
**DISABLED ACCESS & MAINTENANCE RAMPS**

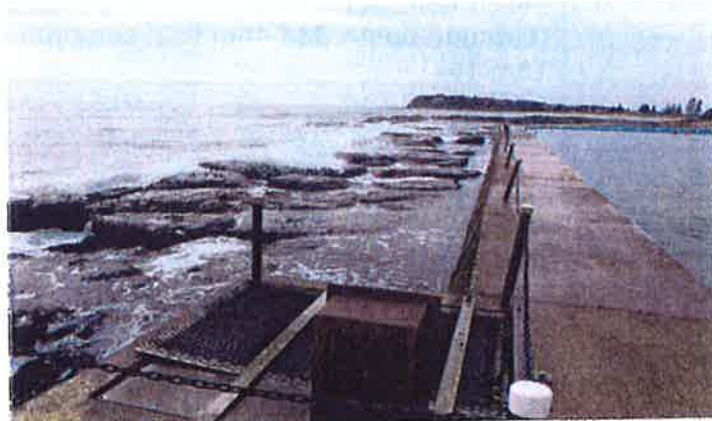
**ROCK SHELF WITH PUMP & PUMP INLET  
(FOREGROUND)**

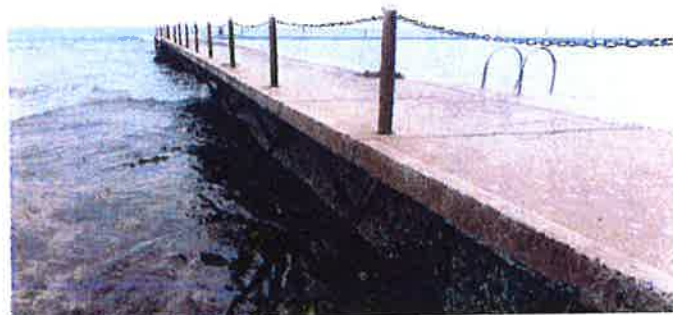
Wave wall is pool side, width at top 2 – 2.5 metres.  
On western side the pool deck is cantilevered using stainless steel supports (see photo )

**CANTILEVERED USING STAINLESS STEEL SUPPORTS**

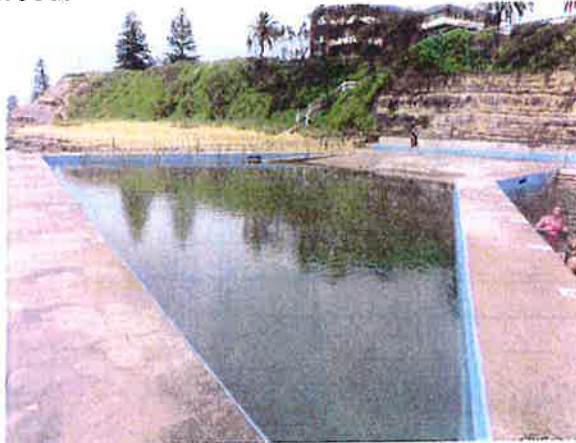
**TODDLERS POOL**

The toddlers pool on the eastern side of the main pool acts as a wave wall and at times a trap for seaweed.

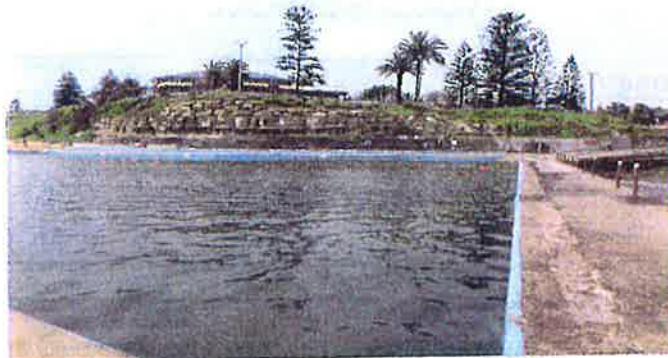
Major refurbishment undertaken 3 years ago

**MAJOR REFURBISHMENT 3 YEARS AGO**

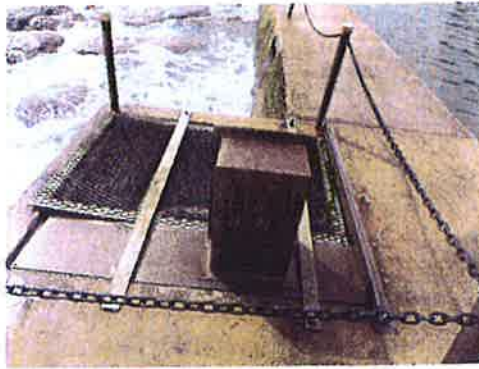
**PUMP & PUMP INLET**

6. Other; Note pump is computer controlled to automatically adjust it operational time to the changing high tide.

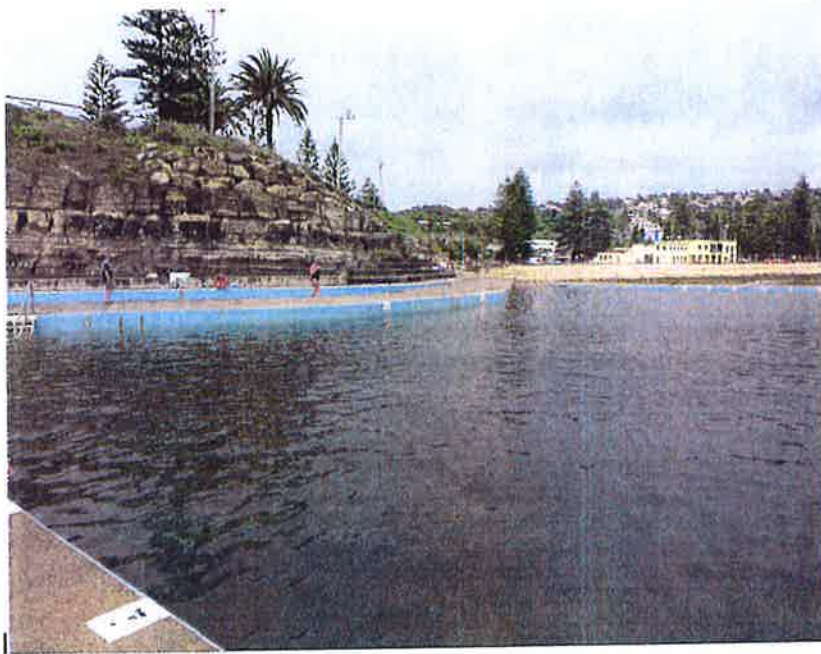
- Collaroy Pool is well used and well looked after.
- If pool floor and walls were raised the pool would be out of the tidal influences eliminating seaweed in the pool in all but large seas associated with storm events.
- The raised floor level would give greater flexibility in the emptying of the pool (not just on the low tide).
- The pump inlet is fairly well positioned; but is still impacted by seaweed build-up from time to time. Investigations should be made to identify other sites for pump inlet relocation.

**COLLARROY POOL IS WELL USED AND WELL MAINTAINED**

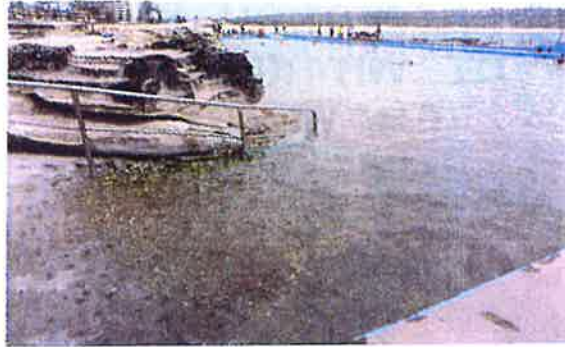
**ACCESS RAMP**

Access is gained from car park by path to south eastern corner of pool to ramp.

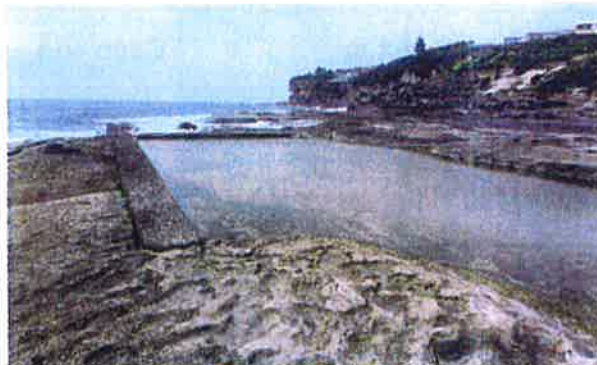
On the eastern side of the pool there is a shallow old low walled pool that acts as a barrier

**SHALLOW LOW WALL POOL EASTERN SIDE**

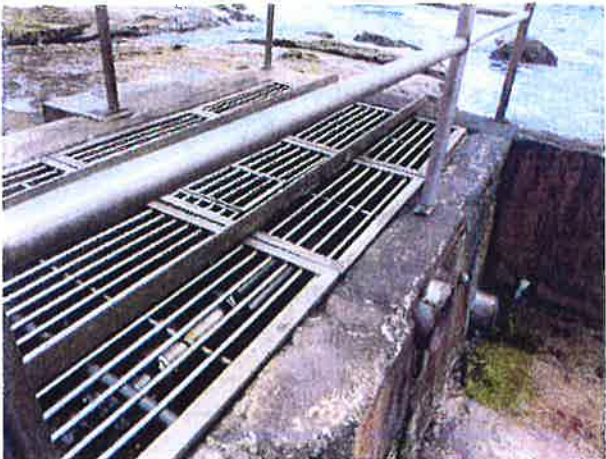
<b>PUMP HOUSE</b>

1.			
2. Size			
3. Year of installation			
4. Operational life of pump; 6 – 10 years			
5. Maintenance issues annual service , impeller ware			
6. Annual cost; Pumps for 6 pools are maintained /replaced by Contractors \$75,000

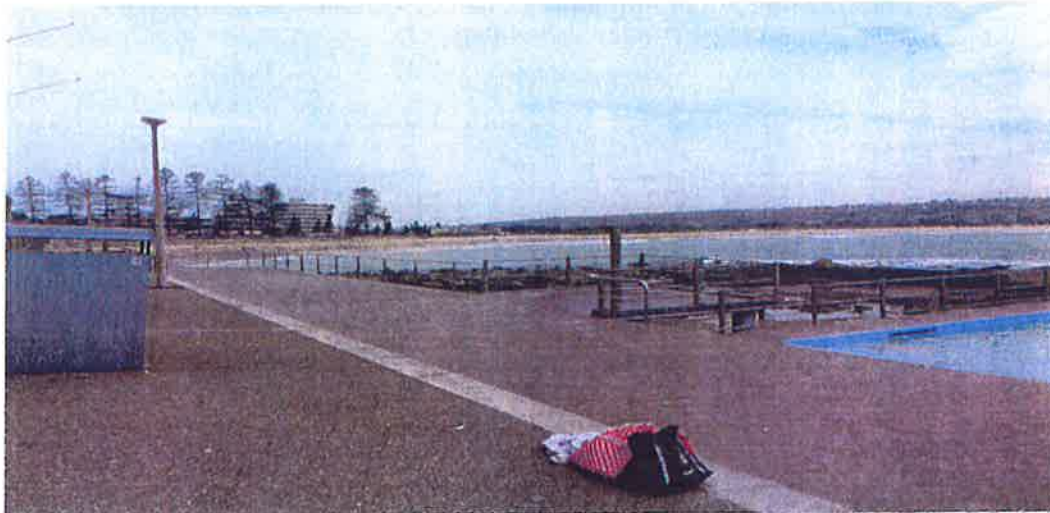
**PROMENADE WITH SUSPENDED SHOWER PLATFORM**

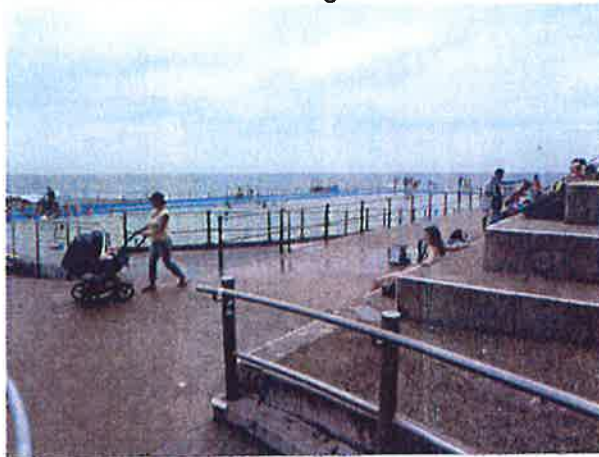
- Replacing of the north and western walls. The walls had major concrete cancer.
- resurfacing the promenade 2 pack epoxy expensive but good
- replace and install new had railings

**HAND RAILS & AND PROMENADE**

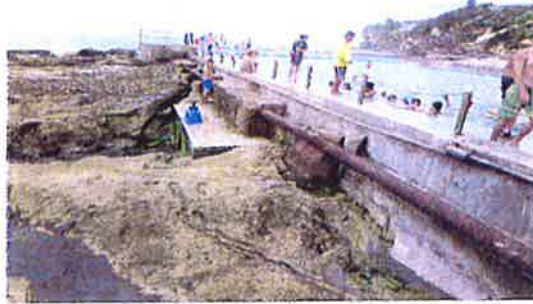
**DRAINAGE VALVE**

- Dee Why pool is well used and in excellent condition.
- If pool floor and walls were raised the pool would be out of the tidal influences eliminating sand and seaweed from the pool in all but large seas
- The pools drainage valve works effectively.

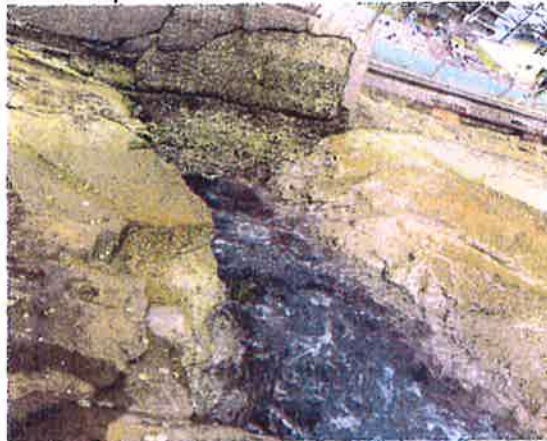
**PUMP INLET**

- The pump inlet is well positioned in deep water with little or nil sediment build-up.

- The pools position on the rock shelf away from the beach allows for cleaner water in the pool when compared to pools that are constructed closer to the beach.
- With respect to Yamba's rock pool if a pump is used to fill the pool great care should be made in the positioning of the inlet, this should be in a area of the least build up of sand and seaweed. (the deeper the water the better.

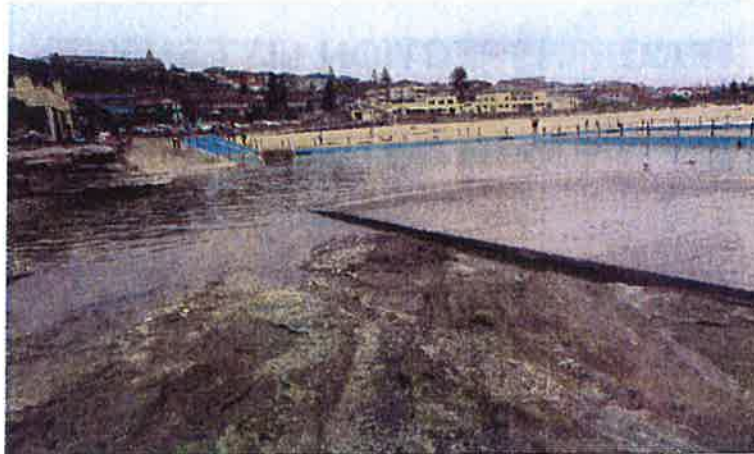
**ACCESS RAMP & STEPS**

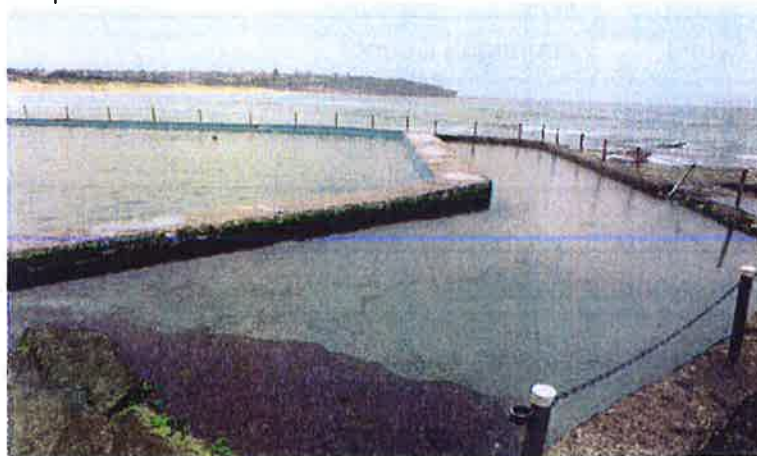
**WAVE WALL**

East side wave wall 25 metres long, 4 – 5 metres from pool, same height as pool

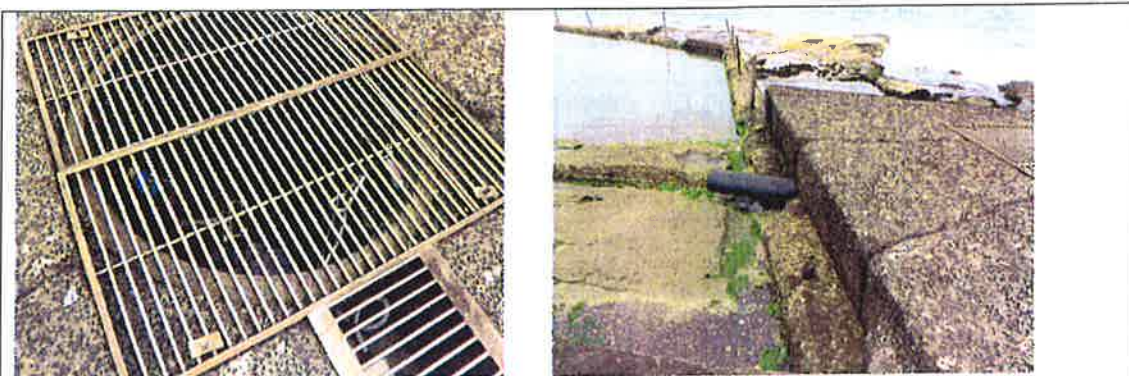
PUMP

- 1.
2. Size
3. Year of installation
4. Operational life of pump; 6 – 10 years
5. Maintenance issues; annual service , impeller ware
6. Annual cost; Pumps for 6 pools are maintained /replaced by Contractors \$75,000

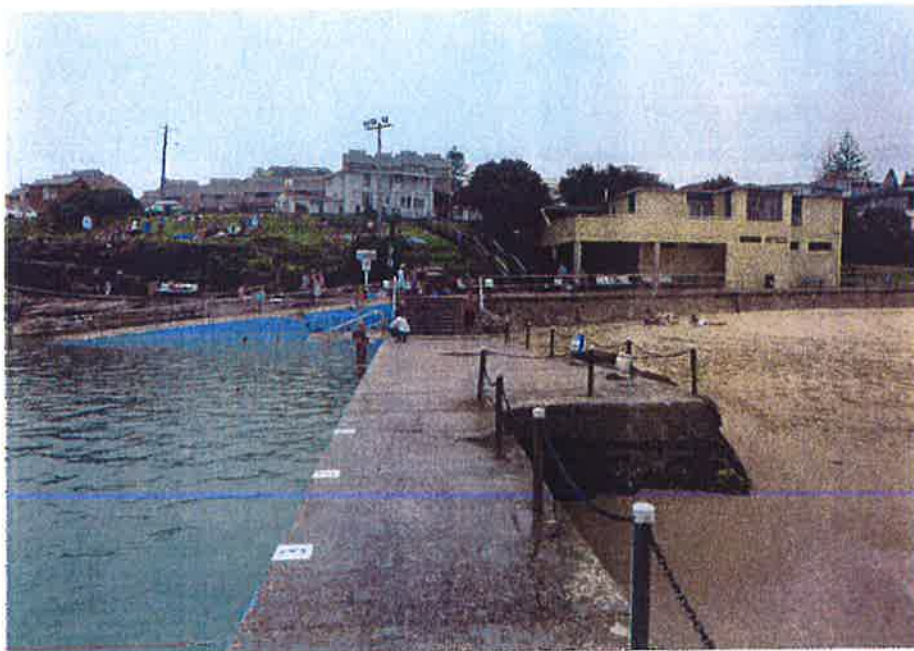
**POOL HAS A HIGH LEVEL OF USE**

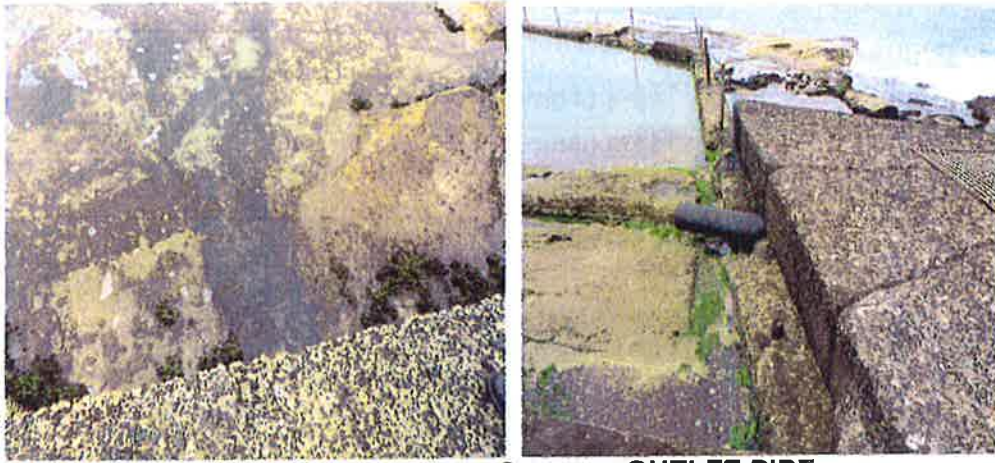
- The pool sediment problems are similar to Yamba Pool (not as severe)
- The pool has a pump that circulates fresh water through the pool and is of better quality than Yamba Rock Pool.
- The pool water quality would be greatly increased if the wall height was raised restricting the amount sediment entering the pool on the higher tide.
- The inlet pipe for the pump can not operate on low tide
- Pump is programmed to operate on high tide
- Warringah council that they are required to undertake a major refurbishment of their rock pools every 10 – 12 years

**INLET PIPE**

**& OUTLET PIPE  
(At low tide)**

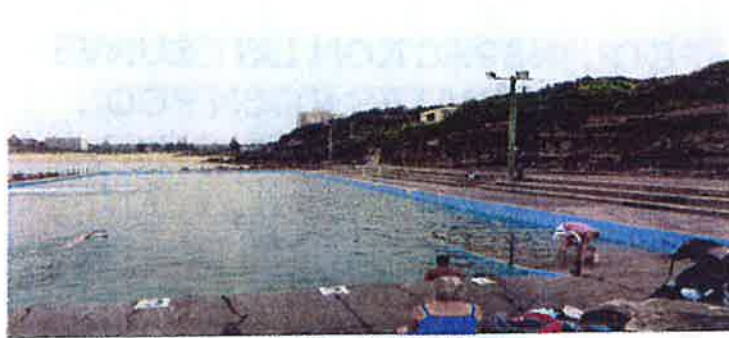
**ACCESS RAMP**

Access is by ramp eastern end of pool, path from car park to rock shelf

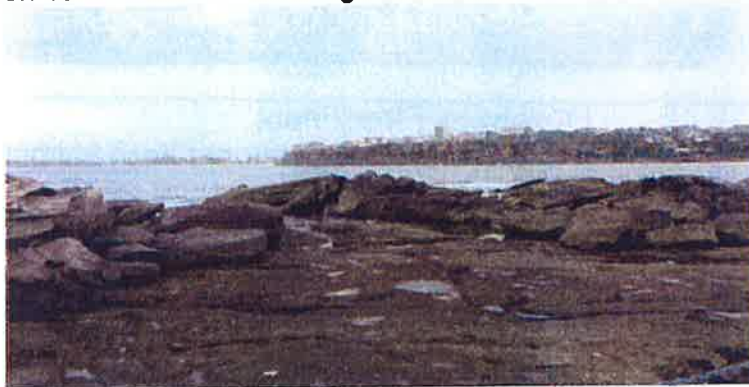
- The rock shelf on the southern and western sides is extensive ranging between 15 – 30 metres with large boulders .

**LARGE BOULDERS ON THE ROCK SHELF**

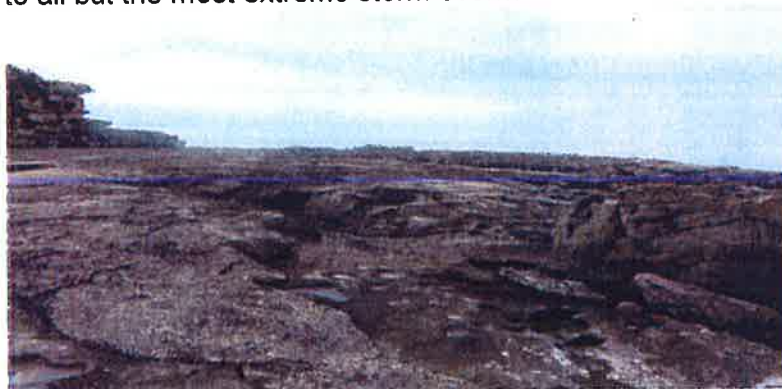
- The Eastern side the shelf raises well above pool height giving protection to the pool to all but the most extreme storm events

**ROCK SHELF RAISES WELL ABOVE POOLHEIGHT  
(Eastern Side)**

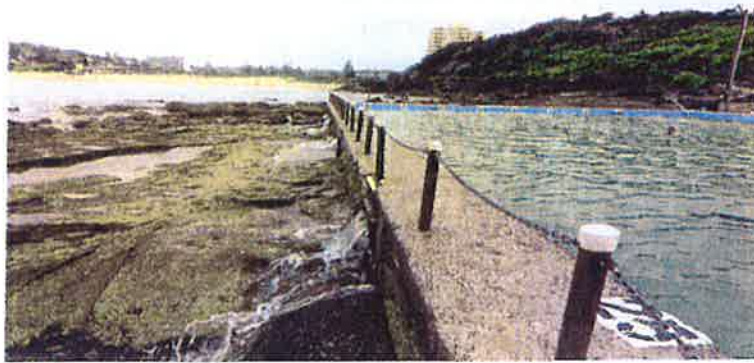
**POOL / WAVE WALL**

The pool wall is the wave wall

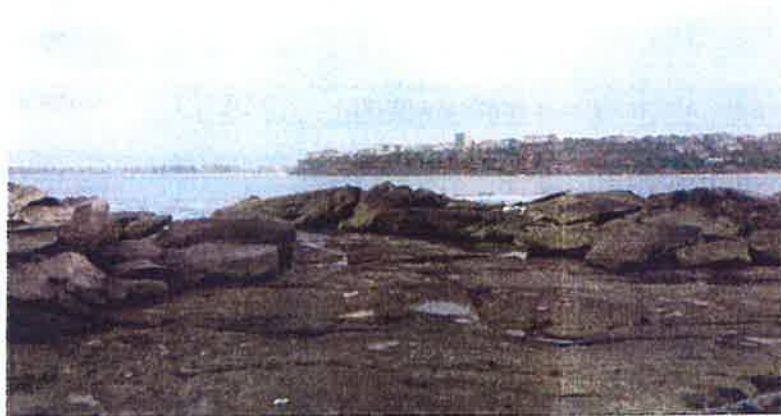
The rock shelf has large boulders laying over it in the southern and western sides of the pool these make a natural barrier.

**LARGE BOULDERS  
(Southern & Western sides)**

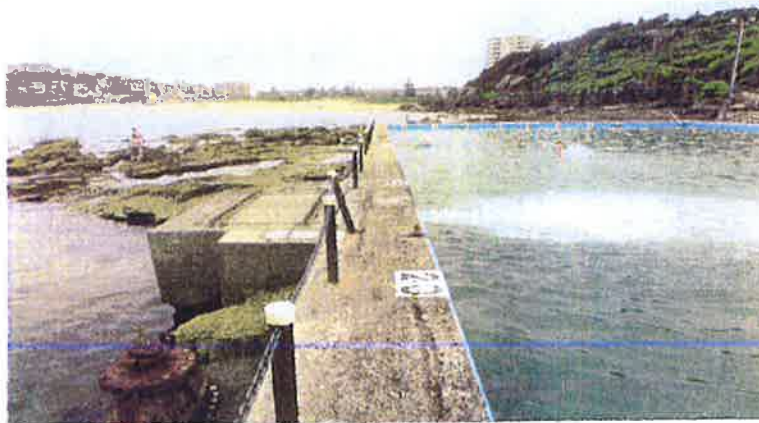
**PUMP HOUSE AND INLET**

- Repairs are on going as needed
- it is planned to deepen the trench for the pumps inlet pipe

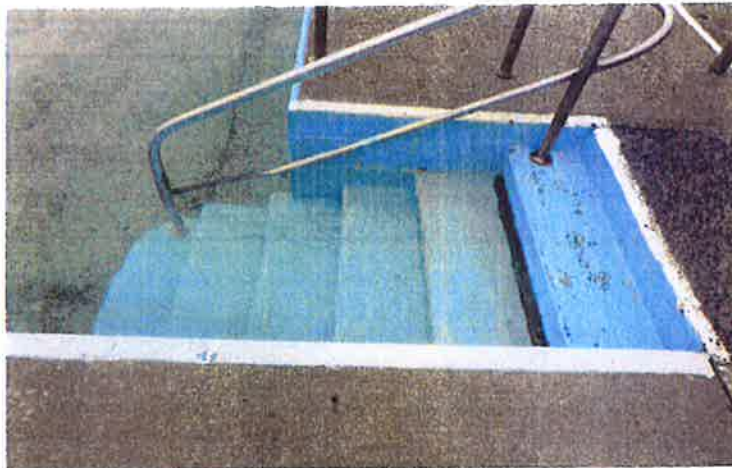
**PAINTED STEPS**

Pool Paint-supplier-Paintec Pty Ltd – product –Chlorinated Rubber Based paint.  
Applied every two years approximate cost \$2,000

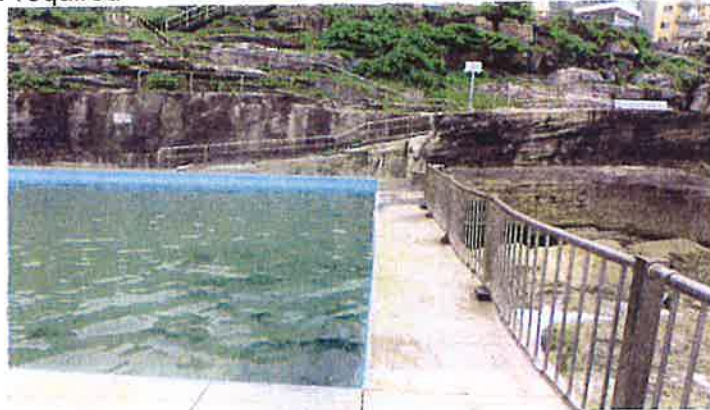
Pool access is limited to two stair ways or across sand from Queenscliff Surf club making maintenance difficult .pumps having to be dragged up the stairs when maintenance is required

**LIMITED ACCESS  
(2 Stairways)**

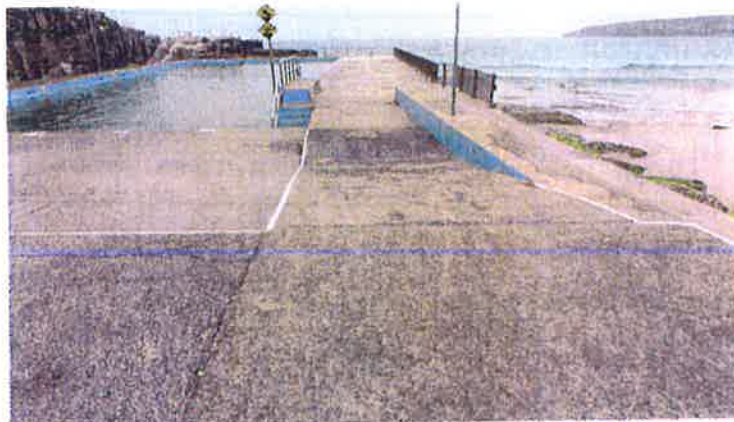
1. Rock Shelf (short description, e.g. length, width, height, other)  
Rock shelf eastern side of pool only 1/3 width only, 2 metres above pool deck.

**ROCK SHELF EASTERN SIDE OF POOL  
(1/3 Only)**

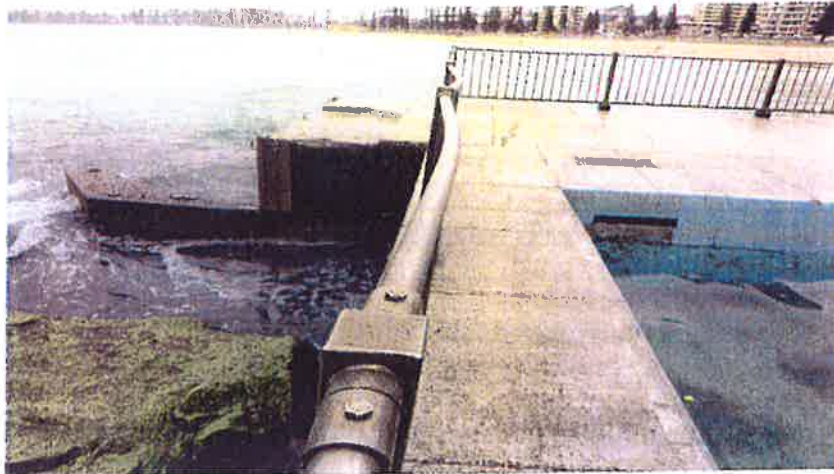
Southern side of pool large outlet 4 – 5 metres wide gives some additional protection

**LARGE OUTLET 4 – 5 METRES WIDE  
(Southern Side)**

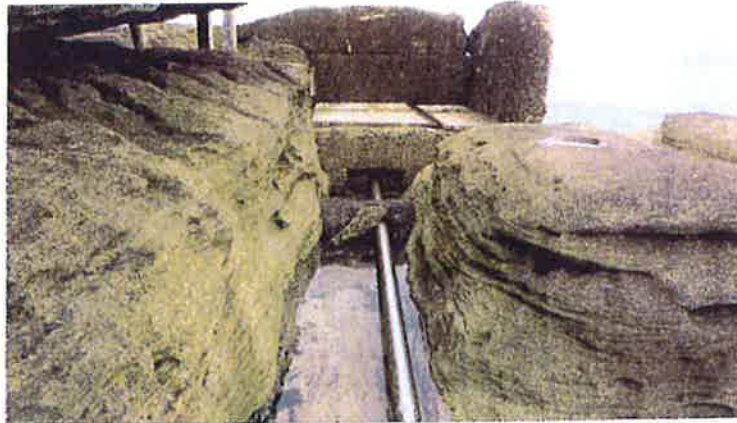
**PUMP HOUSE & STAINLESS STEEL INLET PIPE**

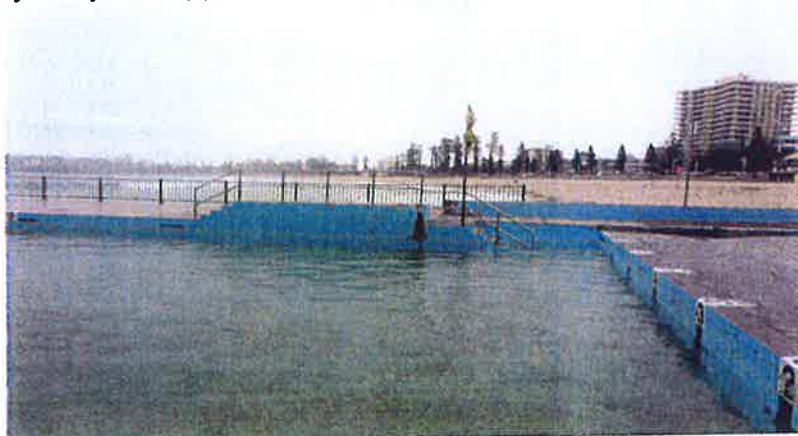
**POOL PAINTED EVERY TWO YEARS**

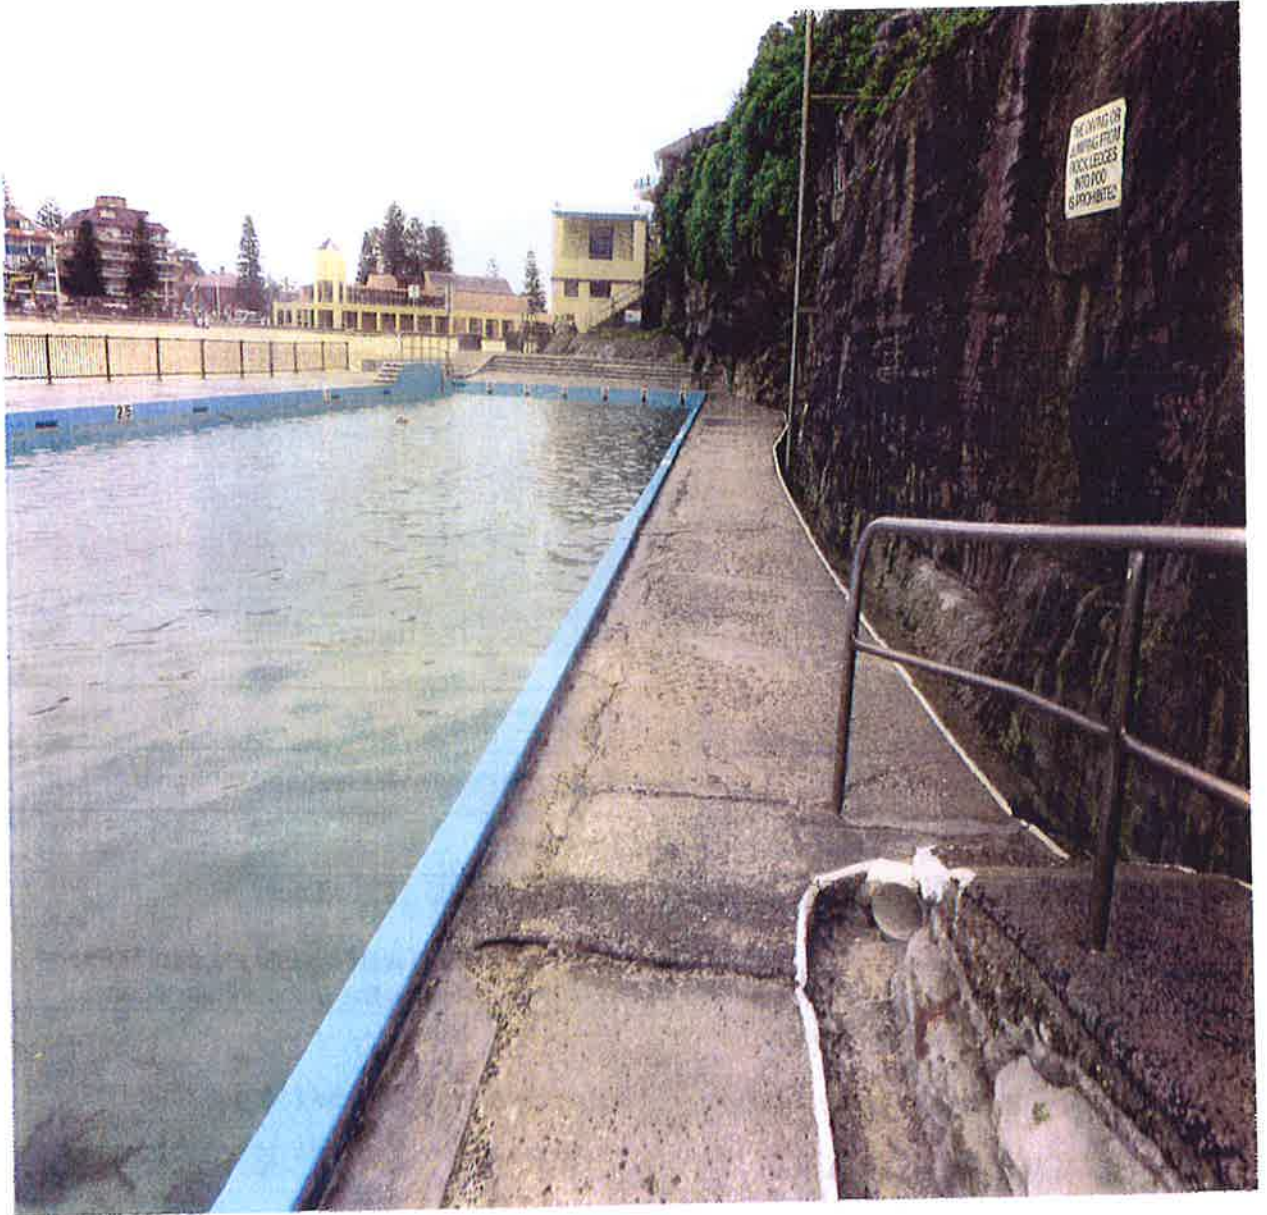
**POOL ACCESS IS BY 2 SETS OF STEPS OR ACROSS SOFT SAND FROM SURFCLUB**

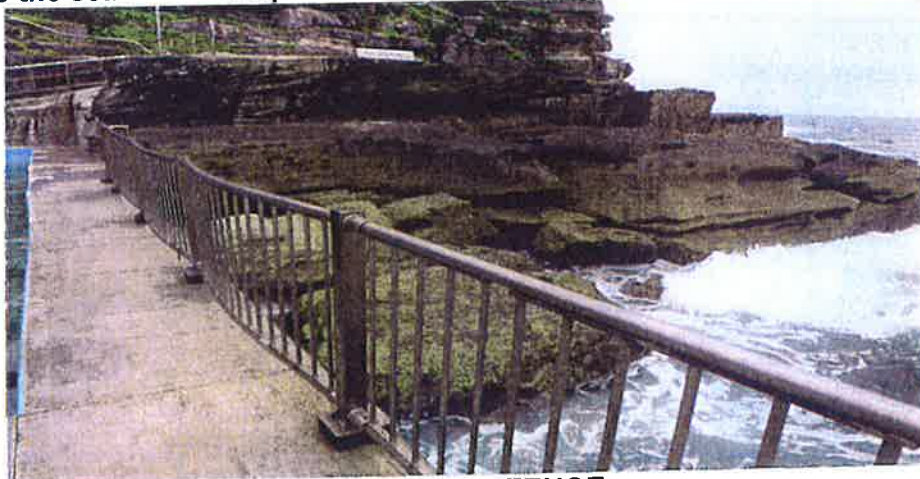
**STAINLESS FENCE  
(Eastern and Southern sides)**

The fence was erected to keep the seaweed from the pool it has not been successful .**Note;** the bent fence panels caused by the wave action coupled with a build up of seaweed in the grates of the fence (this is similar to the bent grates found on Yamba's Rock Pool.)

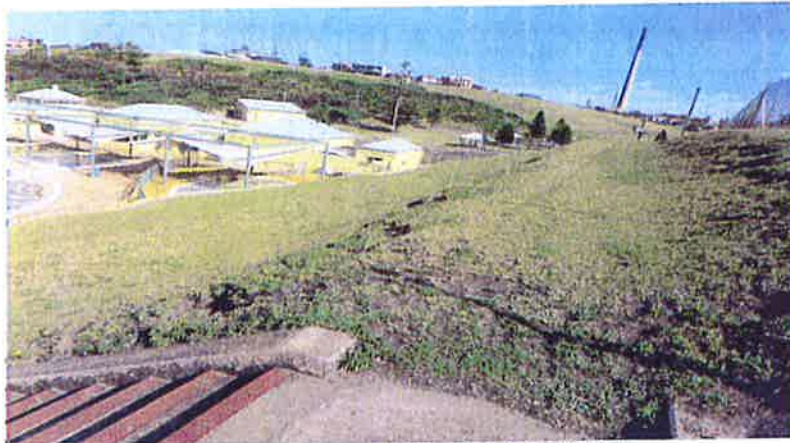
There is limited pool access this is either by way of the front entrance or by a gate in the western fence to the grassed area

**ACCESS GATE WESTERN FENCE  
(Grassed Area)**

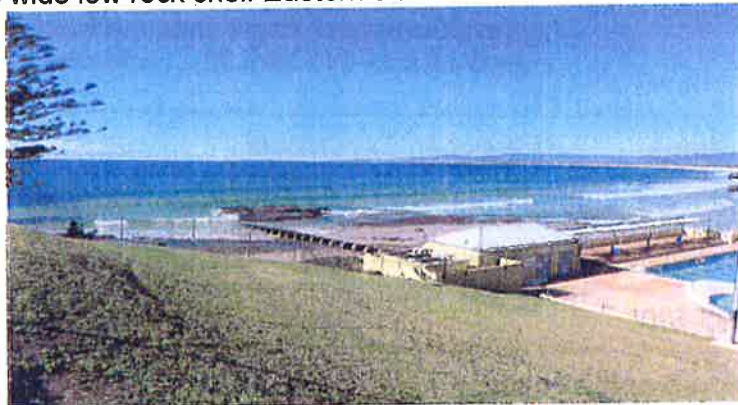
**ROCK SHELF**

1. Rock Shelf (short description, e.g. length, width, height, other)  
50 metres wide low rock shelf Eastern side

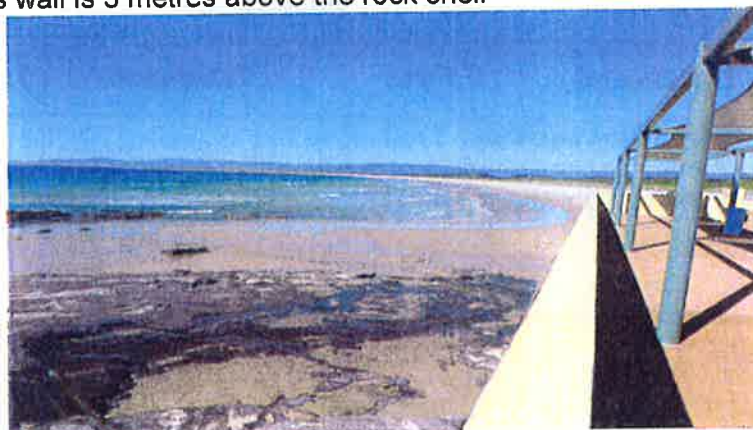
**POOL WALL**

2. Wave wall (short description, e.g. length, width, height, other)  
The pools wall is 3 metres above the rock shelf

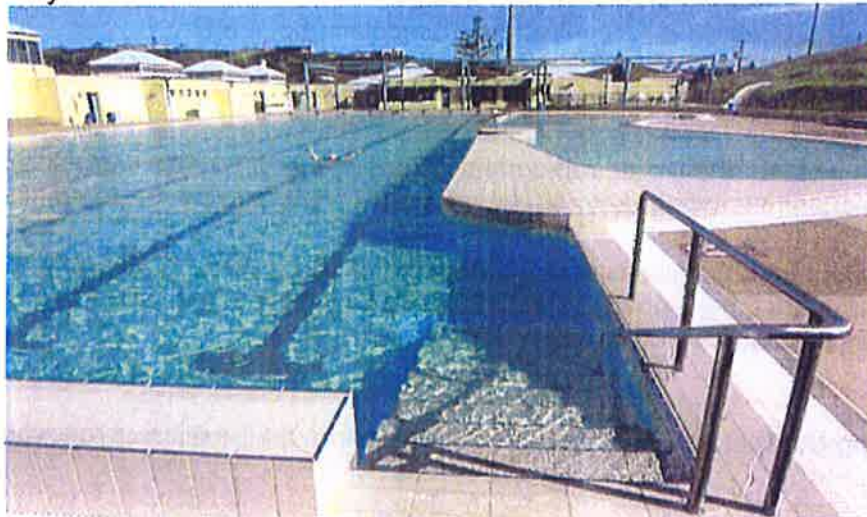
Pool is fully Tiled

**TILED POOL**

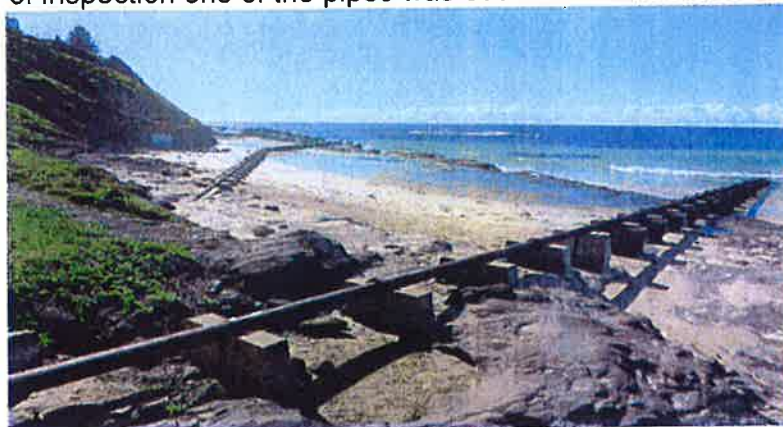
The pump has two ocean inlet pipes, from time to time these pipes are covered in sand at time of inspection one of the pipes was out of action because of this

**THE TWO INLET PIPES**

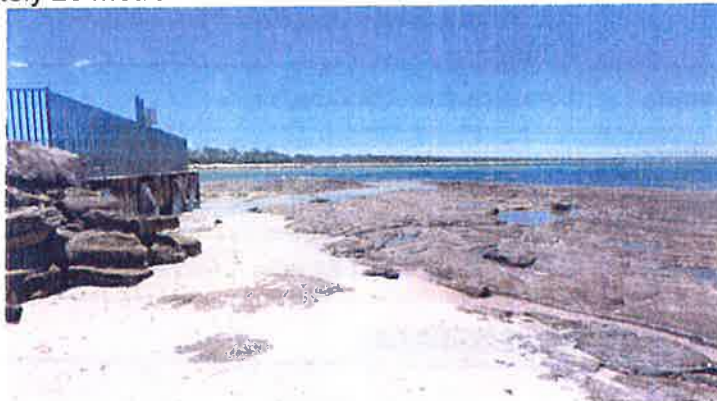
**ROCK SHELF**

1. Rock Shelf (short description, e.g. length, width, height, other)  
The eastern side of the pool has a low rock shelf that is underwater at high tide approximately 20 metres wide.

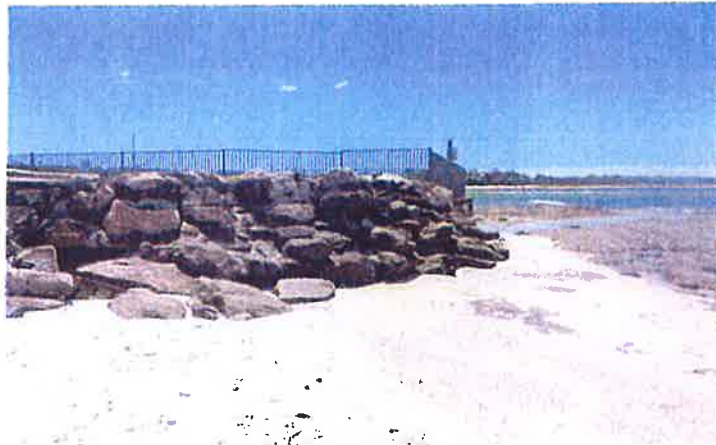
WAVE WALL

There is a 10 – 15 metre long x 2 metre high stone wall on the south eastern corner of the pool.

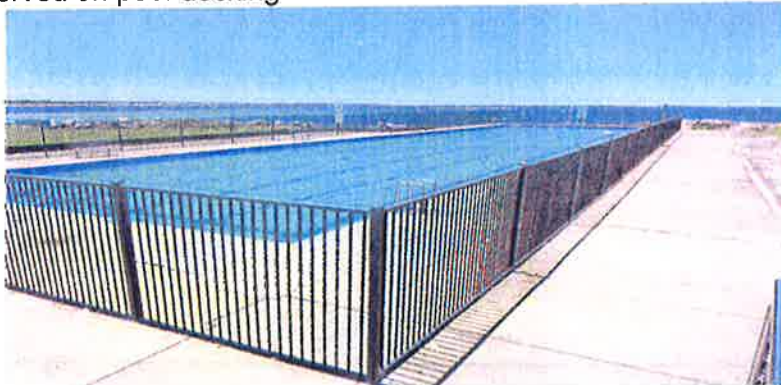
3. Details of any expansion joints and the system used  
 Rubber observed on pool decking

**RUBBER EXPANSION JOINTS POOL DECK**

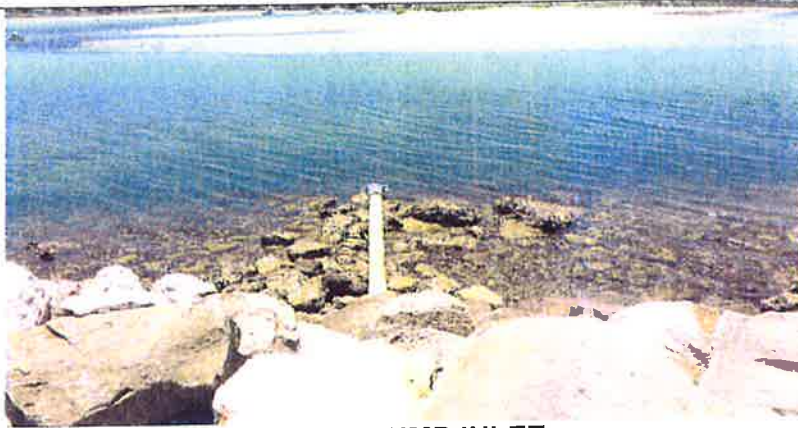
1. Pump Make CMG 3phase
2. Size; no information available
3. Year ;of installation no information available
4. Operational life of pump; no information available
5. Maintenance issues; no information available
6. Annual cost; no information available
7. Other;
  - The pump inlet is in the river this delivers a high standard of water quality.

**RIVER PUMP INLET**

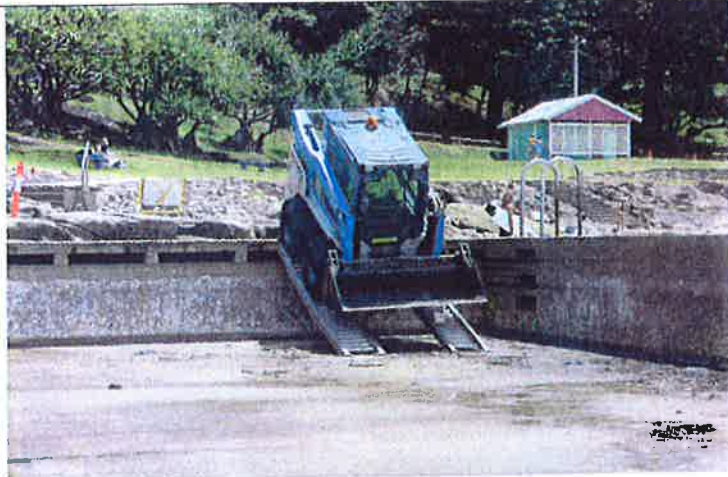
**POOL MAINTAINANCE ACCESS**

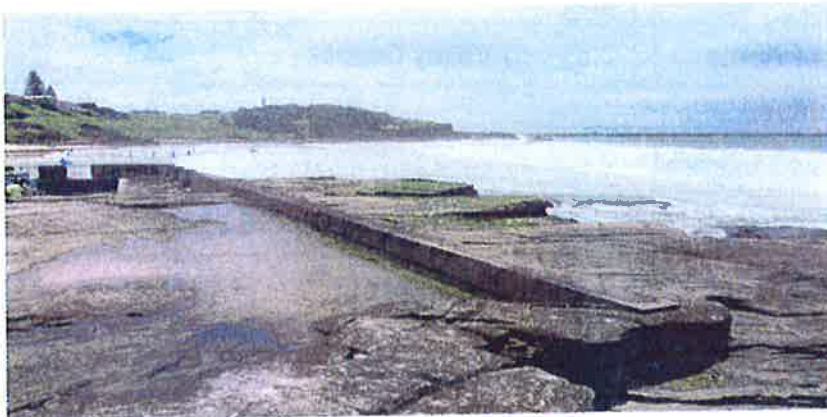
**ROCK SHELF**

1. Rock Shelf (short description, e.g. length, width, height, other)  
The rock shelf is 5 metres wide on the Eastern side of the pool ,nonexistent in the North eastern quadrant of the pool and extends around the headland to Convent Beach in the south.

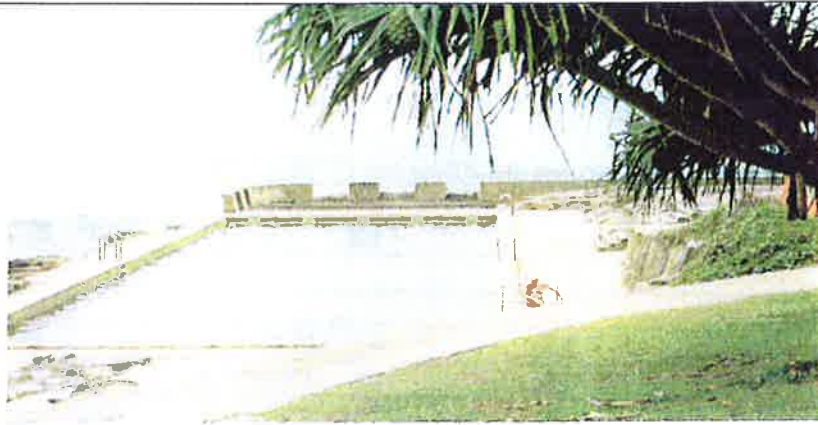
**WAVE WALL**

2. Wave wall (short description, e.g. length, width, height, other)  
Yamba pool's wave wall is approximately 1 metre above the pool deck in the North East quadrant of the pool, while keeping its height in relation to the pool deck the wall continues along the Eastern side of the pool for 18 – 20 metres finishing flush with the rock shelf  
Except for the Stainless Steel grates The wall is a effective sea barrier,  
The grates allow seawater to spill through them to fill the pool a majority of the sediment found in the pool enters in this way
