8.3 Ballina Uniting Church - Structural Inadequacy.DOC

Re: Monitoring Report of Structure, Uniting Church Cherry Street Ballina.

Structural Condition Report
Uniting Church, Cherry Street, Ballina

Uniting Church 54 Cherry Street, Ballina

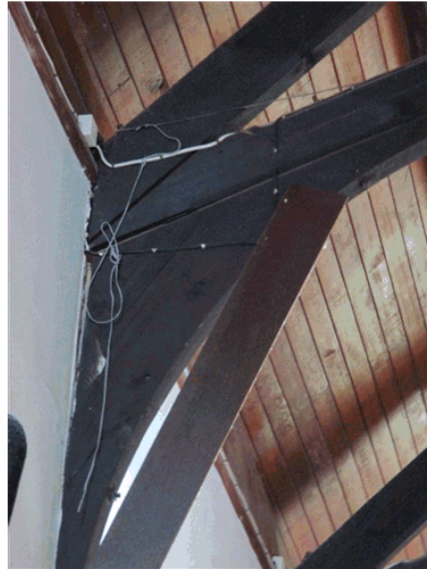
Photo 6 -

Separation between the walls and some of the decorative timber framing to the trusses can be seen (Refer to Photo 6).

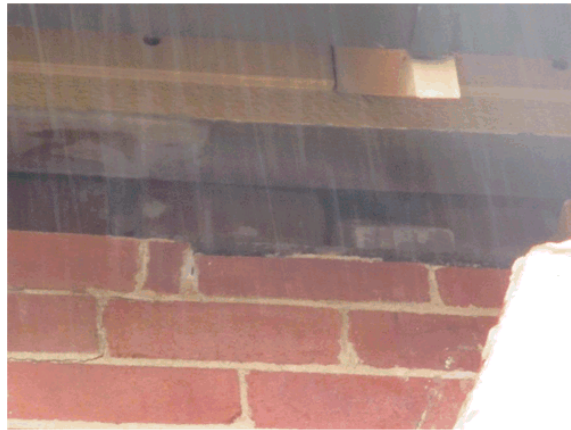
Photo 8 -

From the exterior open brick work pockets reveal the timber truss ends. Access to the top of the walls and the truss supports was not provided, Hence a close up visual inspection of the truss supports has not been performed. (Refer to Photo 8).
